DRAFT
Limited Site Assessment and
Hazardous Building Materials Survey
Former Arctic Village Power Plant
Arctic Village, Alaska

May 2016

**LIMITED SITE ASSESSMENT AND
HAZARDOUS BUILDING MATERIALS SURVEY
FORMER ARCTIC VILLAGE POWER PLANT
ARCTIC VILLAGE, ALASKA**

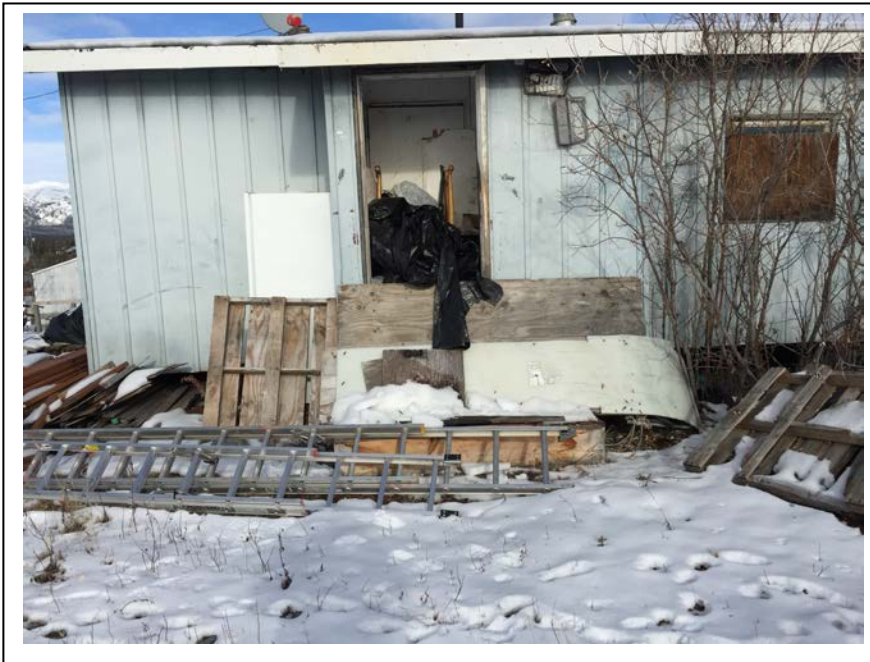
Photograph 1: Looking north at the former power plant.
(September 22, 2015)

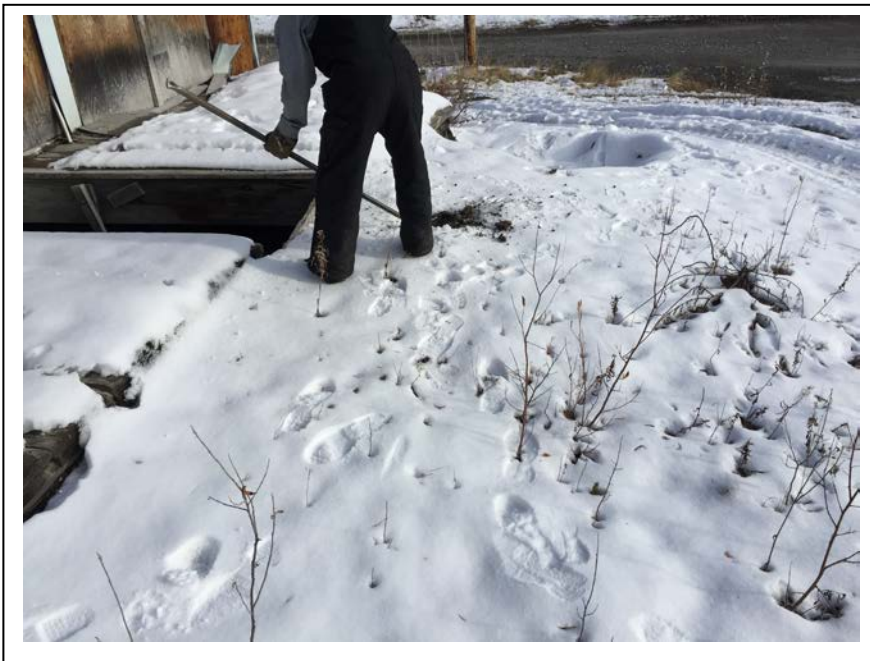
Photograph 2: Looking west at the location of Sample SS3 near
the location of the former aboveground storage tanks.
(September 22, 2015)

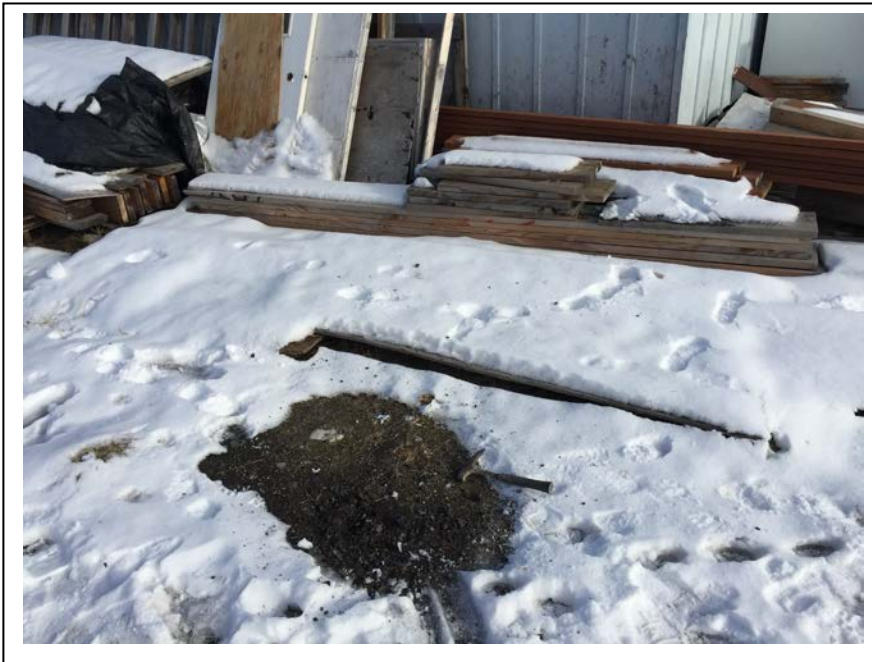
Photograph 3: Potential staining and the location of Sample SS1. (September 22, 2015)

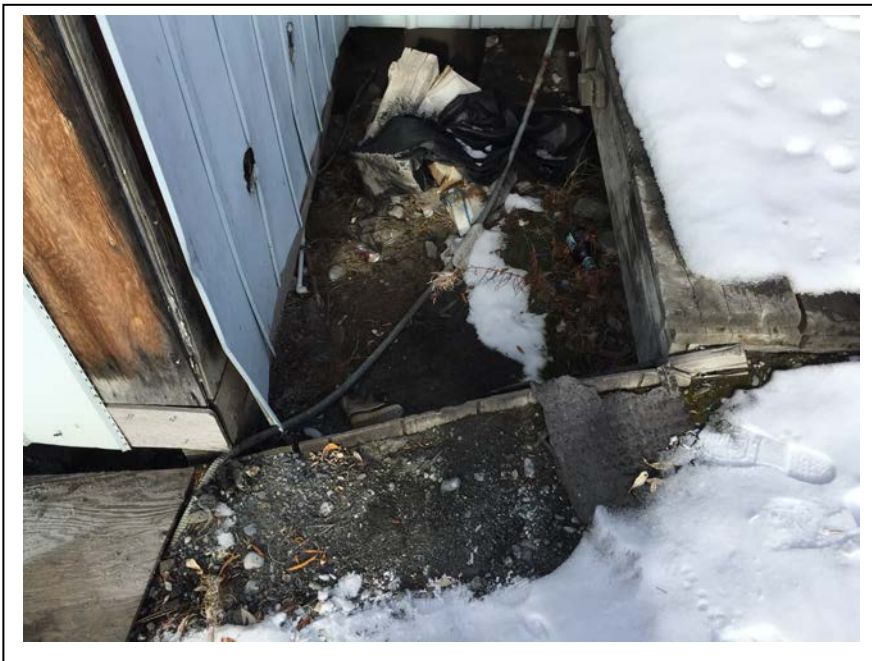
Photograph 4: Location of Sample SS11. (September 22, 2015)

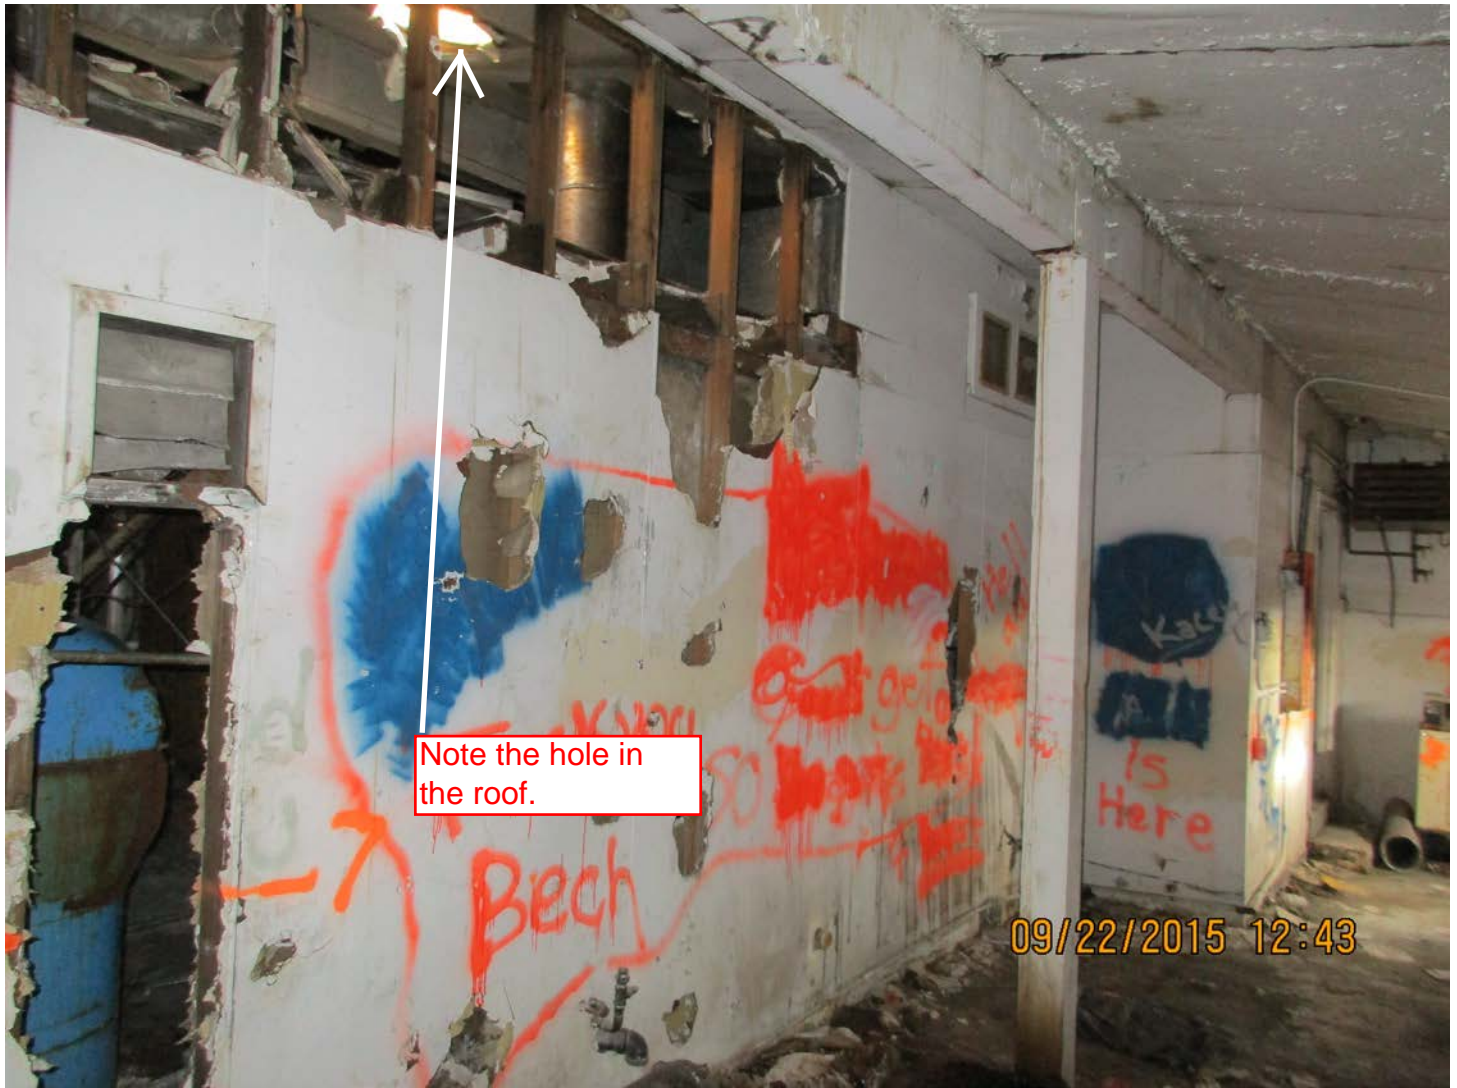
EHS-Alaska’s field inspector performed a visual examination of the building for suspected fungal growth. Fungal growth was observed throughout the mechanical room, laundry room, and bathroom area. Water was entering the ceiling area above the mechanical room due to missing roof vents. Due to the black discoloration of most of the walls and ceilings due to what appears to be soot from the diesel generator, it was difficult for EHS-Alaska’s field

Figure 2 – The wall separating the laundry room and mechanical room. Note the hole in the roof above the mechanical room.

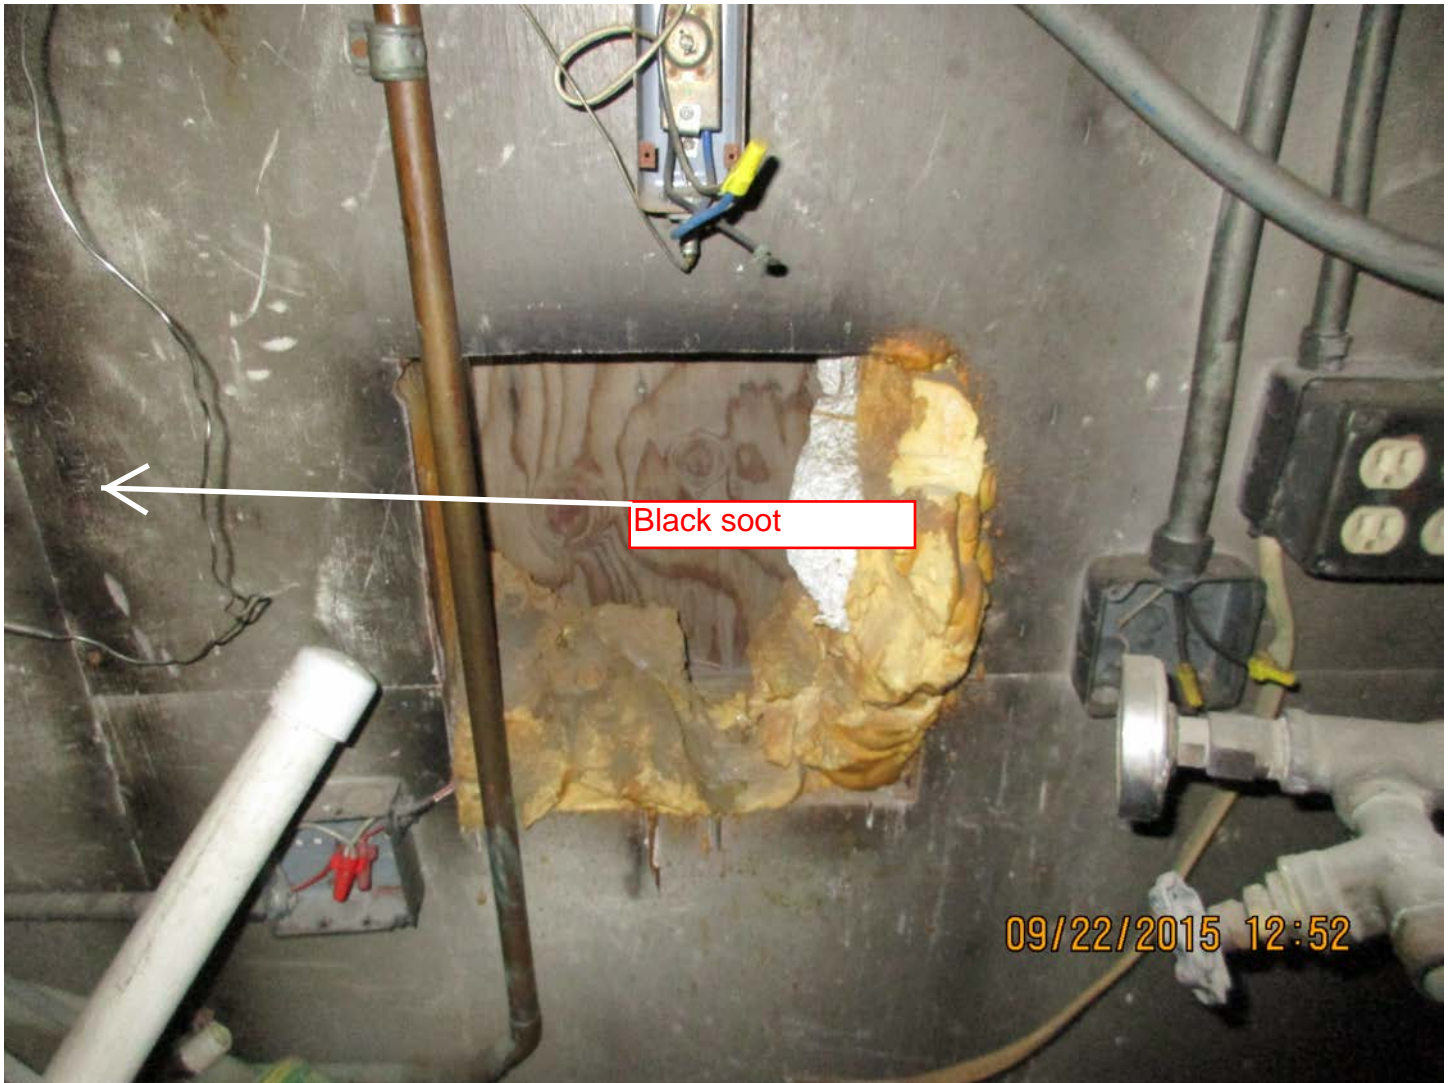
Figure 3 – Black soot on wall in Tank room.

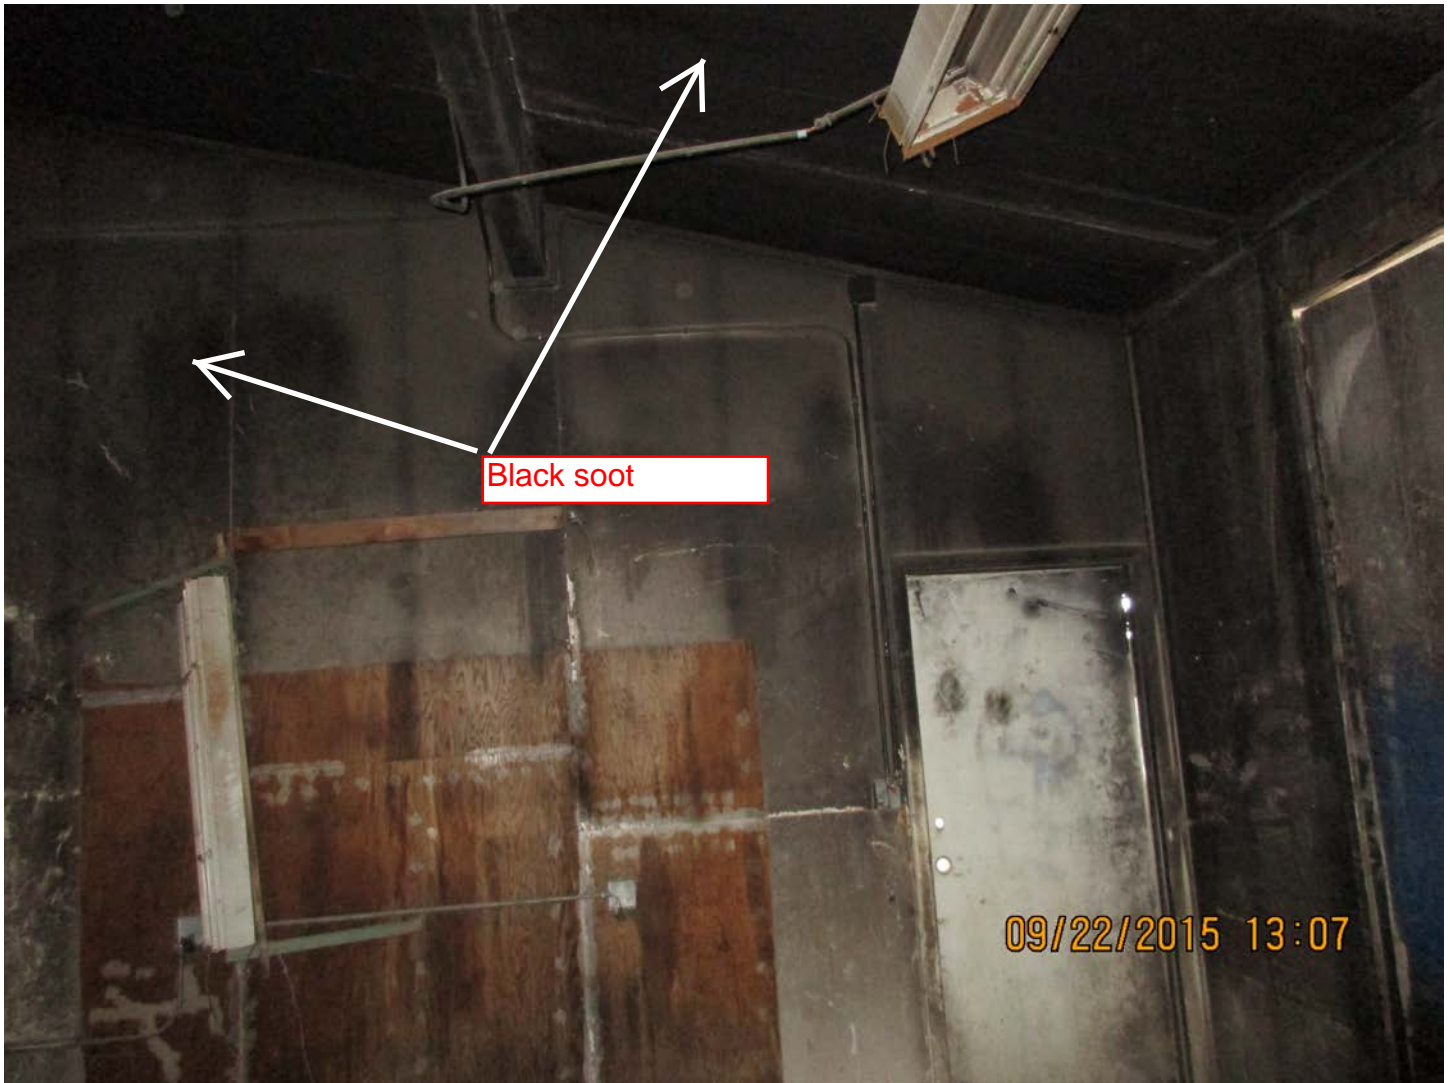
Figure 4 – Black soot on walls and ceiling of shop area S1.

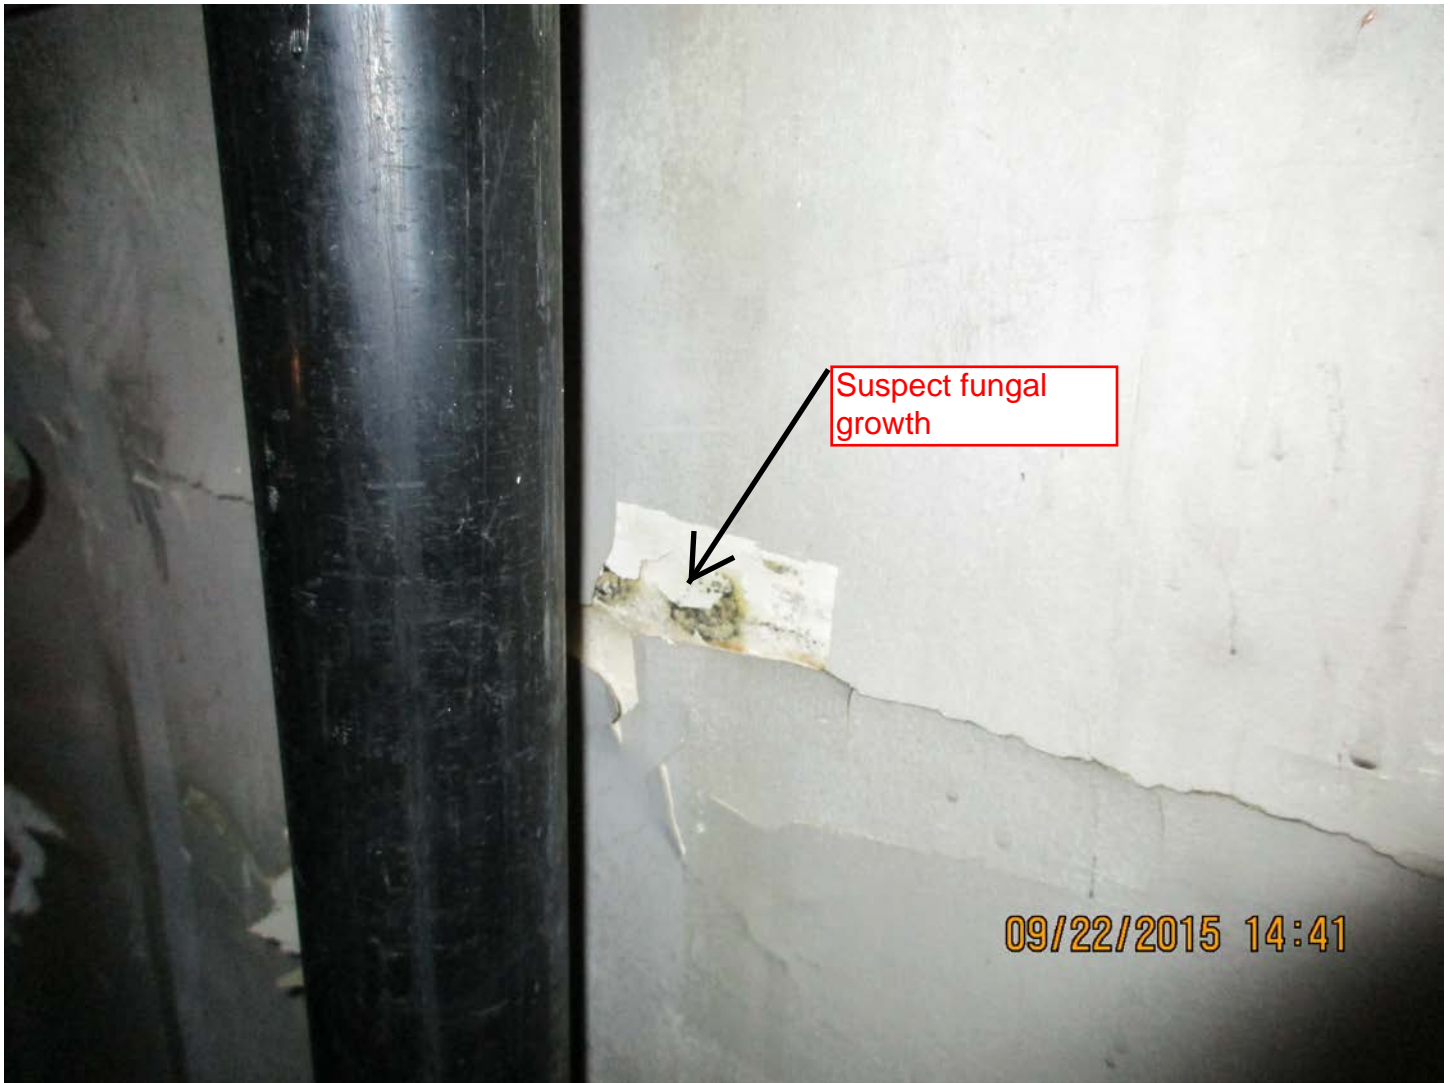
Figure 5 – Suspect fungal growth between the paint layer and gypsum wall board in the mechanical room.

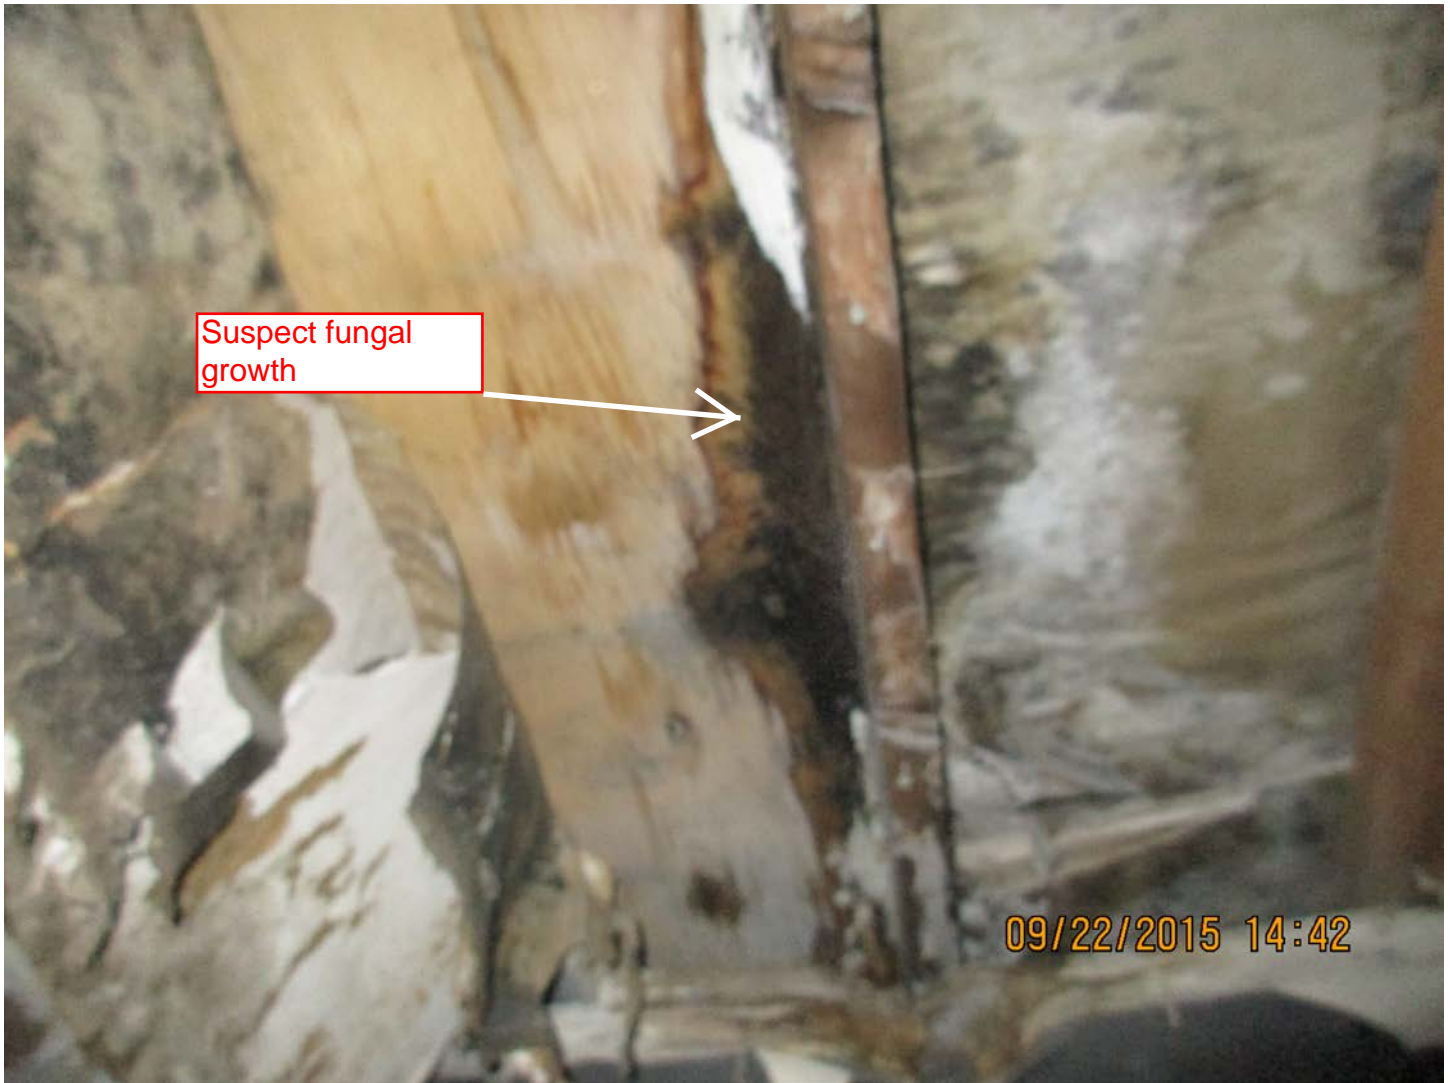
Figure 6 – Suspect fungal growth on wood members in the ceiling of the mechanical room.

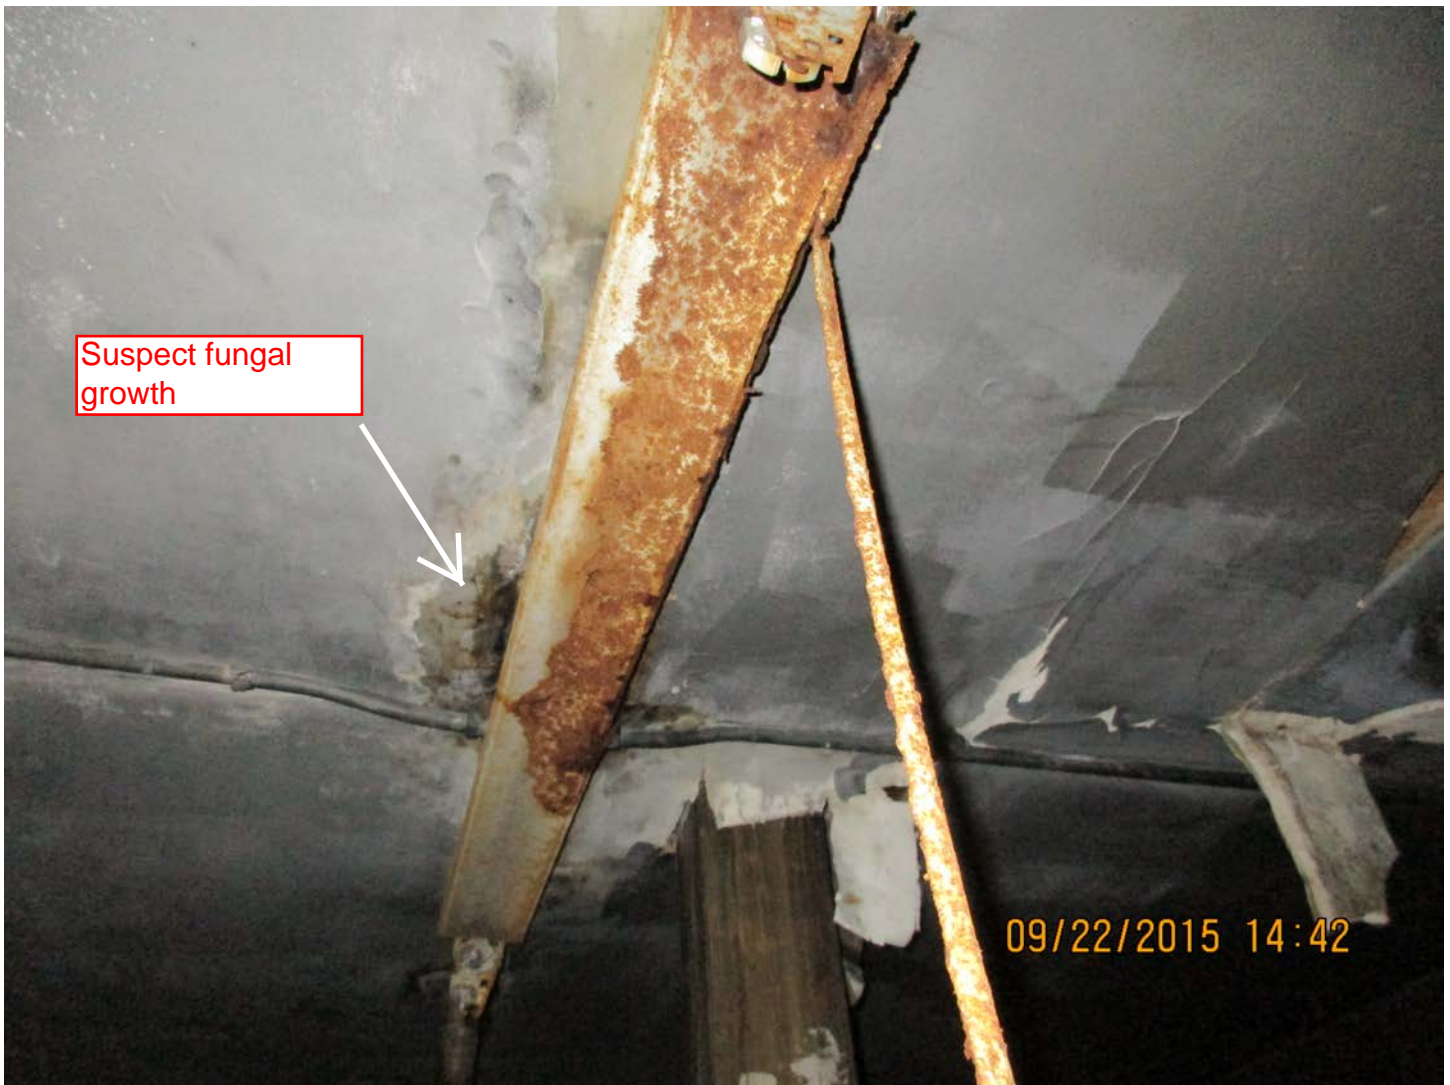
Figure 7 – Suspect fungal growth on gypsum wall board ceiling of the mechanical room.

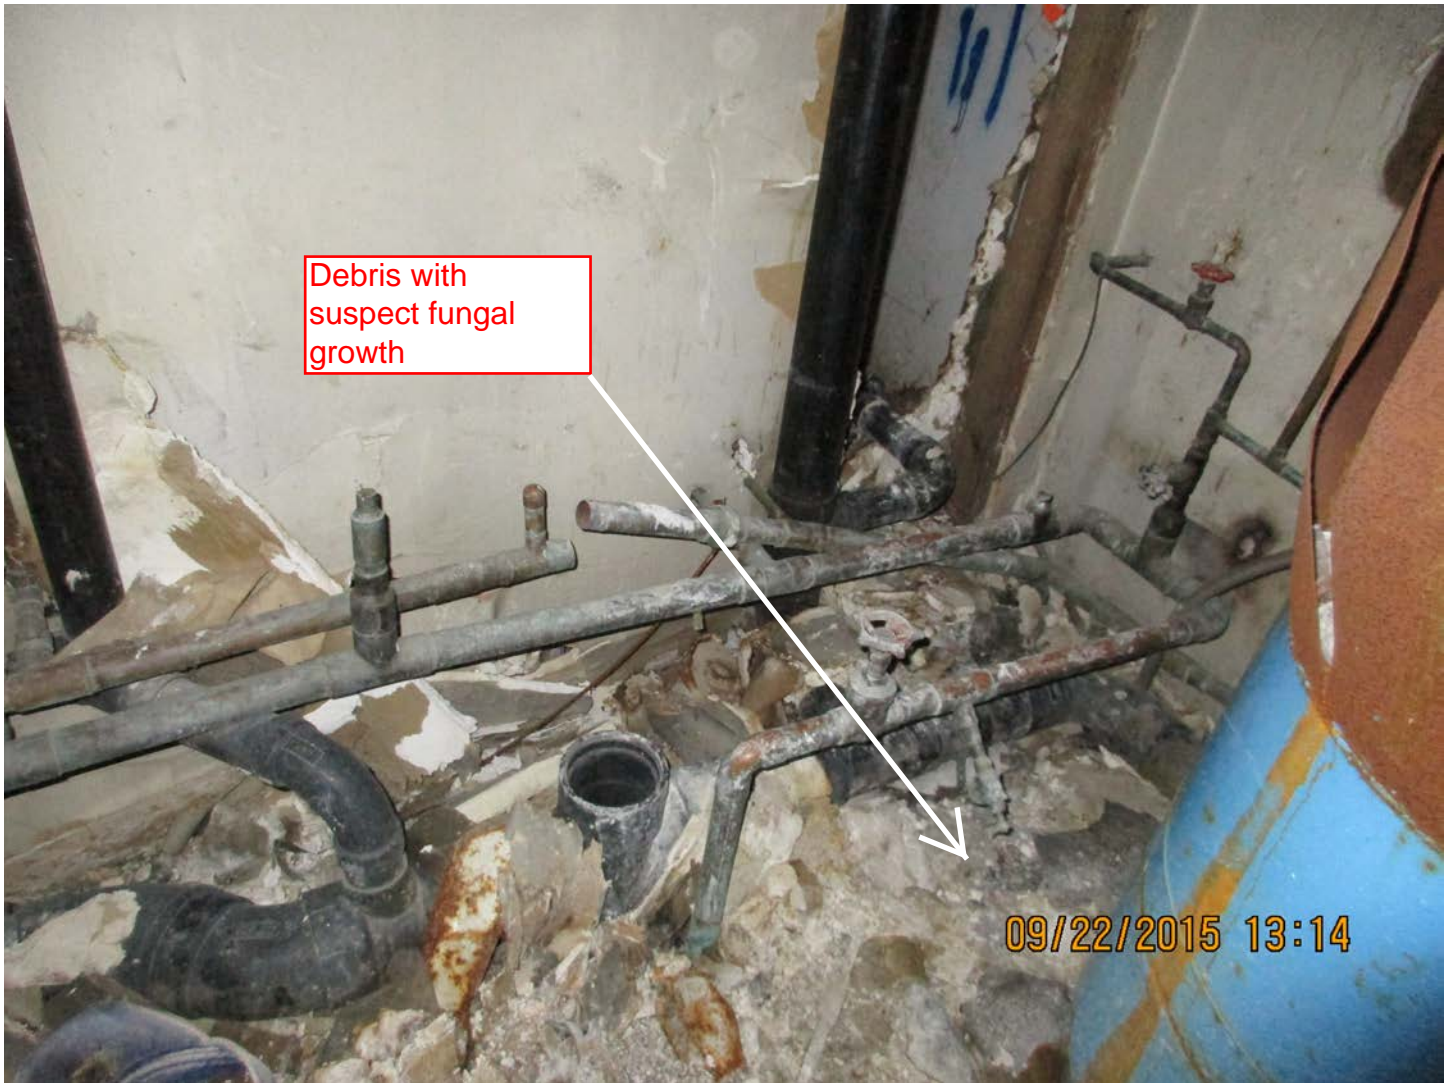
Figure 8 – Suspect fungal growth on gypsum wall board debris on the floor of the mechanical room.

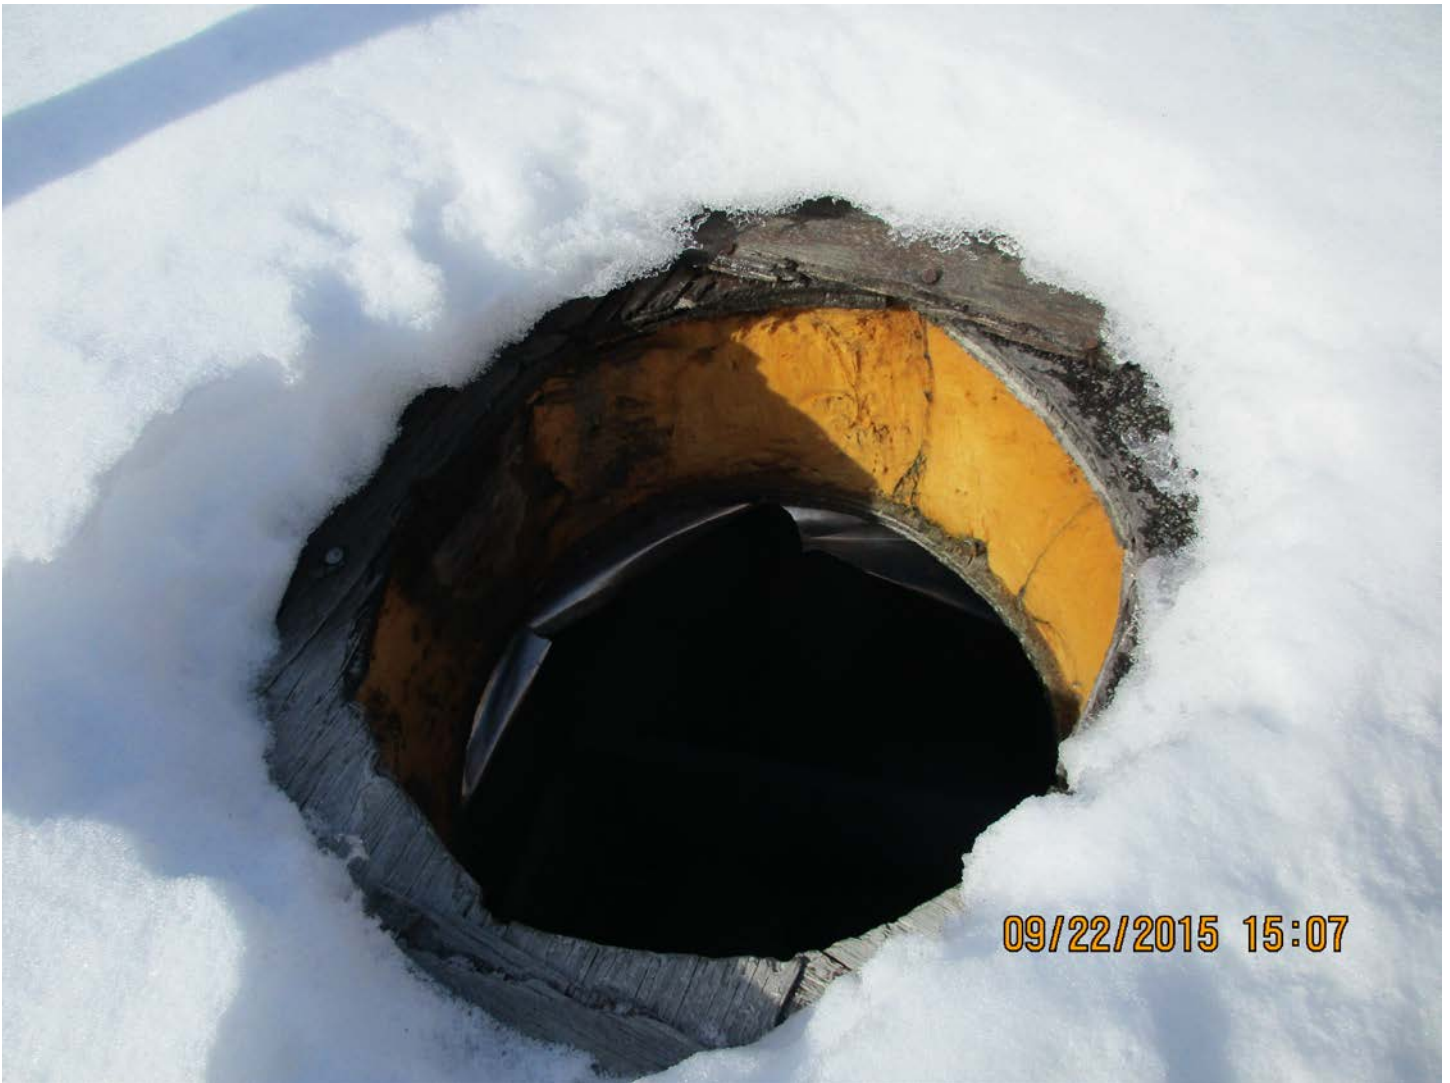
Figure 9 – Missing roof flashing directly above the mechanical room.
