Brownfield Assessment

Fairview Areawide
Property Assessment Report
Anchorage, Alaska

**FINAL
FAIRVIEW AREA WIDE
PROPERTY ASSESSMENT REPORT
JUNE 2015**

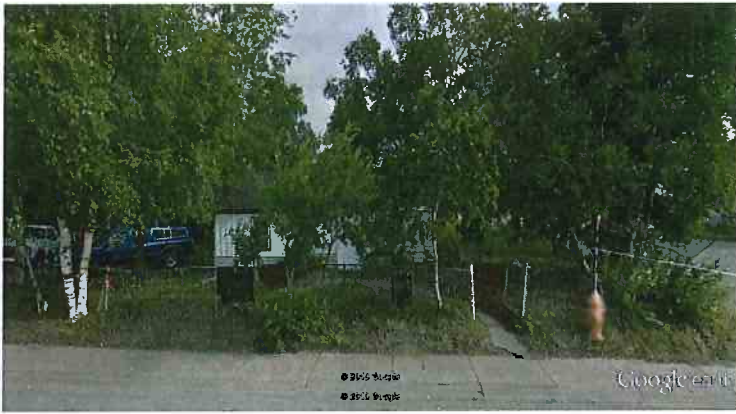
6. 735 E 12th Avenue, (S1/2) Tax ID 00213267000
Zoning: R4, Single Family
Lot Size: 3,500 s.f.
Owner: Stellar, LLC, PO BOX 240961, Anch 99524
Current Occupant: unknown

**1942 cabin, poor condition; surveyed – not eligible for historic preservation*

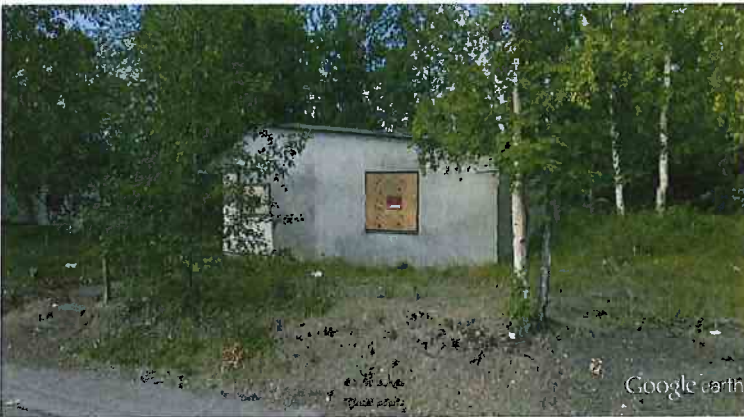
7. 1130 Hyder Street, (N1/2) Tax ID 00213265000
Zoning: R4, Single Family
Lot Size: 3,500 s.f.
Owner: Alvin Alexander Sr., 729 E. 12th Ave, Anch 99501
Current Occupant: N/A

**abandoned 1954 stucco ranch; surveyed – individually NRHP eligible*

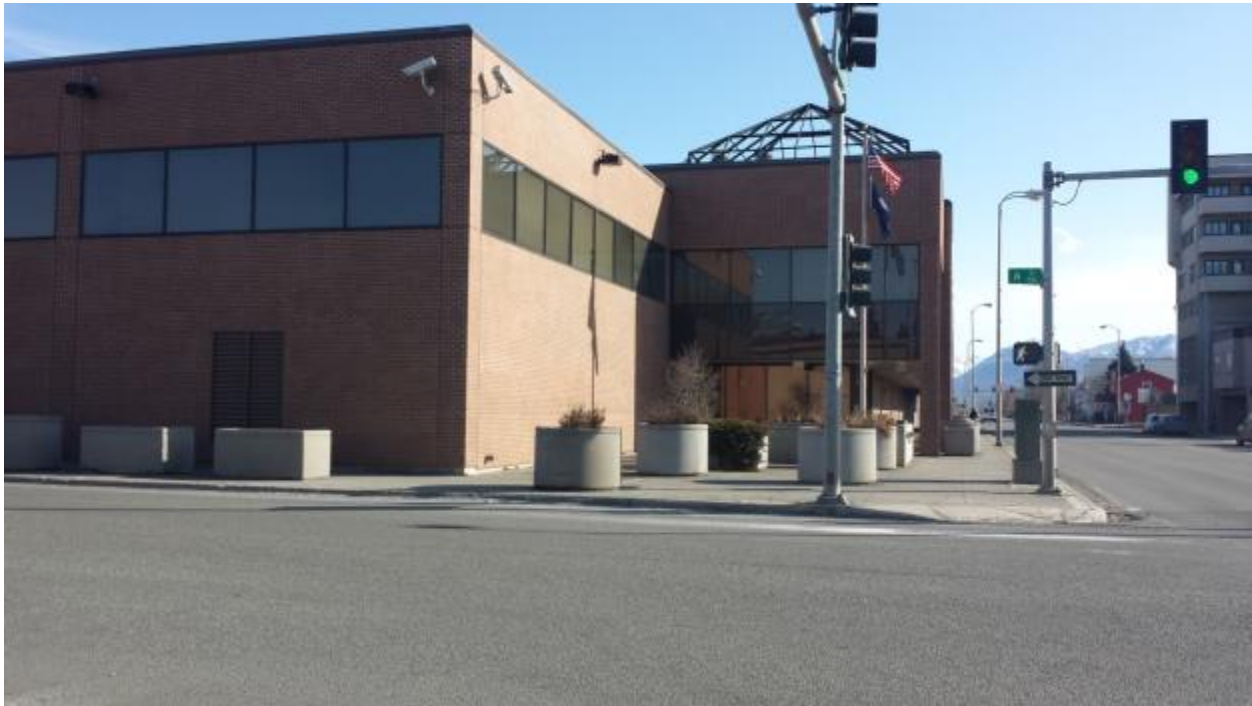
1. FBI Building, historical contamination beneath the building.

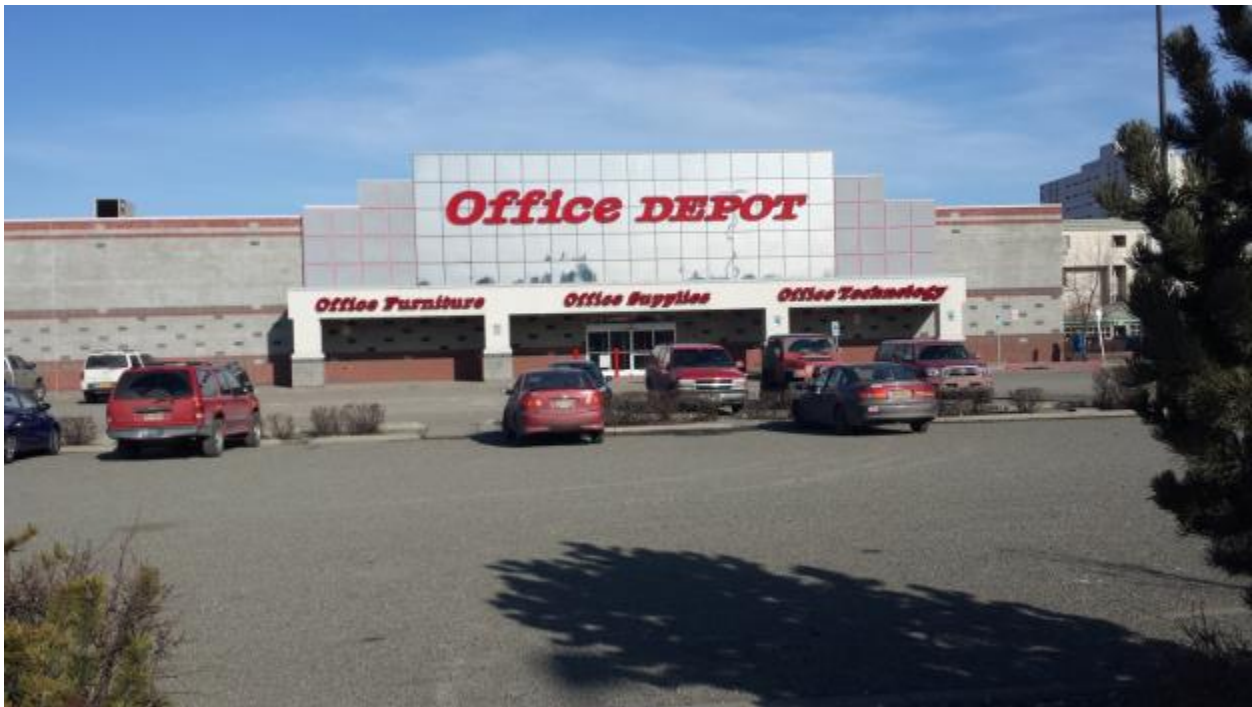
2. Office Depot, contaminated soil beneath the parking lot.

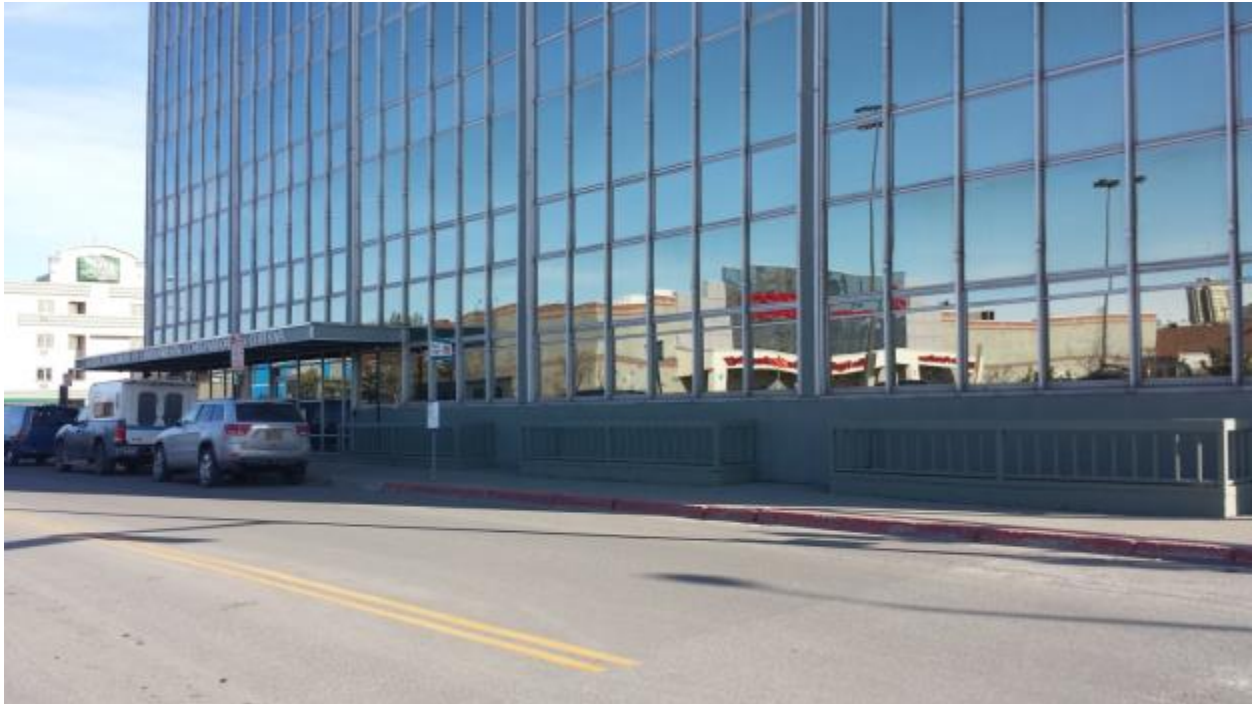
3. 555 Cordova Street, VI has been demonstrated to be an issue in the basement.

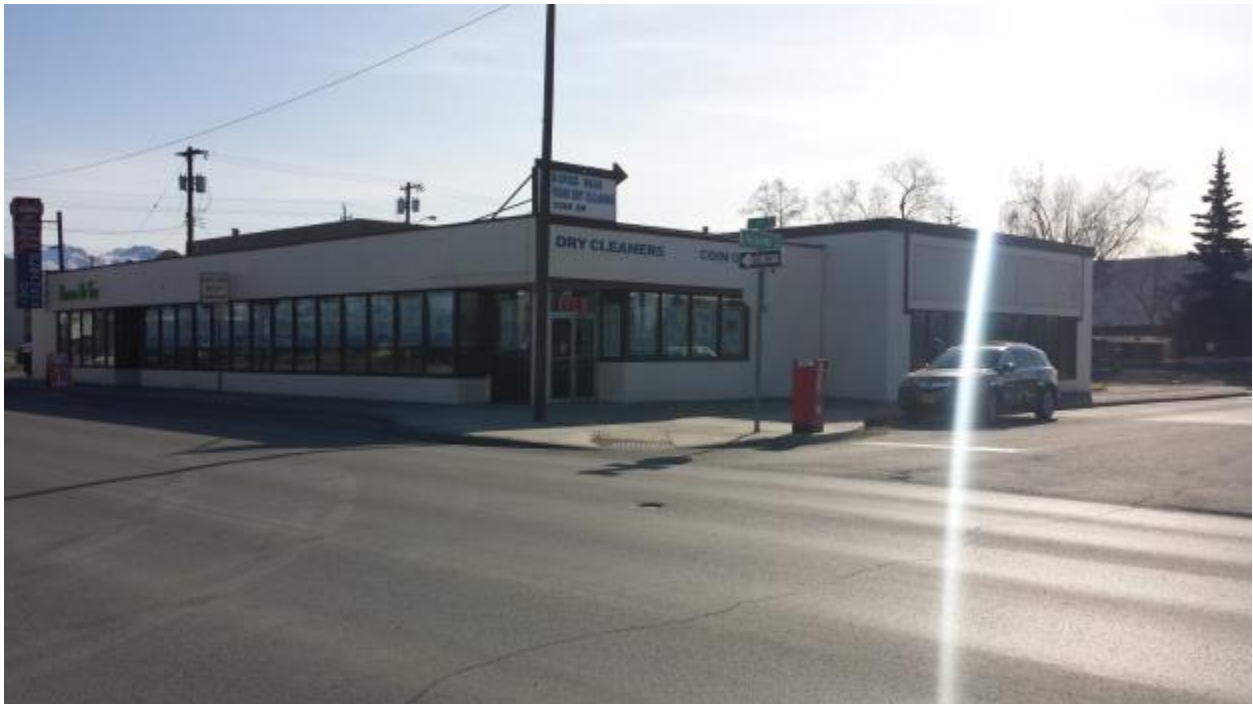
4. Dry cleaning facility

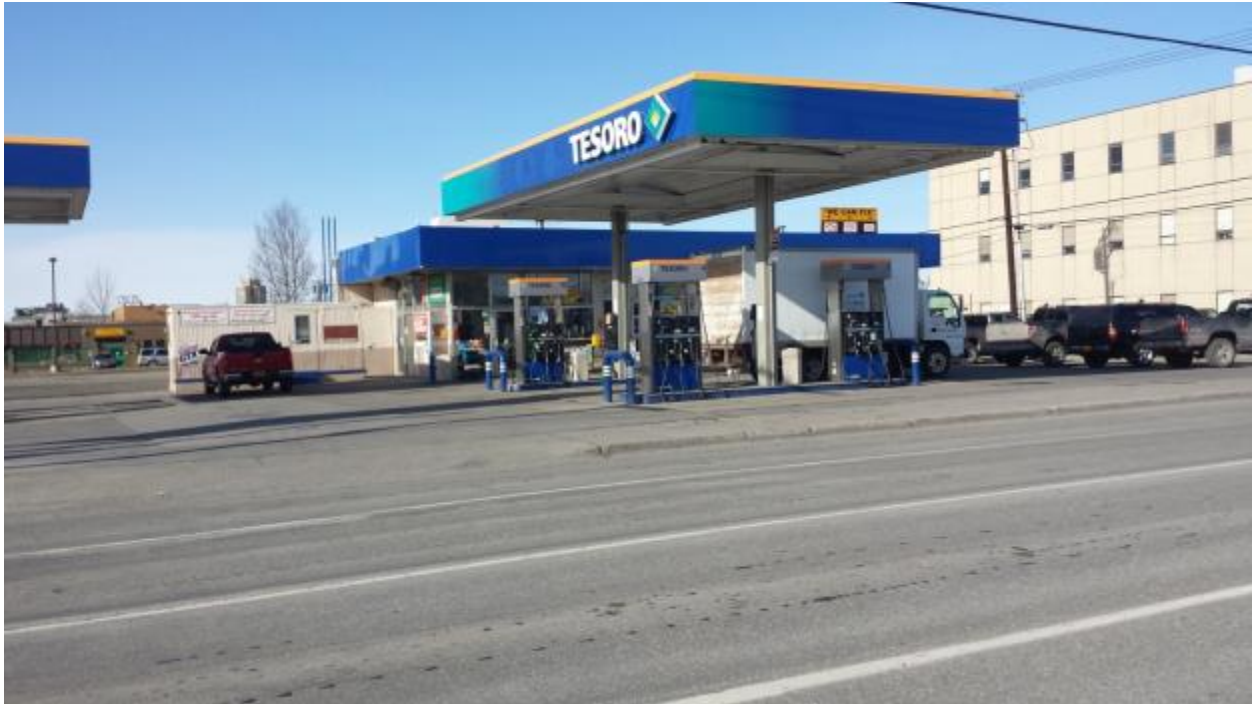
13. Tesoro gas station, known historic contamination at this property

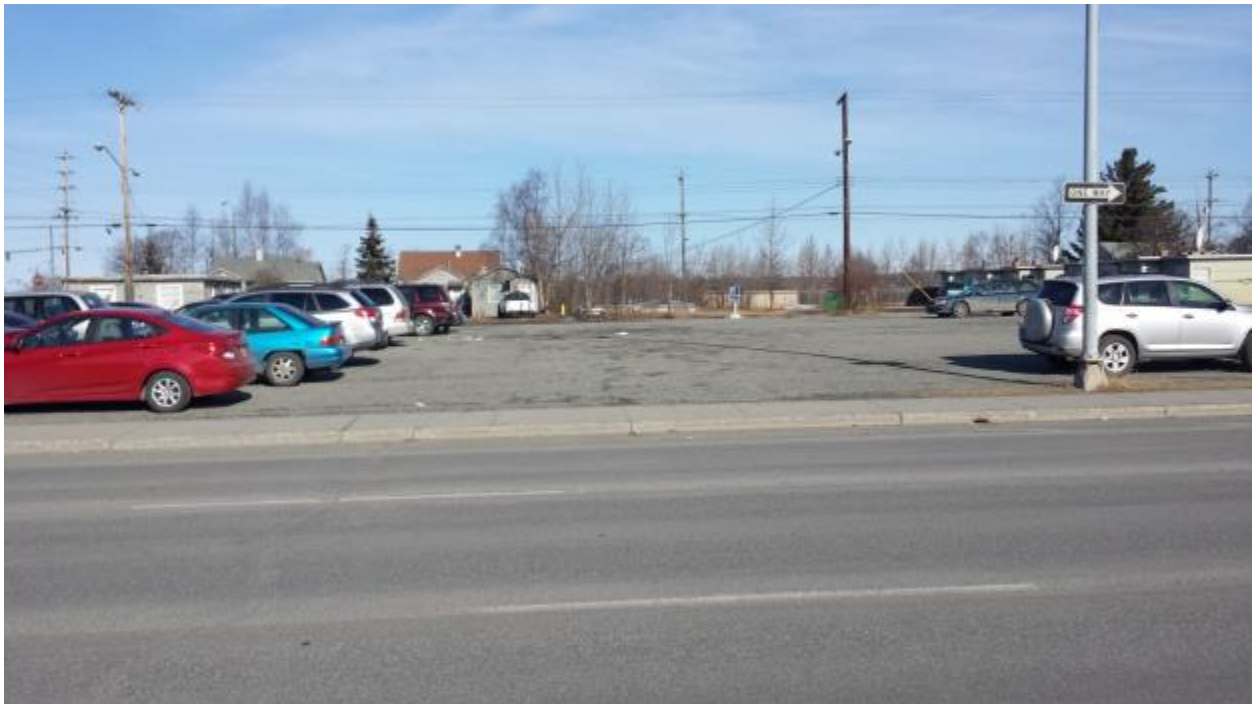
14. Parking lot at 4th & Gambell, historical dry cleaning operation and PCE contamination

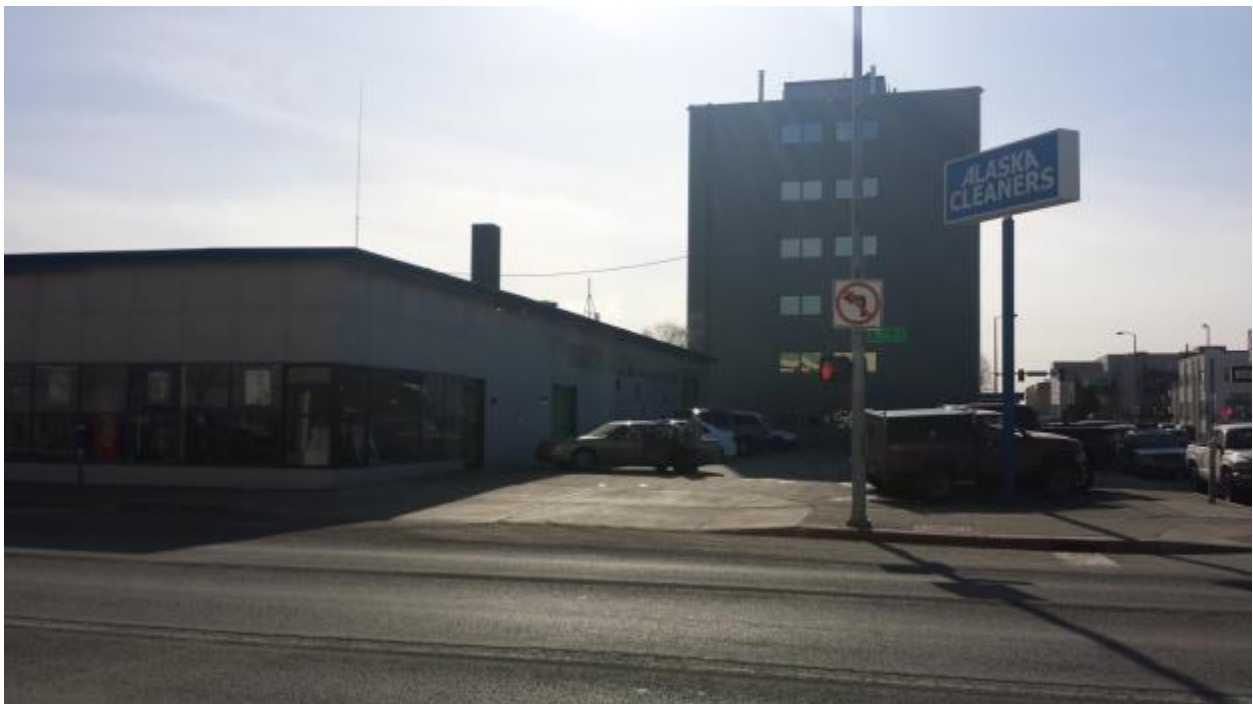
16. Dry cleaning facility, Former Snow White Cleaners
