**Site Assessment and Remediation Plan  
Pelican Seafood Processing Facility  
Pelican, Alaska**

May 2015

By:  
**Shannon & Wilson, Inc.**  
5430 Fairbanks Street, Suite 3  
Anchorage, Alaska 99518  
Phone: 907-561-2120  
FAX: 907-561-4483

32-1-17673

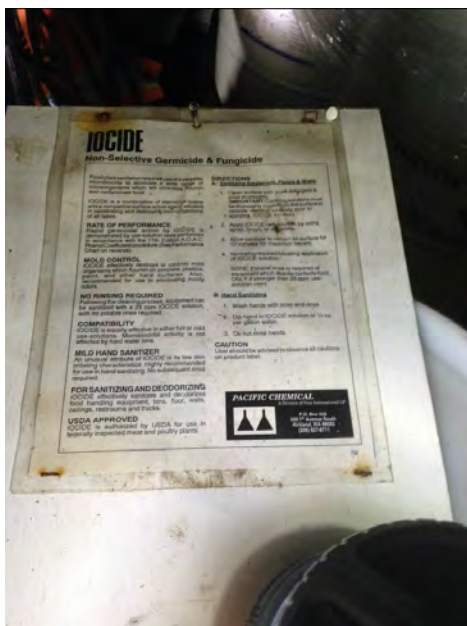
Additional Details: Not tightly capped, corrosive

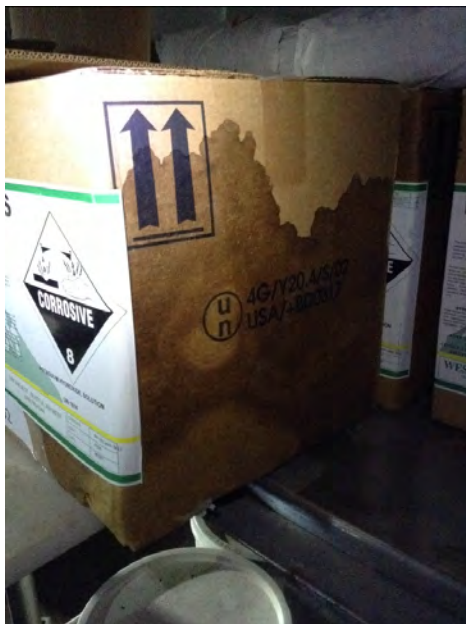
Additional Details: Box with 4 1 gal unopened poly jugs, stains on side of box

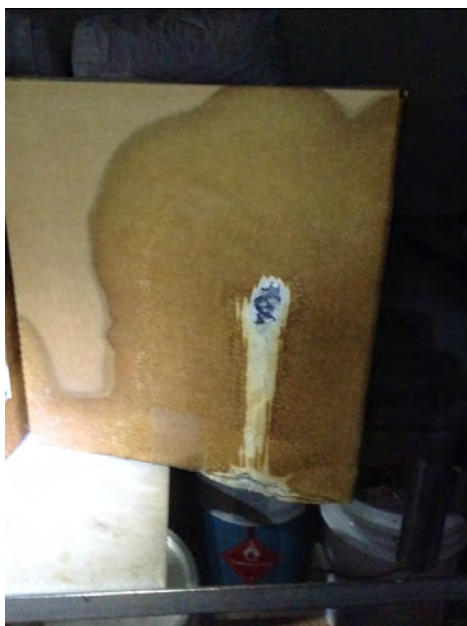
Additional Details: Box with 4 1 gal unopened poly jugs, hole and staining in back

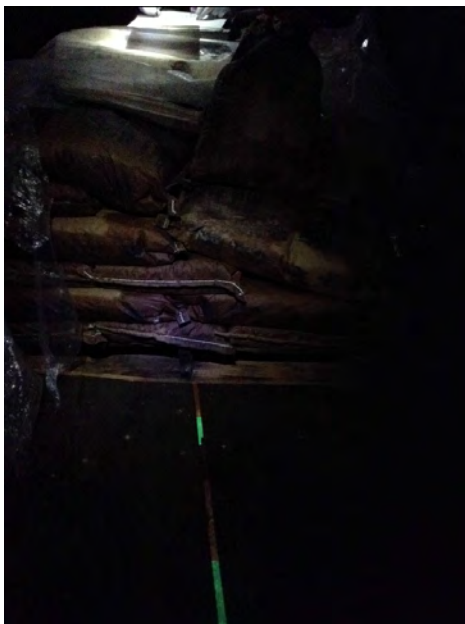
Additional Details: ~45 50 lbs bags on a pallet, one bag torn, some wet

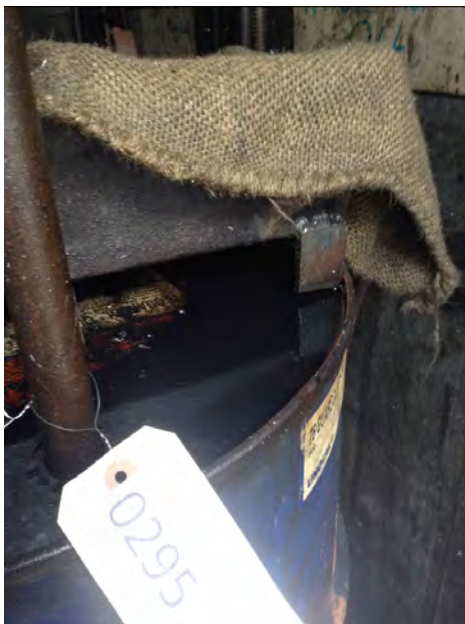
Additional Details: Black liquid pooled on top

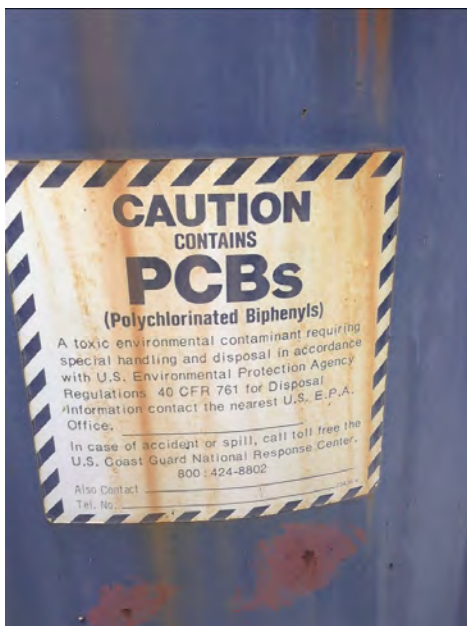
Additional Details: 1330 lb 2400V distribution transformer, 10-CA oil

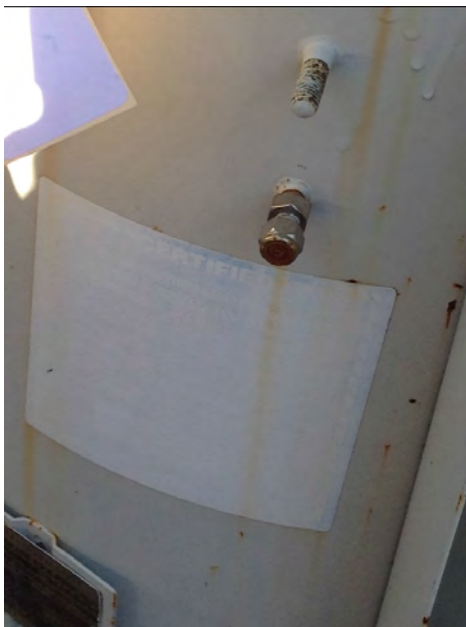
Additional Details: 765 lb distribution transformer
