Property Assessment and Cleanup Plan **Former Moravian Church** Kwigillingok, Alaska

By:
Shannon & Wilson, Inc.
5430 Fairbanks Street, Suite 3
Anchorage, Alaska 99518

November 2013

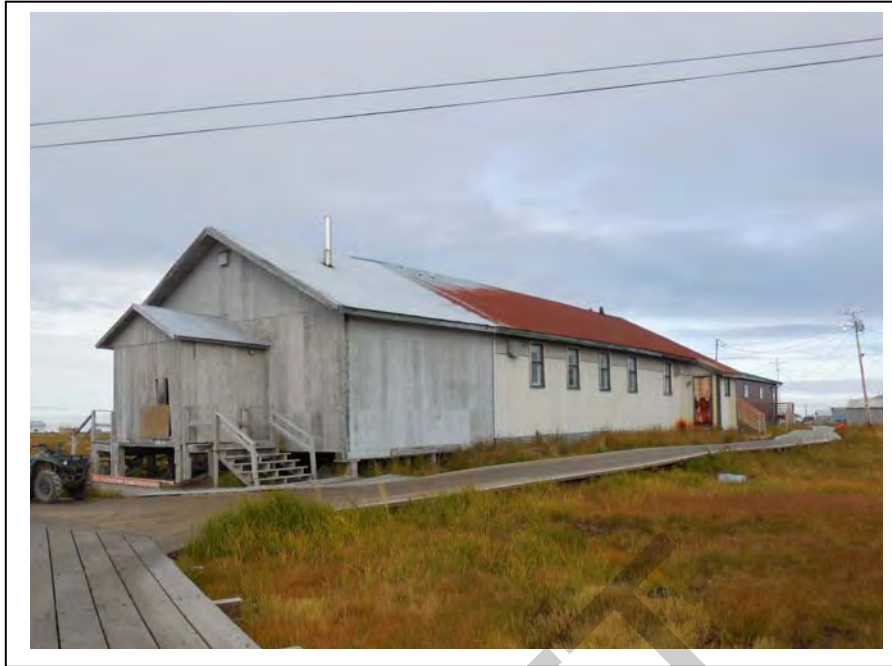
Photo 1: Exterior of the Old Church; looking north.
(September 9, 2103)

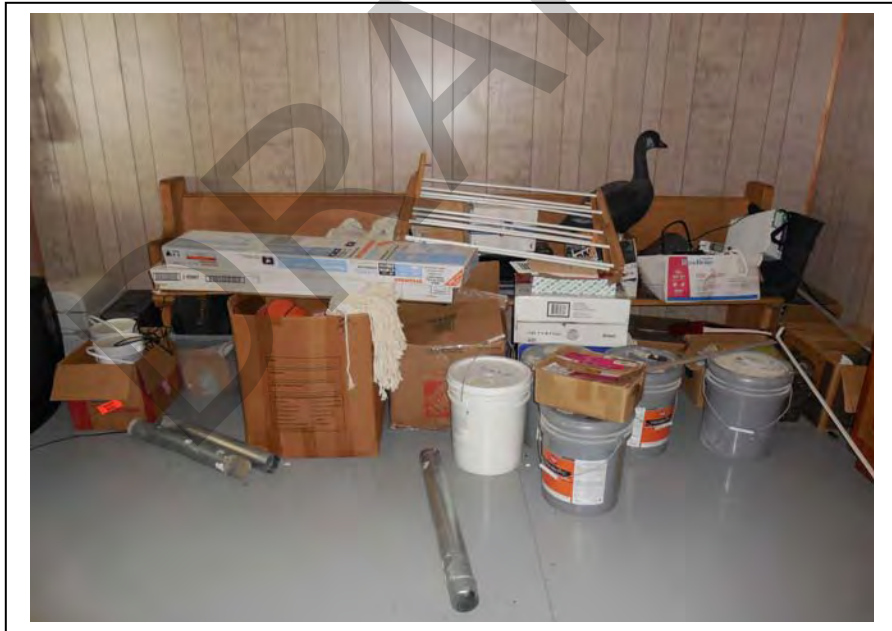
The interior of the Old Church is divided into two main sections. According to Mr. John, the southern third of the structure was completed in the late 1970s or early 1980s and comprises two classrooms, two storage rooms, and an arctic entry. At the time of our site visit, five 5-gallon containers of paint, various electronic equipment, paper goods, and miscellaneous items (Photo 2) were observed in the classrooms. Five additional 1-gallon containers of paint were stored in the storage closet in southeastern portion of the Old Church. Evidence of leaks and/or spills was not observed in the paint storage areas.

Photo 2: Interior of eastern classroom in the Old Church structure. (September 9, 2013)

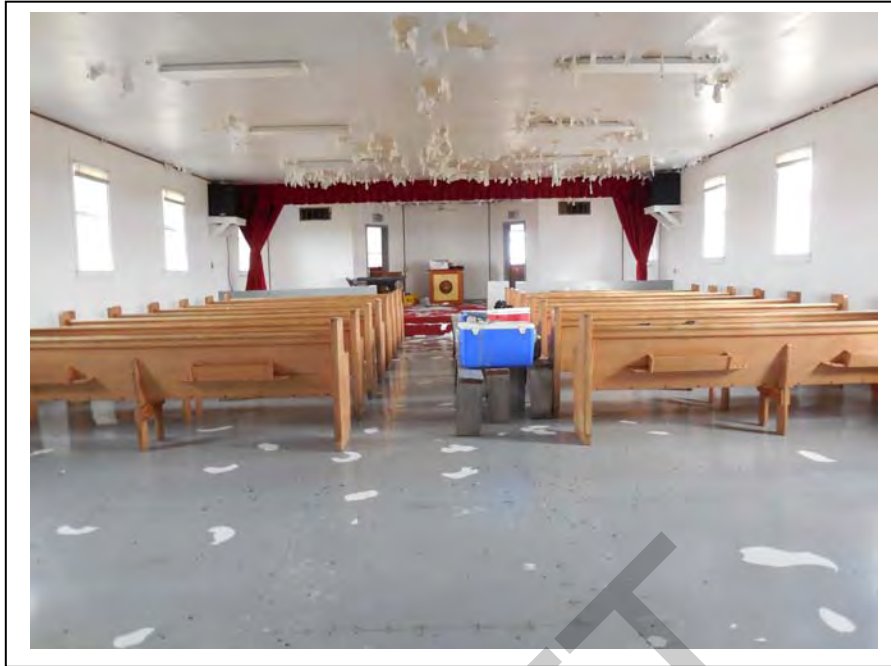
The northern two-thirds of the building comprises the nave, altar (Photo 3), and storage areas. As noted in Photo 3, the ceiling paint is peeling off, likely due to moisture in the attic. Two rooms on either side of the altar appeared to have been used for general storage (Photo 4). Oil-fired forced-air furnaces are located in each of the two storage rooms and are the primary heat source of the nave (Photo 5). A 5-gallon container of heating oil was observed in the

Photo 3: Interior of the Old Church. (September 9, 2103)

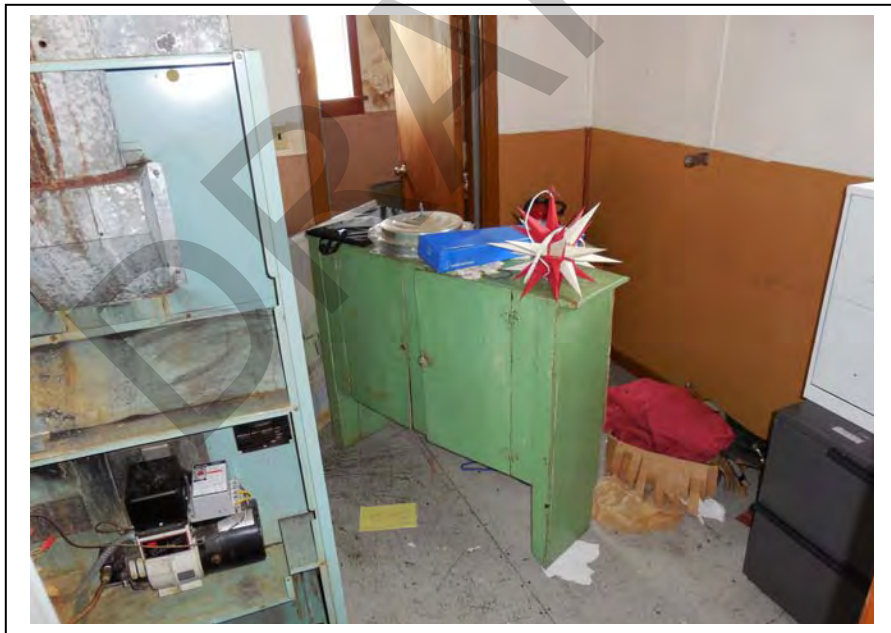
Photo 4: The two rooms on either side of the altar appeared to have been used for general storage. (September 9, 2013)

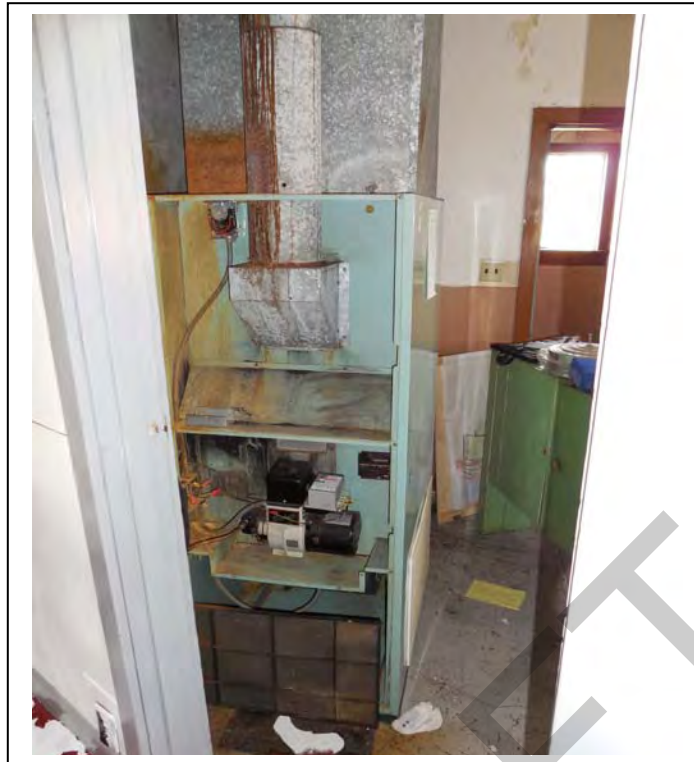
Photo 5: Oil-fired forced-air furnaces are located in each of the two storage rooms near the altar. (September 9, 2013)

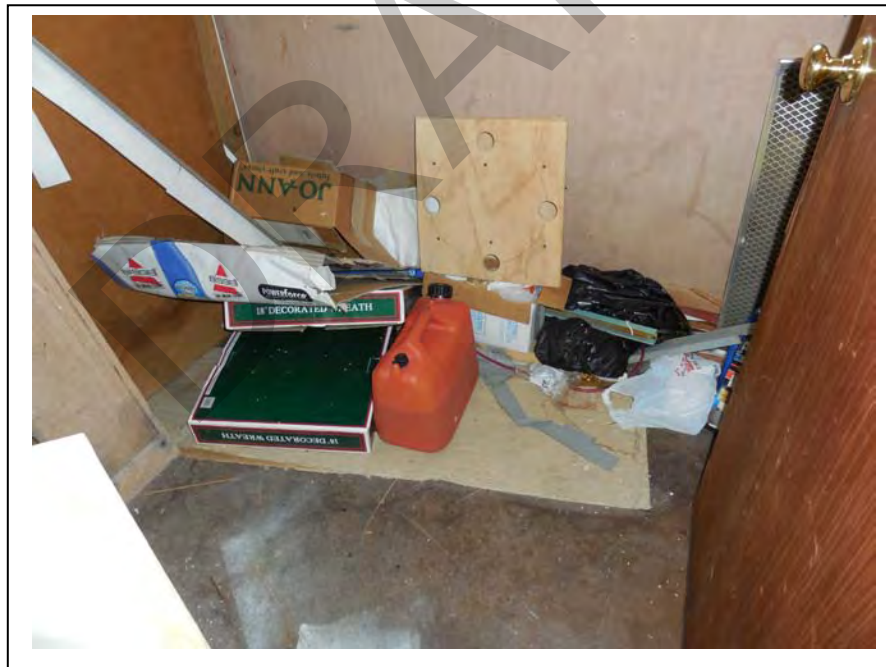
eastern storage room as shown in Photo 6. According to Mr. John, the heating oil was previously used to prime the heating units. Evidence of leaks and/or spills associated with the container was not observed during the September 9, 2013 site visit.

Photo 6: A 5-gallon container of gasoline was observed in the eastern storage room near the altar. (September 9, 2013)

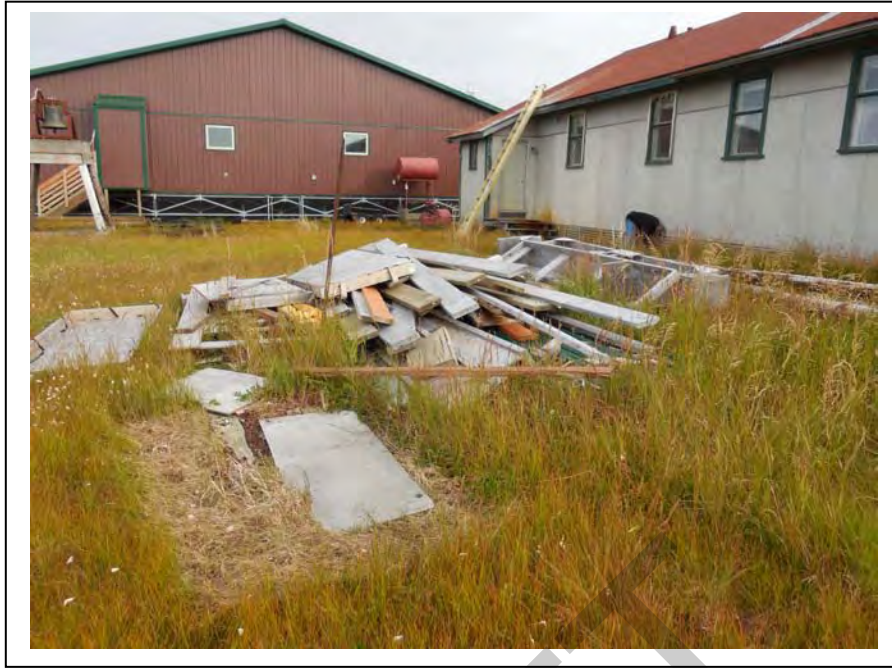
Discarded construction materials are stored north and west of the Old Church as shown in Photos 7 and 8 and on Figure 2. Additional materials were observed under the Old Church structure (Photo 9). What appear to be felled utility poles are located along the northwestern portion of the structure (Photo 10).

Photo 7: Discarded construction materials stored on the west side of the Old Church building; looking north/northeast. (September 9, 2103)

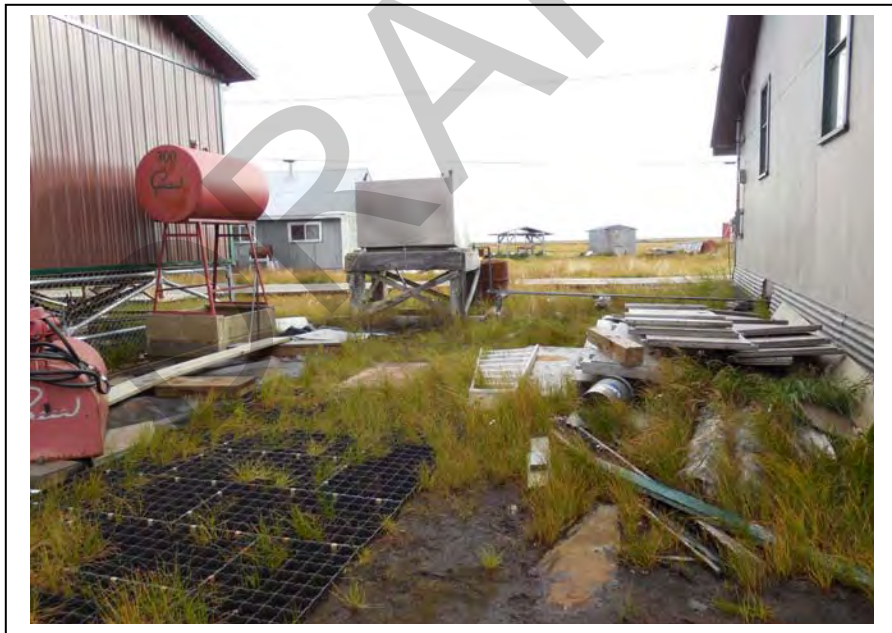
Photo 8: Additional discarded construction materials stored north of the Old Church building; looking east. (September 9, 2013)

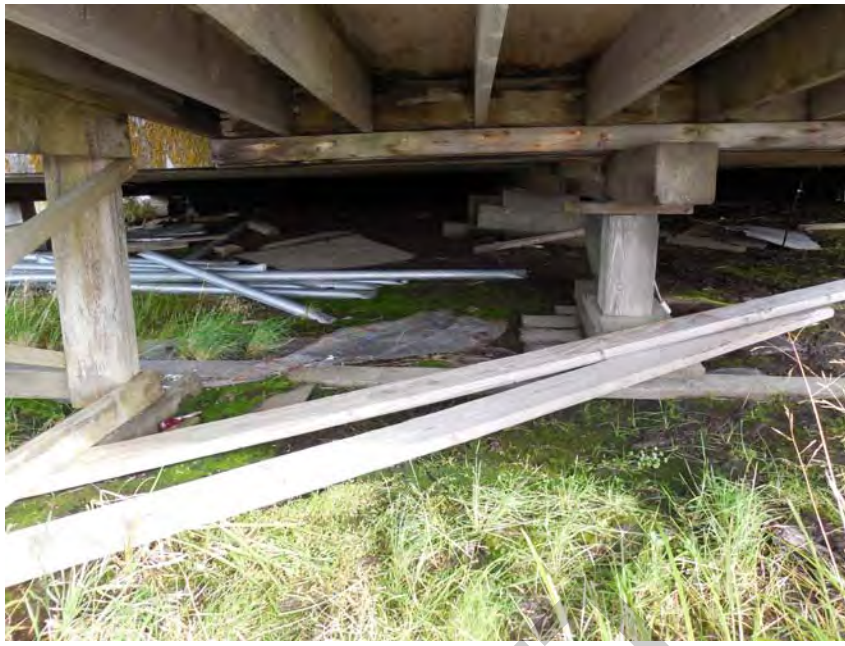
Photo 9: Discarded construction materials stored under the Old Church building. (September 9, 2103)

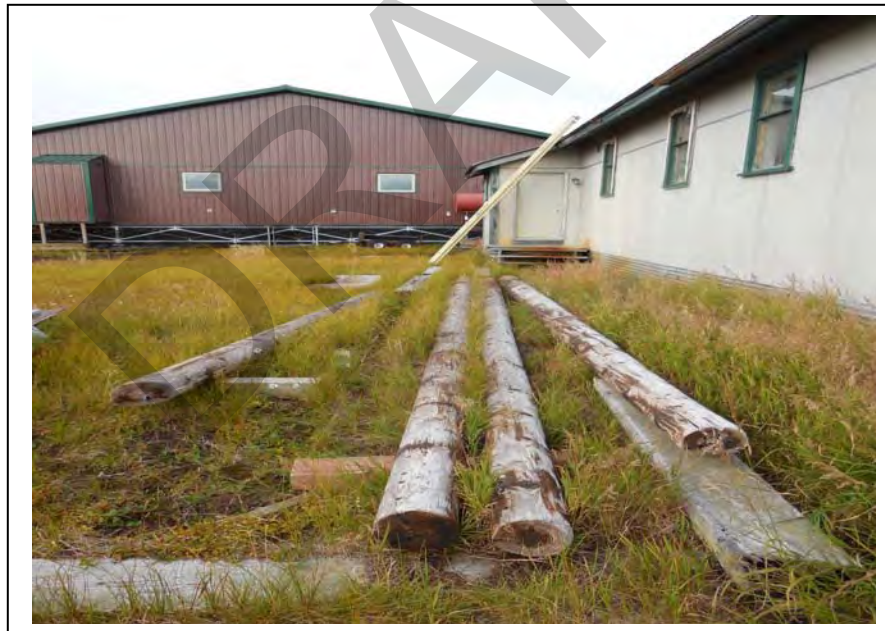
Photo 10: Felled utility poles are stored west of the Old Church building; looking north/northeast. (September 9, 2013)

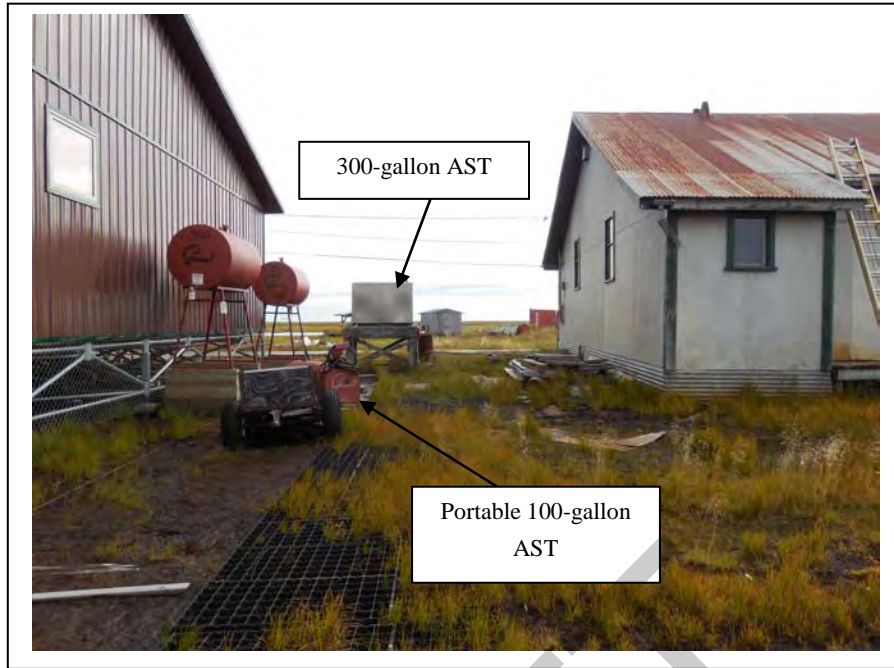
A 300-gallon AST, situated on a wood stand, is located northeast of the Old Church building (Photo 11). Two 2-inch metal pipes convey heating oil to the furnaces inside the Old Church (Photo 12). A 55-gallon drum with unknown contents is located adjacent to the AST. The unlabeled drum showed signs of freeze/thaw damage as shown in Photo 11. According to Mr. John, the drum was most likely used to store and/or transport heating oil. Evidence of leaks and spills associated with the AST, piping, and 55-gallon drum was not observed during the September 9, 2013 site visit.

The new church is located adjacent north of the Old Church building. The new church is serviced by two 300-gallon heating oil tanks as shown in Photo 11 and on Figure 2. According to Mr. John, the ASTs were installed in 2011. Evidence of leaks and/or spills associated with the ASTs was not observed during the September 9, 2013 site visit. ASTs were also observed adjacent to multiple structures as shown on Figure 2.

Photo 11: Two ASTs are located north of the Old Church building; looking east. (September 9, 2103)

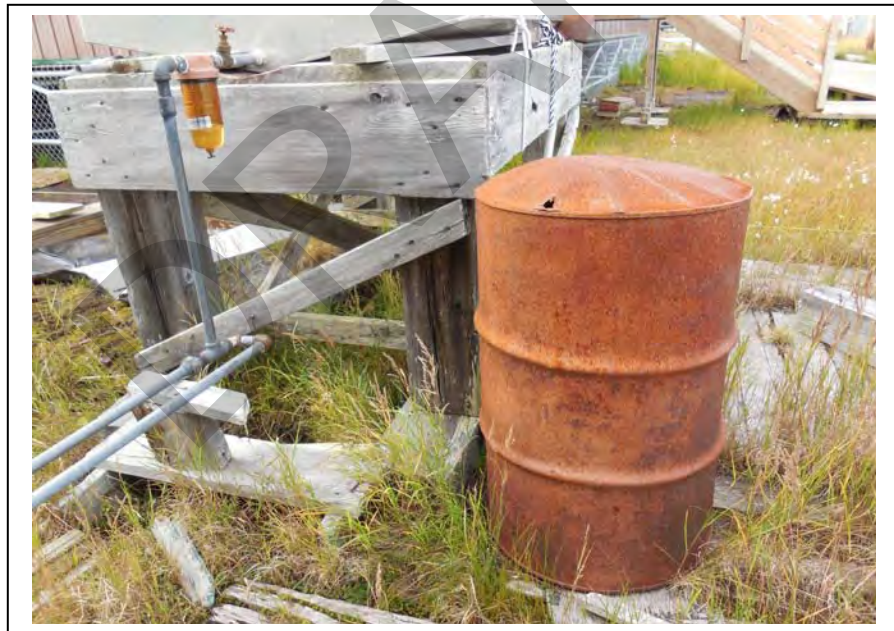
Photo 12: AST stand, piping, and 55-gallon drum located north of the Old Church building; looking north/northeast. (September 9, 2013)
