Brownfield Assessment

Property Assessment and Cleanup Plan
Spenard Road Development Area
Anchorage, Alaska

By:
Shannon & Wilson, Inc.
5430 Fairbanks Street, Suite 3
Anchorage, Alaska 99518

June 2014

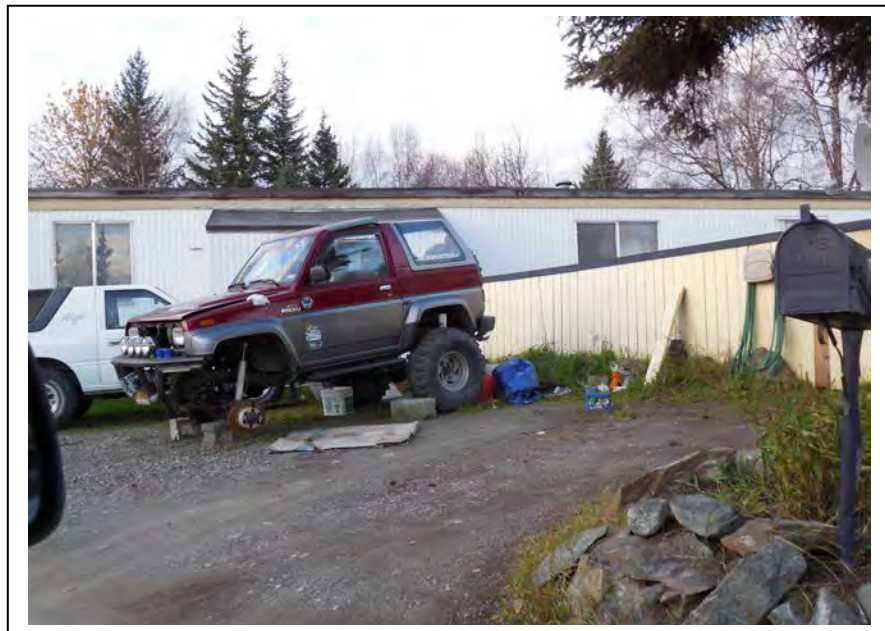
Photo 8: Unused and/or discarded items were observed throughout the Idle Wheels Trailer Court; looking northeast. (October 16, 2013)

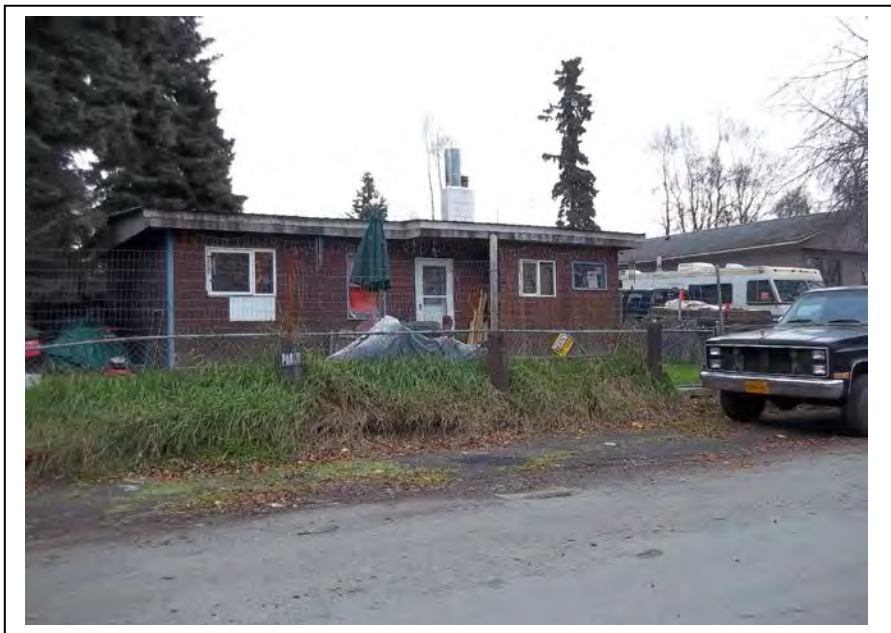
The northern portion of the SRDA is characterized by both commercial and residential use. Areas interior to the major thoroughfares are predominantly residential. Four trailer courts are located in the northern portion of the study area (Photos 14, 15, 16, and 17). In general, the trailer homes appear to be of vintage construction. Similar to the trailer homes in the southern portion, the trailer homes observed in the northern half were generally characterized by pre-1970s construction, sloughing exterior siding, peeling exterior paint, broken windows, and plastic sheeting used in place of roofing material. Single-family and multi-family homes are interspersed throughout the trailer courts and commercial properties (Photo 18).

Photo 18: Representative single-family home in northern project area; looking east. (October 16, 2013)

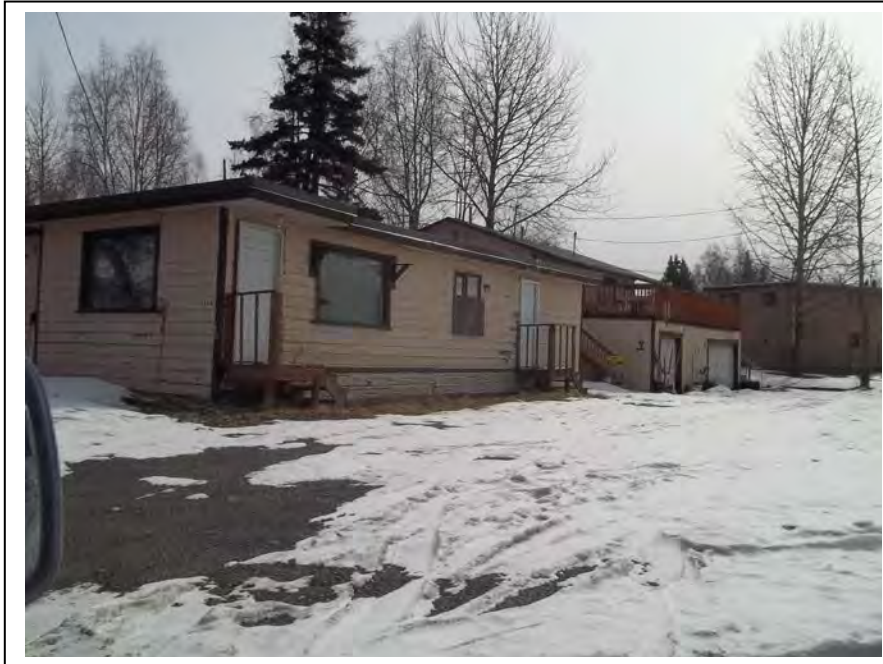
What appeared to be vacant and/or abandoned residential structures are present along 36th Avenue, west of Spenard Road (Photos 19 and 20). In general, windows on the vacant and/or abandoned structures were either broken or covered with plywood. The siding, paint, and general infrastructure (e.g. porch and stair guard rails) were in various states of disrepair. A residential neighborhood is located adjacent east of the abandoned structures (Photo 21).

Photo 19: Vacant and/or abandoned residential structure along Wilshire Avenue; looking southeast. (April 18, 2014)

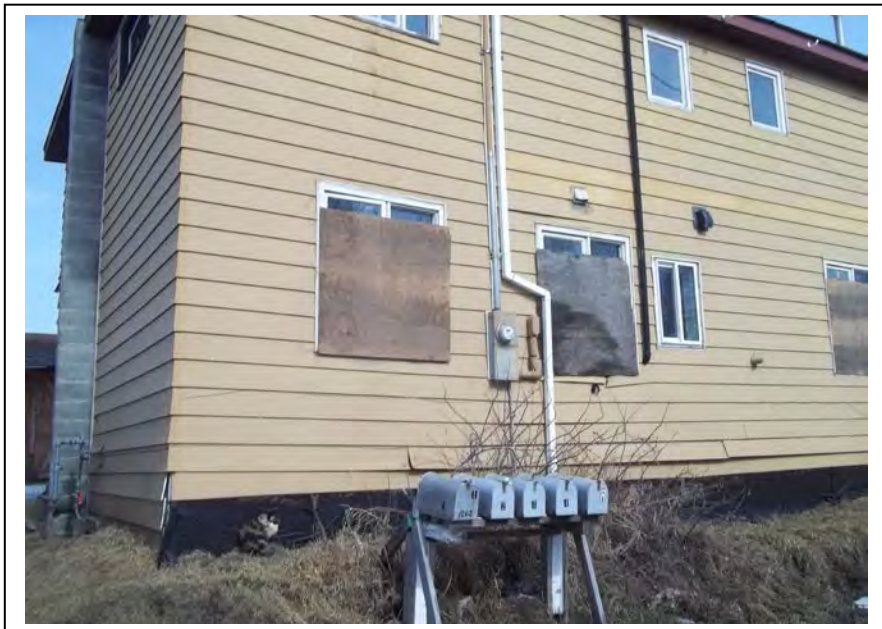
Photo 20: Vacant and/or abandoned residential structure along 36th Avenue; looking north. (April 18, 2014)

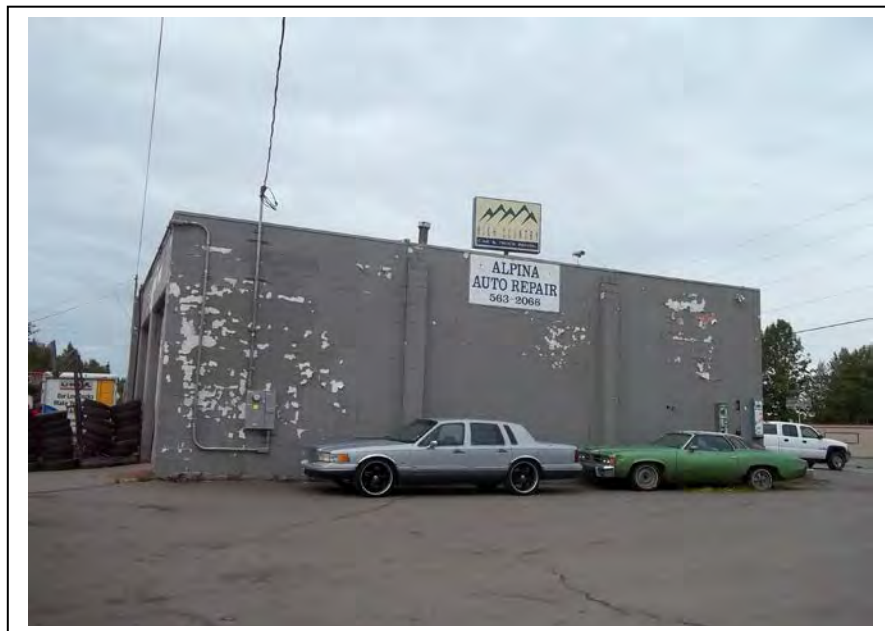
The Alpina Auto Garage (aka Olson Tesoro #1) is located at the northeast corner of Spenard Road and Chugach Way (Photo 22). Fish Creek (Photo 23) is located adjacent east of the Alpina parcel. A vacant lot (Photo 24) is located adjacent east of Fish Creek. Based on historical aerial photographs, it appears as though this parcel has been used to store discarded and/or unwanted items. At the time of our site visit, a fragmented boat was abandoned on the parcel. Residential parcels and a trailer court are located further east of Fish Creek along Chugach Way. Dated trailers were observed in the Chugach Drive Trailer Court.

Photo 22: Alpina Auto Repair; looking southwest. (October 16, 2013)

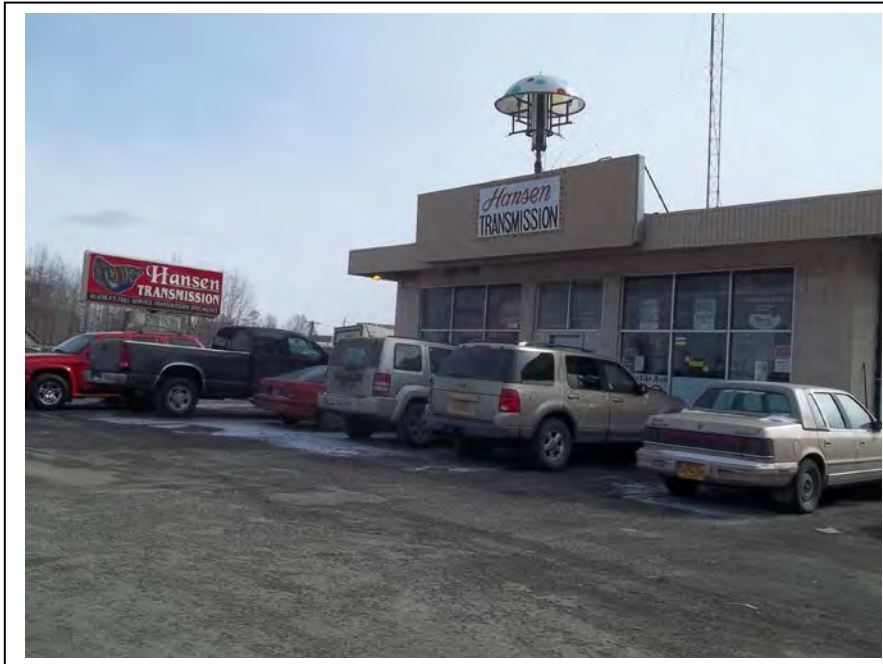
Hansen Transmission is located at the southeast corner of Spenard Road and Chugach Way. Note that according to the Polk City Directory, Queens Dry Cleaning previously occupied this parcel (and is shown as such on Figure 2). Numerous 55-gallon drums and surface stains were observed on the property during the October 2013 and April 2014 site reconnaissance efforts (Photos 25 through 27). Golden Paint Body & Frame is located east of Hansen Transmission (Photo 28). Vehicles and miscellaneous debris was observed in the associated storage yard.

Photo 25: Hansen Transmission is located on the southeast corner of Spenard Road and Chugach Way; looking northeast. (April 18, 2014)

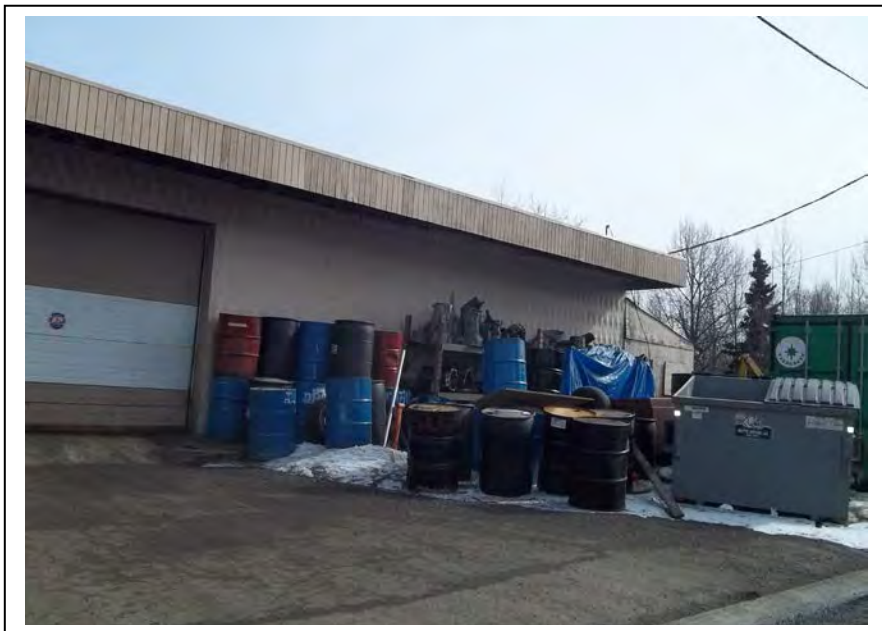
Photo 26: Multiple 55-gallon drums were observed on the Hansen Transmission parcel; looking east. (April 18, 2014)

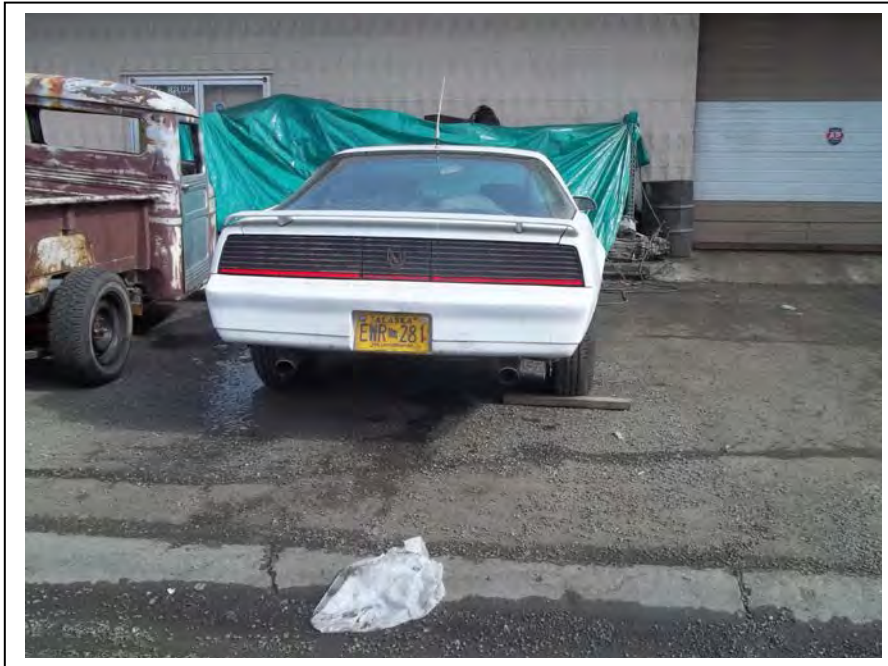
Photo 27: Areas of surface staining were observed on the Hansen Transmission parcel; looking east. (April 18, 2014)

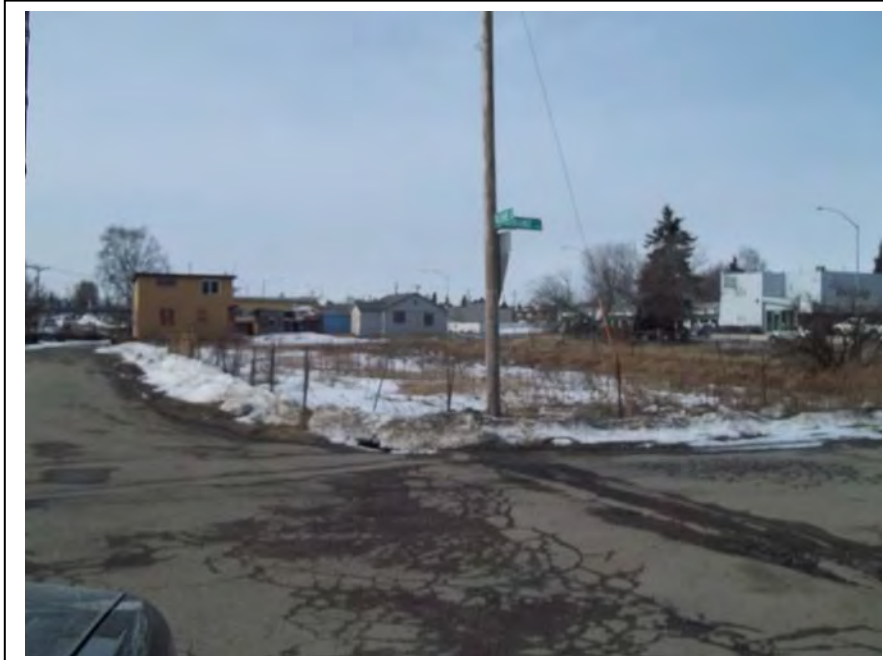
General infrastructure throughout the SRDA appears to be outdated and/or non-compliant with current municipal standards. For example, pavement on most roads is deteriorated and cracked in multiple places (Photos 29 and 30). Sidewalks and curbs are nearly nonexistent except for areas along the major arterial thoroughfares. As such, legal boundaries and right-of-ways are often unclear. The project area in general and specifically the area of interest appeared to be lacking storm sewer drains to convey surface water during spring breakup and rainfall events.

Photo 29: Deteriorated pavement; looking northeast. (April 18, 2014)

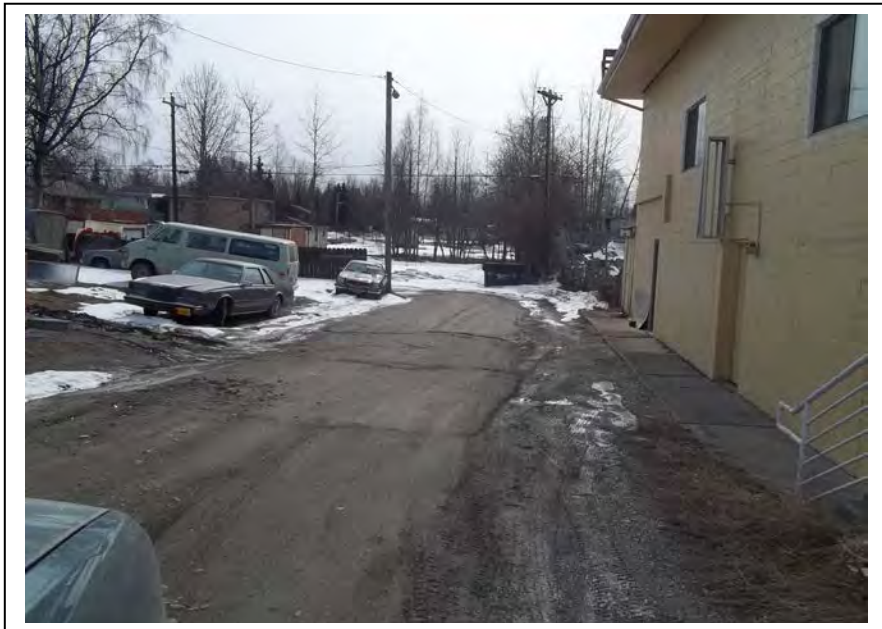
Photo 30: Representative pavement conditions on non-arterial roads throughout project area; looking south. (April 18, 2014)
