Investigation Report - Final

**Site Name: Old School
Chevak, Alaska
Hazard ID: NA**

**E3 Environmental, LLC
219 East International Airport Road, Suite 100
Anchorage, Alaska 99518**

November 17, 2015

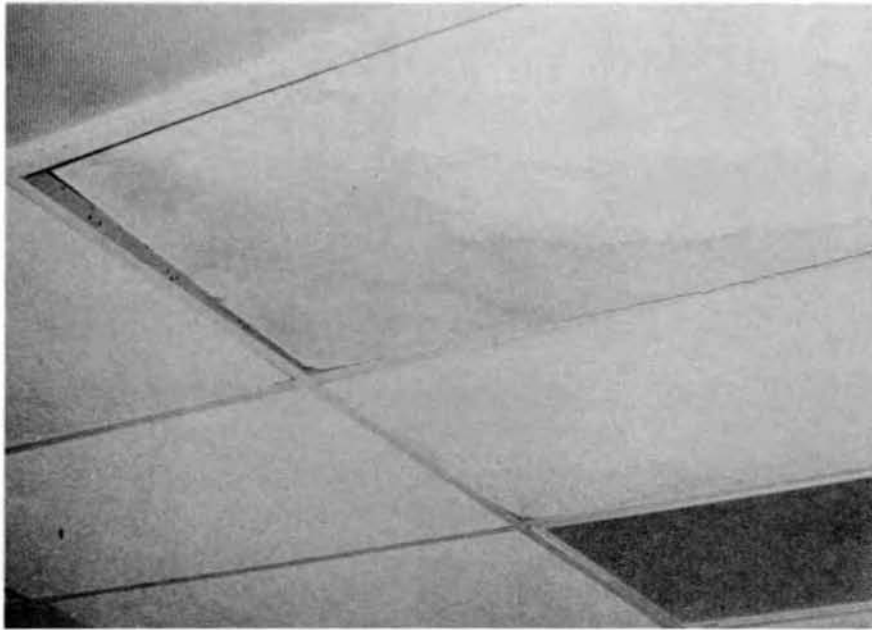
Figure 6. Suspended ceiling stained by water in many areas.

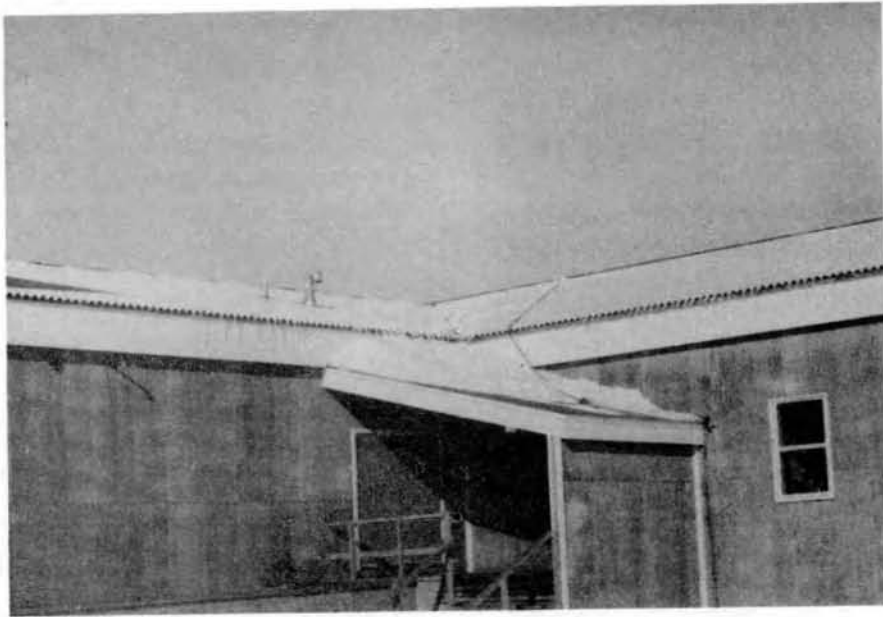
Figure 10. Porch roof on which snow and ice accumulates below the "problem valley."

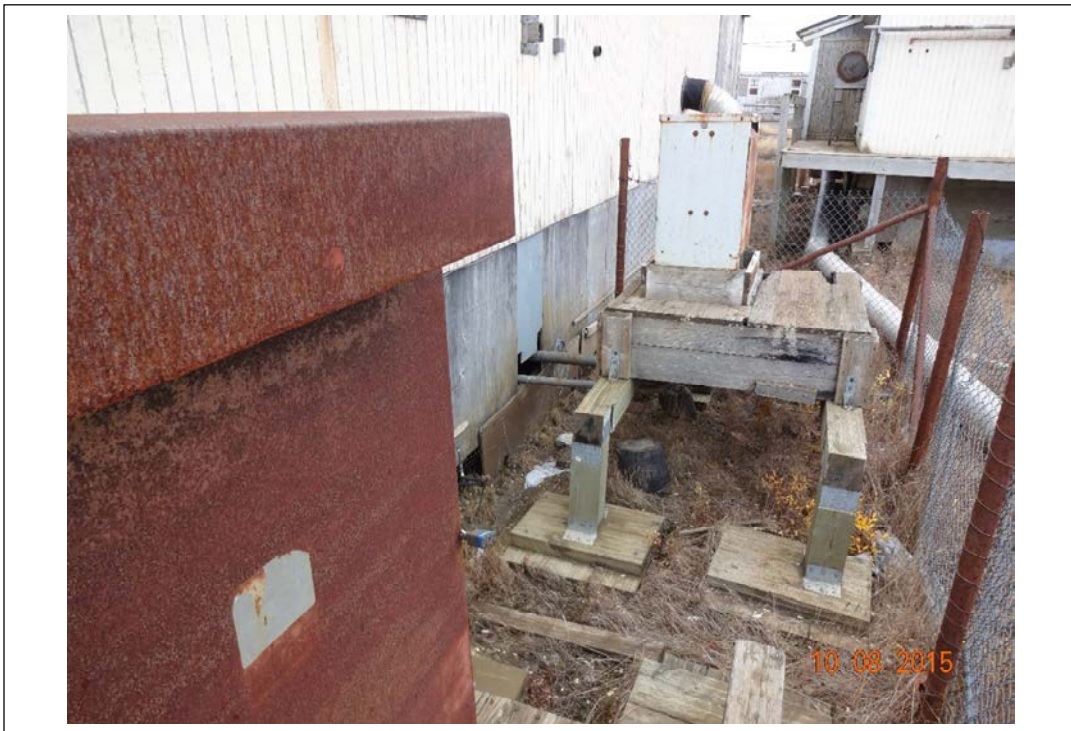
The transformers did not show obvious signs of leakage. E3 does not have a trained electrician, but it appears the transformers were not designed to hold liquid. However, samples were collected to be certain of potential impacts. Sample locations for the two soil samples are shown in Figure 3.

There are two transformers located south of the Old School building (Figure 3). There is no obvious evidence of leakage of fluid and laboratory analytical results of soil samples collected beneath the transformers for polychlorinated biphenyls (PCBs) were non-detect.

Photo 31. Transformer 1 on left, Transformer 2 on right. October 8, 2015.

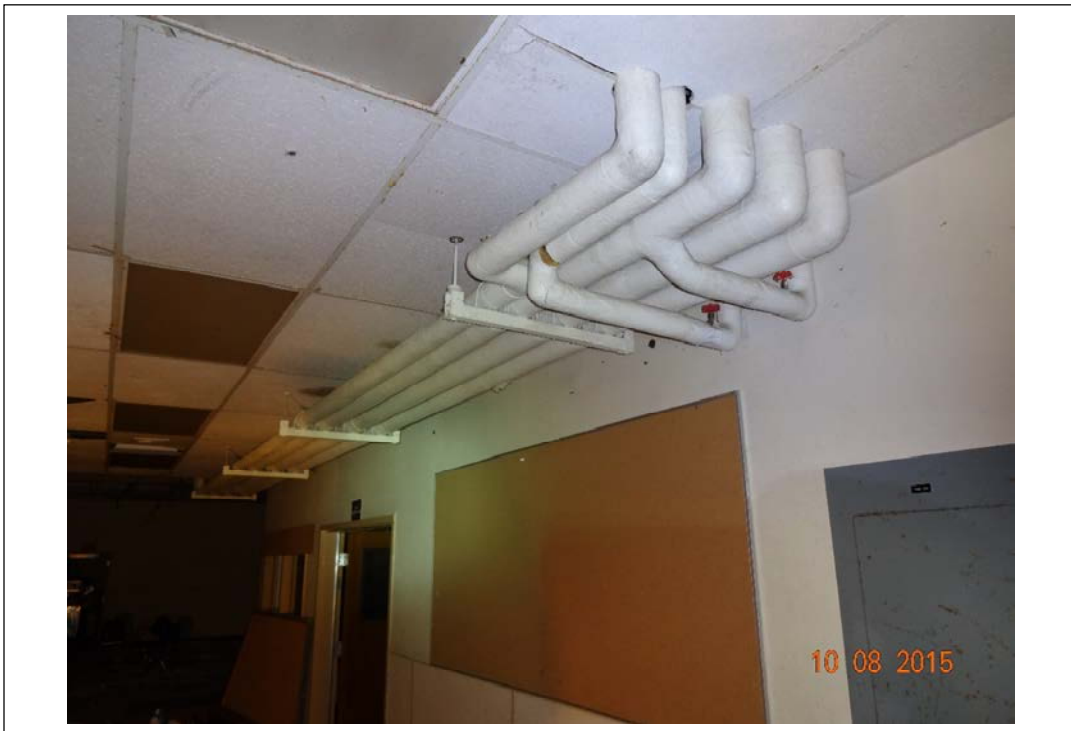
Photo 3. Possible asbestos-containing material on pipes in hallway between gymnasium and cafeteria. October 8, 2015.

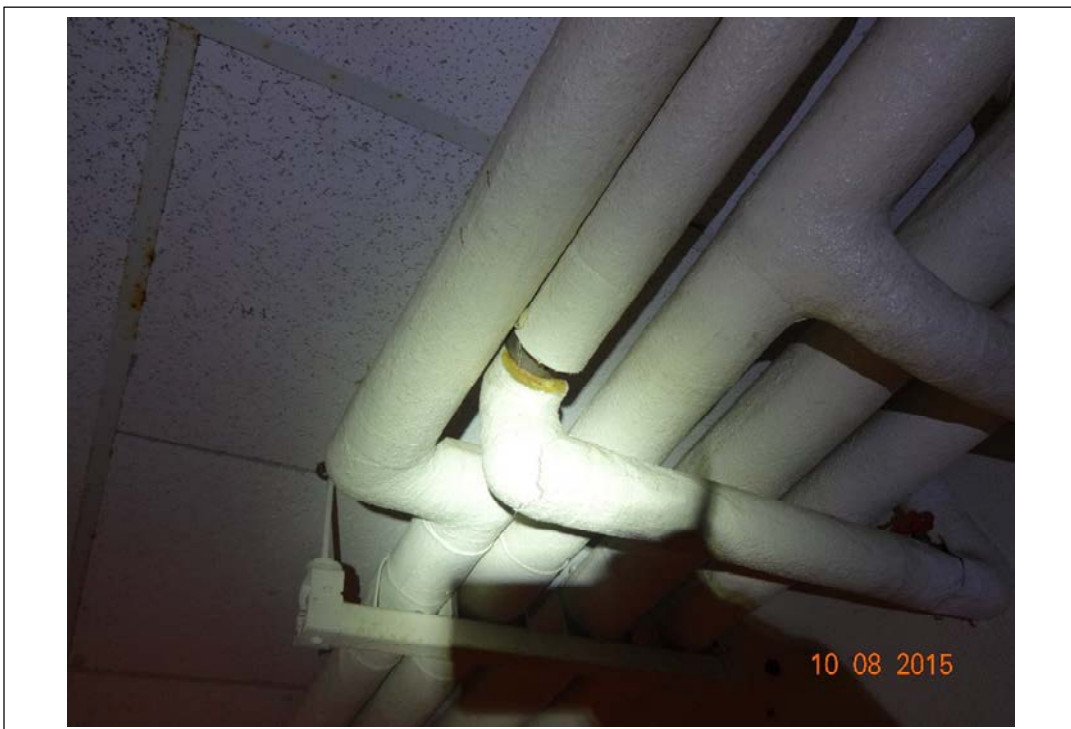
Photo 4. Possible asbestos-containing material on pipes in hallway between gymnasium and cafeteria. October 8, 2015.

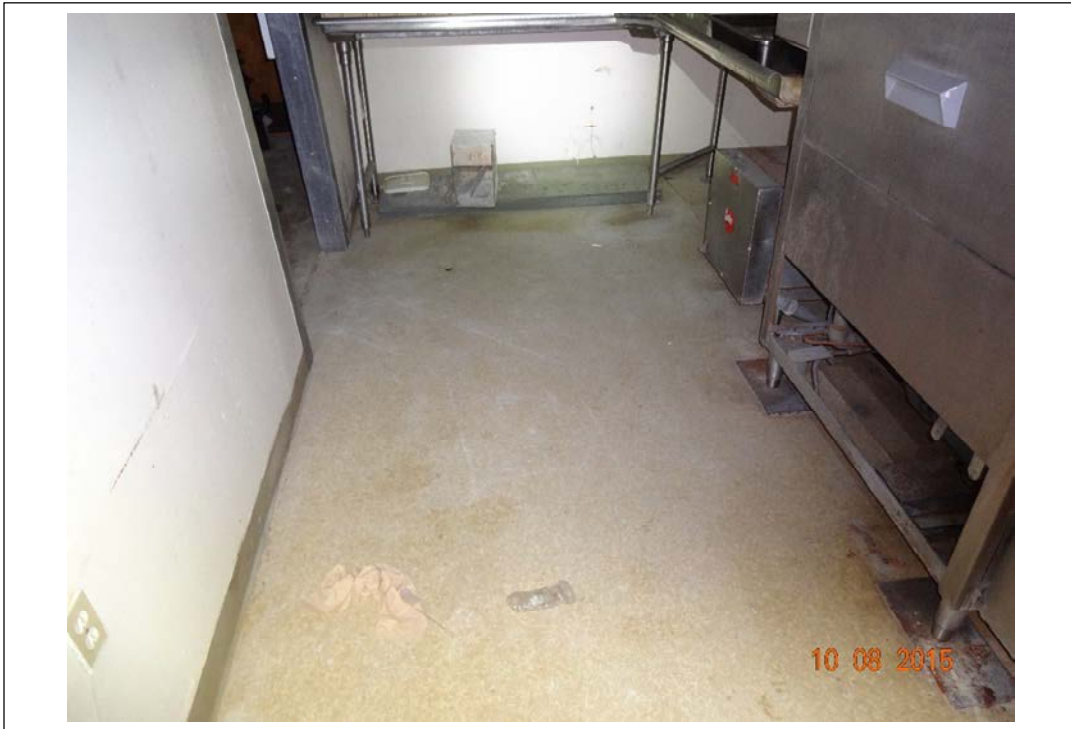
Photo 5. Asbestos-containing linoleum of Room 13. October 8, 2015.

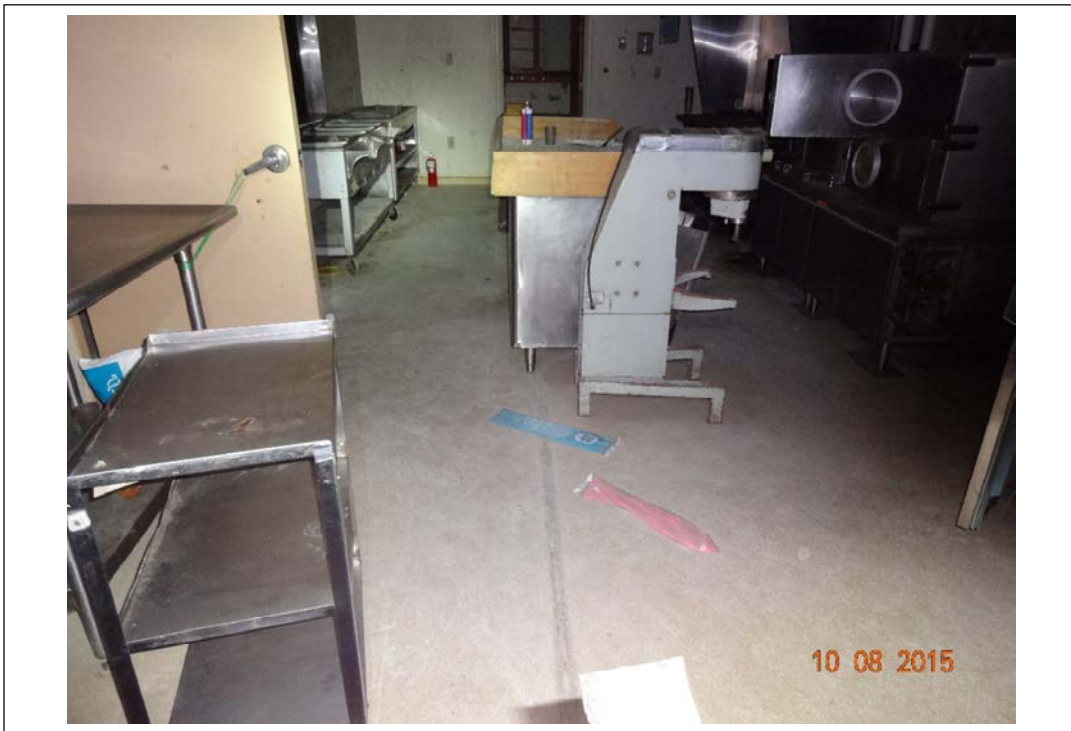
Photo 7. Asbestos-containing linoleum of Room 12. October 8, 2015.

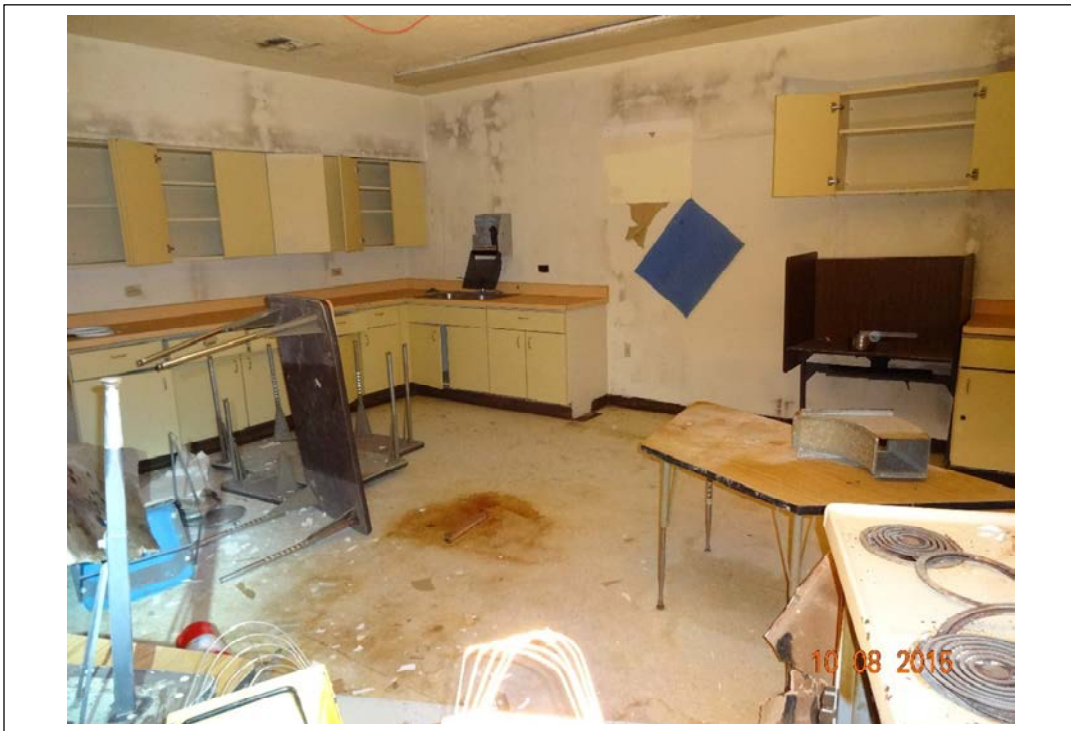
Several photographs show stained ceiling tiles: an indication of potential water damage from a leaking roof. Photographs of Room 4 (Photos 9 and 10 in Appendix D) show prevalent black staining on the walls (suspected mold) and stained ceiling tiles.

Photo 9. Asbestos-containing linoleum in Room 4. October 8, 2015.

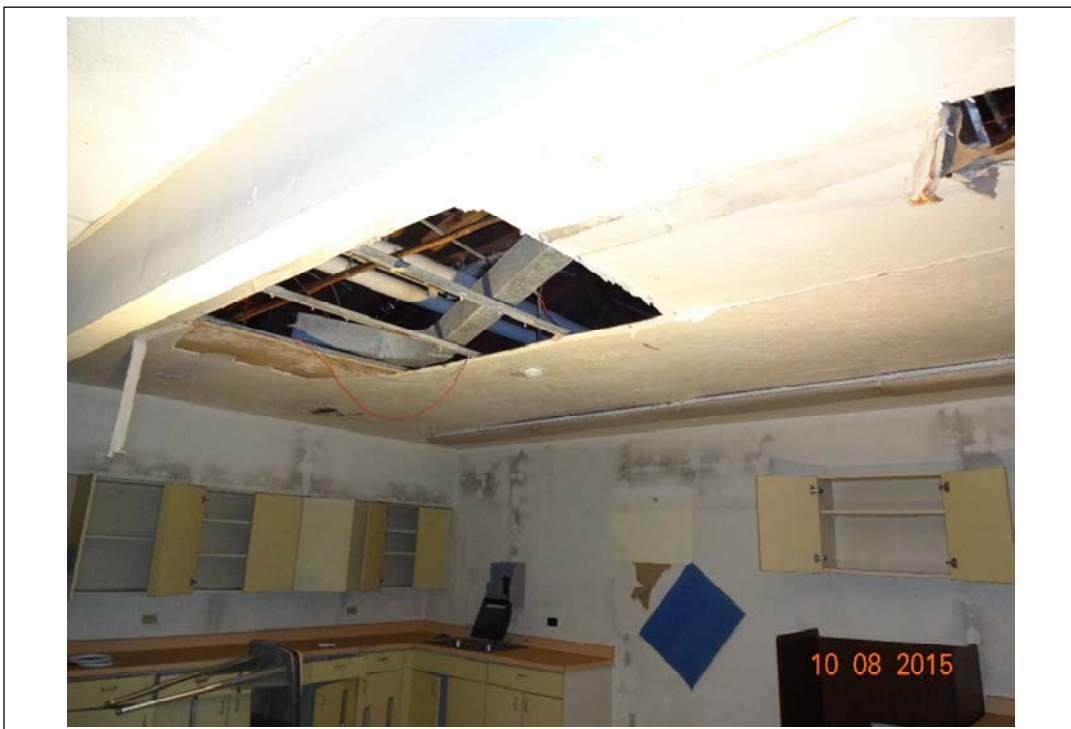
Photo 10. General interior conditions. Ceiling in Room 4. October 8, 2015.

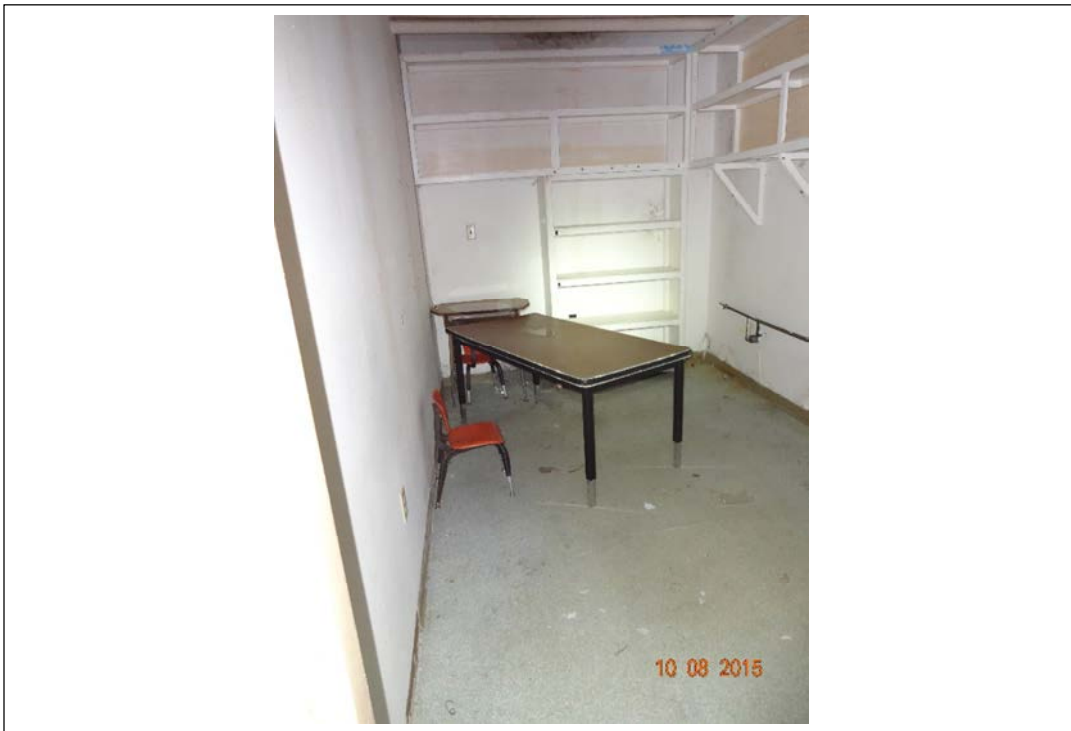
Photo 13. Asbestos-containing linoleum in Room 33 (based on map) but “13” on door. October 8, 2015.

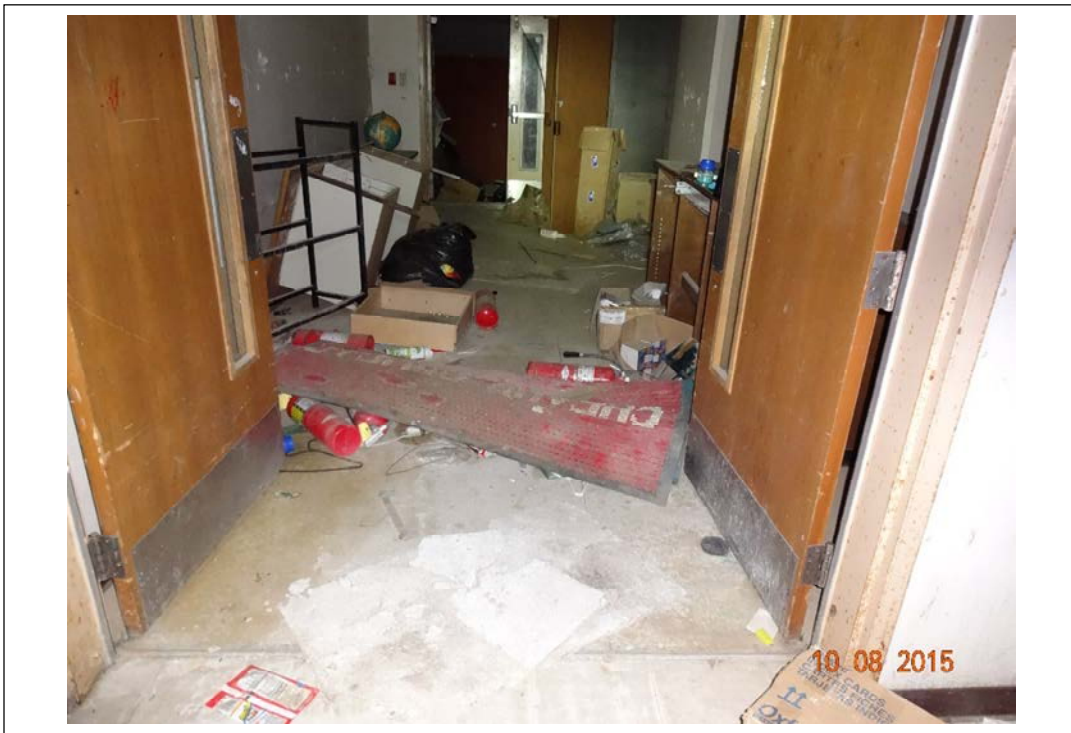
Photo 15. Asbestos-containing linoleum of Room 57. October 8, 2015.

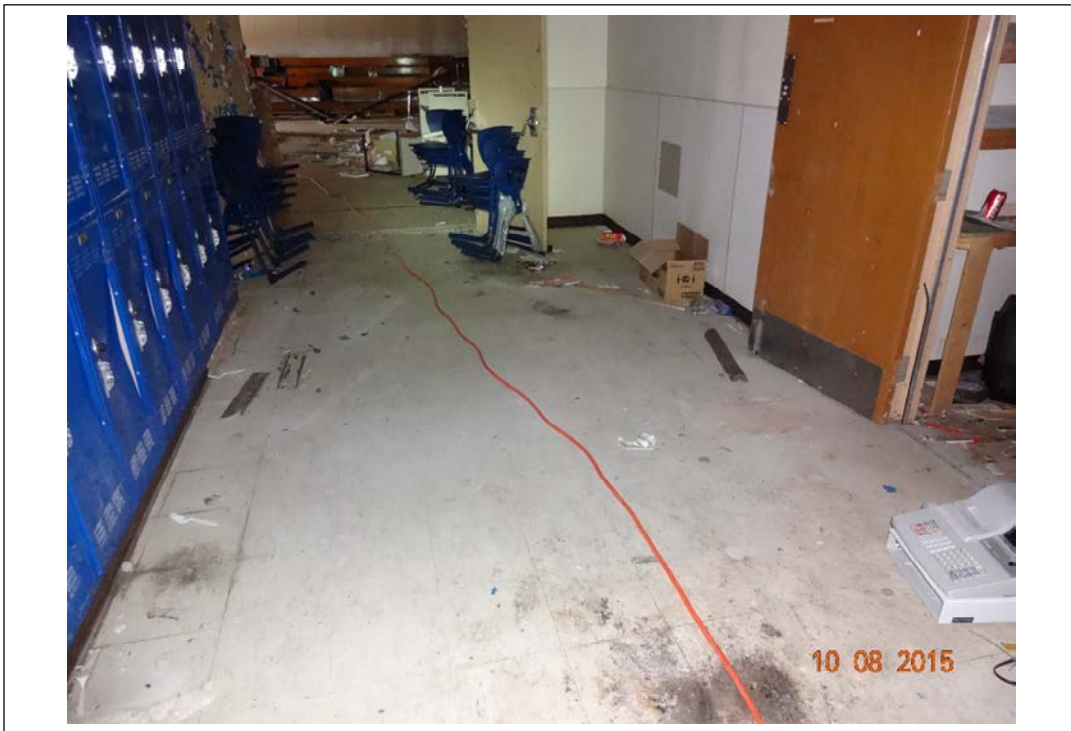
Photo 17. Asbestos-containing linoleum in Room 62. Gymnasium in background, Room 57 on right. October 8, 2015.

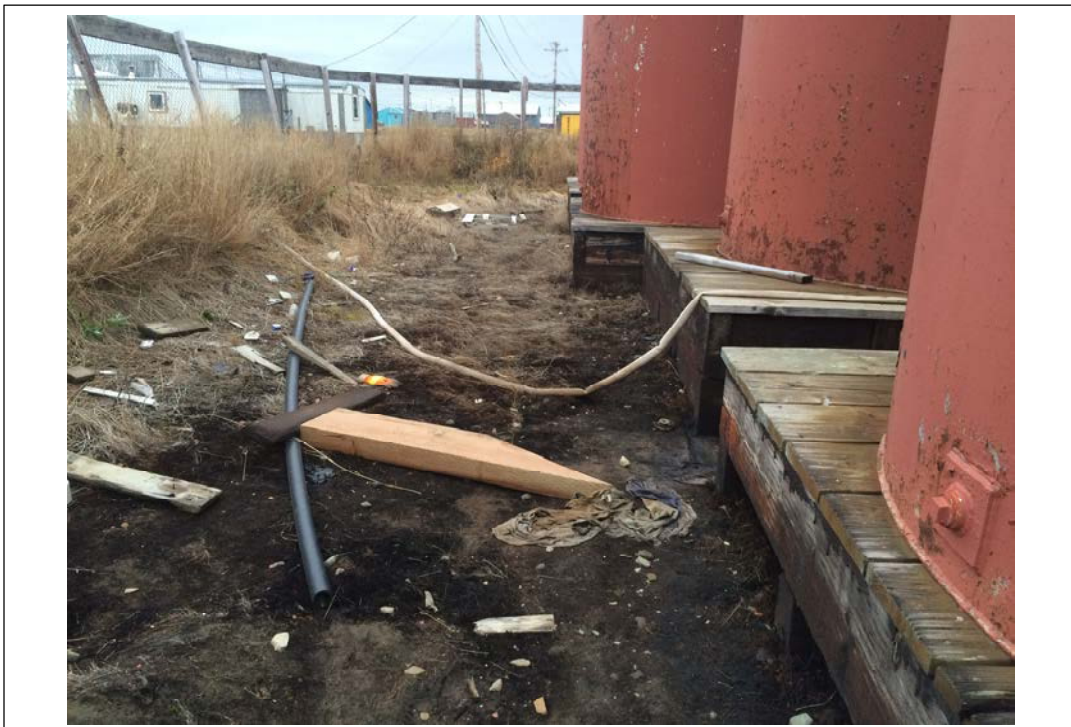
ASTs at the Old School tank farm were apparently not used, but E3 noted a hose leading into one of the tanks (Photos 2 through 4 in Appendix E). The hose appeared to have been recently placed. There was also a ladder leaning against the tank into which the hose lead. The hose was a discharge hose (ie: flexible, non-rigid), suggesting a liquid has not been removed, but rather added to the tank.

Photo 2. Stained soil. Taken from southeast edge of tank farm. Looking southwest. October 8, 2015.

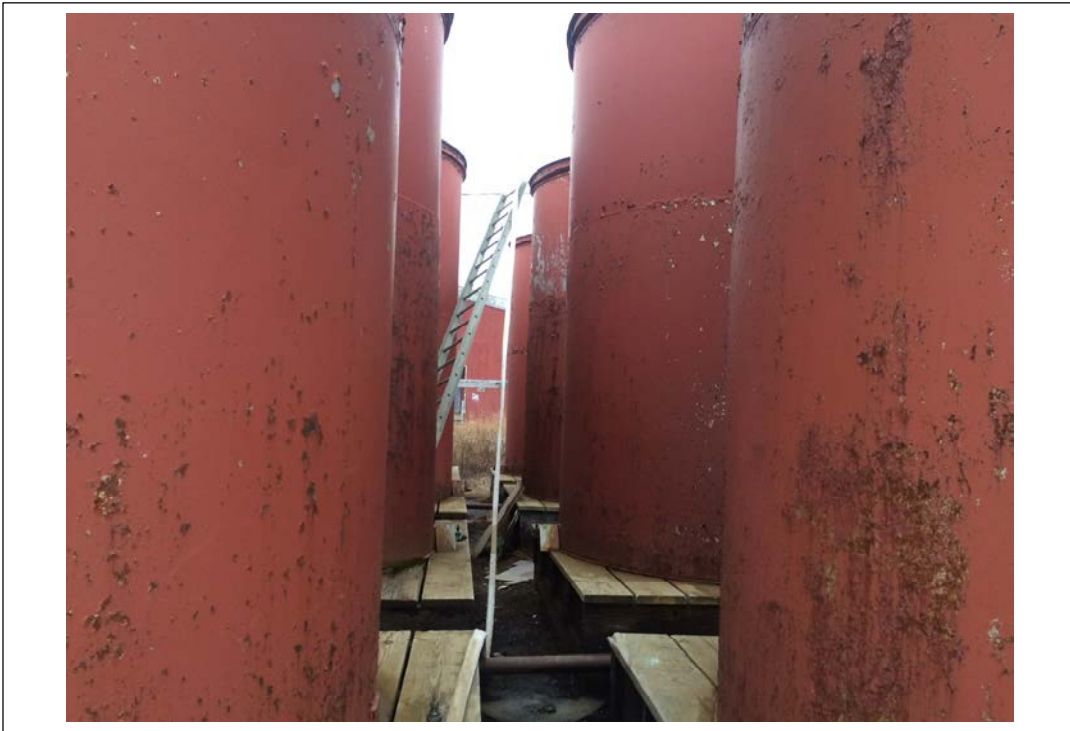
Photo 3. Hose leading to tank next to ladder. Picture taken while standing on southeast edge of tank farm. Looking northwest. October 8, 2015.

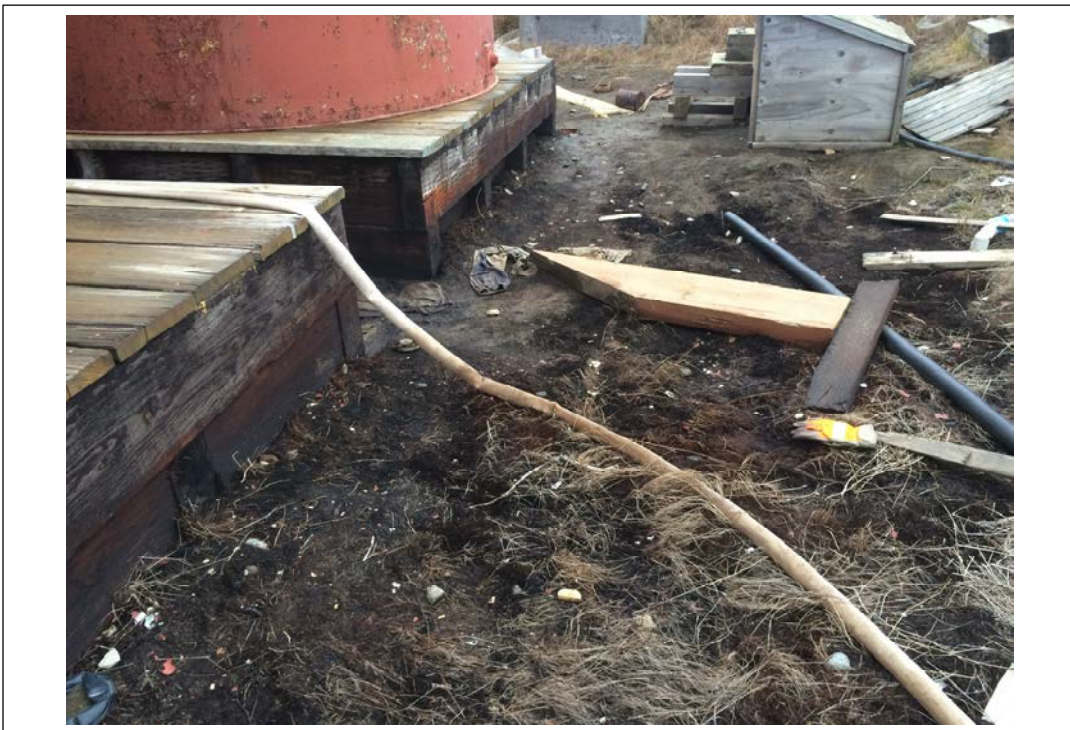
Photo 4. Same hose from Photo 3. Picture taken while standing along southeast edge of tank farm. Looking northeast. October 8, 2015.

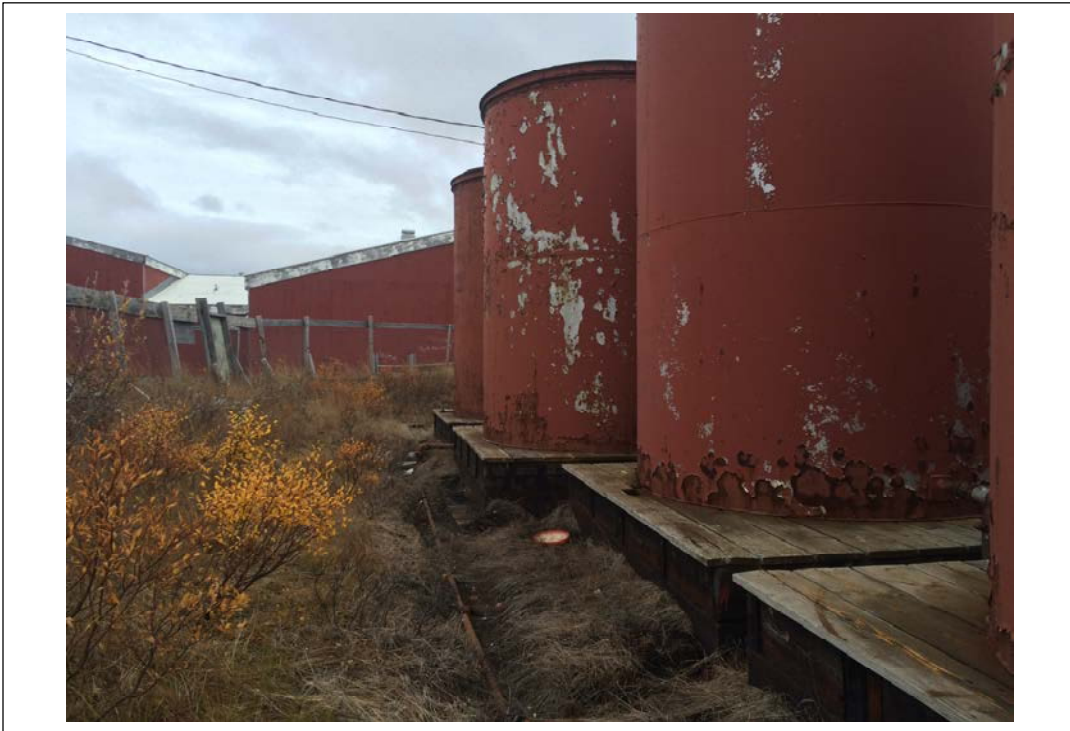
Photo 5. Stained soil along southwest edge of tank farm. Facing northwest. October 8, 2015.

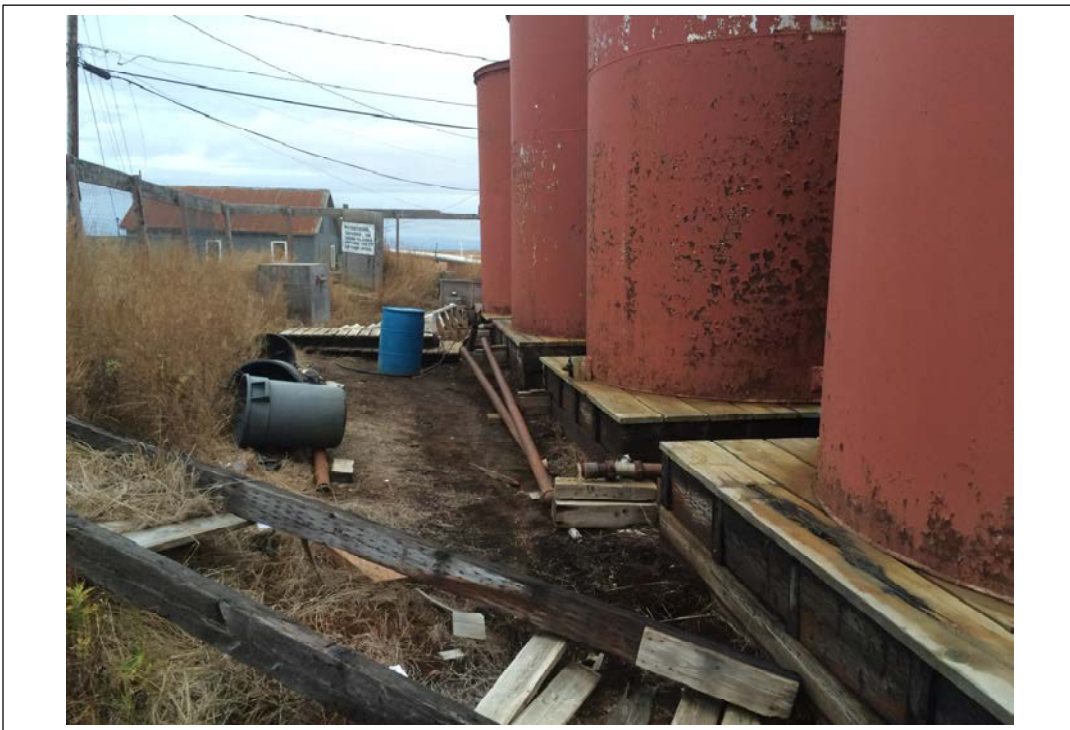
Photo 6. Stained soil and debris along northeast edge of tank farm. Looking southeast. October 8, 2015.
