# DETAILED ACTION PLAN SHAGELUK CITY TANK FARM

## WASTE EROSION ASSESSMENT & REVIEW (WEAR)

MAY 2015

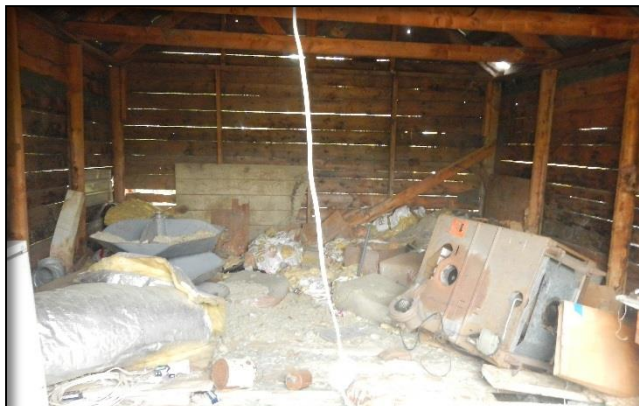
Community Freezer Building (ADEC 2013)

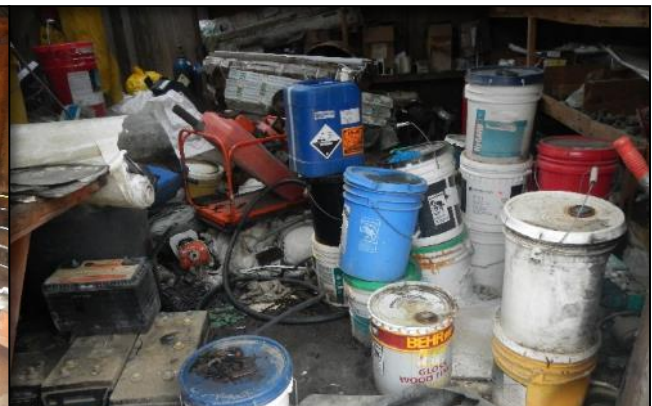
Paints, Batteries, Misc. (ADEC 2013)

As the Shageluk City Tank Farm is no longer in service, it is recommended to remove the site. The empty fuel tanks can be cut into smaller pieces for easier transport and disposal. The Shageluk Landfill is permitted and could accept many of the materials from this site. The contents of the shed (paint, corrosives, lead acid batteries, etc.) cannot be placed in the landfill and should be shipped out of the community. The soil should be characterized for any residual contamination and should be cleaned up as appropriate. Continued drinking water monitoring is recommended.

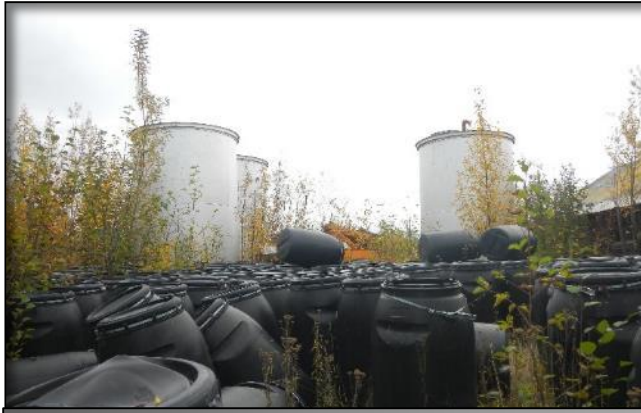
Tanks and Barrels (ADEC 2013)

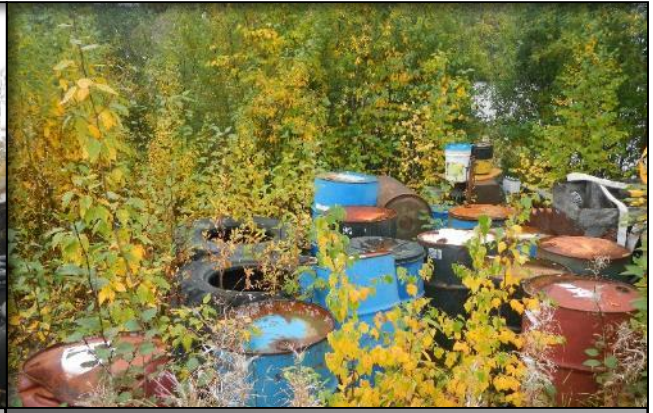
Drums (ADEC 2013)

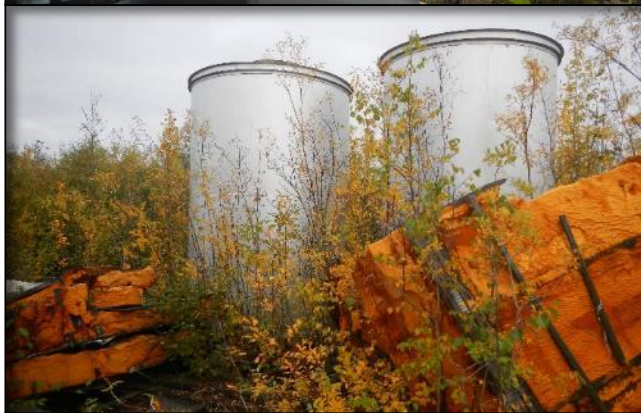
Tanks and Insulation (ADEC 2013)

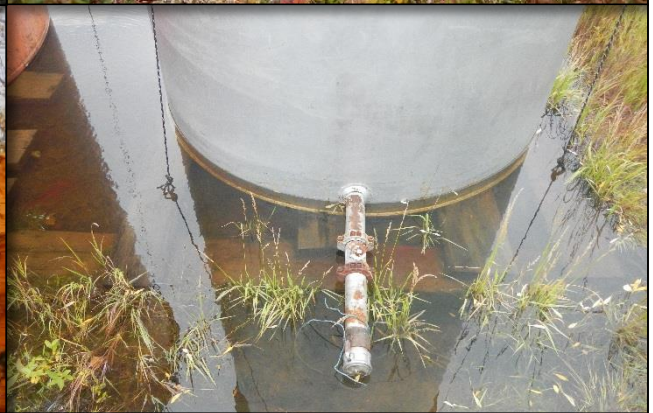
Standing Water and Inactive Tank (ADEC 2013)

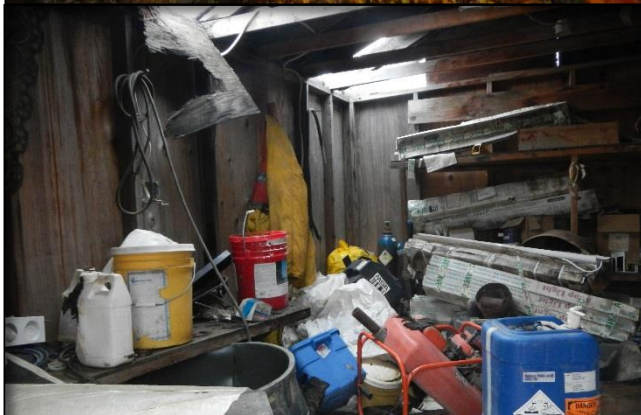
Roof Collapsed in Shed (ADEC 2013)

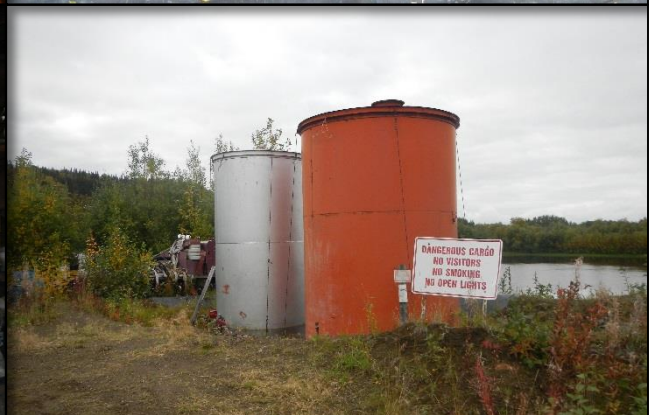
Red and Grey Tanks by River (ADEC 2013)

The US Army Corps of Engineers 2009 study, *Alaska Baseline Erosion Assessment* (BEA), lists an estimated erosion rate of 1-3 feet per year for Shageluk. During the 2013 inspection, the red and grey tanks were only 5 feet from the eroding riverbank and the other tanks were 10 feet from the riverbank. According to the BEA, periodic fluctuations in river flow and water levels, ice jams, spring break up, storm water runoff, and permafrost melt all contribute to erosion. The soil structure consists of silt and clay. Silt will stick together when wet, but will fall apart when dry, making it more easily eroded. However, clay soils are more difficult to erode as they stick together when wet or dry.

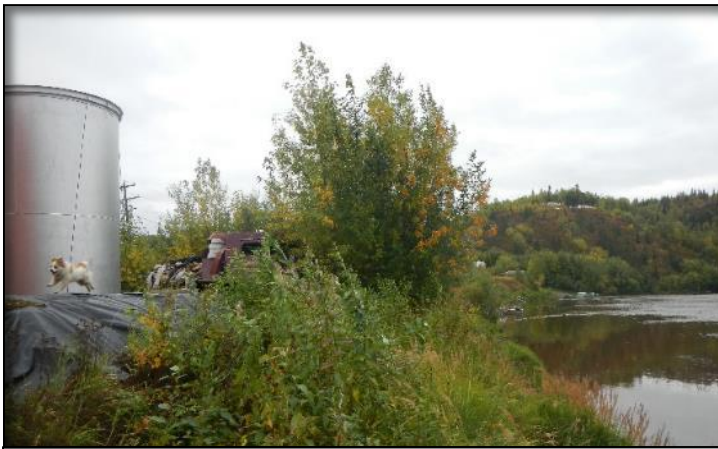
City Tank Farm by Innoko River (ADEC 2013)

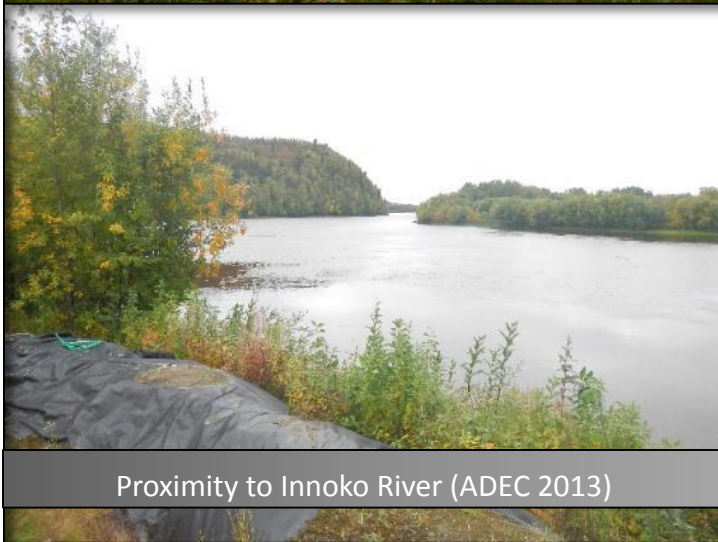
Proximity to Innoko River (ADEC 2013)

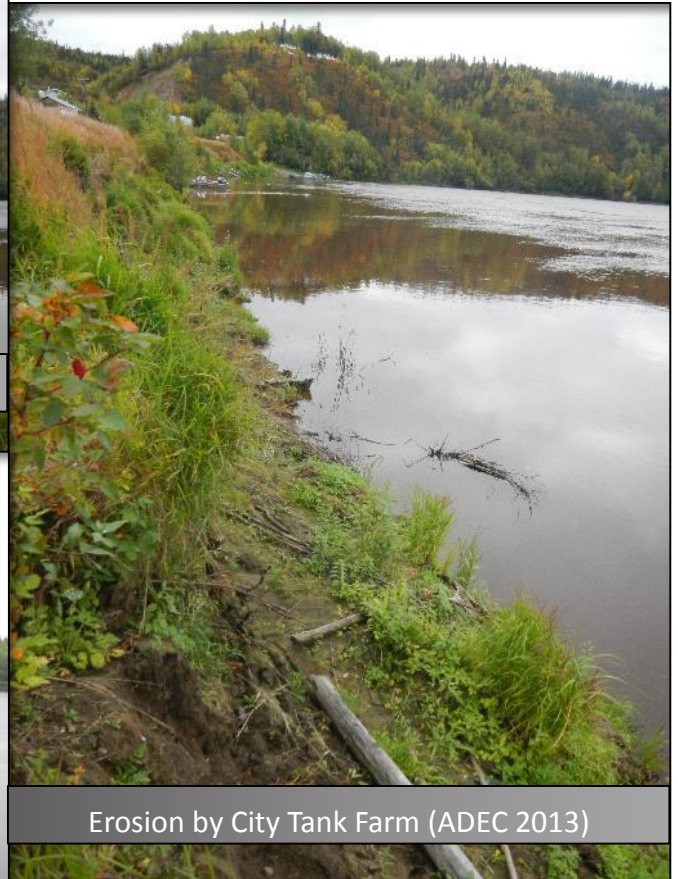
At current erosion rates, the site is estimated to be impacted around 2018.

Erosion by City Tank Farm (ADEC 2013)
