Alaska Department Environmental Conservation (ADEC) Solid Waste Program (Elizabeth Stergiou and Jacob Timmons) conducted a Coastal Impact Assistance Program (CIAP), Waste Erosion Assessment and Review (WEAR) site visit for Atka, July 10th, 2012. The following narrative is a brief description of our findings during our July inspection.

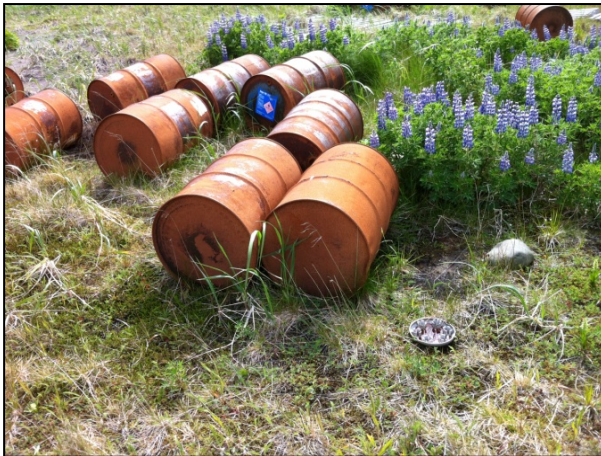
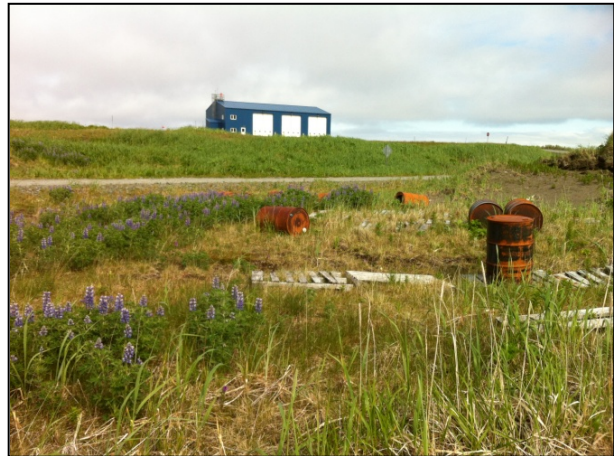
- **Airport Barrel Dump, 52.215348/-174.209082 (Abandoned)** – This site is 800 feet east of Korovin Lake and near the airstrip. The nearest source of erosion is a creek 190 feet to the east. The site includes 17 barrels. Stressed vegetation was found at the site around some of the barrels. The site is generally flat and the soil was sandy with high organic content.

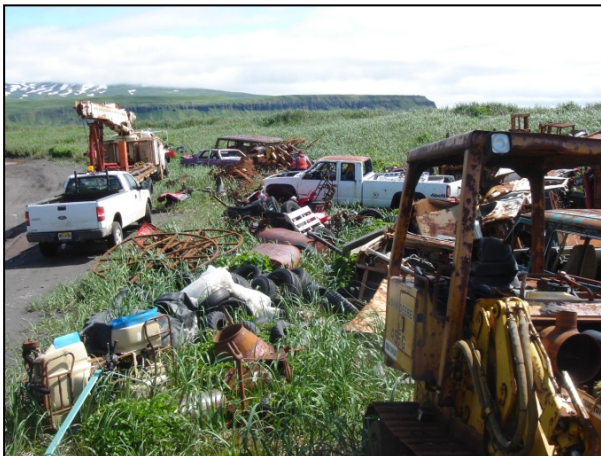
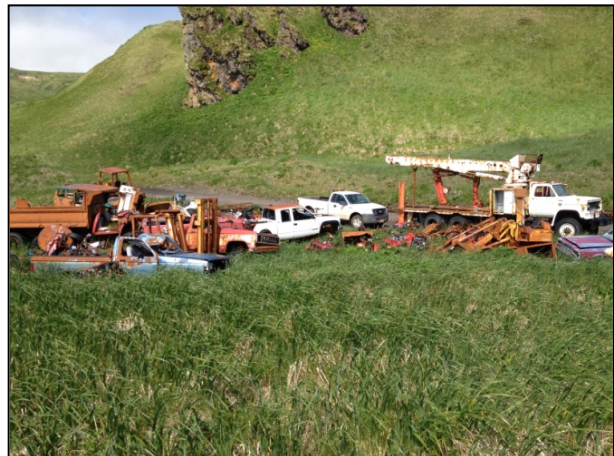
- **Beach Dune Vehicle Boneyard, 52.221357/-174.200484 (Active)** – This site is located 1,300 feet east of the airport between the road to the landfill and the ocean. The nearest source of erosion is the Pacific Ocean 100 feet away. The site includes more than 40 vehicles, some with fuel still inside. The dunes behind the site are actively eroding. The soil around the site is fine sand colonized by beach grass.

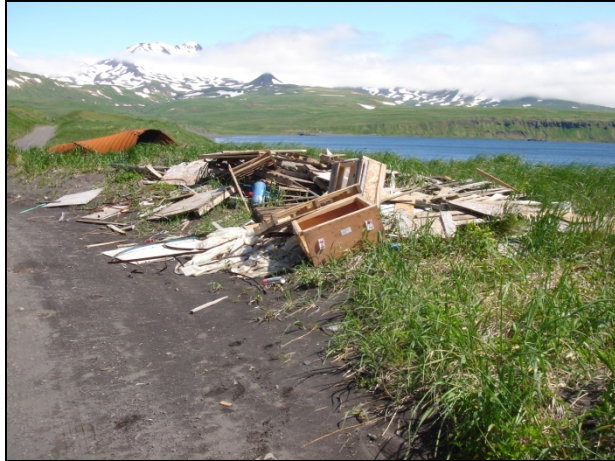
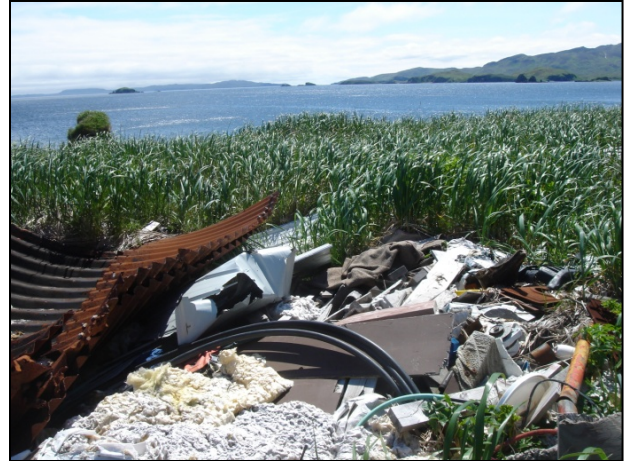
- **Bonfire C&D, 52.223755/-174.19791 (Active)** –This site is located 2,000 feet east of the airport off of the road going to the landfill. The nearest source of erosion is the Pacific Ocean 20 feet away. The site includes mostly construction and demolition (C&D) waste but also includes some household waste, batteries, electronics, motor oil, and a pesticide sprayer. Residents use wood from this site to make bonfires on the beach. The site is on a bluff overlooking the ocean between two rocky outcroppings. The soil around the site is fine sand.

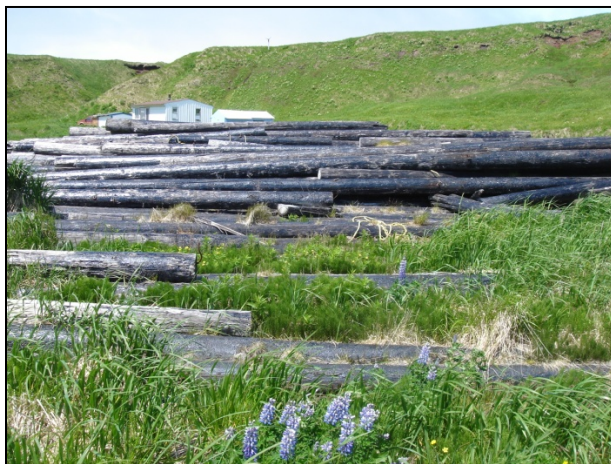
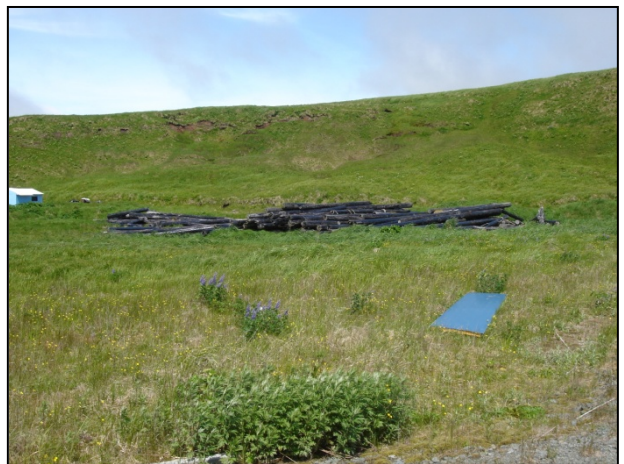
- **Creosote Pilings near Crab Pot Storage, 52.235545/-174.177803 (Abandoned)** – This site is located near the crab pot storage area 1,700 feet northwest of the dock. The site is 240 feet away from the Pacific Ocean, which is the nearest source of erosion. The site consists of creosote pilings. There were dead and stressed vegetation found around the pilings. A thick creosote odor was observed in the vicinity.

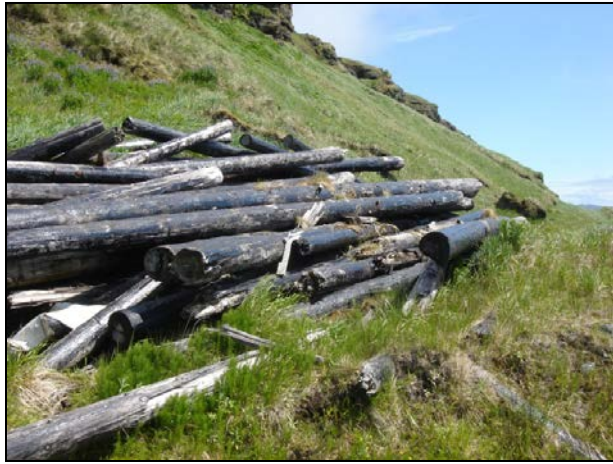
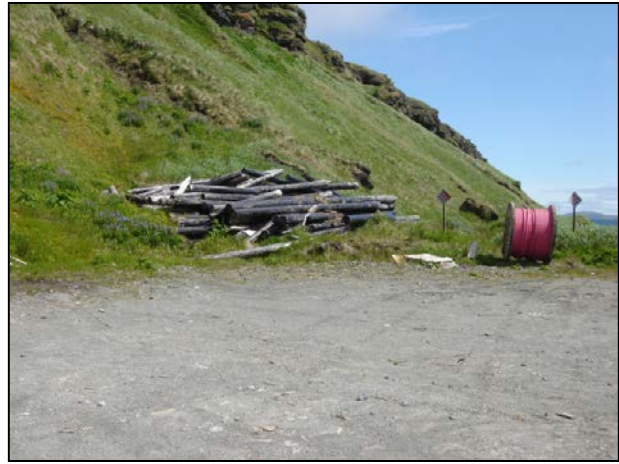
- **Dock Creosote Pilings, 52.232573/-174.170799 (Abandoned)** –This site is located 140 feet southeast of the dock. It is 40 feet north of actively eroding coastline. This site consists of creosote pilings. Dead and stressed vegetation were found near the pilings. A thick creosote odor was observed around the pilings.

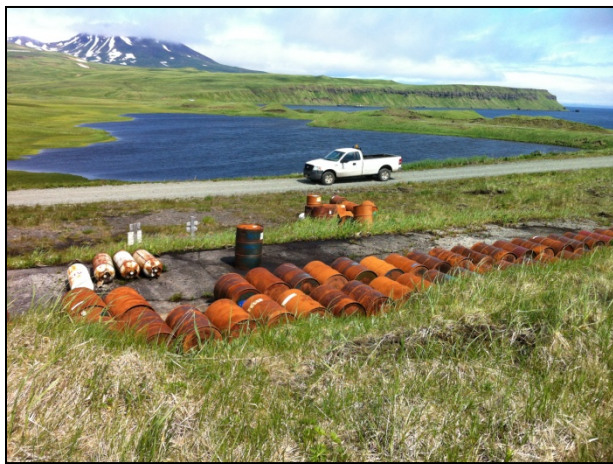
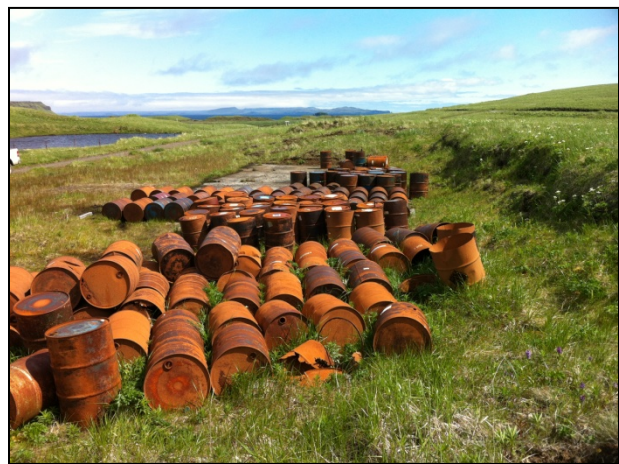
- **Dock Lake Barrels and Compressed Gas Tanks, 52.230727/-174.201166 (Inactive)** –This site is located 450 feet west of Dock Lake. It is 1,970 feet from the Pacific Ocean, the nearest source of erosion. This site contains approximately 150 barrels and 8 compressed gas tanks. Most of the tanks are on top of a concrete pad. The soil around the site is sandy with high organic content. Stressed and dead vegetation was found in the area. Stained soil and blackened plants were observed where petroleum products had run off of the pad. Approximately ninety percent of the pad was stained by petroleum. A strong, distinct petroleum odor was observed around the site.

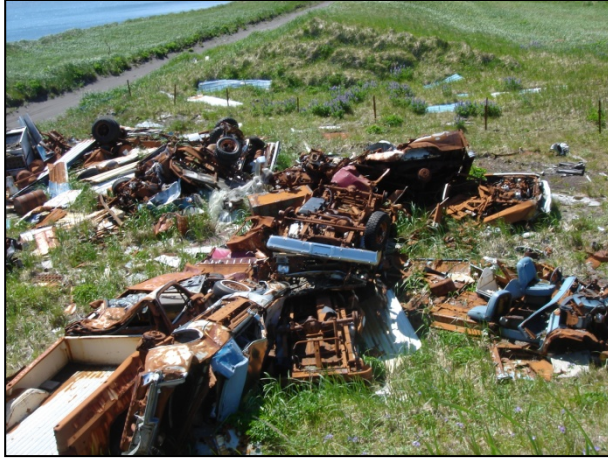
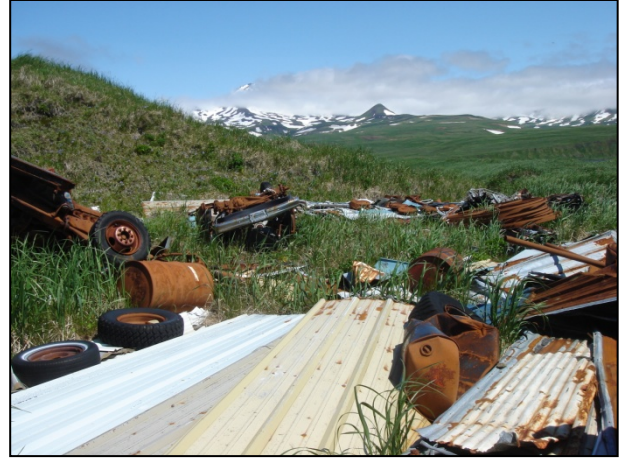
- **Fenceline Vehicle Boneyard, 52.225733/-174.196623 (Active)** –This site is located 1,000 feet south of the landfill. It is 90 feet from the Pacific Ocean, the nearest source of erosion. This site contains approximately 16 vehicles, 6 Conex refrigerator units, 3 day tanks, barrels, metal siding, and miscellaneous metal and plastic waste. Some stressed vegetation was found around this site.

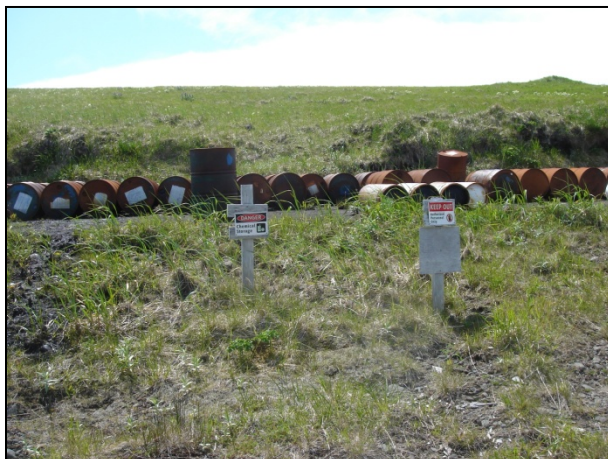
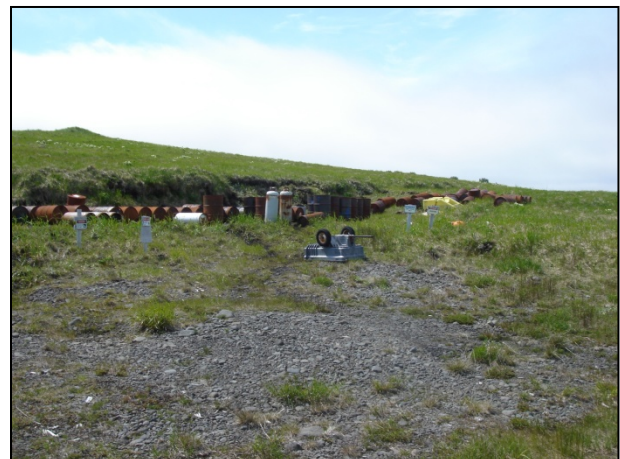
- **Korovin Lake Barrel Dump, 52.234716/ -174.205161 (Inactive)** –This site is located 800 feet east of Korovin Lake. It is 3,500 feet from the Pacific Ocean, the nearest source of erosion. This site contains approximately 140 barrels on a concrete pad. The pad was completely saturated with petroleum. A strong, distinct petroleum odor was observed around the site. Dead and stressed vegetation were found where petroleum products had run off of the pad.

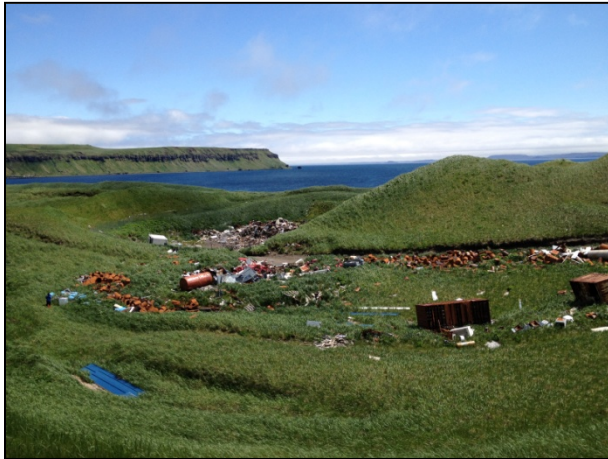
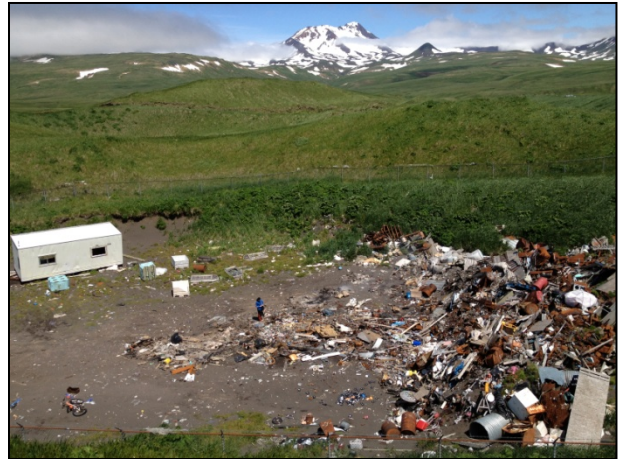
- **Landfill, 52.22862/-174.194808 (Active)** –This unpermitted site is located north of the airport, about 500 feet southwest of Dock Lake. It is 190 feet from the Pacific Ocean, the nearest source of erosion. Unauthorized dumping and open burning without separation was observed. Additionally, improper storage of hazardous waste such as paint and batteries was found.

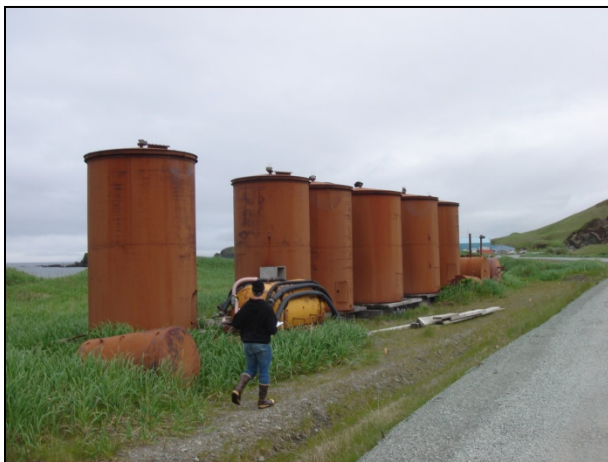
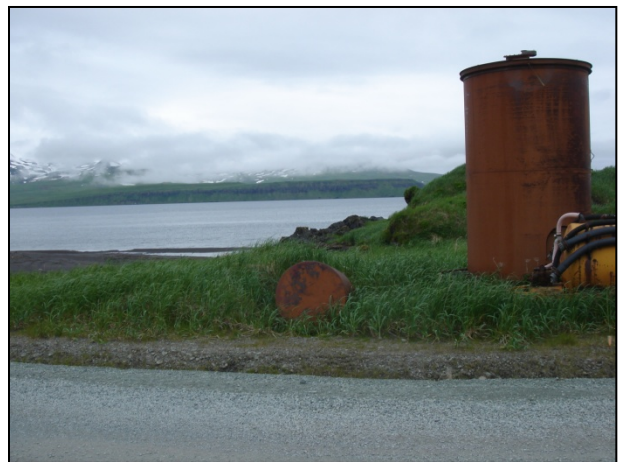
- **Old Tanks North of Gravel Pit, 52.206696/ -174.200838 (Abandoned)** –This site is located 600 feet southeast of current city tank farm. It is 70 feet from the Pacific Ocean, the nearest source of erosion. This site contains 6 upright tanks, 4 horizontal tanks, 2 day tanks, a truck tank, and more than ten barrels. All were reported as being empty of fuels. Most of the barrels were partially buried. The sea and a small, nearby stream both pose as erosion risks. Small patches of dead vegetation were found in the area.

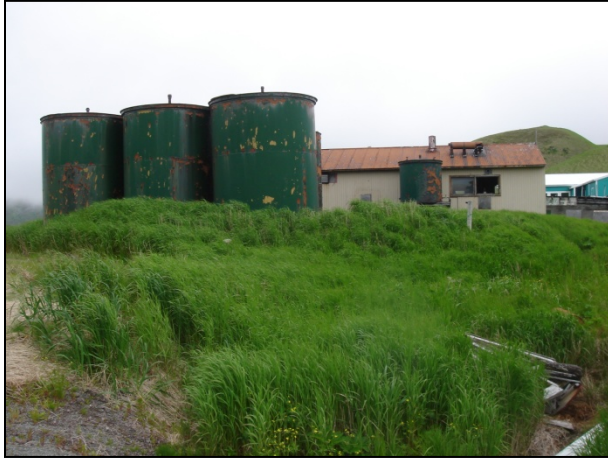
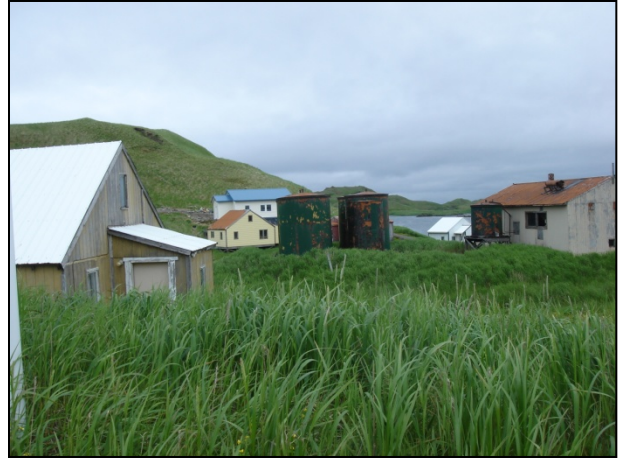
- **Old Town Power Plant, 52.199102-174.198137 (Abandoned)** –This site is located in the middle of the old town, about 300 feet northeast of the church. It is 60 feet from a creek, the nearest source of erosion, and 250 feet from the Pacific Ocean. This site contains 6 upright tanks and one day tank. Sheen was observed in a small pool of standing water between the upright tanks and the day tank. Sheen was also found in small amounts of water around the tanks. Dead and stressed vegetation were seen around the sheen pool and some of the tanks. Moss had grown in between the upright tanks, but was saturated with petroleum.

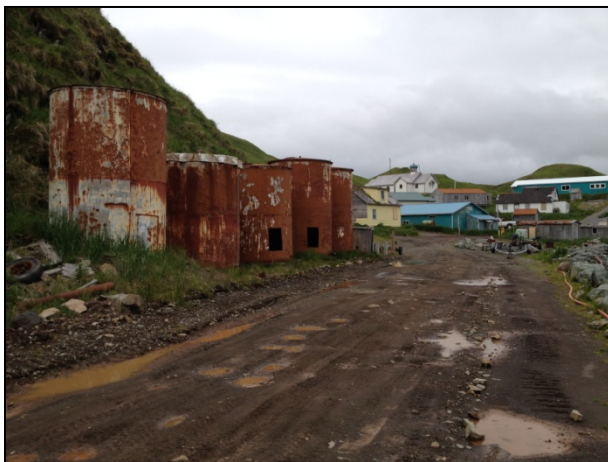
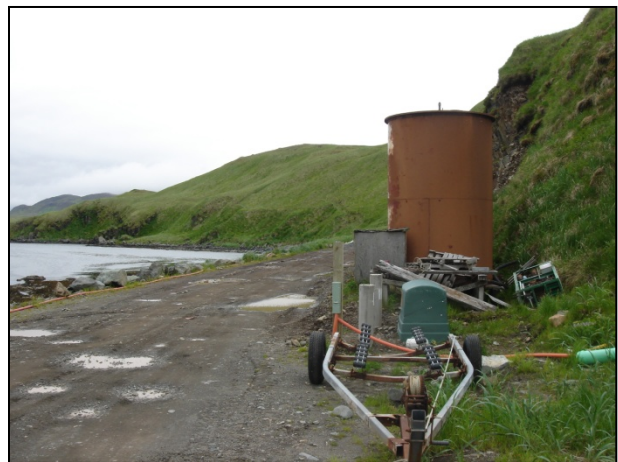
- **South Old Fuel Tanks, 52.197315/-174.198507 (Inactive)** –This site is located less than 300 feet south of the old town. It is 20 feet from the Pacific Ocean, the nearest source of erosion. This site contains 5 upright, empty tanks that were moved here from an unknown location. Riprap has been set up to protect against erosion. Some soil had a petroleum odor. Vegetation near this soil was stressed or dead.
