CIAP WEAR Trip Report
Clark's Point (population 59)
July 12, 2012

Alaska Department of Environmental Conservation (ADEC) Solid Waste Program (Kitrina Persson and Jamie Gorman) conducted a Coastal Impact Assistance Program (CIAP), Waste Erosion Assessment and Review (WEAR) site visit for the Village of Clark's Point, July 12th, 2012. Sharon Clark, the Village Council Administrator, and Tom Egbert, the City Manager helped coordinate our visit. The following narrative is a brief description of our findings during the July inspection.

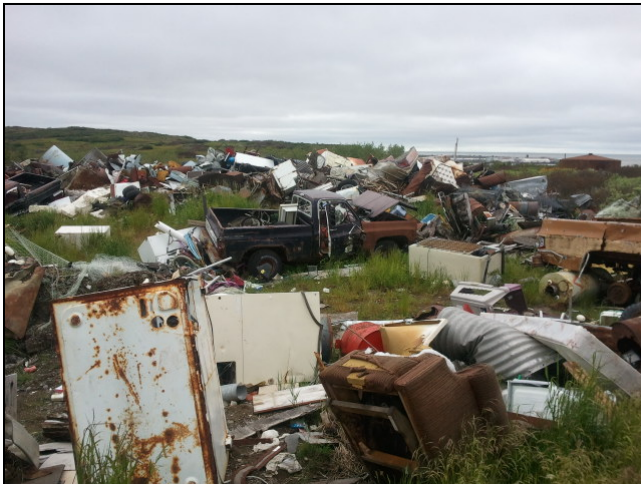
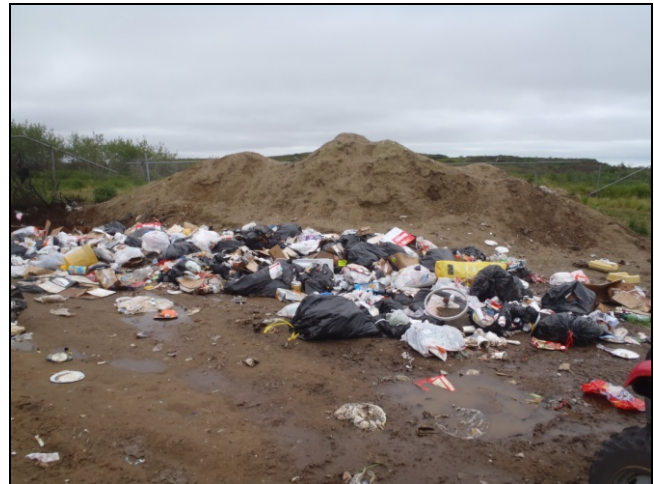
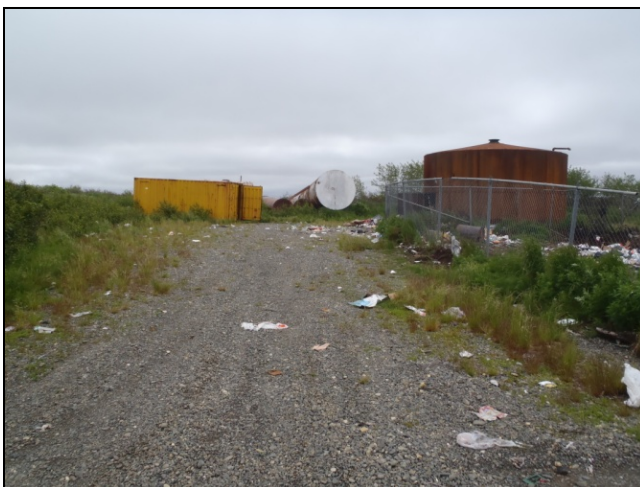
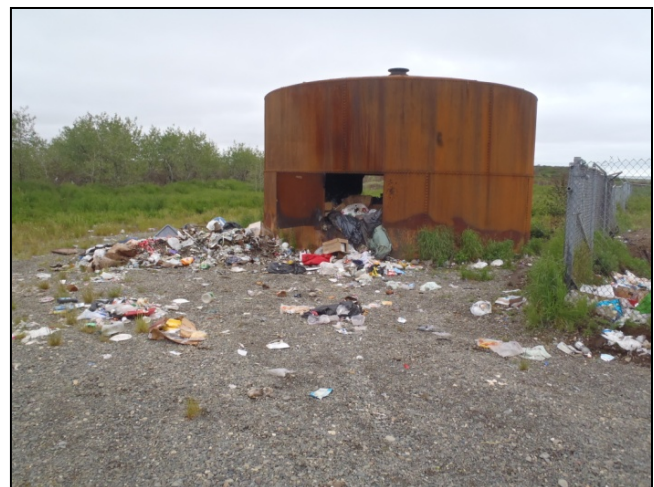
- **Landfill, 58.831868/-158.555465 (Active)** – This unpermitted landfill is located on a bluff above town overlooking the Nushagak Bay. It includes a separate unsorted salvage area, an old water tank used as an incinerator, a fenced area for waste disposal, and a shipping crate used for battery collection. The fence is standing but in poor condition and there is no gate to limit access or posted signs to direct users. The current waste cell was full of unburned garbage and waste had been placed in various other areas around the landfill site. A large mound of excavated soil was available next to the trench for cover. The landfill is approximately 200 feet from the edge of the bluff. The 2009 Alaska Baseline Erosion Assessment study by the Army Corps of Engineers specifies an erosion rate for Clark's Point of 2 to 4 feet per year.

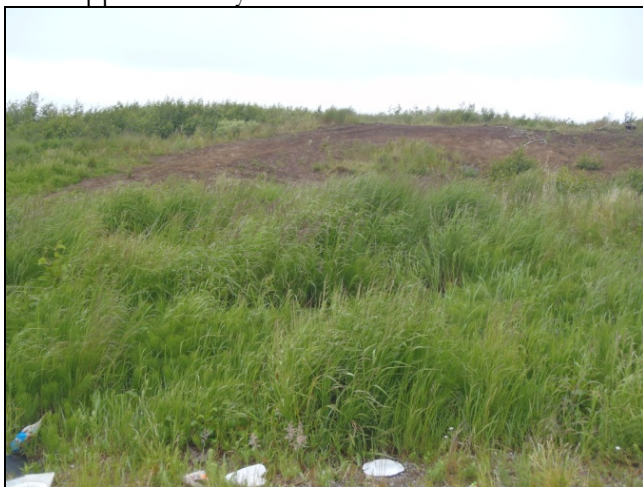
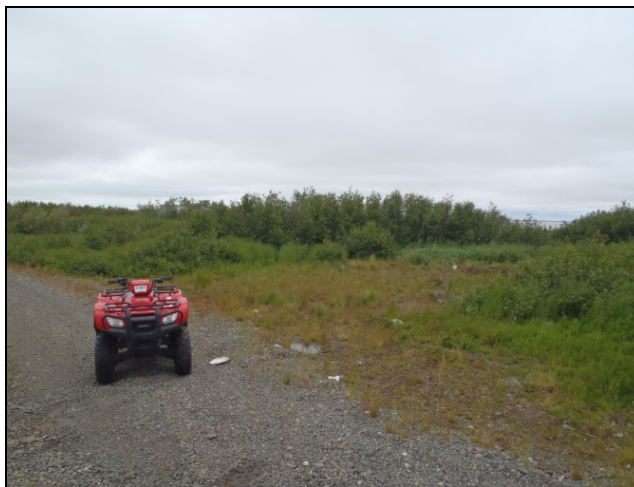
- **Old Landfill, 58.831900/-158.556158 (Closed)** – This landfill site is located across the road directly west from the current landfill. The landfill has been closed with the proper cover and vegetation is re-growing rapidly. The site extends towards the edge of the bluff, which is approximately 130 feet west.

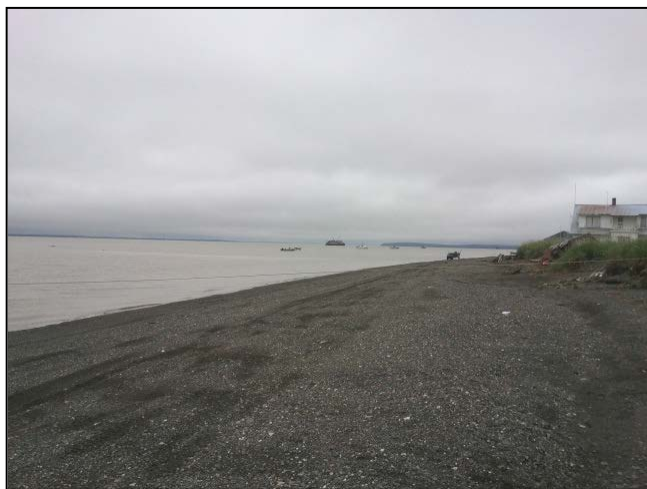
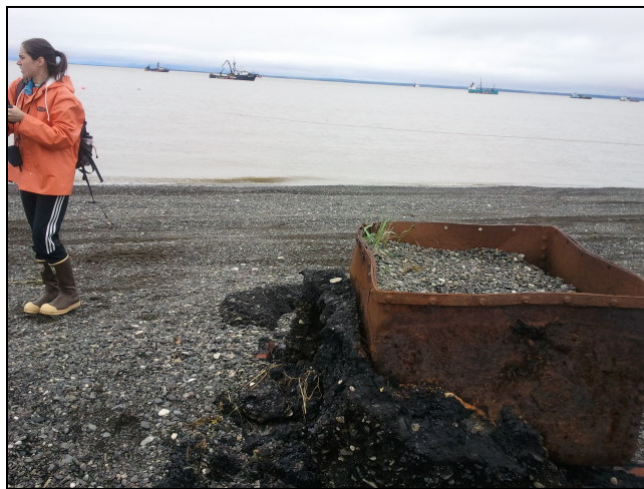
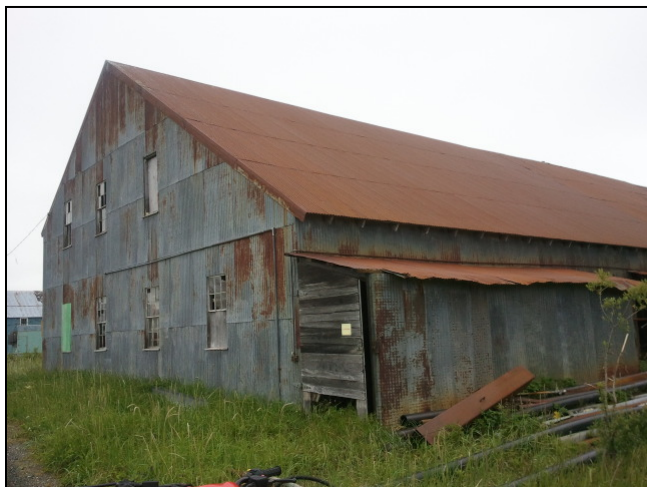
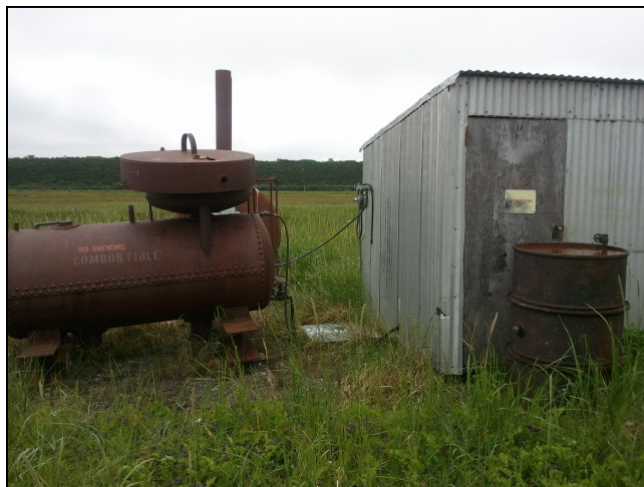
- **Cannery Remains, 58.844086/-158.552245 (Abandoned)** – The old cannery buildings and other equipment from the cannery (established in 1888) remain as they were left in 1952. There is a rusted box with bricks and tar eroding on the beach, a fuel tank, and thousands of pounds of leftover materials around the old buildings. The buildings are less than 5 feet from the high tide line. The cannery has been closed and off-limits to the public for several years due to asbestos concerns.

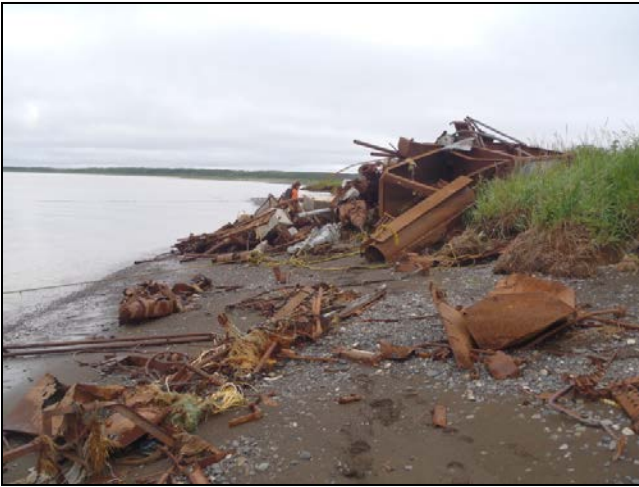
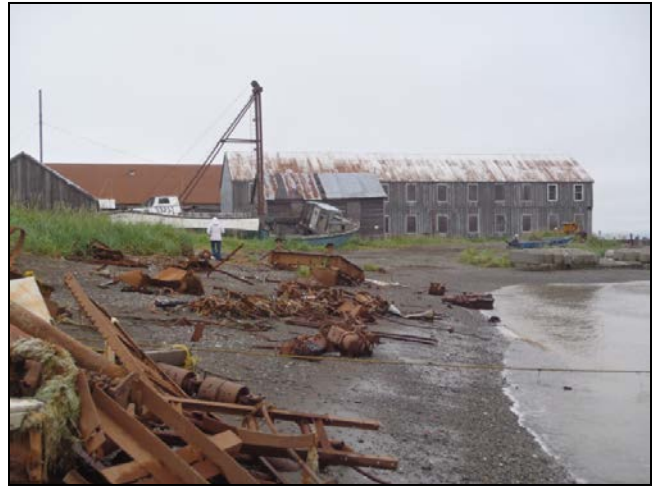
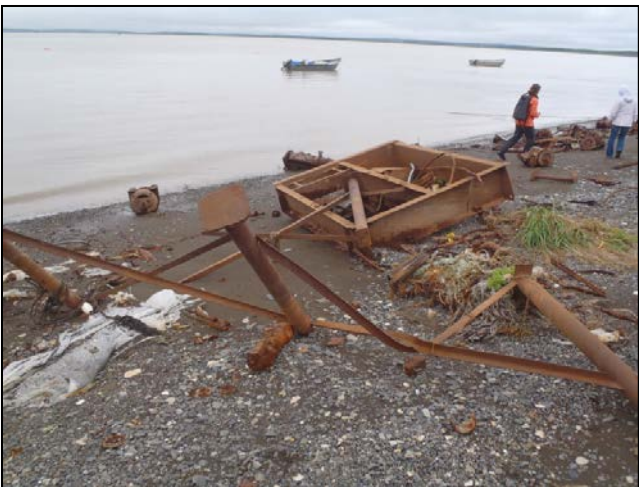
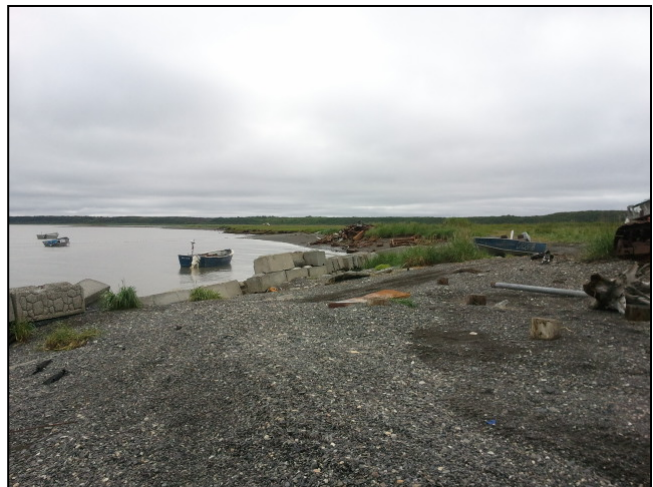
- **Old Cannery Landfill, 58.844371/-158.549600 (Abandoned)** – This landfill from the 1980's and earlier is actively eroding into the ocean. The site mainly contains old rusted scrap metal and is located on the tip of the point, 150 feet east of the cannery. Much of the point has eroded in the past 30 years (approximately 50 feet) and a sea wall has been installed to the west of the site, in front of the cannery.

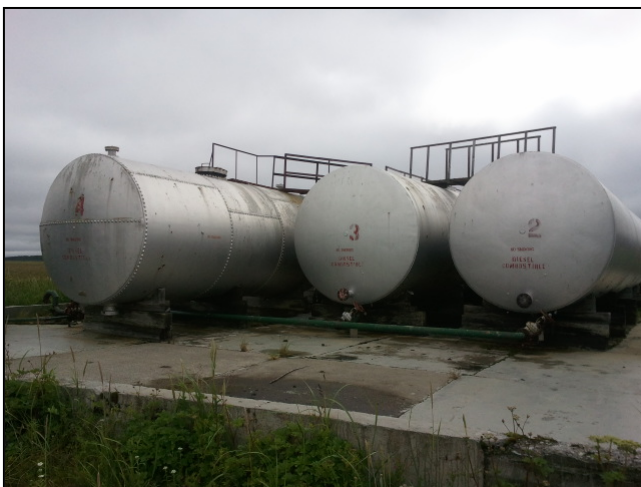
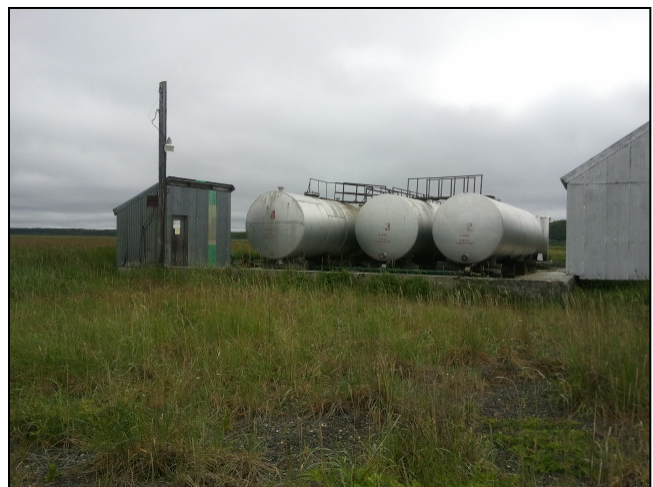
- **Tank Farm, 58.841523/-158.553983 (Active)** – The tank farm is about 450 feet from the beach. There are four horizontal fuel tanks on a concrete pad and there is no visible secondary containment.

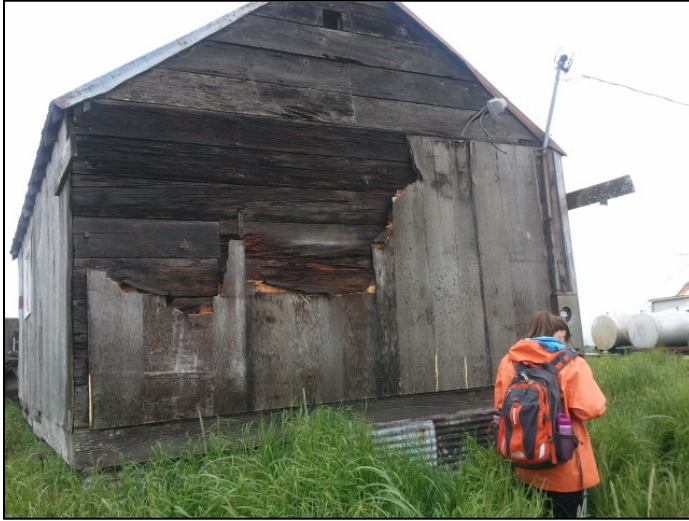
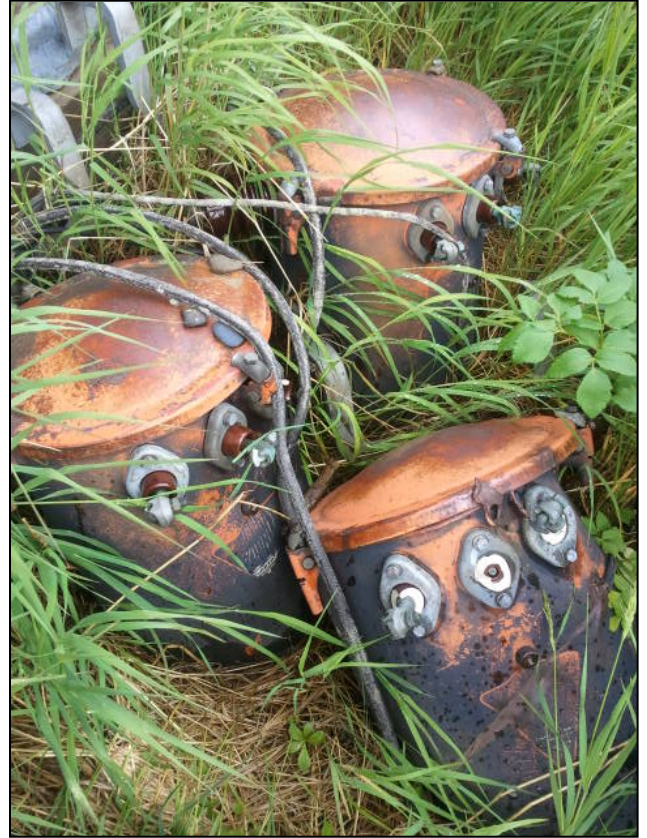
- **Transformers, 58.838652/-158.557512 (Abandoned)** – There are several transformers throughout the community buried in high grass. At one location visited, the blackened transformers were sitting atop dead vegetation and were 200 feet from the beach.
