Alaska Department of Environmental Conservation (ADEC) Solid Waste Program and Contaminated Sites Program (Doug Huntman and Grant Lidren) conducted a Coastal Impact Assistance Program (CIAP), Waste Erosion Assessment and Review (WEAR) site visit for Kipnuk on September 18th, 2012. Harvey Dock participated on the site visit. The following narrative is a brief description of our findings during the September inspection.

WEAR Sites

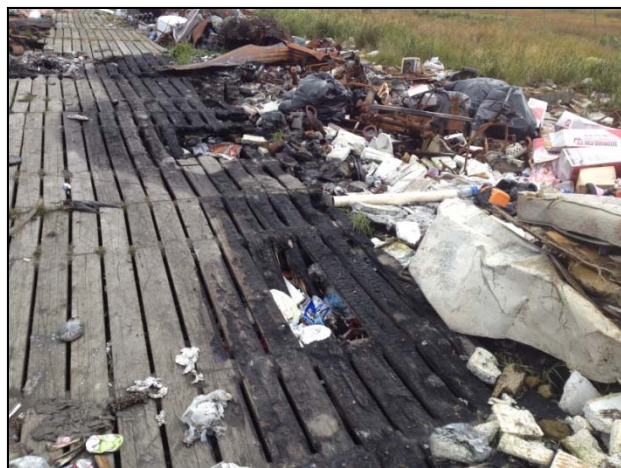
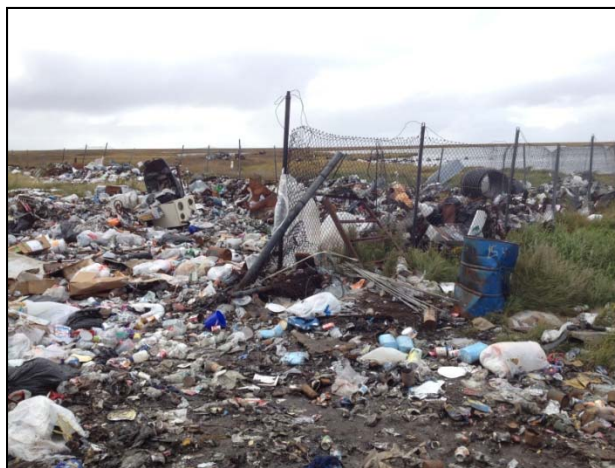
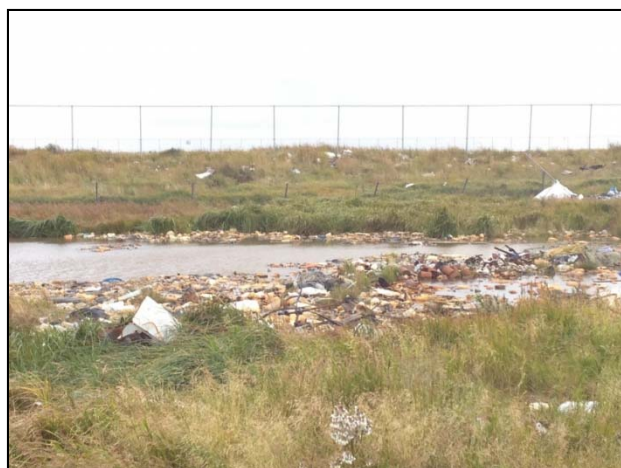
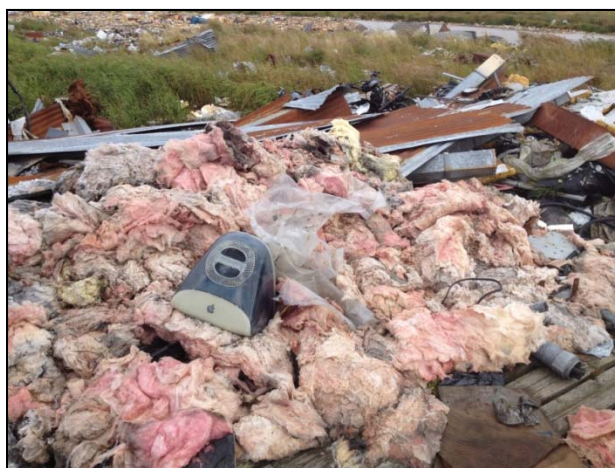
- **Landfill, 59.932264/-164.064701 (Active)** – The permitted, self-haul landfill covers 3.2 acres and is located half a mile from the nearest structure. The landfill is owned and operated by the Native Village of Kipnuk and located on semi-discontinuous permafrost. The site's boundary is less than 60 feet from a medium sized lake and contains a half acre tundra pond within the landfill boundaries. The landfill accepts municipal waste, but it does not prohibit any special wastes or hazardous wastes. The landfill's operations are very basic: there is no cover material, there is no heavy equipment for consolidation/compaction, and they open burn. There was a large amount of contractor waste in the landfill at the time of the inspection. The landfill is situated approximately 2,000 feet from the banks of the Kugakhtlik River. This site has flooded in the past.

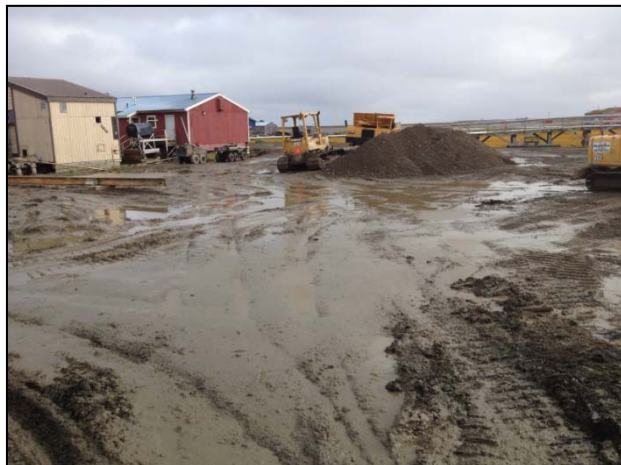
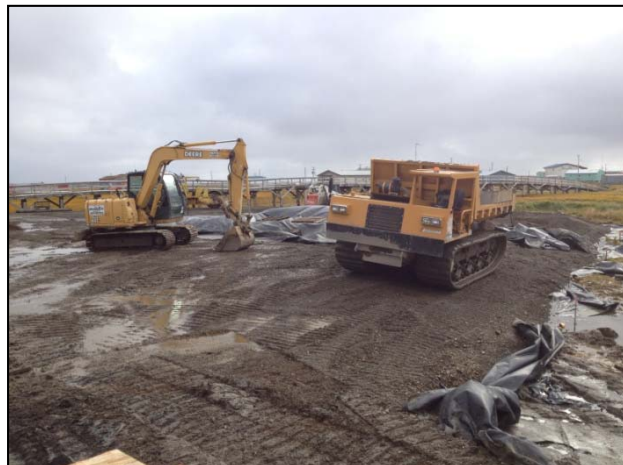
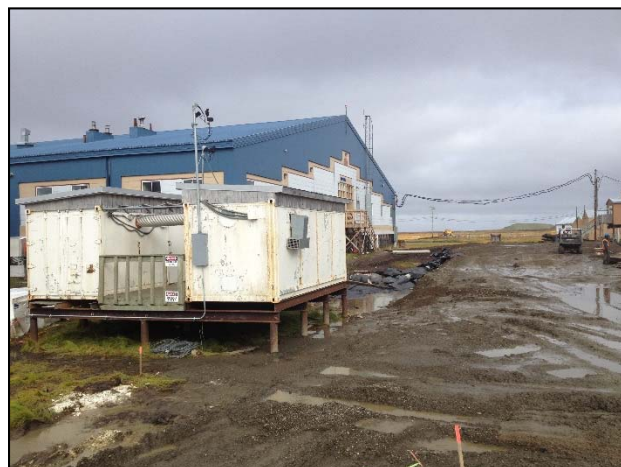
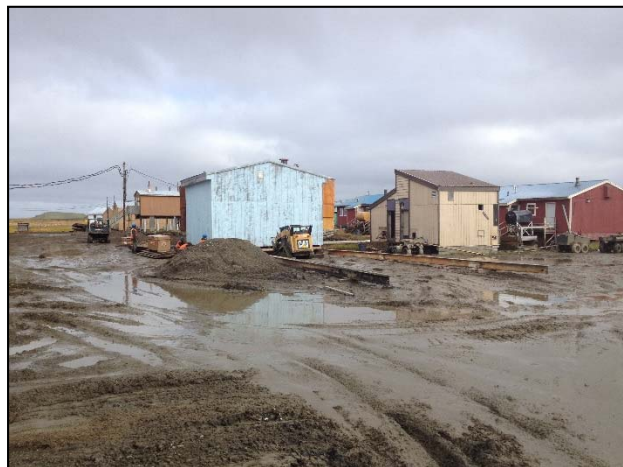
- **School Sewage Monofill, 59.935915/-164.038538 (Closed)** – This site is the former sewage lagoon for Chief Paul Memorial School, which is owned and operated by the Lower Kuskokwim School District. Closure of the sewage lagoon was approved by the Solid Waste Program. The lagoon was de-watered, treated and capped with fill material in 2012. As of this visit, the site was fully covered with soil and construction was on-going for the school expansion approved on the site's footprint. It is located 1,140 feet from the Kugkaktlik River, which is eroding at 6 feet a year in this section per the BEA study.

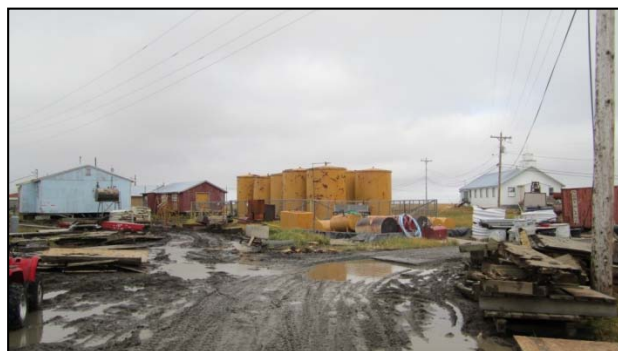
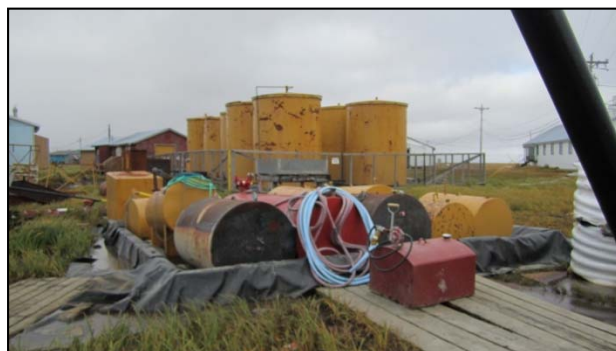
- **Tank Farm, 59.935736/-164.036632 (Active)** – This tank farm is located in the village, approximately 120 feet from the church and adjacent to the old clinic. It contained 10 vertical fuel tanks within a fenced area and around 10 smaller tanks in an unfenced area with secondary containment. It was reported that several hundred gallons of diesel spilled out of an above ground storage tank in the past. It is located 1,450 feet from the Kugkaktlik River.

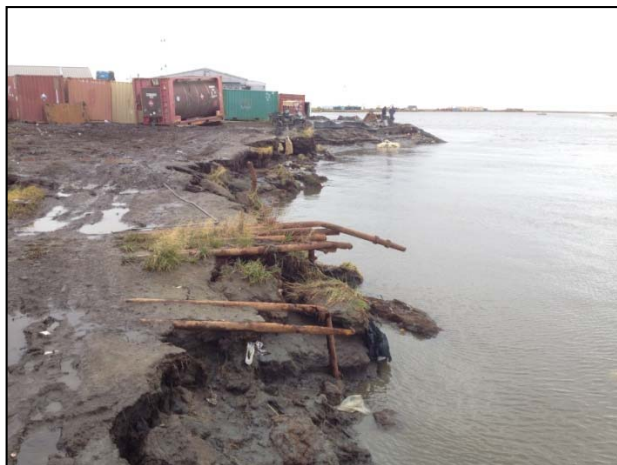
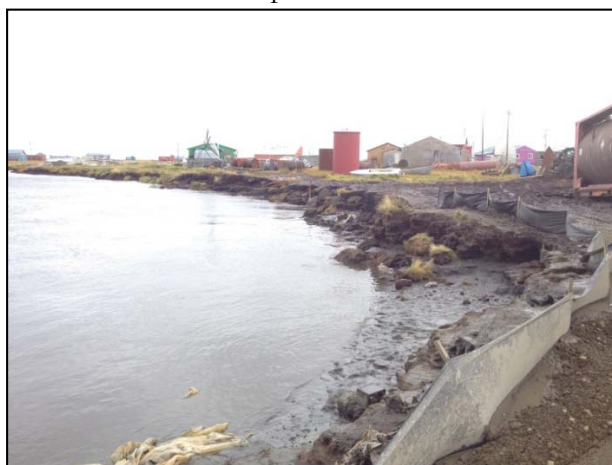
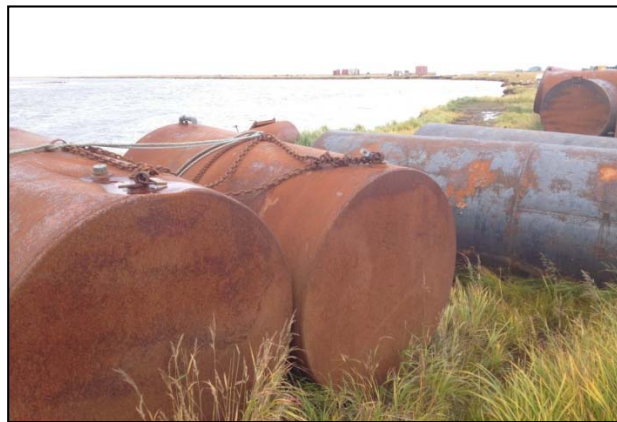
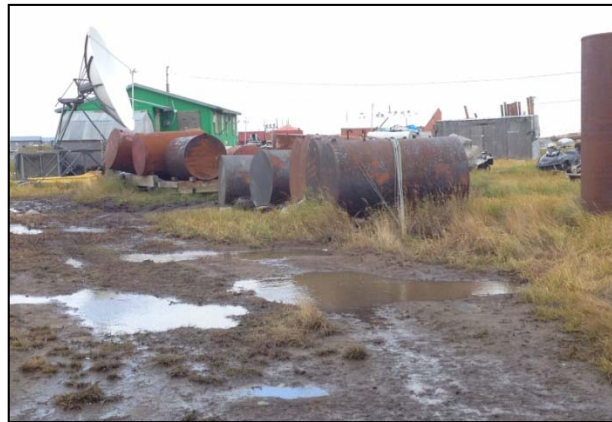
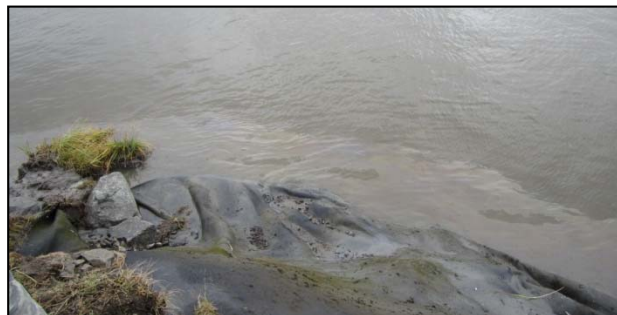
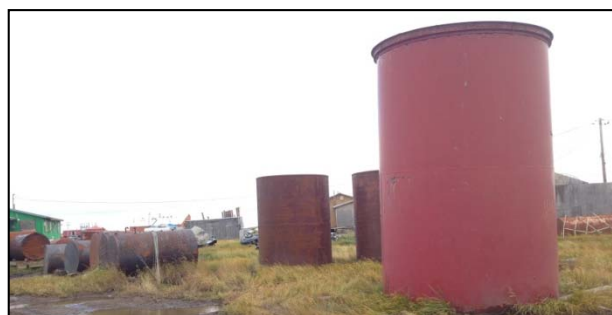
- **Tanks and Sheen, 59.938401/-164.042494 (Abandoned)** – This site is located right on the banks of the Kugukaktlik River near the old KTC Lodge and Garage. It is on discontinuous permafrost with a silty soil that was observed to be very mucky with ponds of standing water. The site contained several dozen abandoned personal use fuel tanks and a few commercial fuel tanks. The tanks were not hooked together and were loose, indicating they all originated somewhere else and are being stored at the site until permanent disposal or removal occurs. There was no indication that the tanks had been emptied or cleaned prior to storage. There were the remnants of header piping that hung 4-5 feet out into the river, indicating a possible former fuel station. We observed a rainbow sheen coming out of the site by the Lodge building and going directly into the river, where there is very aggressive erosion; however a later site visit by a contractor was unable to locate the sheening. The site is a popular boat landing area. Geotextile fabric was installed at the site to help slow the erosion. Huge slumps in the banks were observed along the banks. Erosion was reported by locals to be greater than 5 feet a year, which is confirmed as the BEA study lists erosion at 7 feet a year in this section of riverbank. We observed this site lose at least two feet of ground between the September and October visits.

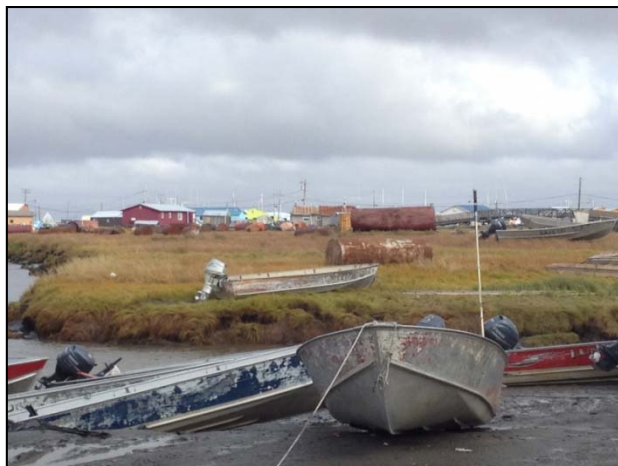
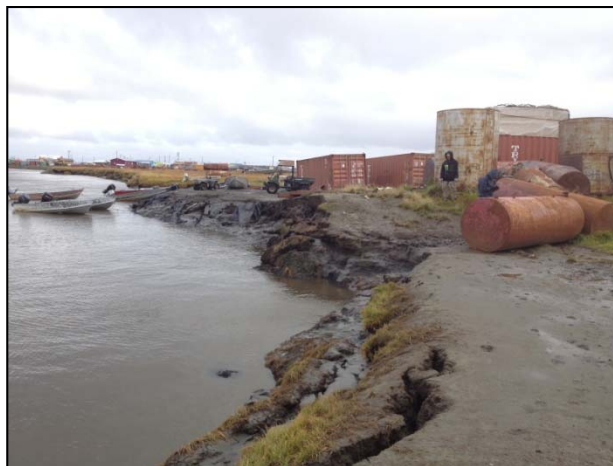
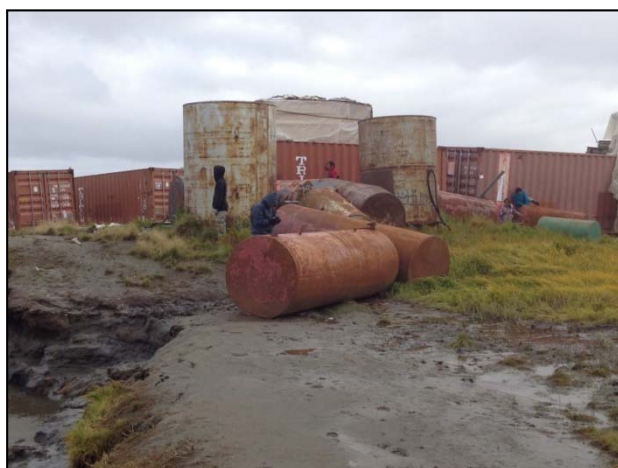
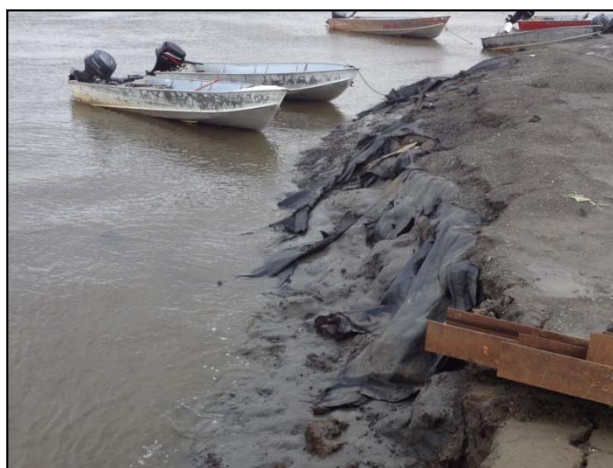
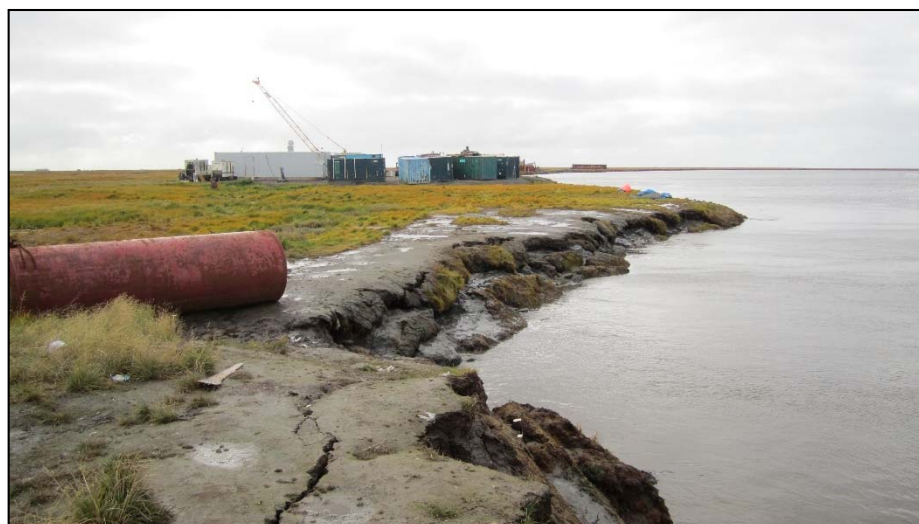
- **West End Tanks, 59.936503/-164.048359 (Abandoned)** –There are approximately 3 dozen abandoned personal heating tanks located on the western end of the village along with six 5,000 gallon tanks. We were not able to make it across the slough to inspect the six larger tanks. The entire site is used as a boat launch area and encompasses 2.15 acres. This site is located west of the Tanks Near Armory site and is right on the banks of the Kugkaktlik River. The site is suffering from an accelerated erosion rate of 7 feet a year per the BEA study. Mitigation at this site consists of geotextile fabric draped across the back to slow down the erosion rate; however, it does not appear to be working.

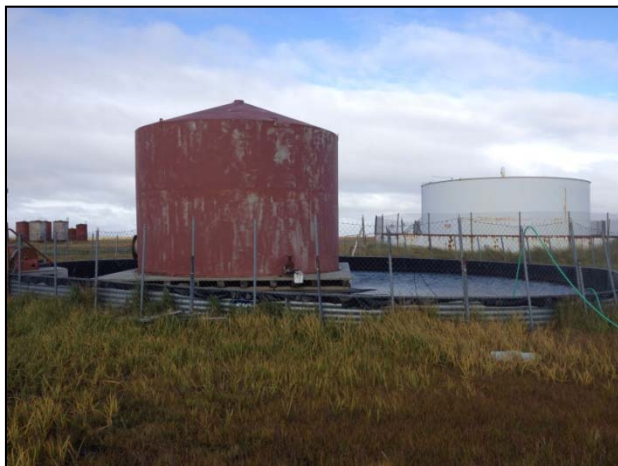
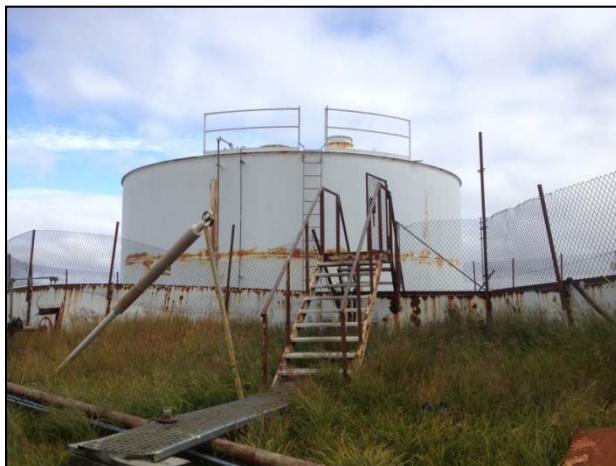
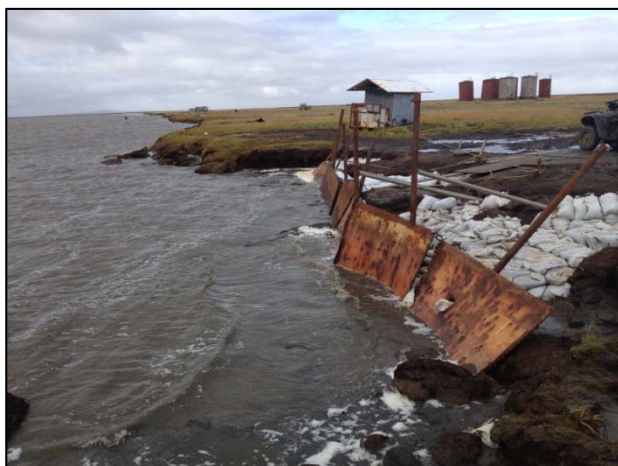
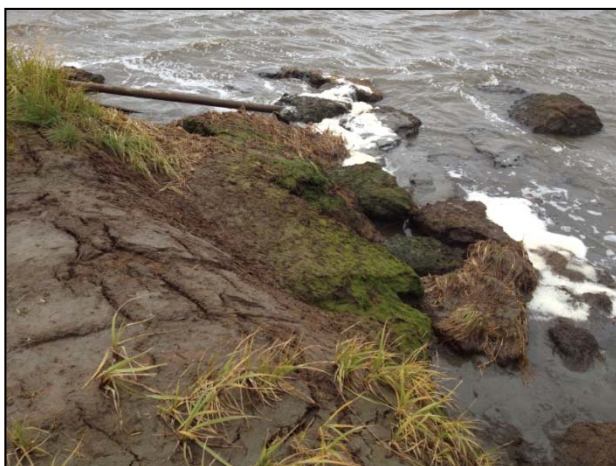
- **Native Fuel Station, 59.941433/-164.040926 (Active)** – This site contains three large fuel tanks and is approximately 25 feet from the Kugkaktlik River. There are two very large, white fuel tanks on the site complete with secondary containment. Another large, older red fuel tank was reported to be “out of service” during the time of the inspection with disconnected piping. The river in this area is eroding at 9 feet a year per the BEA study. Several erosion control measures are in place at the site, but they seem to be failing.

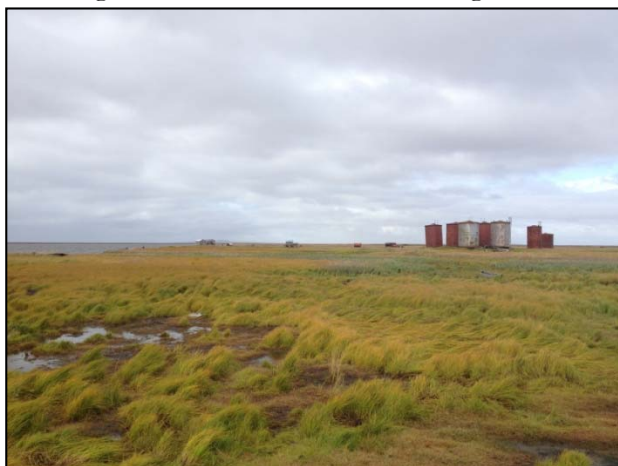
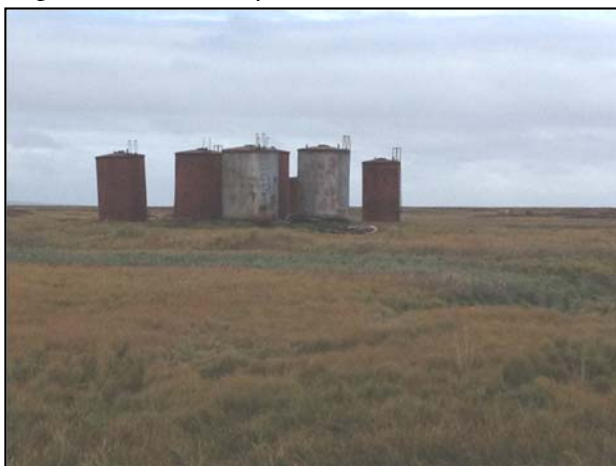
- **Northern Tank Farm, 59.942538/-164.040784 (Abandoned)** – This former tank farm site is located .25 miles north of the village. There were around 6-9 vertical fuel tanks; however, they were too difficult to access as they were across a slough from the current gas station. Our contact did not know the status of the tanks. The site is approximately 240 feet from the Kugkaktlik River, which is eroding at 9 feet a year per the BEA study.
