CIAP WEAR Trip Report Koliganek (population 223) September 11, 2012

Alaska Department of Environmental Conservation (ADEC) Solid Waste Program and Contaminated Sites Program (Kitrina Persson and Katrina Chambon) conducted a Coastal Impact Assistance Program (CIAP), Waste Erosion Assessment and Review (WEAR) site visit for the Village of Koliganek, September 11th, 2012. Delores Larson, the Village Council IGAP Coordinator, helped coordinate our visit. The following narrative is a brief description of our findings during the September inspection.

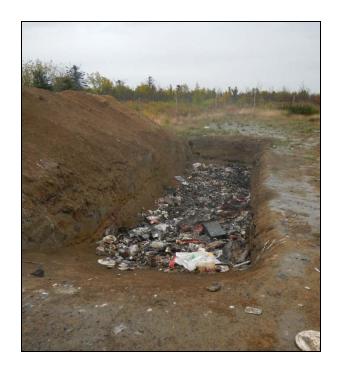
Landfill, 59.717463/-157.314716 (Active) – This unpermitted landfill is fenced, but usually unlocked. There is one trench for waste disposal; waste is burned in the trench as the homemade burn unit is not functional. There is a salvage area outside of the gate in an old gravel pit. Evidence of burning waste in the salvage area was observed and no control or management of the salvage area was evident. Several 55-gallon drums and 5-gallon buckets of used oil and oily rags, as well as batteries, paint, and aerosol cans had collected in the center of the landfill resulting in heavy staining of the surrounding soil. There was no working used-oil burner in the community. The landfill is approximately 1 mile south of the Nushagak River.

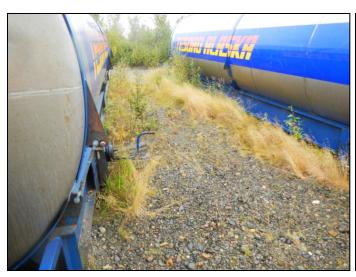
➤ Old Fuel Tanks, 59.725783/-157.283491 (Inactive) — Near the new tank farm are four old, vertical fuel tanks. Two unlabeled tanks are on a liner material. Two Tesoro Alaska labeled tanks are not on a liner material. No soil staining was observed. It is approximately 830 feet from the Nushagak River.

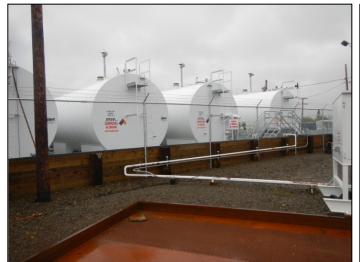
➤ Tank Farm, 59.726058/-157.284235 (Active) – This tank farm consists of four horizontal fuel tanks with secondary containment. It was constructed in 2011 with funding from the Denali Commission and Alaska Energy Authority. It is approximately 740 feet from the Nushagak River.

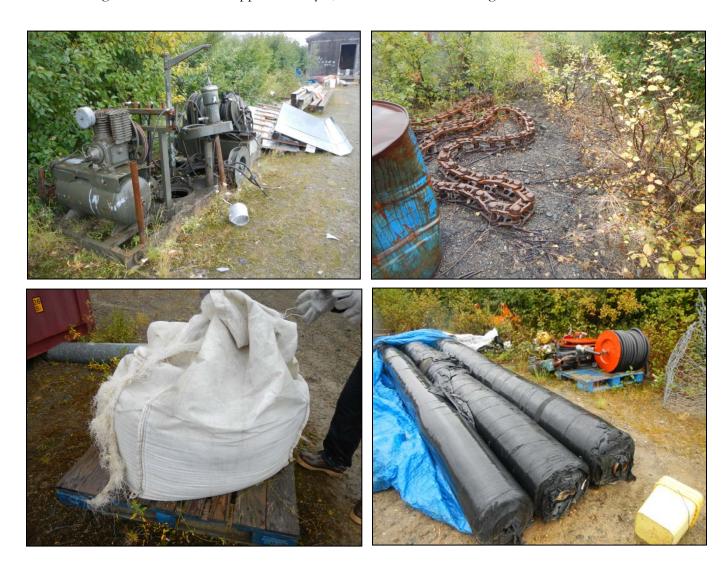
➤ Old Runway, 59.725323/-157.283828 (Abandoned) — Waste from various community projects lines the old runway. Items include: construction debris, 55-gallon drums, spilled paint and used oil, junk vehicles, a super sack of soil, shipping containers and shacks full of mixed waste, unused cable, various scrap metals, wood waste, used propane tanks, PVC piping, liner material, heavy equipment parts, and other items. Some of the waste was left by Bureau of Indian Affairs (BIA) road improvement projects and the new tank farm construction in 2011. More than three areas were stained and had distressed or dead vegetation. This site is approximately 1,000 feet from the Nushagak River.
