Alaska Department of Environmental Conservation (ADEC) Solid Waste Program and Contaminated Sites Program (Doug Huntman and Grant Lidren) conducted a Coastal Impact Assistance Program (CIAP), Waste Erosion Assessment and Review (WEAR) site visit for Kwigillingok on September 20<sup>th</sup>, 2012. Moses Alexie and Mike White with the EPA Tribal IGAP Program participated on the site visits. The following narrative is a brief description of our findings during the September inspection.

### WEAR Sites

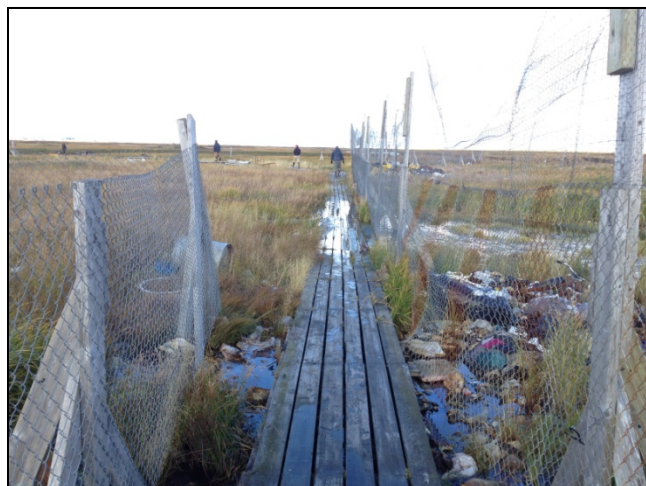
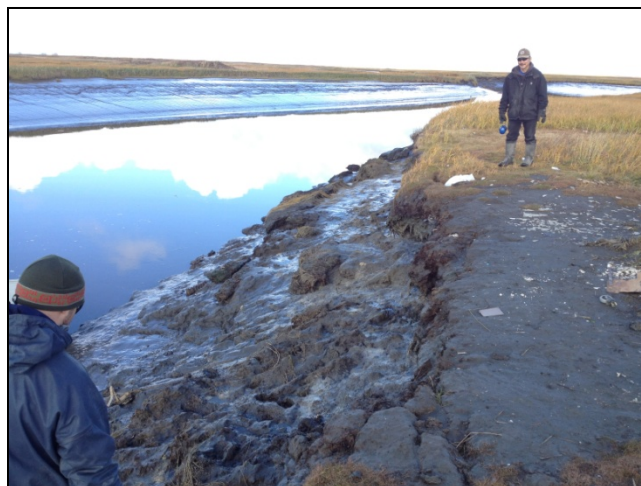
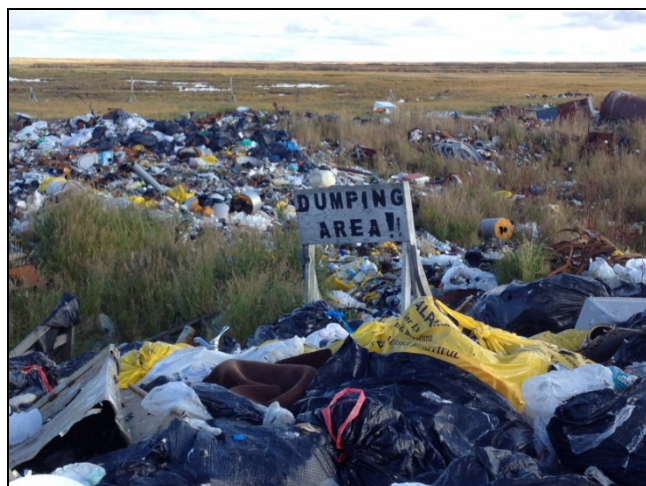
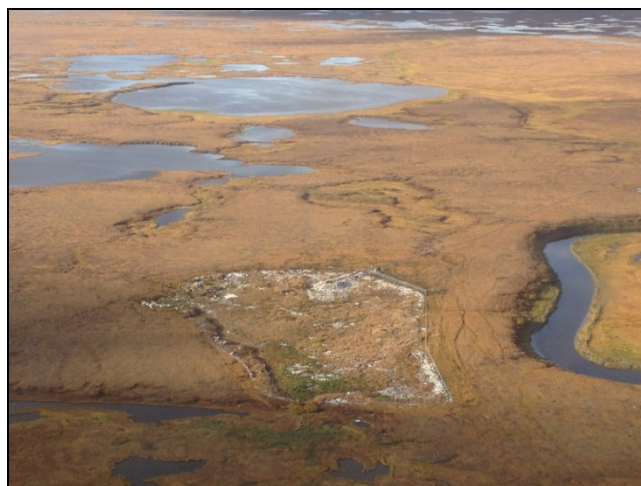
- **Landfill, 59.870809/-163.122683 (Active)** – The landfill is a self-haul landfill located roughly half a mile away from the village adjacent to a Kwigillingok River Slough. The site is only accessible by boat in the summer and snow machine in the winter. The site is approximately 5 acres with waste spread throughout the site. Waste is manually pulled back and covered with a thin layer of local silty material every year. The entrance to the site erodes approximately two feet annually. The nearby slough is tidally influenced and is susceptible to storm surges. During the storms of October 2012, the landfill flooded to depths of two feet, washing away much of the waste as far as a mile inland of the landfill.

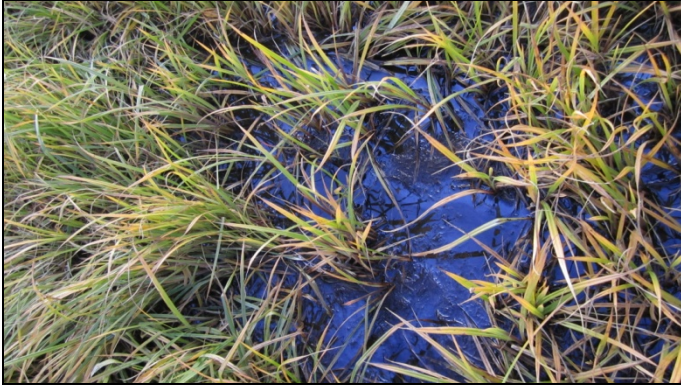
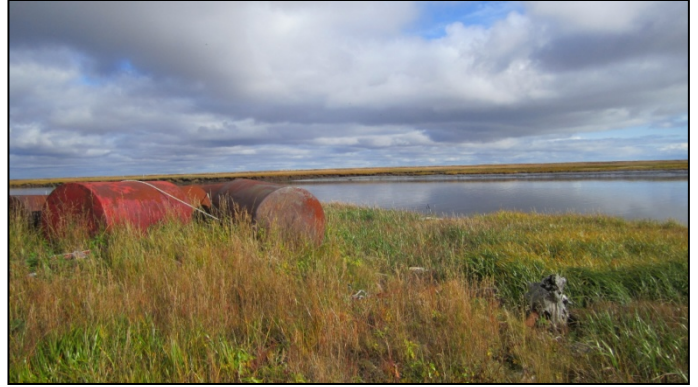
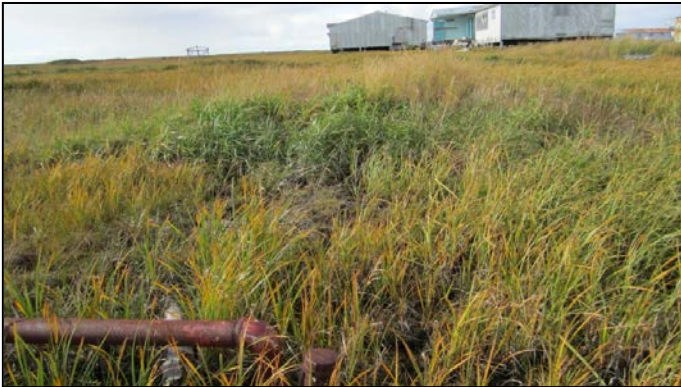
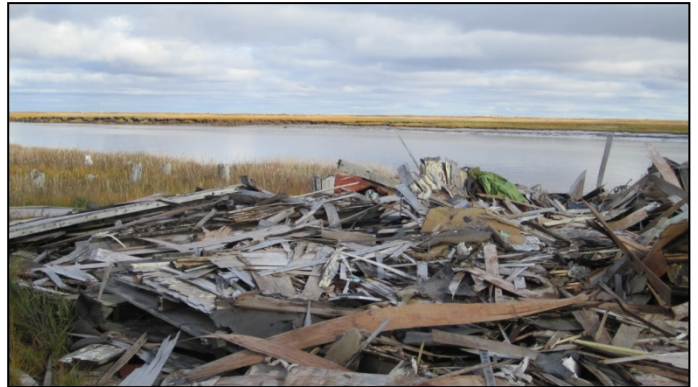
- **Kwik Inc. Former Tank Farm, 59.863169/-163.135520 (Active)** – This former tank farm is an active Contaminated Site (File ID 2425.38.004). The tanks have been moved to the consolidated tank farm, but fueling pump, piping, header, and horizontal drums still remain. The silty, wet ground is known to have fuel contamination. Wetland type grass has grown up in the area. The tank farm site is located approximately 85 feet from the Kwigillingok River bank which is eroding at a rate of four feet per year per the US Army Corps of Engineers 2009 study Alaska Baseline Erosion Assessment (BEA). Sloughing of the bank has been observed. The onsite building has collapsed into a pile of rubble approximately 10 feet from the Kwigillingok River.

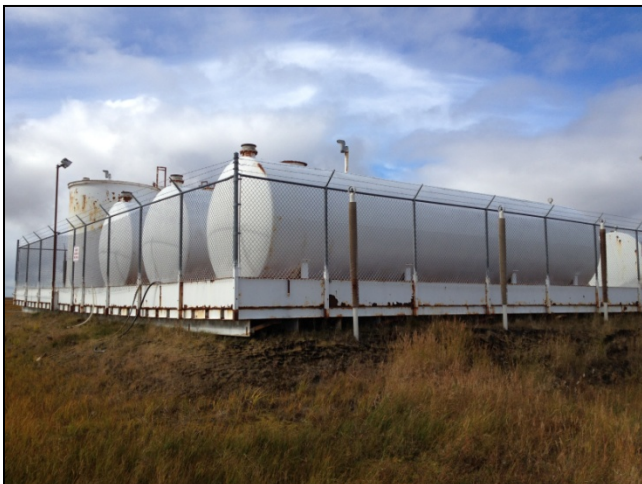
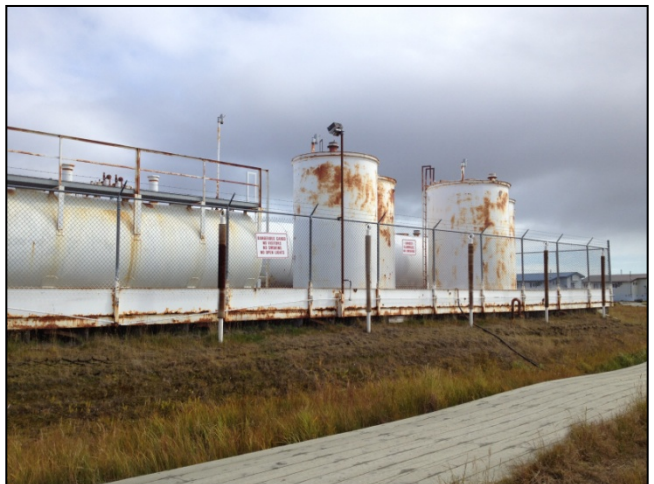
- **Kwik Inc. Consolidated Tank Farm, 59.881941/-163.151836 (Active)** – There are nine horizontal and four vertical fuel tanks in a secondary containment area. Some of the tanks are from the Kwik Inc. Former Tank Farm. There were no observed signs of a recent fuel spill. The tanks are about 345 feet from the banks of the Kwigillingok River. These banks are eroding at a rate of two feet per year per the BEA study. The tank farm is on silty, wet soil.

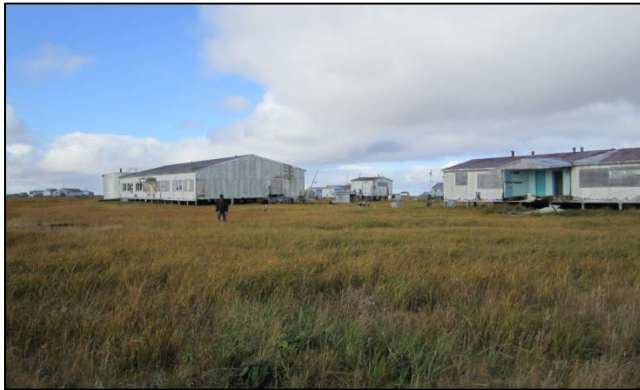
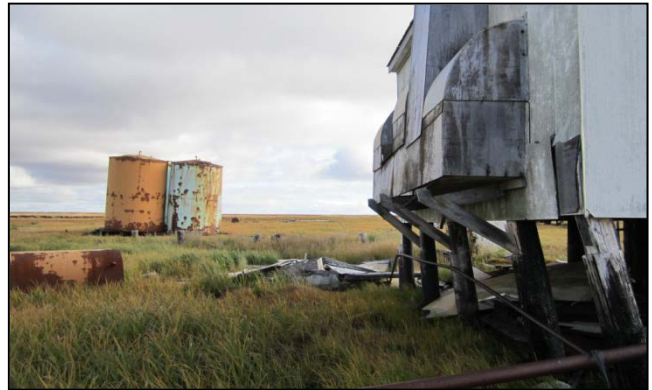
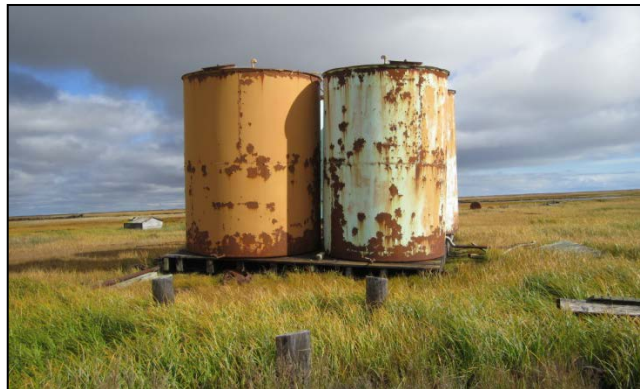
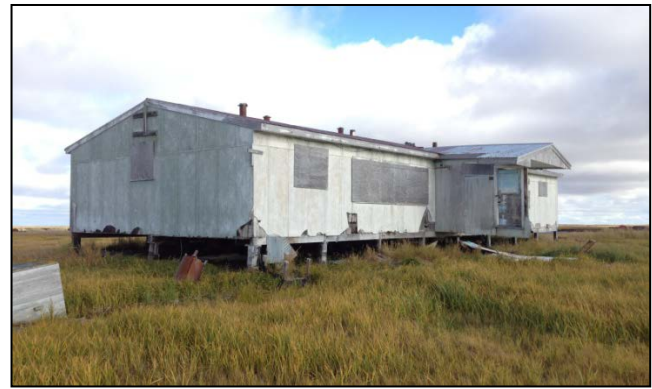
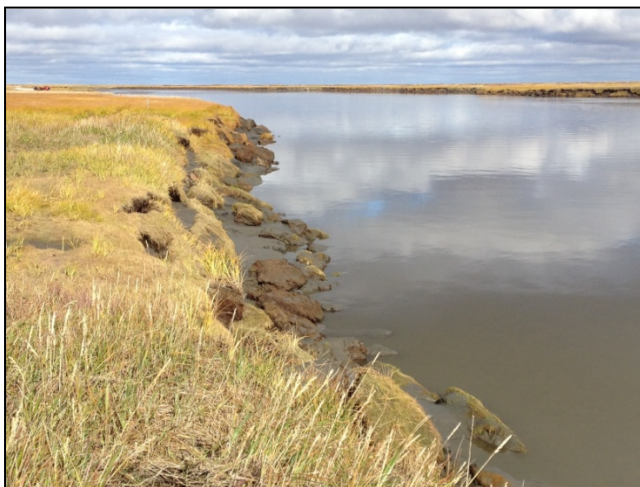
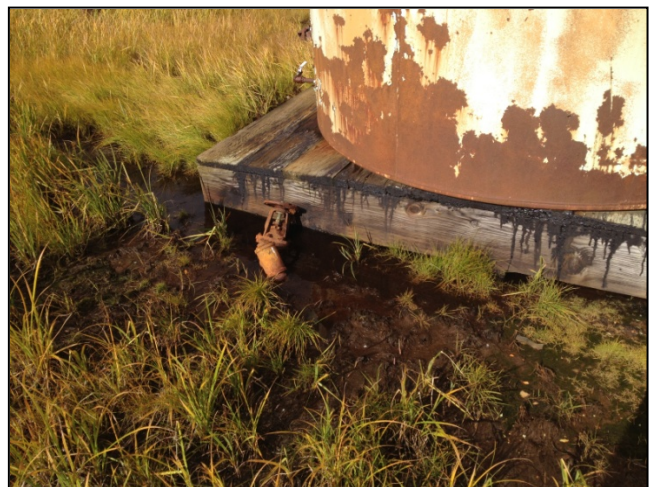
- **Former BIA School, 59.863459/-163.137806 (Active)** – The former BIA school is a Brownfield site under the Contaminated Sites Program (File ID 2425.57.001). It consists of several old buildings and a former tank farm. The buildings, which are owned by the Lower Kuskokwim School District, are scheduled to be demolished later in 2013 and will likely be taken to the Kwigillingok Landfill. There are four empty vertical fuel tanks on the property with evidence of previous leaks in the form of stressed soil and a visible sheen. The tanks are located approximately 350 feet from the Kwigillingok River whereas the closest school structure is about 150 feet from the bank. There is a reported erosion rate of four feet per year for the closest stretch of riverbank per the BEA study. However there was observed over two feet of bank erosion over the span of two months due to the October 2012 storms which caused widespread flooding in the area.
