CIAP WEAR Trip Report
Nelson Lagoon (population 520)
August 13, 2013

Alaska Department Environmental Conservation (ADEC) Solid Waste Program (Doug Huntman and Jamie Gorman) conducted a Coastal Impact Assistance Program (CIAP), Waste Erosion Assessment and Review (WEAR) site visit for the Village of Nelson Lagoon on August 13th, 2013. The following narrative is a brief description of our findings during the August inspection.

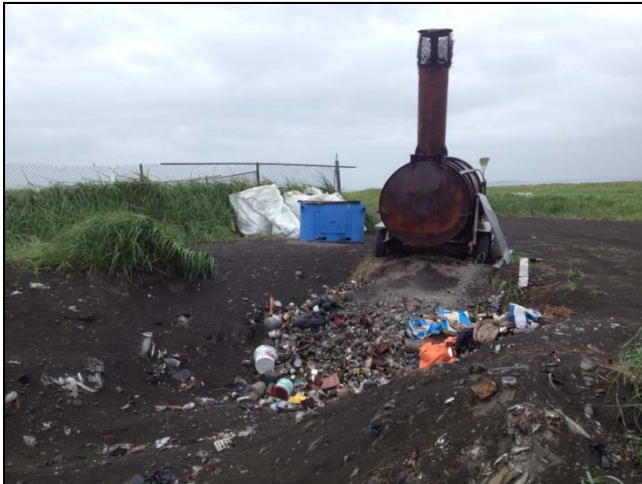
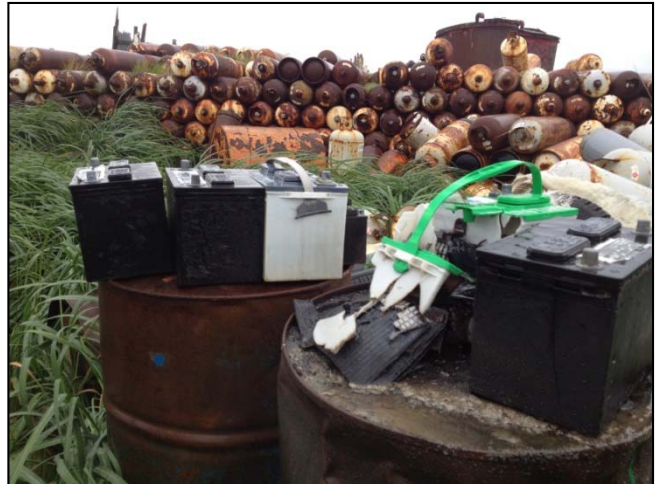
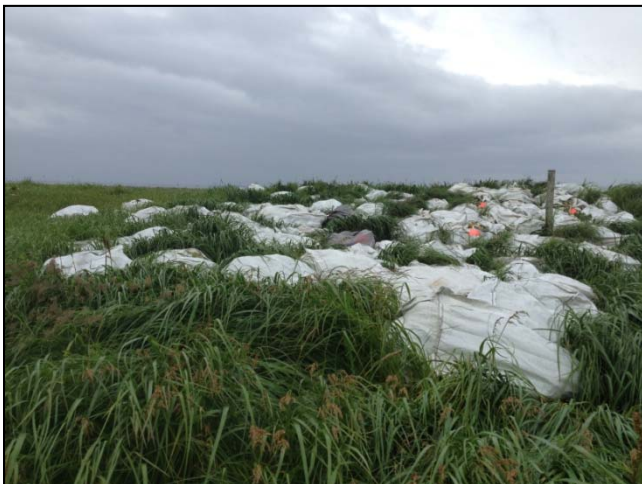
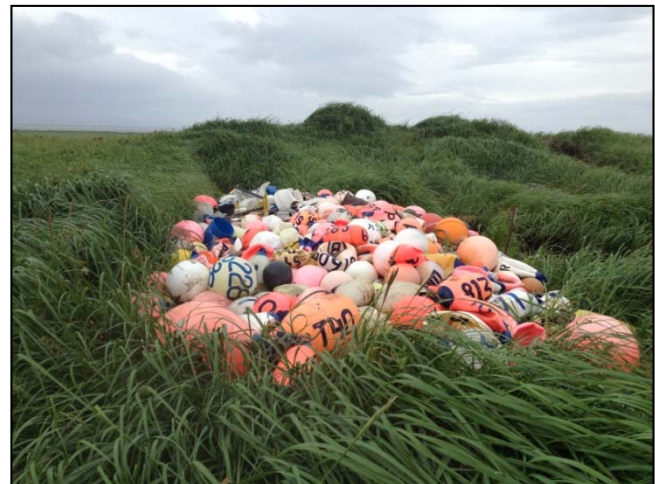
- **Landfill, 55.997119/-161.229392 (Active)** – This unpermitted 2.4 acre landfill is located about half a mile west of the community of Nelson Lagoon and was constructed around 1988. The landfill accepts municipal waste, sewage sludge, and construction and demolition debris. Residents self-haul waste to the site. The landfill is managed on an “as needed” basis by the Nelson Lagoon Village Council. There is no restricted site access or hazardous/prohibited waste screening. A Tok Burn Box is used to burn waste near the entrance to the landfill, and the ash is emptied from the unit and buried in an adjacent trench. There are large stores of various segregated waste items including empty propane tanks, lead acid batteries, old fuel tanks, fishing nets and buoys, and a metals pile. The landfill is 80 feet south of the Bering Sea which, according to the US Army Corps of Engineers – 2009 Alaska Baseline Erosion Assessment (BEA), is eroding at a rate of up to 5 feet per year.

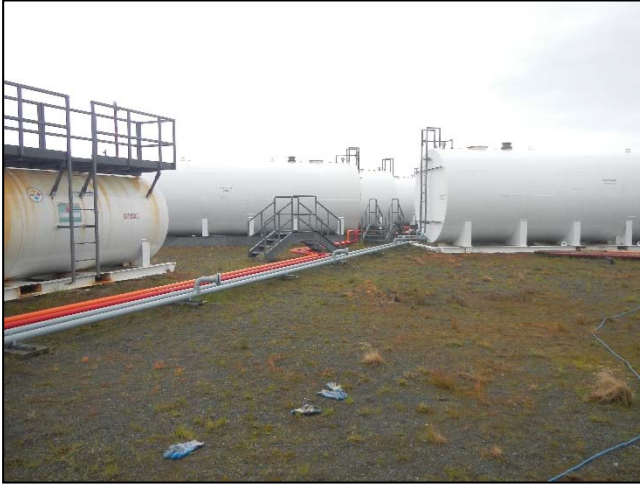
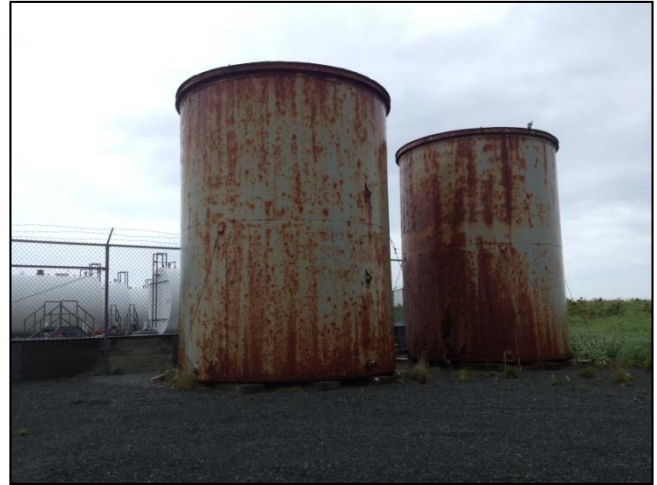
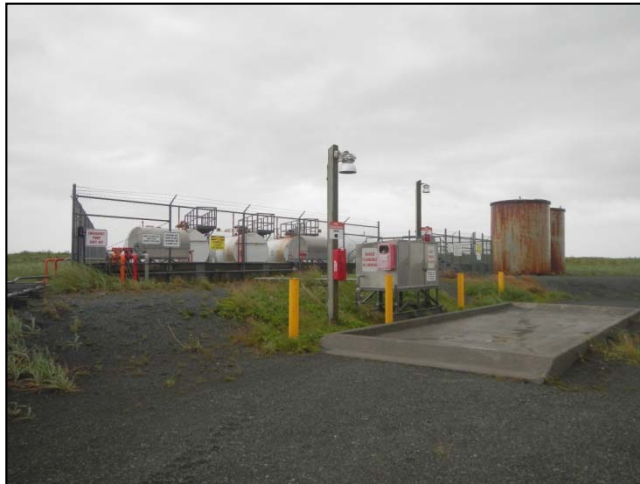
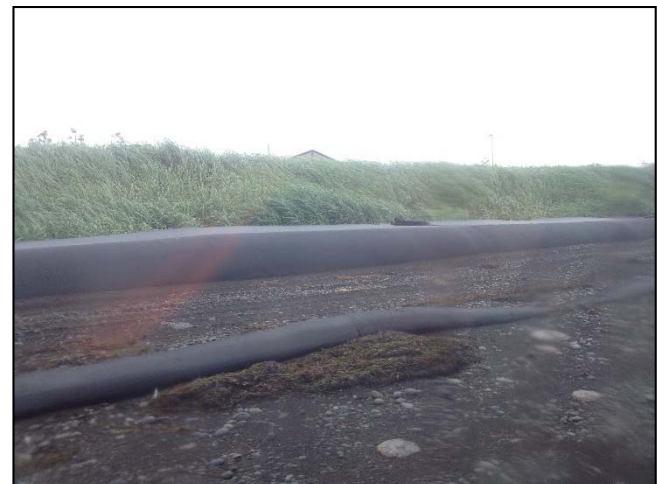
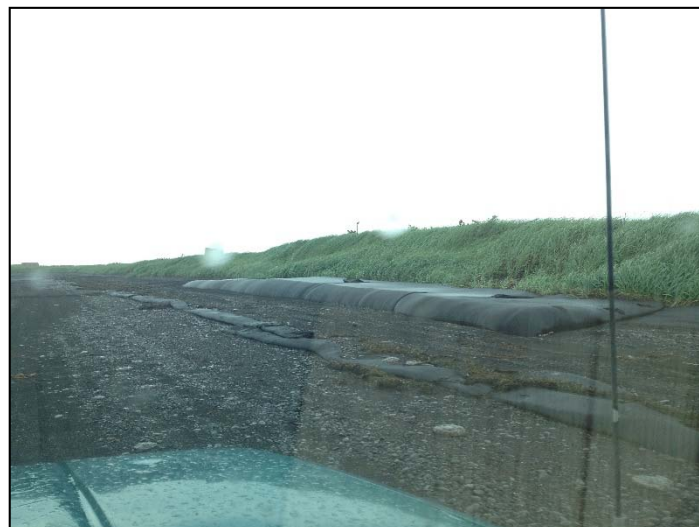
- **Tank Farm, 56.006299/-161.177389 (Active)** – This 0.45 acre tank farm is located a quarter mile west of the airport, north of the dock. The site serves as the gas station and houses nine tanks with a total capacity of 259,000 gallons within the fenced perimeter. It is completely fenced with secondary containment. Outside of the fencing there are two vertical tanks, of an estimated 35,000 gallon capacity, which are labeled as spill response. The tank farm was constructed in 2004 through a Denali Commission project and is 450 feet from the Bering Sea. The community has installed gabions to anchor existing wood in the breakwater and has placed geotube containment structures in an effort to slow erosion.
