CIAP WEAR Trip Report
Port Heiden (population 123)
September 9, 2012

Alaska Department of Environmental Conservation (ADEC) Solid Waste Program (Elizabeth Stergiou) conducted a Coastal Impact Assistance Program (CIAP), Waste Erosion Assessment and Review (WEAR) site visit for the City of Port Heiden on September 9th, 2012. The following narrative is a brief description of her findings during the inspection. Please note that due to staffing changes this report was not written by Elizabeth Stergiou.

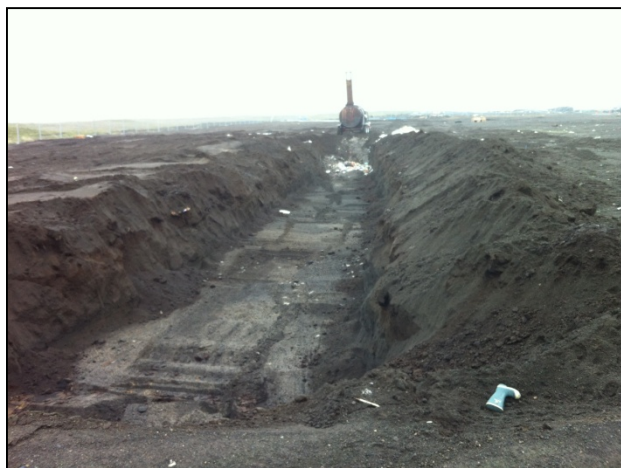
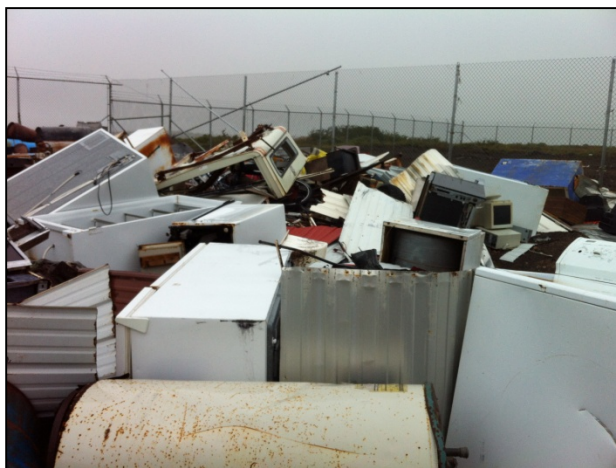
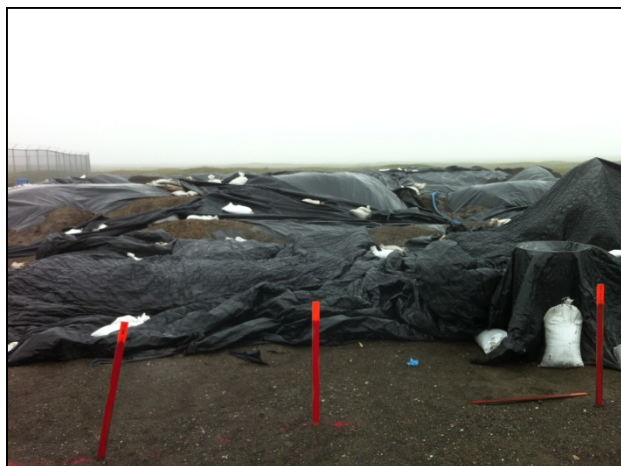
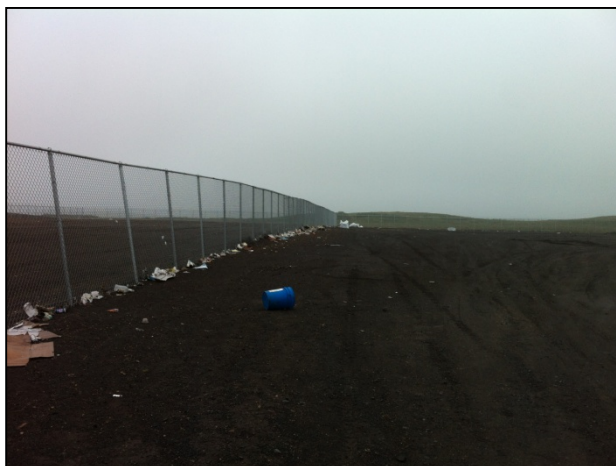
- **Landfill, 56.942129/-158.576732 (Active)** – This self-haul landfill was constructed in 2009 and is located approximately 2.5 miles east of the community. The footprint for the site is around 5 acres. The landfill is currently permitted, although inspections have noted the approved operations plan is not being followed. Noted problems with the site include: the site is fenced, but not locked, and waste is not separated prior to being burned in the burn unit. This landfill contains municipal waste, inert waste and polychlorinated biphenyl (PCB) polluted soil per ADEC approval. It is located 3.75 miles east of Bristol Bay, which is eroding at 20 feet per year according to the Army Corps of Engineers 2009 Baseline Erosion Assessment (BEA) study.

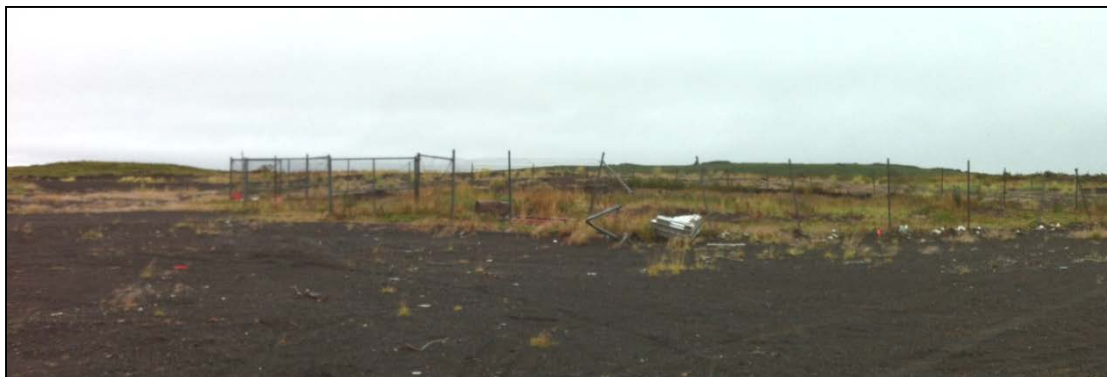
- **East Landfill, 56.942073/-158.570161 (Closed)** – This fenced landfill is approximately 2.3 acres in size. It was closed in 2009 when the current landfill was constructed, which is 810 feet directly west. Wastes in the landfill include municipal waste and construction and demolition waste. It is approximately 4 miles east of Bristol Bay, which is eroding at 20 feet a year per the BEA study.

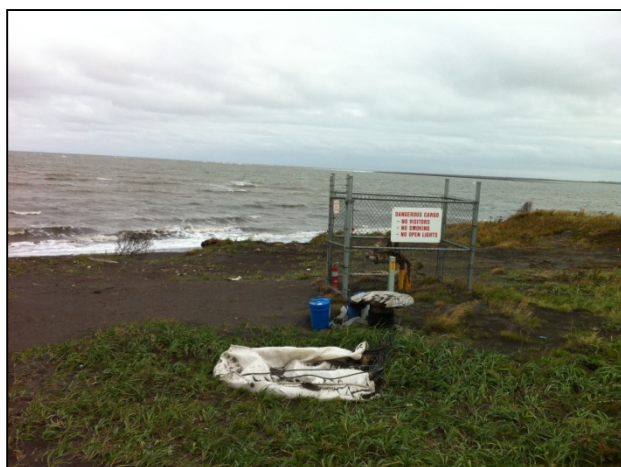
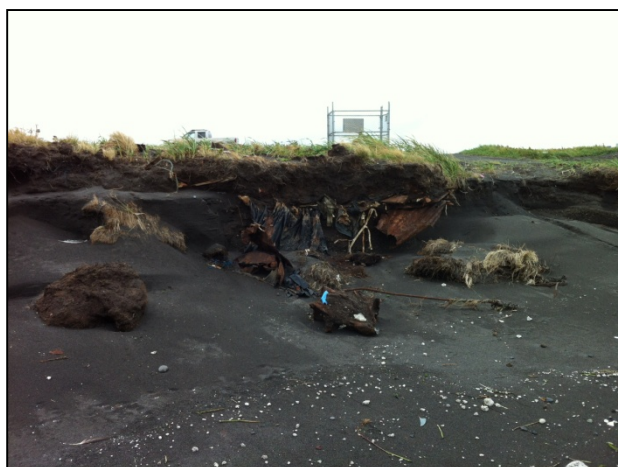
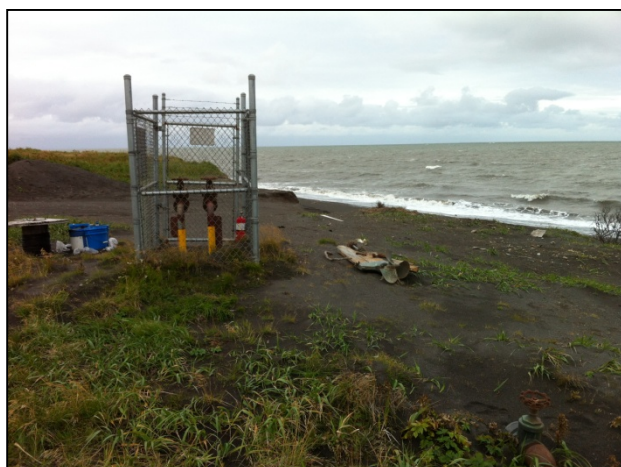
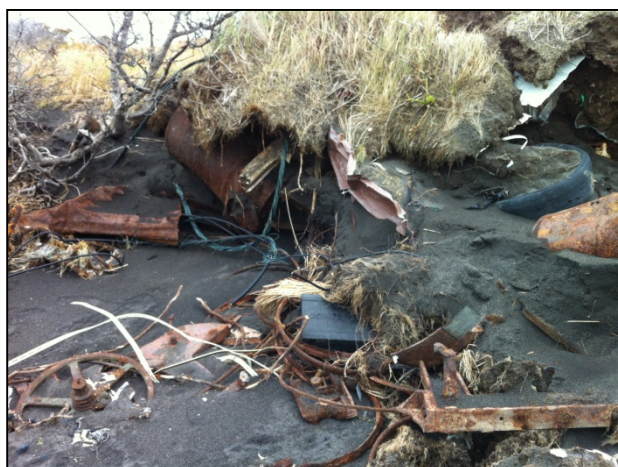
- **Marine Header, 56.916079/-158.682935 (Active)** – This marine header is located between Goldfish Lake and Bristol Bay. It was built adjacent to the east side of the Meshik Landfill. Erosion has exposed barrels, metal scraps, and lead acid batteries on the marine header shoreline. Ground is of volcanic ash and pumice and gravelly sands. The erosion is caused by the fierce storms in the area. As of this site visit, the header was approximately 10 feet from the shoreline of Bristol Bay, which is eroding at 20 feet a year per the BEA study.

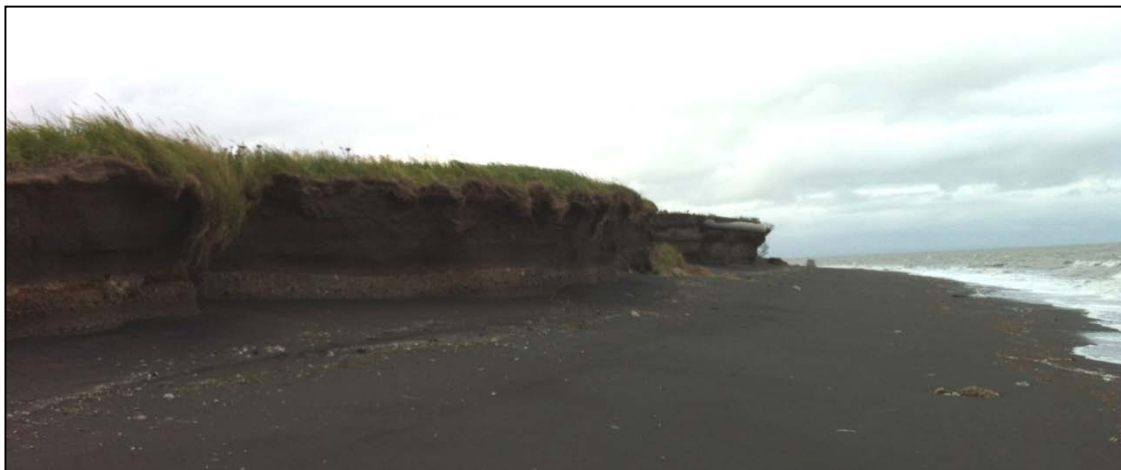
- **Meshik Landfill, 56.916078/-158.683758 (Eroded)** – This closed landfill was in operation beginning in World War II and operated for approximately 70 years. It contained municipal waste and military waste from the war and was approximately 1.3 acres in size. On March 18, 2013 the Solid Waste Program received photographs showing the bulk of the landfill has eroded into Bristol Bay. The erosion is caused primarily by fall storms with strong winds and storm surges, and secondarily by high tides. Ground is of volcanic ash and pumice and gravely sands. Locals estimate the yearly rate of erosion for 2011 to be 10 feet; however the BEA study estimates the yearly rate to be 20 feet.

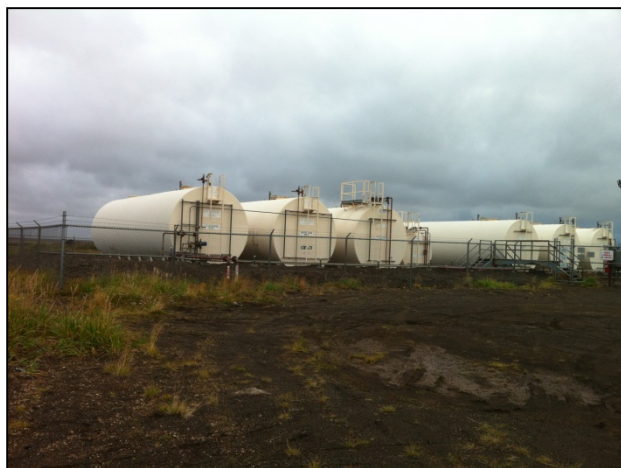
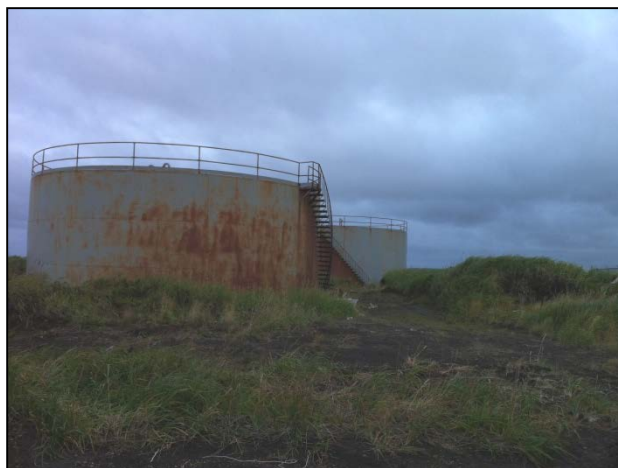
- **Tank Farm, 56.917889/-158.680744 (Active)** – This active tank farm consists of 2 vertical fuel tanks and 7 horizontal tanks on 1.83 sq acres. It is located between Goldfish Lake and Bristol Bay. It is 160 feet from Bristol Bay, the closest source of erosion. The erosion is caused primarily by fall storms with strong winds and storm surges, and secondarily by high tides. Ground is of volcanic ash and pumice and gravely sands. Locals estimate the yearly rate of erosion for 2011 to be 10 feet and the BEA study estimates the yearly rate to be 20 feet.

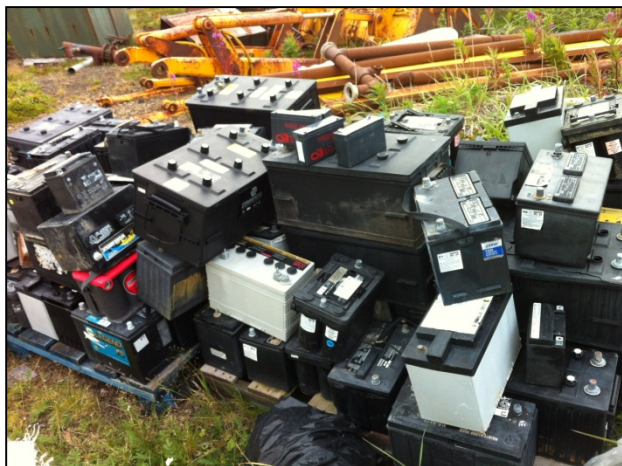
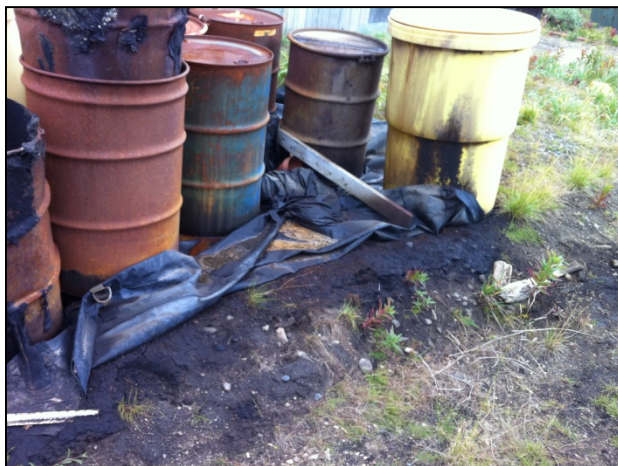
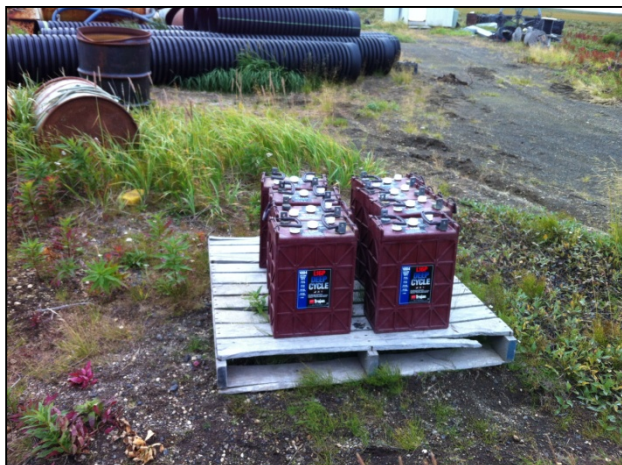
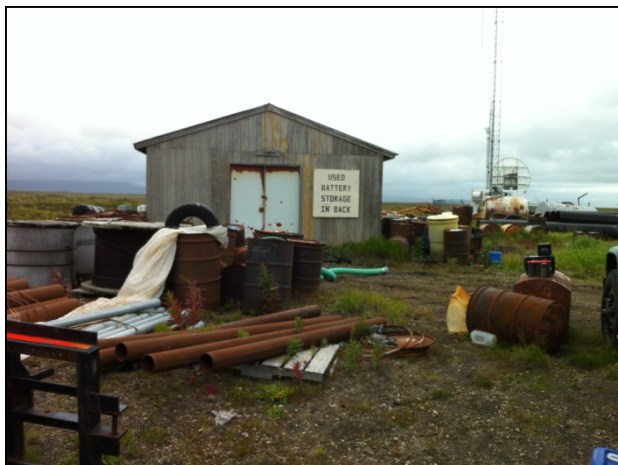
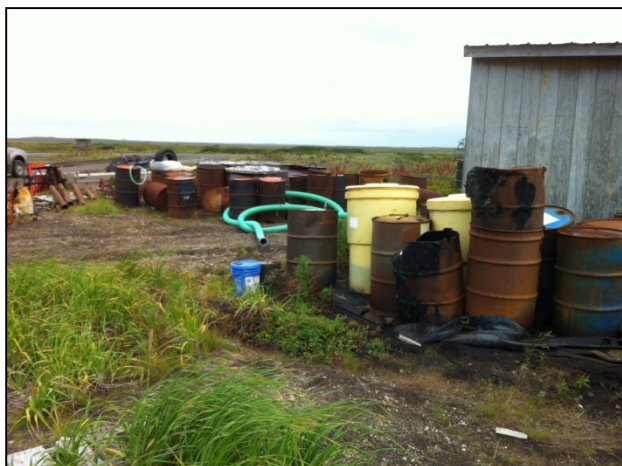
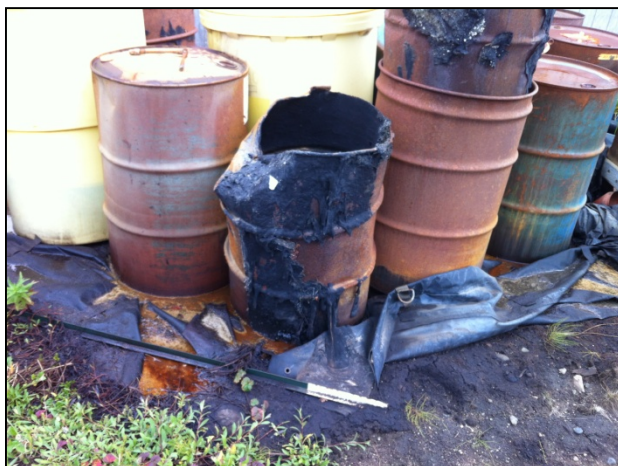
- **City Shop, 56.923196/-158.663487 (Active)** – This site consists of the city shop and used lead-acid battery storage. There are 50 batteries, of various types and sizes, stored on a pallet, outside. There are approximately 20 other batteries scattered throughout the site, some stored in barrels, some resting on cars, and some on the ground. There are approximately 45 barrels stored in groupings near the shop. Some barrels show evidence of fire, some of corrosion, and others of leakage onto the ground. One grouping of barrels sits on a black oil-stained cloth that clearly shows black soil underneath. There is also scrap metal, tubing, yellow plastic drum containers, and plastic culverts stored at the site. This site is located 0.6 miles from Bristol Bay, which is eroding at 20 feet a year per the BEA study.

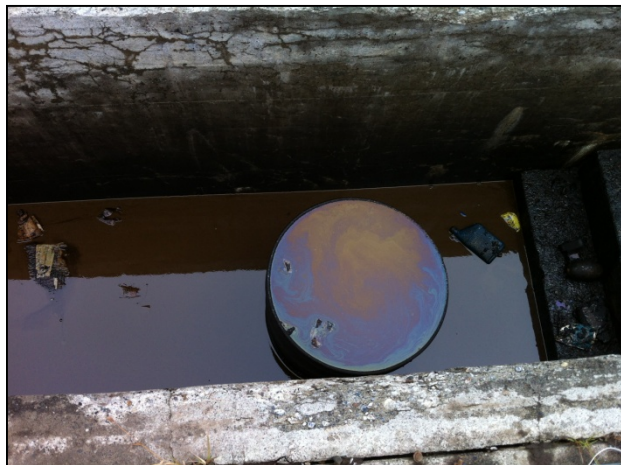
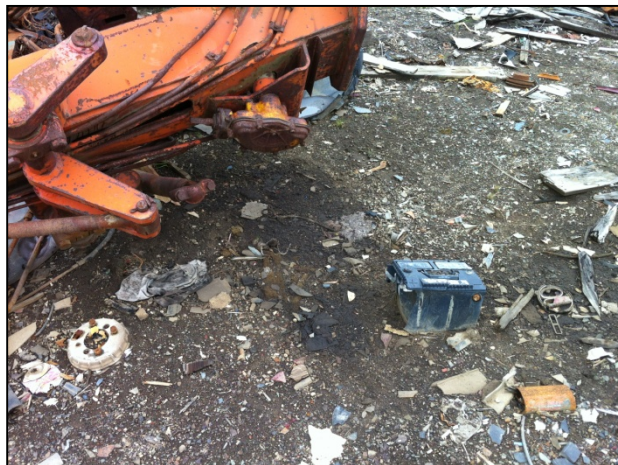
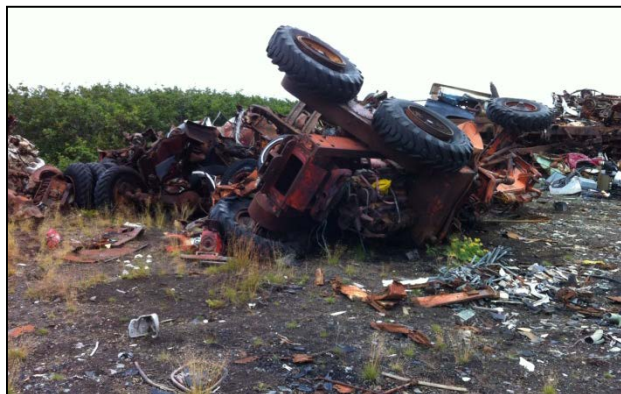
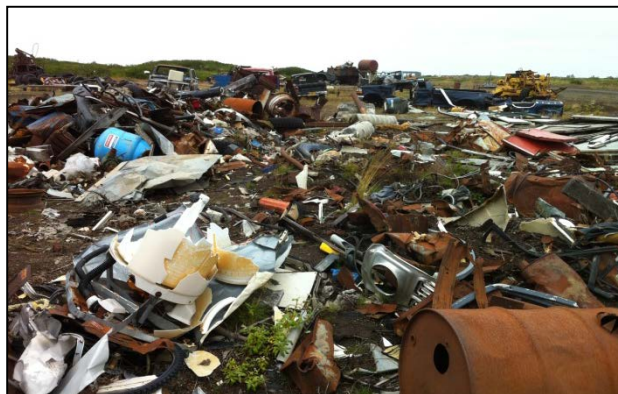
- **Boneyard, 56.952816/-158.633175 (Active)** – This site is currently used for stockpiling vehicles and draining fluids. The majority of the vehicles are rusted and in varied states of decomposition. There is evidence of fluids underneath the cars. The wells where fluids were drained contain oily sheens, discolored water, barrels, free product and emptied oil containers. This site is associated with Fort Morrow and may be cleaned up as part of ongoing activities associated with the fort. The site is 1,200 feet south of the runway and 2 miles from Bristol Bay, which the BEA study lists as eroding 20 feet a year.
