CIAP WEAR Trip Report  
Tuntutuliak (population 420)  
August 28, 2012

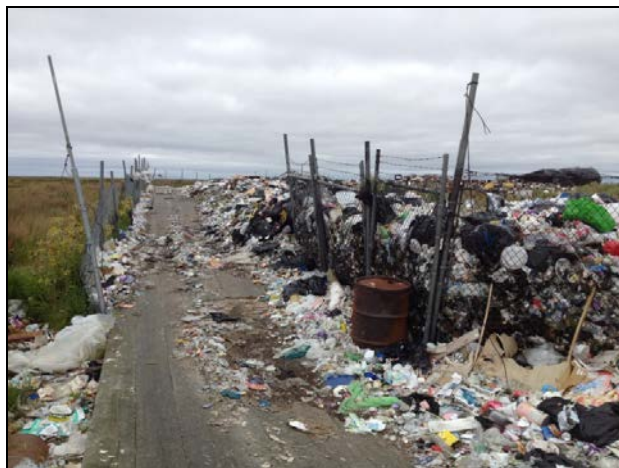
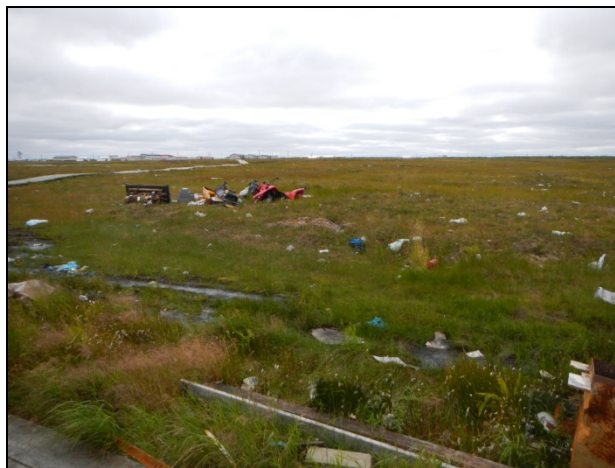
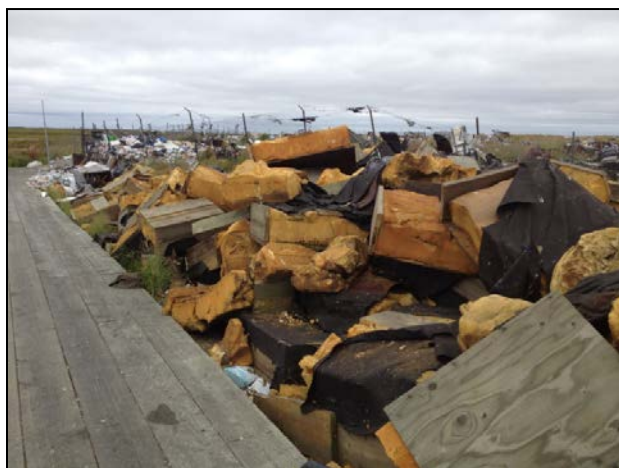
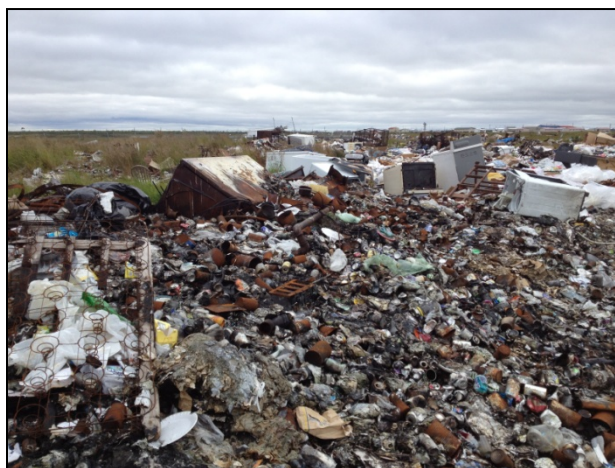
- **Landfill, 60.350417/-162.684556 (Active)** – The site is a 1.9 acre self-haul landfill, located 1,600 feet from the nearest structure. The landfill is owned and operated by the Native Village of Tuntutuliak and is on semi-discontinuous permafrost. The site is adjacent to the sewage lagoon used to dispose honeybucket waste. Although the landfill is fenced, waste has overflowed outside of it. The landfill accepts municipal wastes, but does not prohibit any special wastes or hazardous wastes. Its operations are very basic: there is no cover material, no heavy equipment for consolidation/compaction, and they open burn. There was a large amount of contractor waste in and outside the landfill at the time of the inspection. The site contains silty soil. The site is located 3,270 feet from the Qinaq River, but is surrounded by tundra ponds. ADEC observations from a 2012 October storm event showed that both the sewage lagoon and landfill flooded.

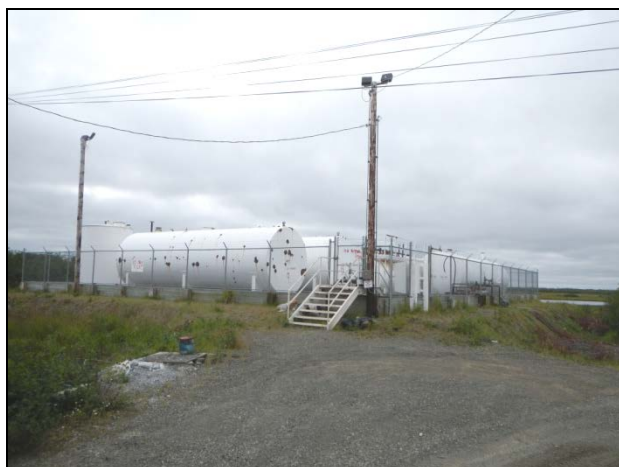
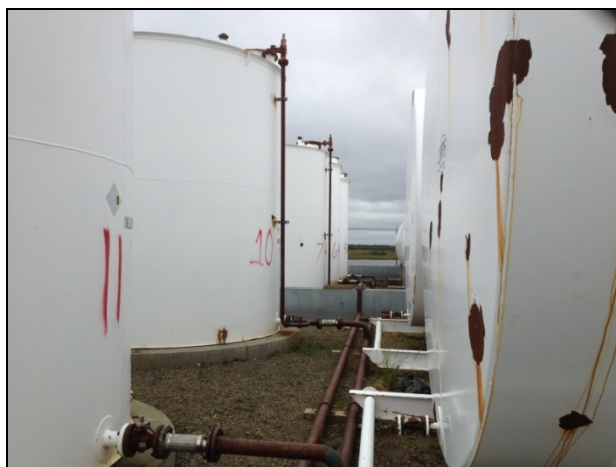
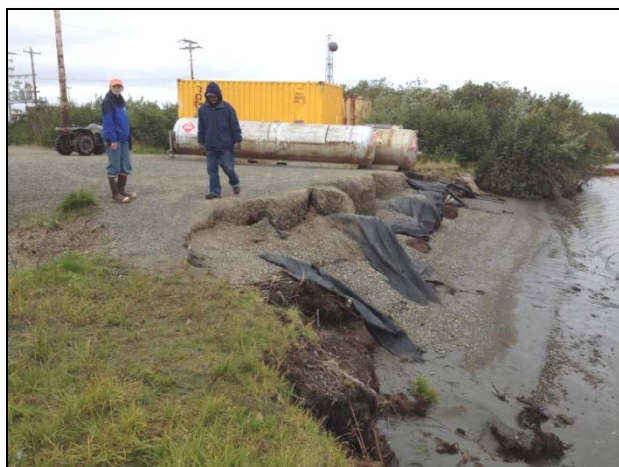
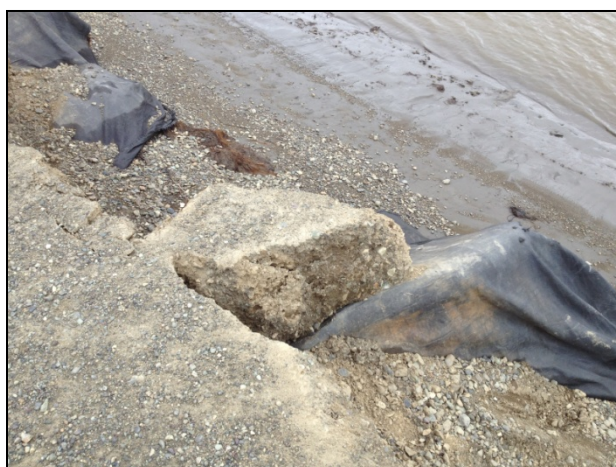
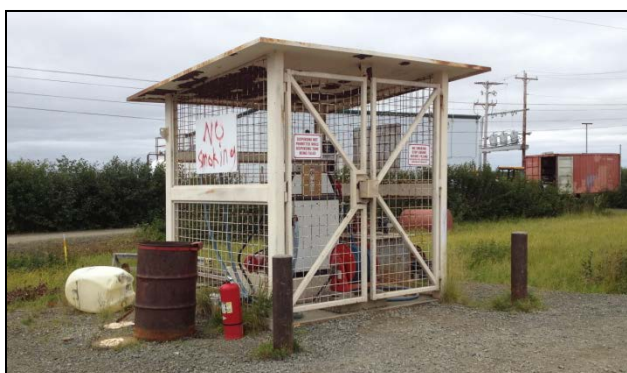
- **Bulk Tank Farm, 60 60.338758/-162.664766 (Active)** – This tank farm was completed in 2000 under the Denali Commission. It contains five vertical and six horizontal fuel tanks with diesel and gasoline. The tank farm is a fenced secondary containment facility built on a gravel pad above flood level. There was no evidence of fuel spills. The site is located 150 feet from an actively eroding Qinaq River. Per the Army Corps of Engineers 2009 study Alaska Baseline Erosion Assessment (BEA), this section of riverbank is eroding at a rate of 2 feet per year. There are some mitigation efforts in place along the bank to slow erosion. Rip rap of geotextile fabric has been placed in a 400 foot section along the banks at this section of the Qinaq River. It is not effectively controlling erosion as local residents reported having to continually move the onsite village propane tanks away from the eroding riverbank. ADEC documented approximately 5 feet of erosion between the August inspection and an October 2012 storm event.

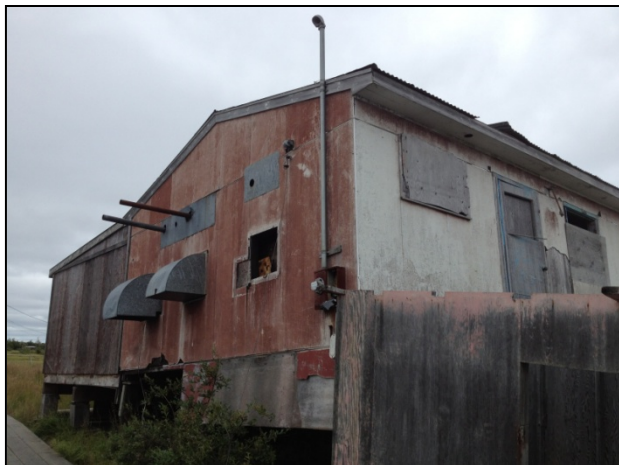
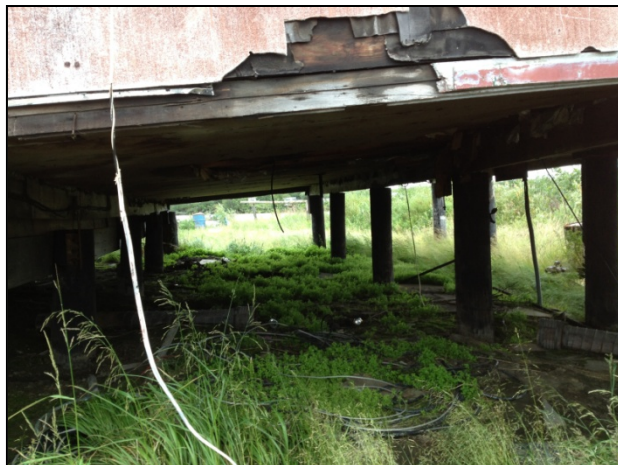
- **Former BIA Power Plant, 60.34304/-162.666324 (Active)** – This building is part of the Brownfield site ‘Former BIA School Site’ under the Contaminated Sites Program (File ID 2452.57.001). It is owned by the Alaska Department of Education and Early Development (DEED). It was built in 1957 as the power plant for the BIA school. The building was constructed on top of pilings above the tundra and is in very unstable condition. Although it is adjacent to the boardwalk, the windows and doors are boarded up and inaccessible to the public. It contains asbestos and lead-based paint per sampling completed in 2009. There was no visible evidence of petroleum contamination outside the building. The silty soil was vegetated with grass and alder. It is 50 feet from the Qinaq River, which has no erosion mitigation in this section. Per the BEA study this section of riverbank is eroding at a rate of 1 foot per year. This site also floods during storm surge events.

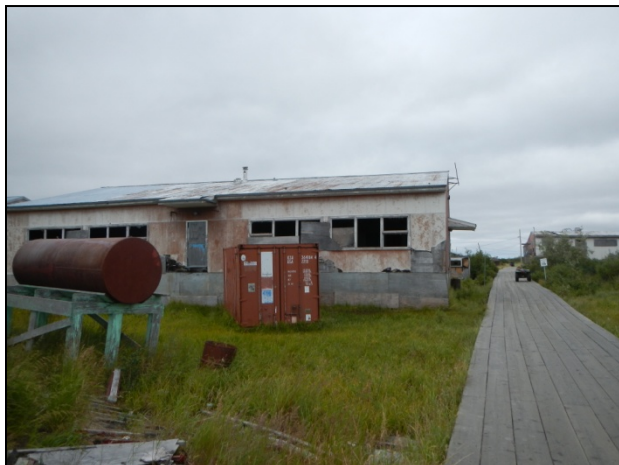
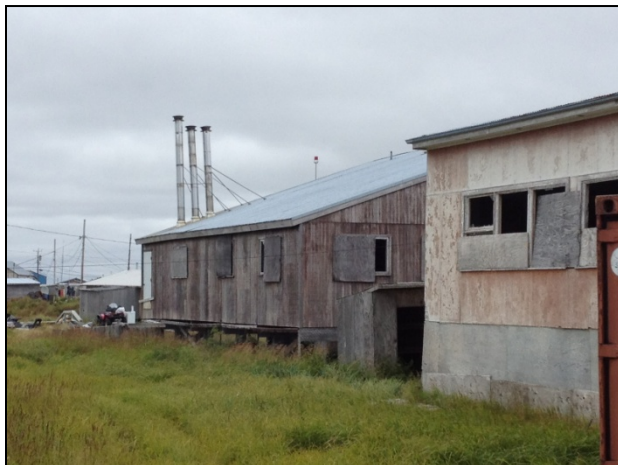
- **Former BIA School, 60.342669/-162.666382 (Active)** – This former school is owned by DEED and is part of the Brownfield site ‘Former BIA School Site’ under the Contaminated Sites Program (File ID 2452.57.001). It contains two connected buildings constructed in 1957 that are approximately 85 feet from the Former BIA Power Plant. One of the buildings is slated for future demolition, and the other building may be reused by the community. Sampling in 2009 found the siding to contain asbestos. This site is located approximately 65 feet from the Qinaq River. Like the Former BIA Power Plant, no erosion mitigation efforts are being implemented in this section of riverbank. The erosion rate is 1 foot a year per the BEA study.

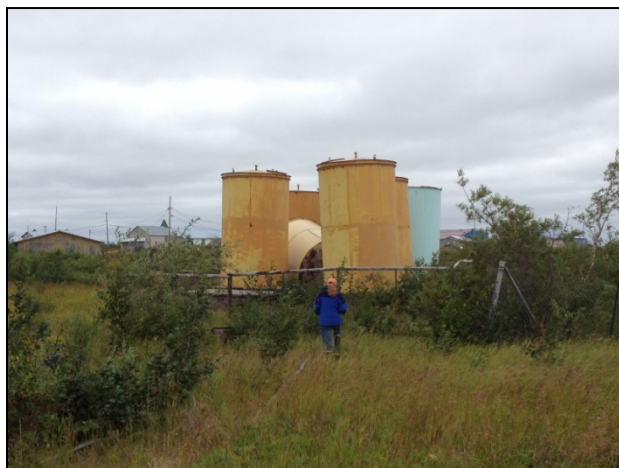
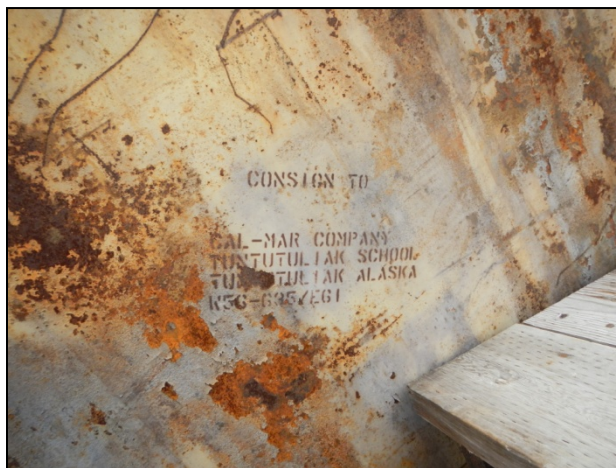
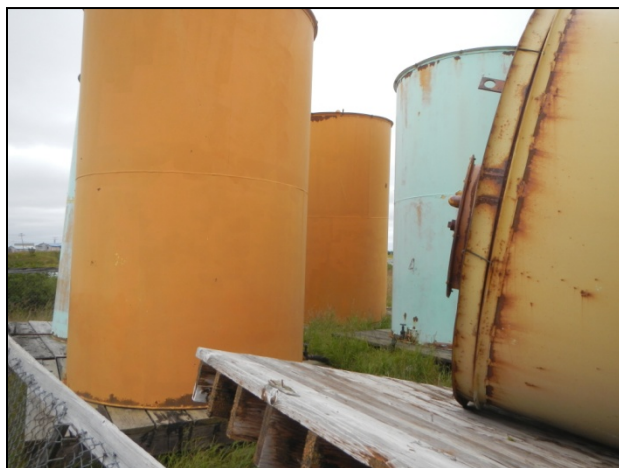
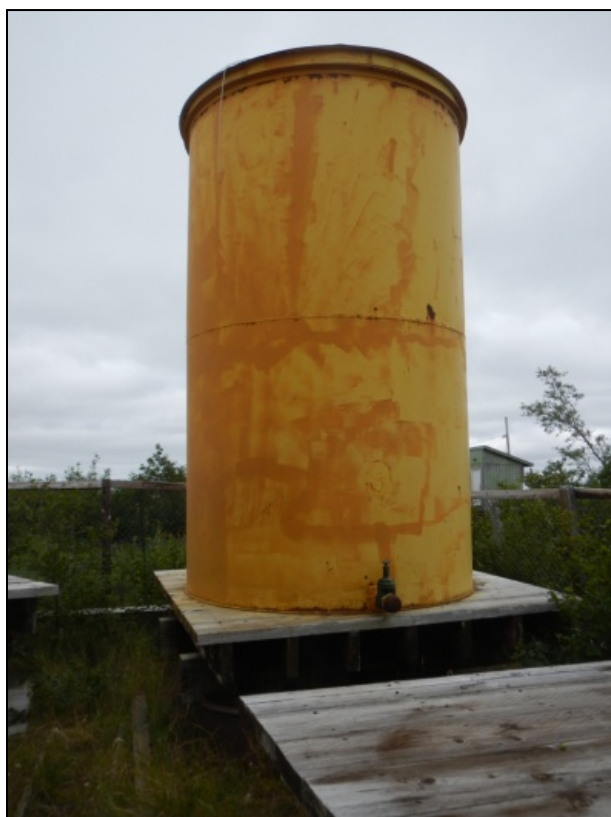
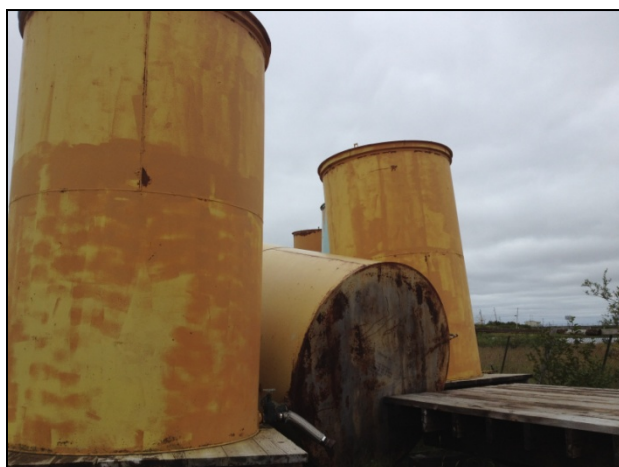
- **Former BIA Tanks, 60.343063/-162.666826 (Active)** – This is the tank farm for the former BIA school built in 1957. It is also part of the Brownfield site ‘Former BIA School Site’ under the Contaminated Sites Program (File ID 2452.57.001). It contains 10 vertical, 5000 gallon fuel tanks. The tanks were emptied but were not reported to have been cleaned of fuels. They were on wooden platforms in a fenced area. The fencing was falling over in places and some of the tanks had tipped over from their platforms. Piping to some of tanks had been removed. There was no evidence of stressed vegetation. The site less than 200 feet from the banks of the Qinaq River, which has an erosion rate of 1 foot a year per the BEA study. This site floods during storm surge events.

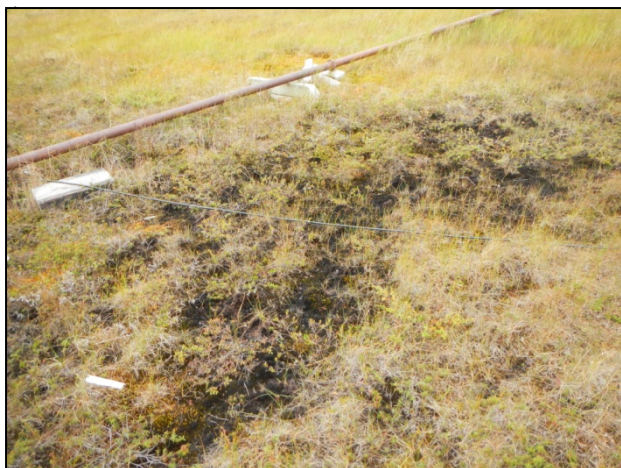
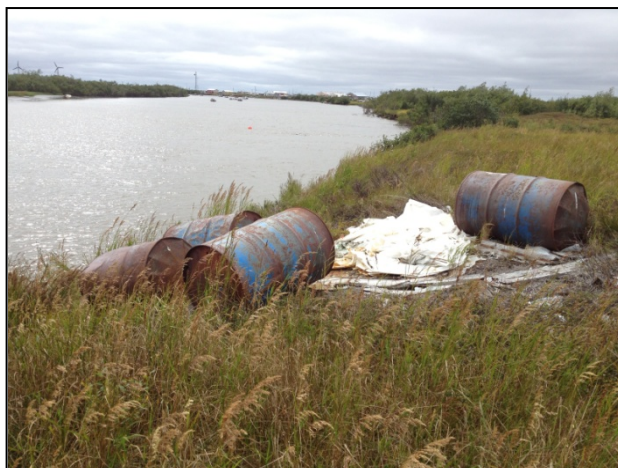
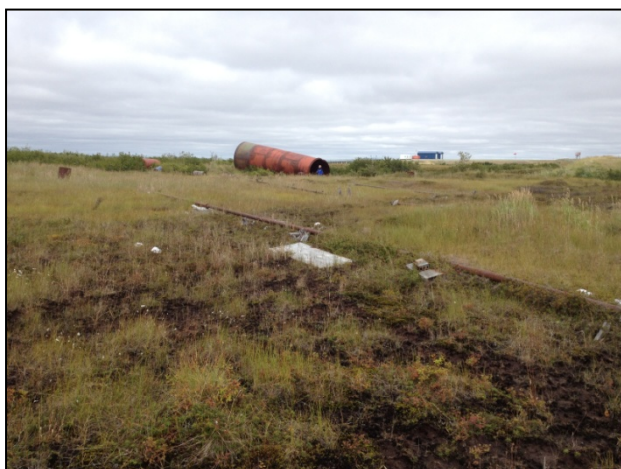
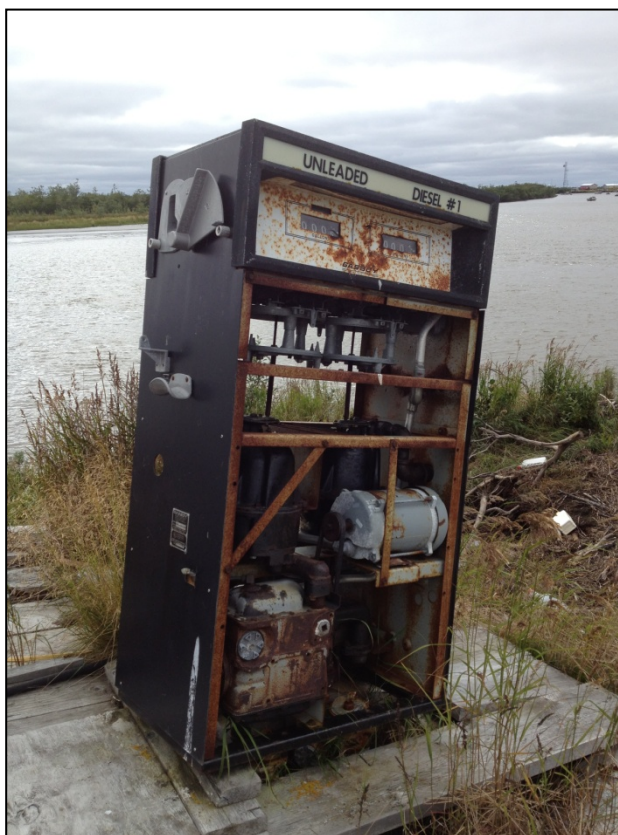
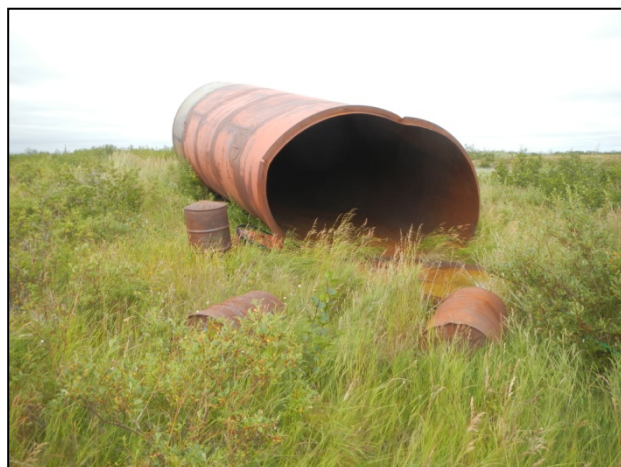
- **Old Fuel Station, 60.346679/-162.66078 (Abandoned)** – This old fuel station is located at the south end of the airstrip. One empty and tipped over 10,000 gallon fuel tank remained on site along with piping. There were also a few 55 gallon drums scattered from the riverbank to the downed tank. Most of other infrastructure had been removed. The ground was blackened and shows signs of stressed vegetation. The old fuel pump and piping are approximately 15 feet from the Qinaq River. Through the stressed vegetation to the tank is approximately 220 feet from the river at the farthest point. The BEA study indicates this section of riverbank is eroding at a rate of 3.5 feet a year. It is also prone to flooding during the storm surges.
