**Technical Memorandum 1**

**Assessment of the Existing Wastewater Disposal System  
(Septic Tank/Drainfield)**

**Tununak, Alaska**

**August 8, 2018**

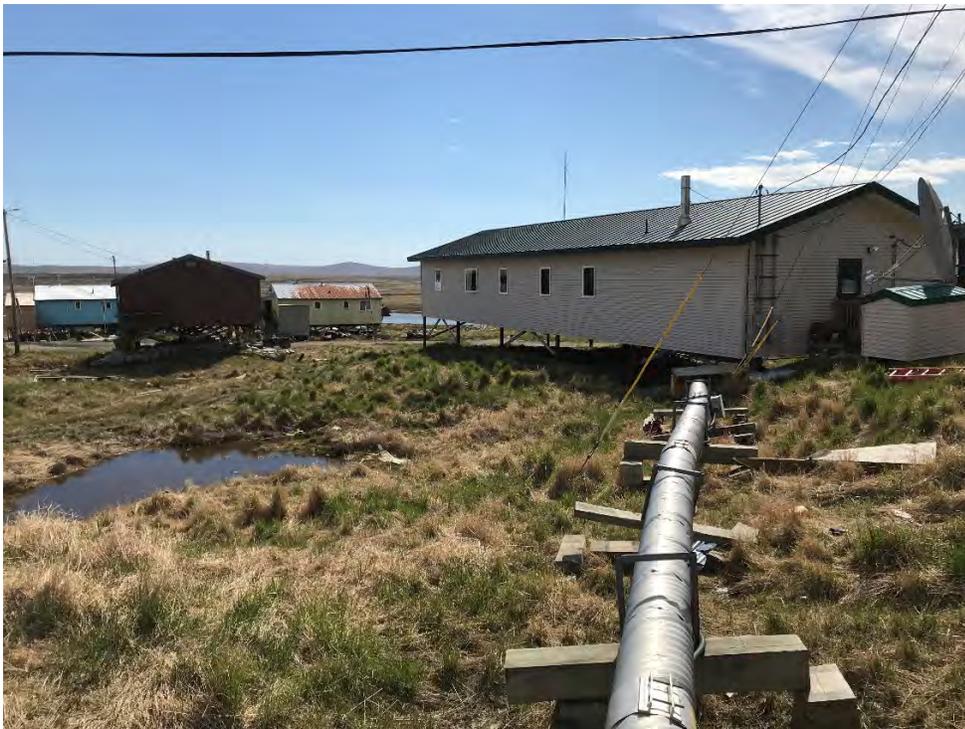
*Photo 2 - Looking south along water transmission line towards the turn box #1 at clinic. Note the condition of the Arctic pipe foundation system.*

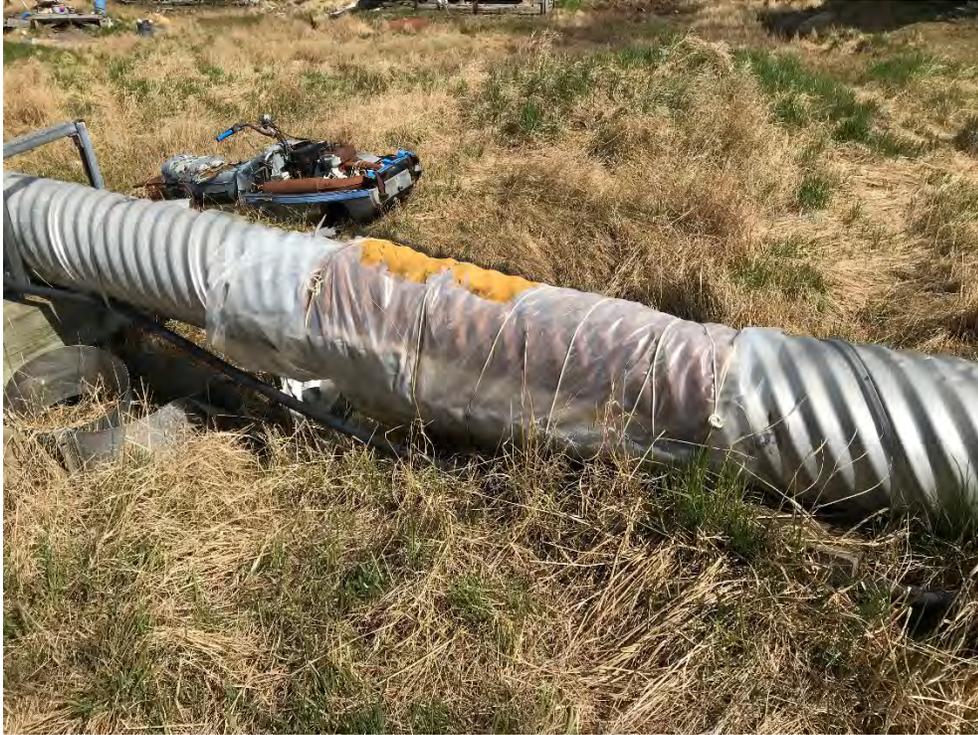
*Photo 7 – Temporary repair of an exposed section on the Arctic pipe.*

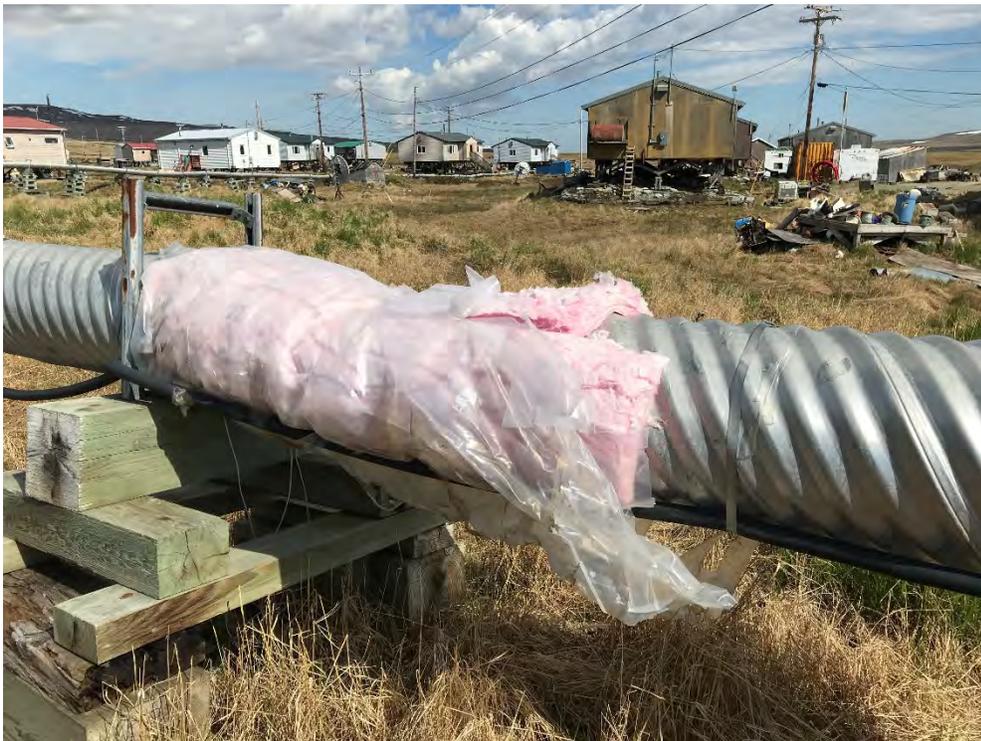
*Photo 8 – Looking east towards temporary repair on another section of the Arctic pipe.*

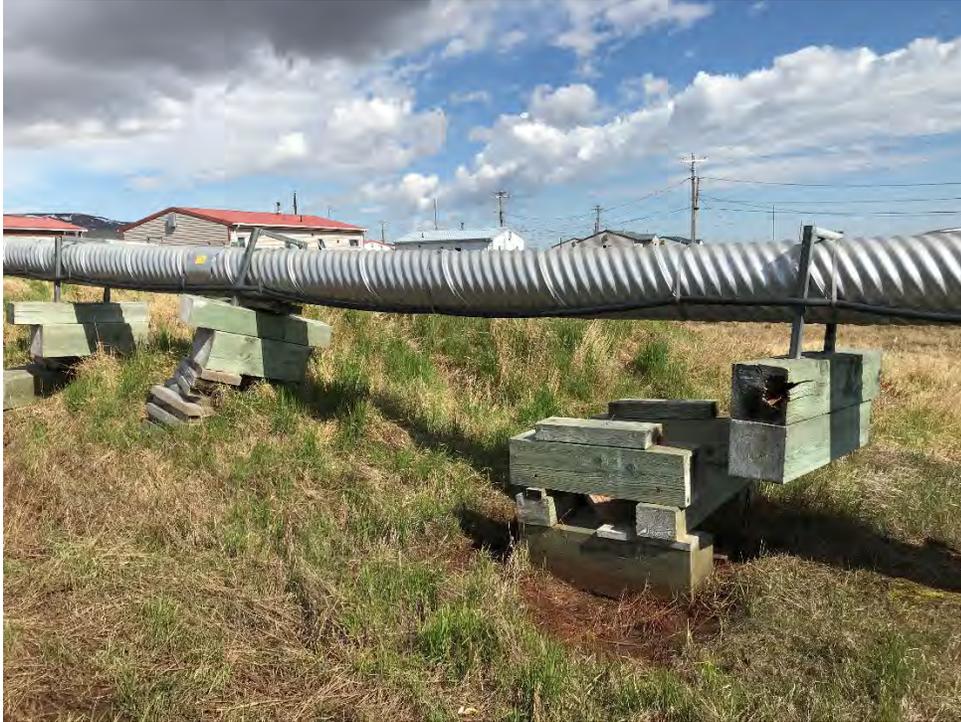
*Photo 11 – Looking east on western portion of the water transmission line with foundation issues.*

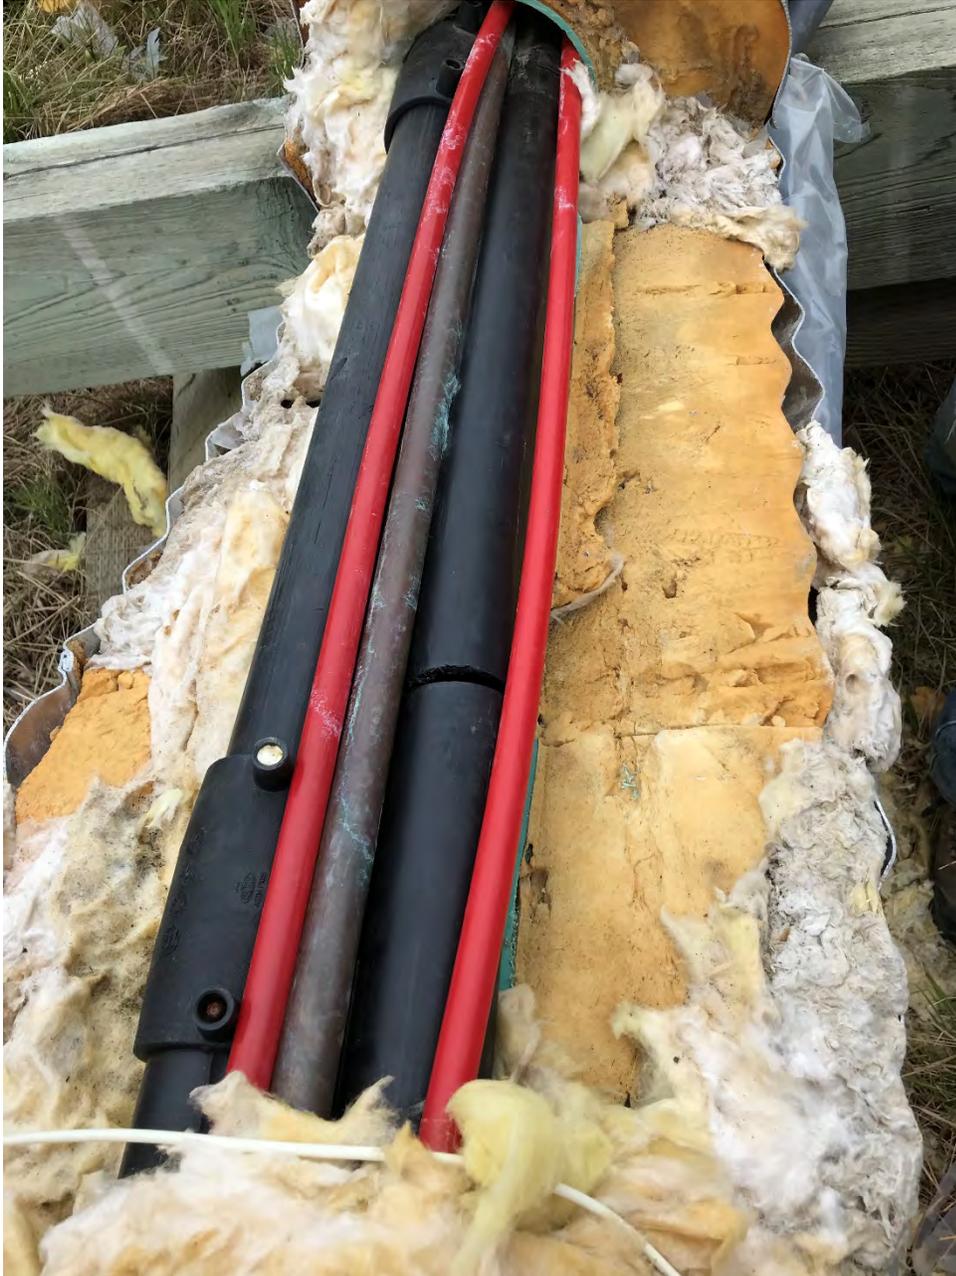
*Photo 13 - Uncovered section of water transmission line showing repair work.*

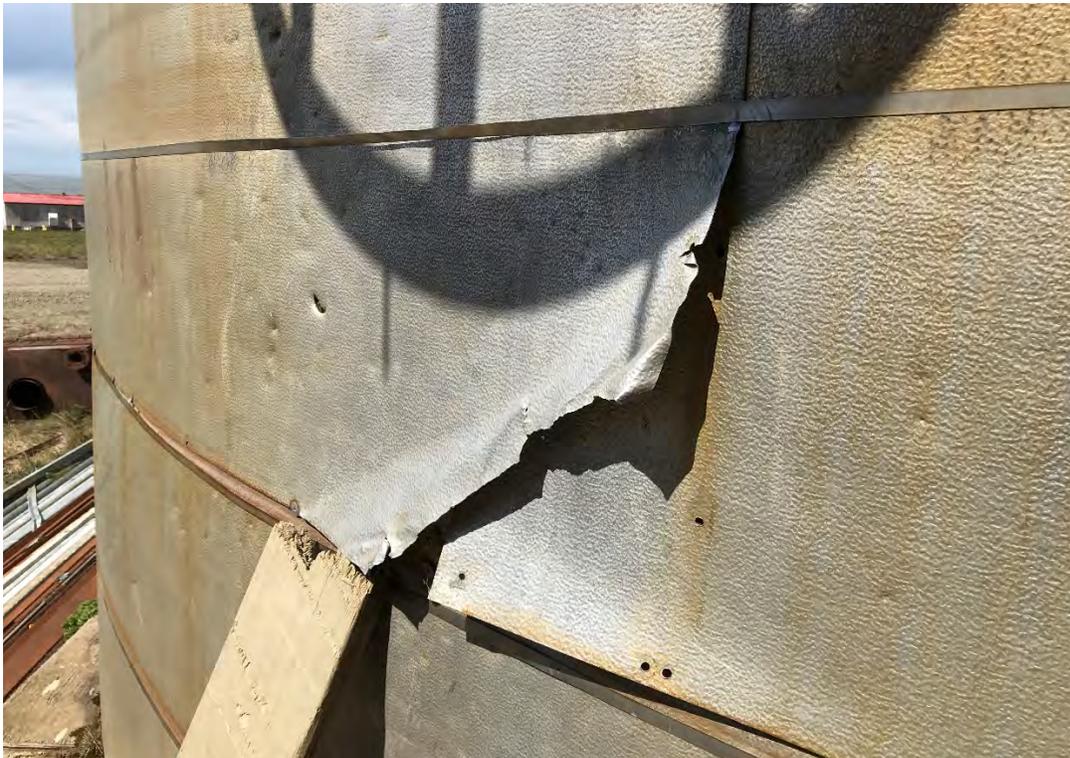
*Photo 6 - Horn aluminum exterior skin covering on Southwest side of WST beneath the roof access ladder.*

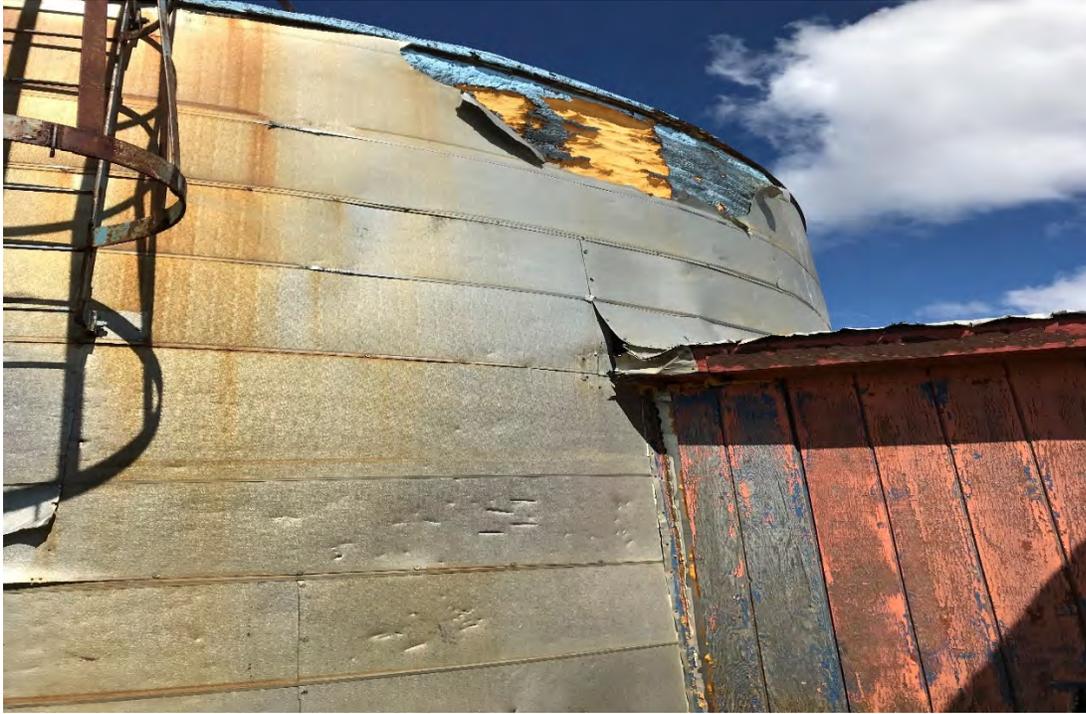
*Photo 7 - Missing aluminum skin on WST surface exposing foam insulation on South side of tank.*

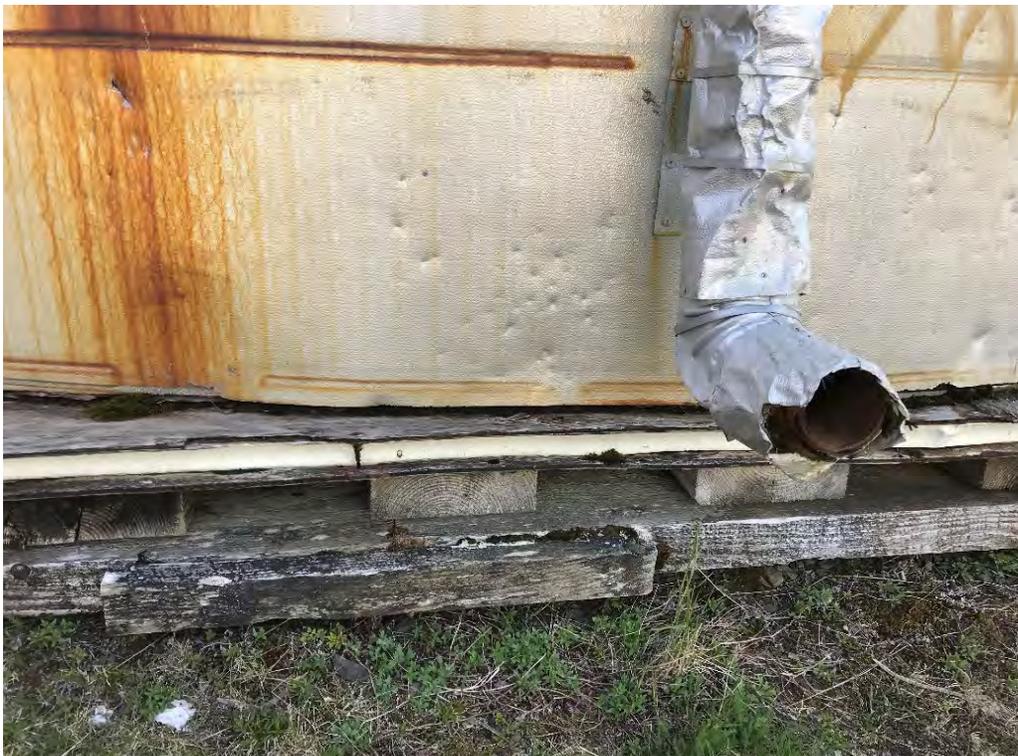
*Photo 10 - Tank overflow drain with deteriorated section on exterior of tank timber foundation*

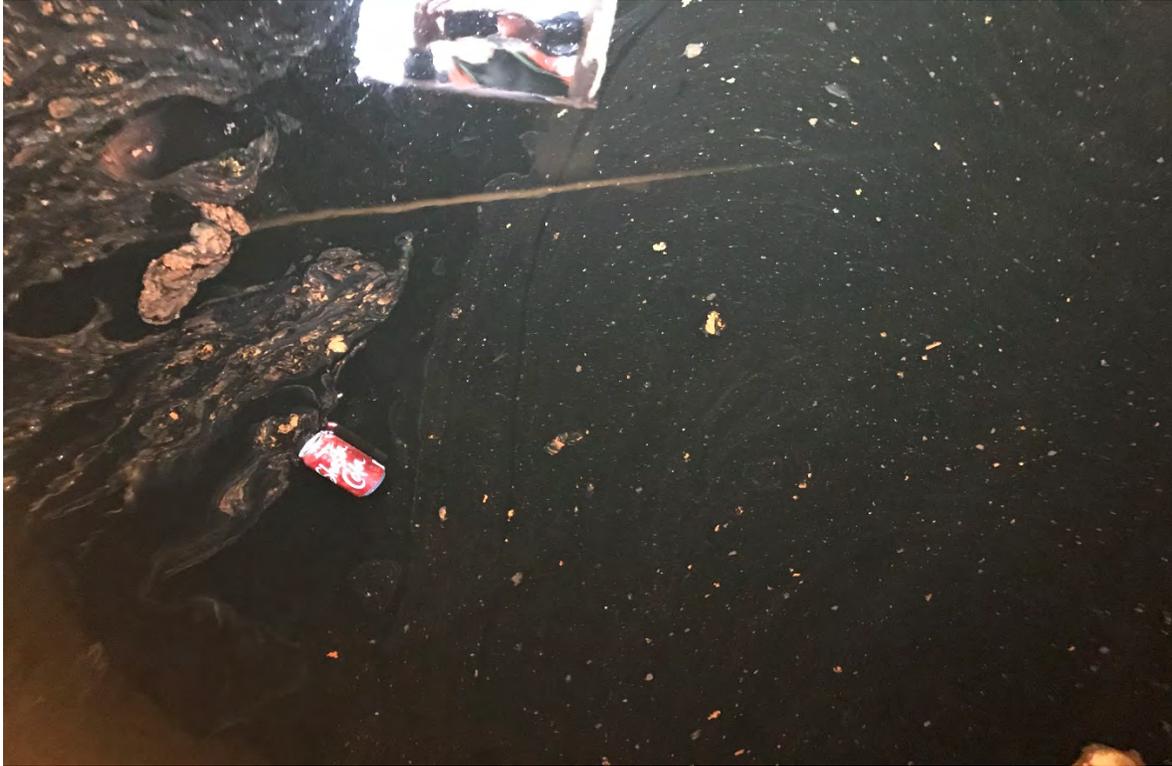
Observed rust debris floating in tank plus an empty soda can floating

*Photo 15 - Looking down inside the WST, observed floating debris including flakes of insulation, rust and an empty soda pop can.*

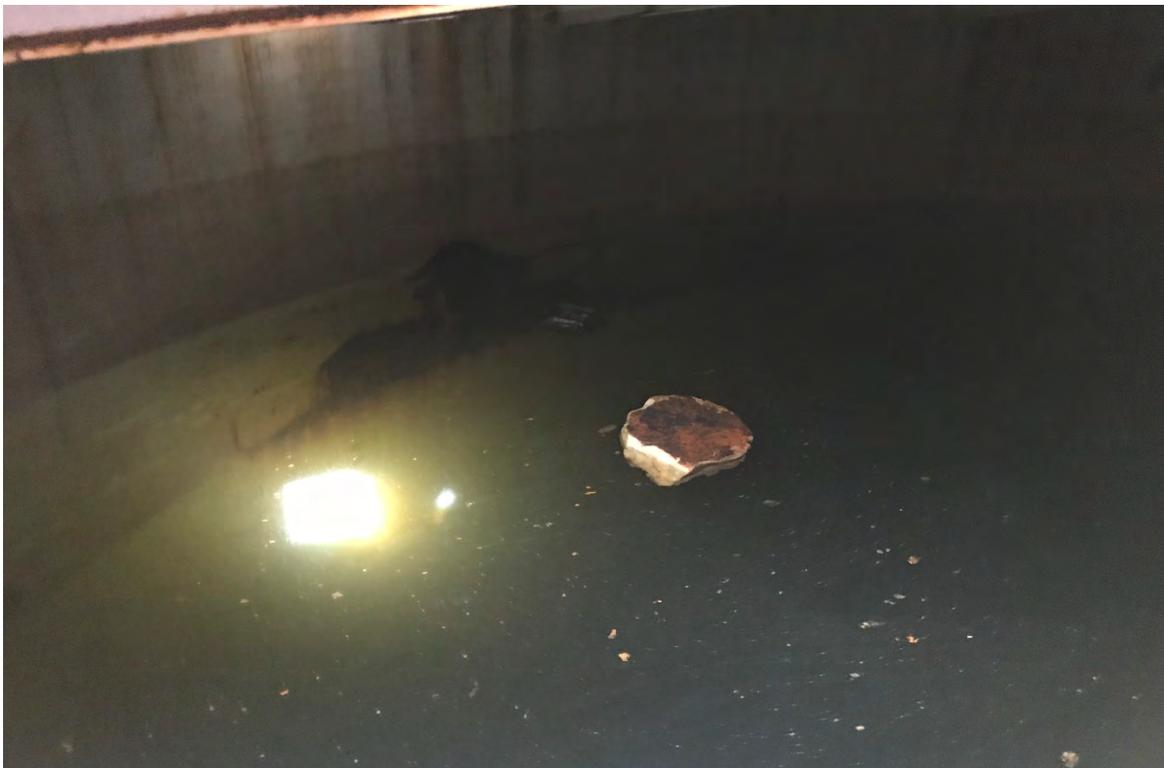
*Photo 16 - Looking down inside the WST, observe floating chunks of insulation and rust.*

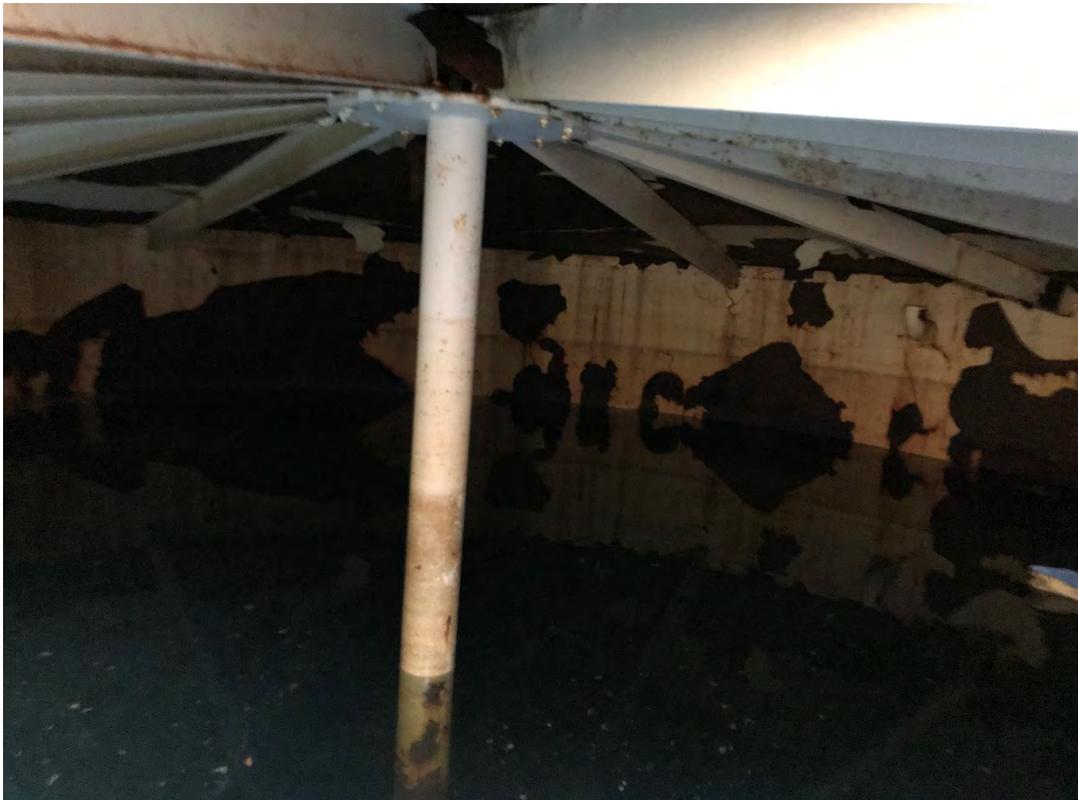
*Photo 18 – Looking inside the WST towards the east side of tank – note deteriorated side wall.*
