**ALASKA DEPARTMENT OF ENVIRONMENTAL CONSERVATION**  
**Division of Spill Prevention and Response**  
**Prevention Preparedness and Response Program**  
***SITUATION REPORT (SITREP)***

## 2026 WNS Rig Move Incident

**SITREP #:** 3

**SPILL #:** 26399902301

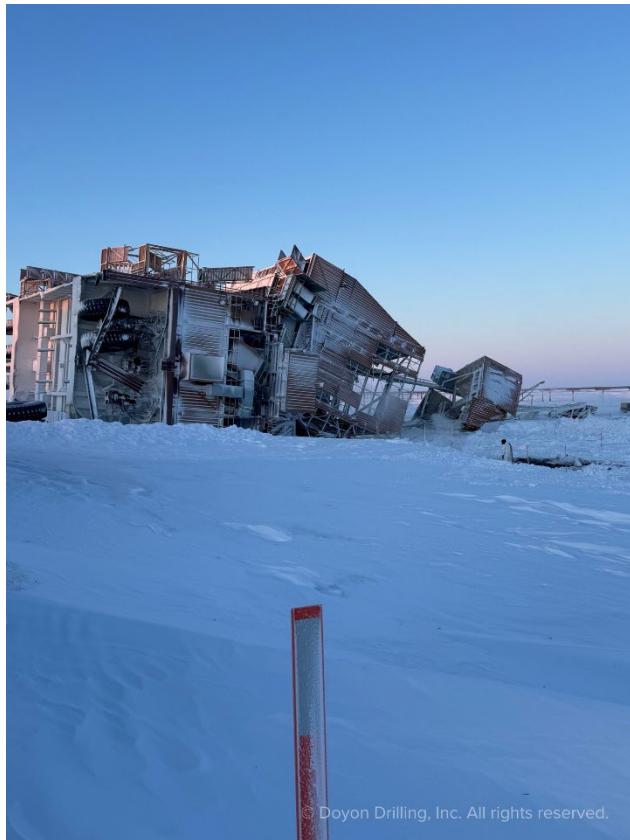
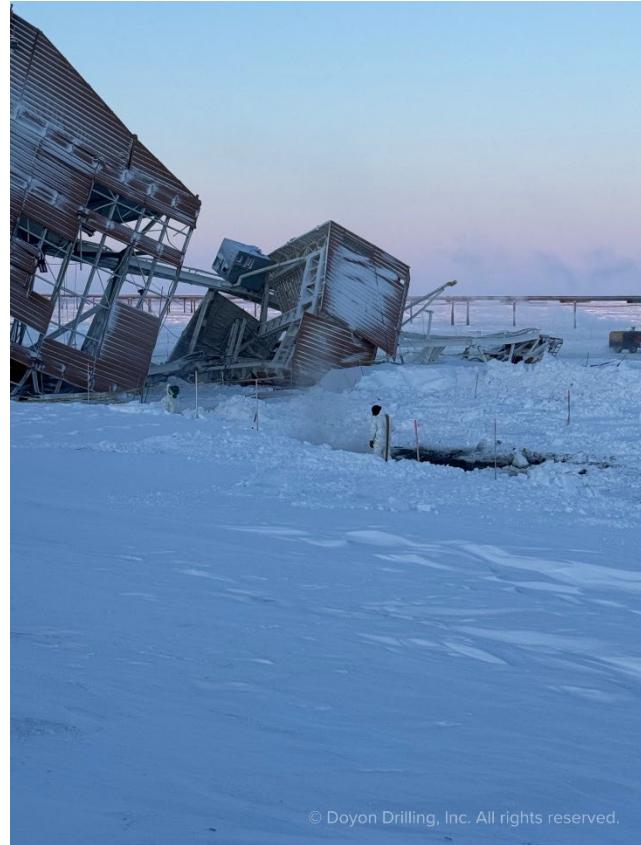
Alaska Clean Seas' spill response technicians flushing contaminated areas to the east of the fallen drilling module on February 4th, 2026, provided courtesy of Doyon Drilling, Inc.
