**ALASKA DEPARTMENT OF ENVIRONMENTAL CONSERVATION**  
**Division of Spill Prevention and Response**  
**Prevention Preparedness and Response Program**  
***SITUATION REPORT (SITREP)***

## 2026 WNS Rig Move Incident

**SITREP #:** 2

**SPILL #:** 26399902301

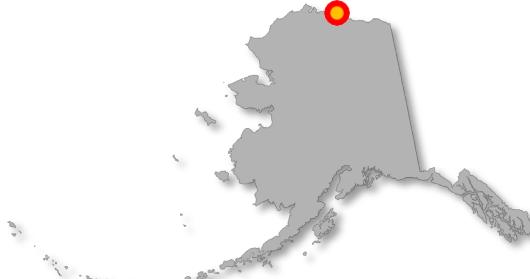
**RESPONSE ACTION:** The response continues to prioritize the safety of all personnel first and foremost. Minor injuries were reported with eight personnel treated on the North Slope and released. Initial response actions were taken to address a fire onboard Rig 26. The site was released by the on-scene Fire Chief Saturday at 3:45 p.m., though structural hazards continue to limit access. A safety team has been dispatched to evaluate concerns. **Initial delineation of the spill area was conducted using visual, infrared, and aerial methods. Where safe to do so, sandbags were placed to minimize migration of diesel. Operations are currently on hold due to**

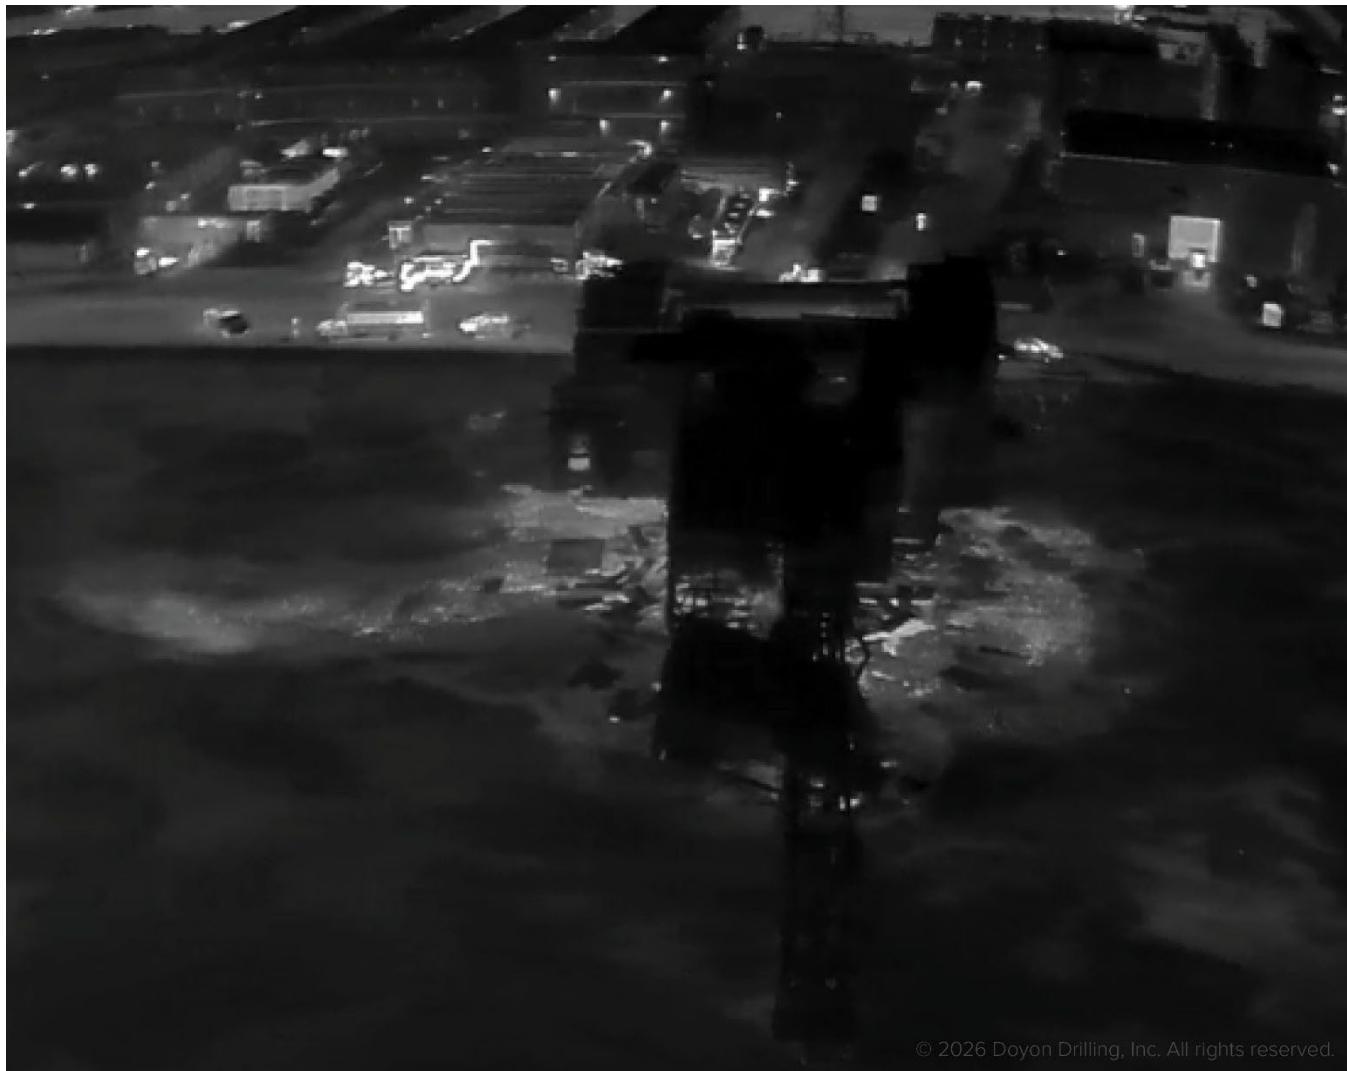
Thermal image from January 24th, 2026, provided courtesy of Doyon Drilling, Inc.

Alaska Clean Seas completed mapping and surveillance of spill on land. Aerial imagery was collected via unmanned aircraft system flights utilizing electro-optical and thermal infrared sensors. This imagery was used to verify the results of delineation and to generate orthomosaic maps depicting the delineated area and providing calculated estimates of impacted tundra.
