APPENDIX B
SITE PHOTOGRAPHS

Former WACS Aniak Middle School Site
Aniak, Alaska

May 2007

32-1-17070

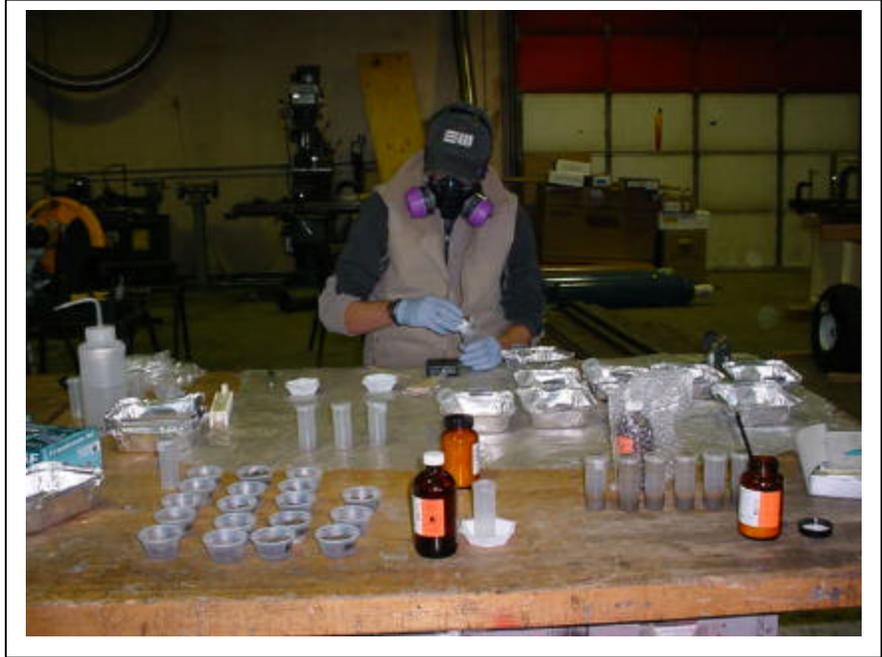
Photograph 1: The PCB field screening samples were extracted and screened using Hach test kit procedures.

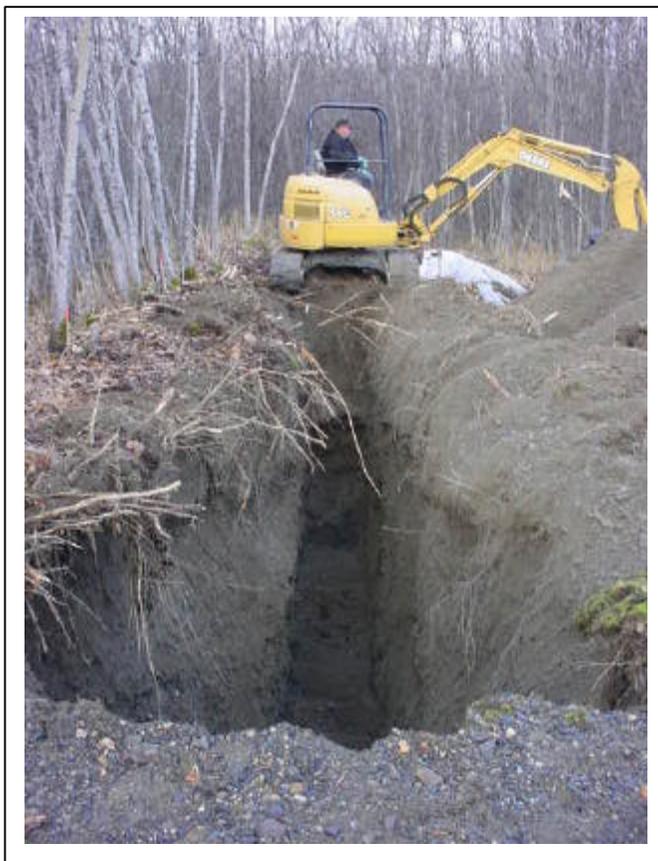
Photograph 2: Looking northwest, the northwestern septic trench was advanced along the former septic lines toward the seepage pit.

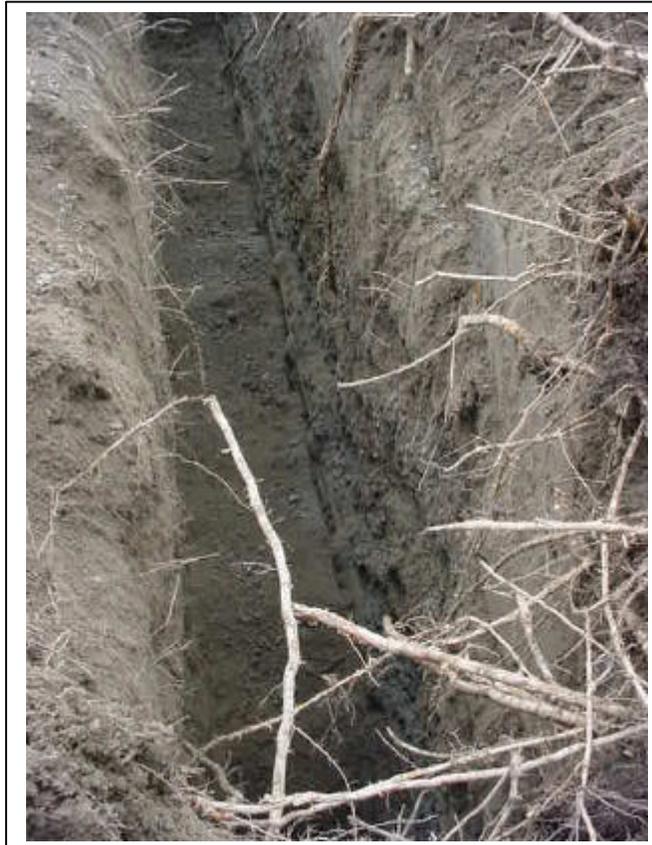
Photograph 3: Looking southeast into the northwest septic trench, the former septic line (on the right at the bottom of the trench) was encountered at 9.5 to 10 feet bgs.

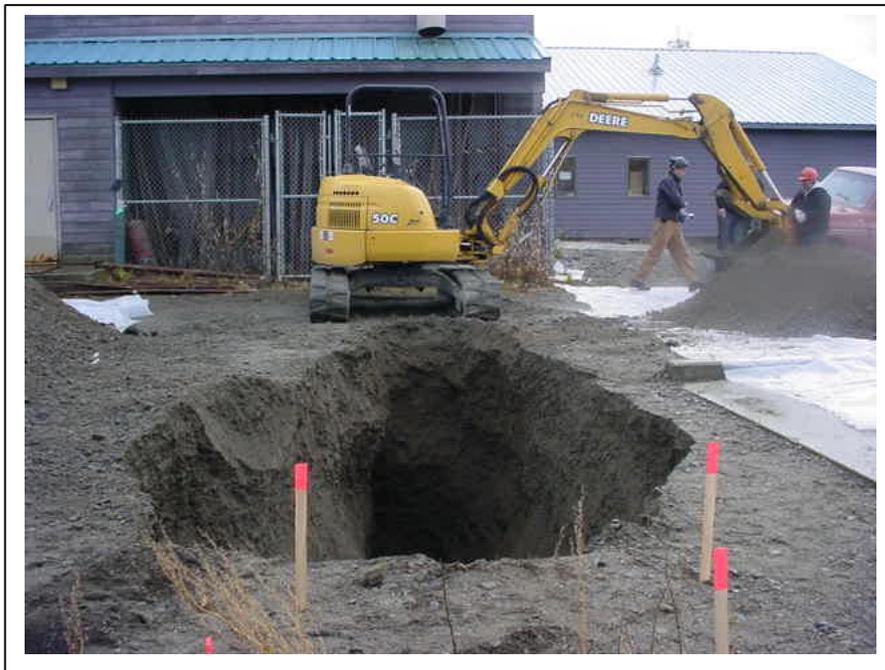
Photograph 4: Looking southeast, the southeastern septic trench was advanced to the southeast of the PCB Grid and to the northwest of the school.

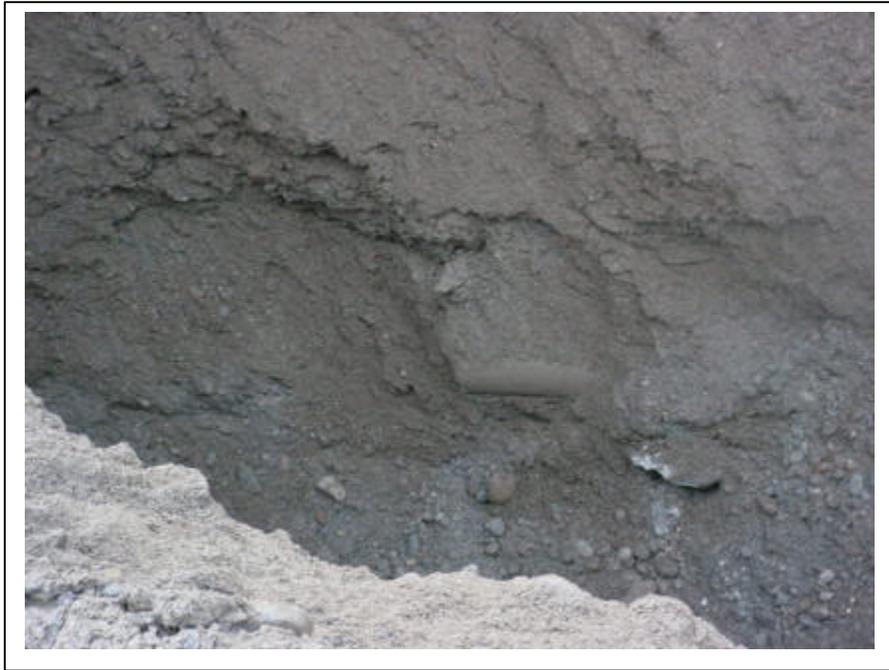
Photograph 5: Looking down into the southeast end of the southeast septic trench, a break was observed in the former septic line.

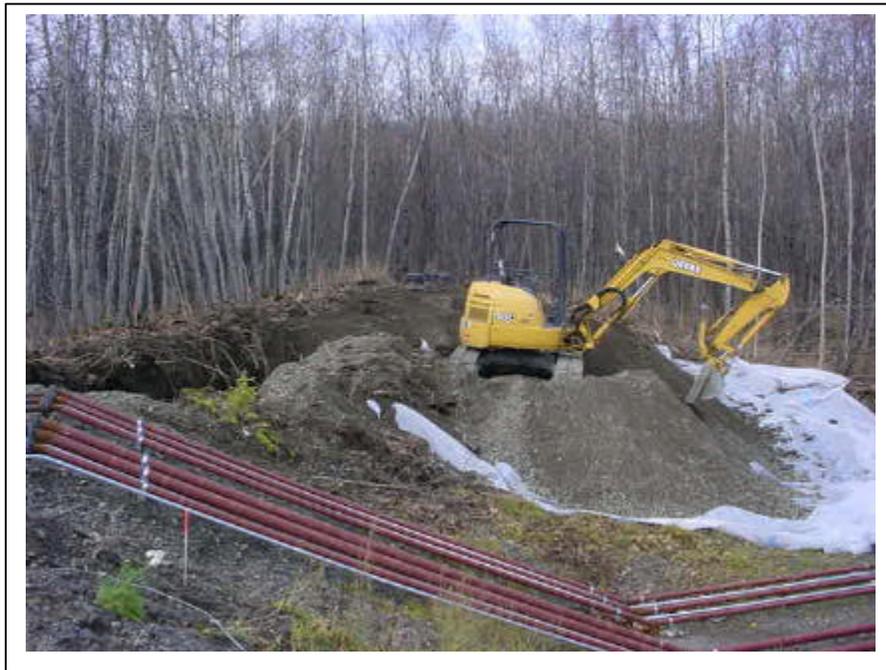
Photograph 6: Looking northwest, the trench was backfilled following sampling activities.

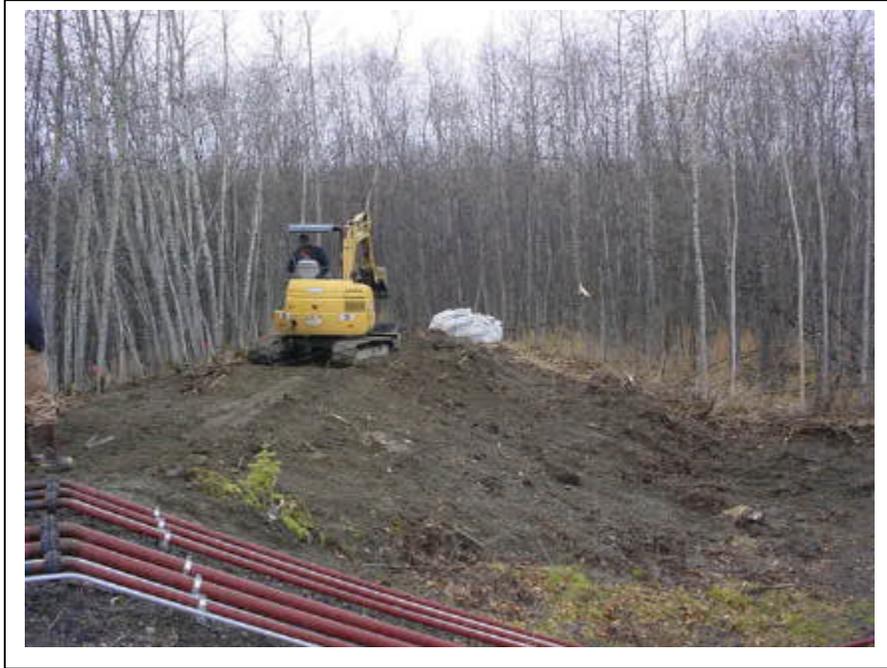
Photograph 7: Looking northwest, the northwest septic trench was compacted with the tracks of the backhoe following backfill activities.

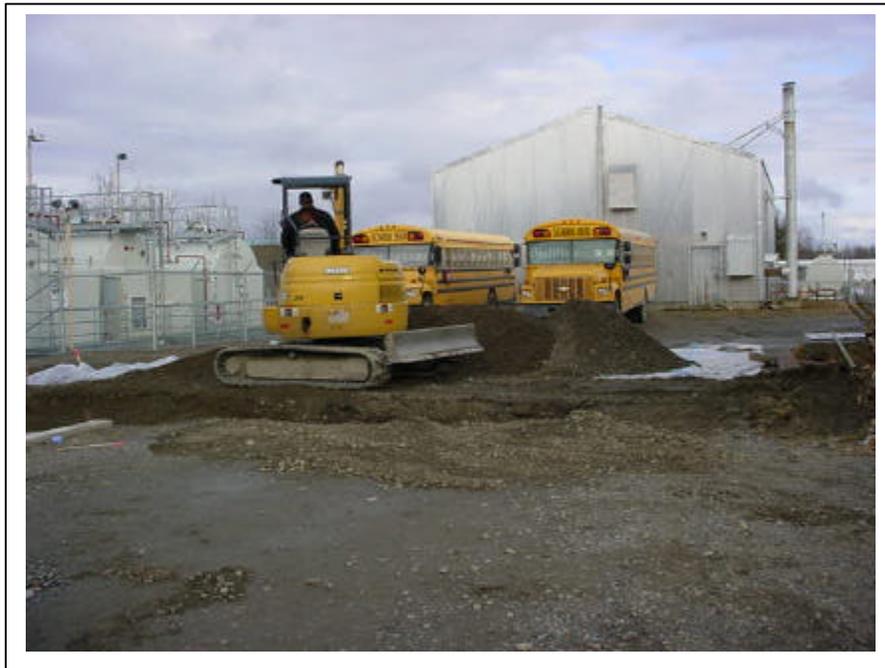
Photograph 8: Looking north, the southeastern septic trench was backfilled following sampling activities.

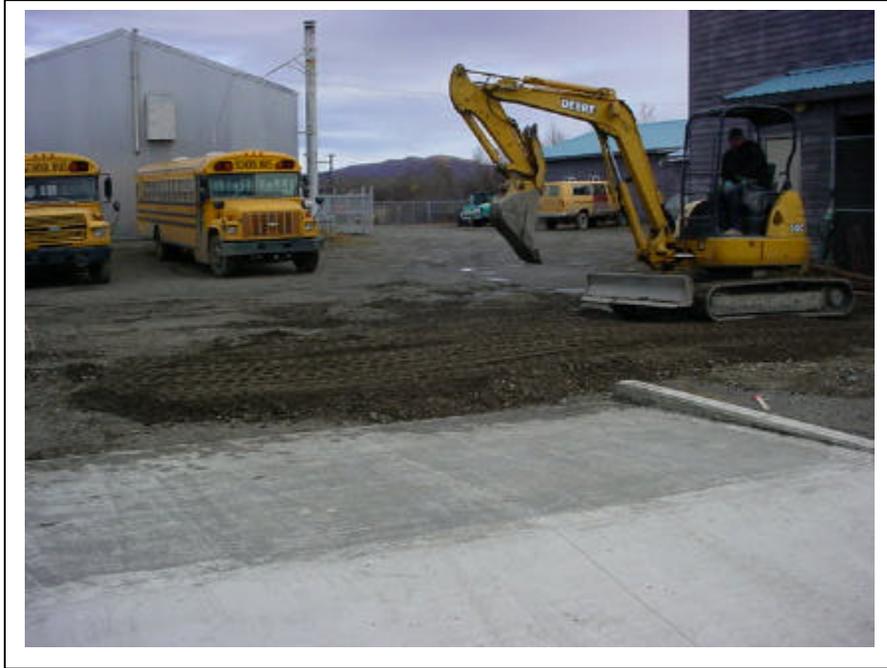
Photograph 9: Looking northeast, the southeast septic trench was compacted with the tracks of the backhoe following backfill activities.

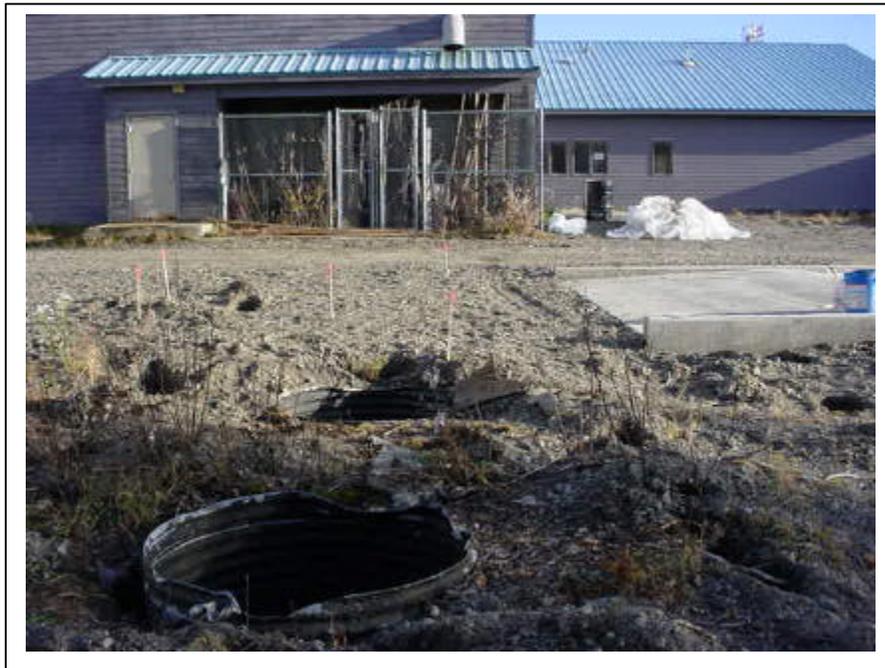
Photograph 10: Looking southeast, two CMPs were located to the northwest of the school.

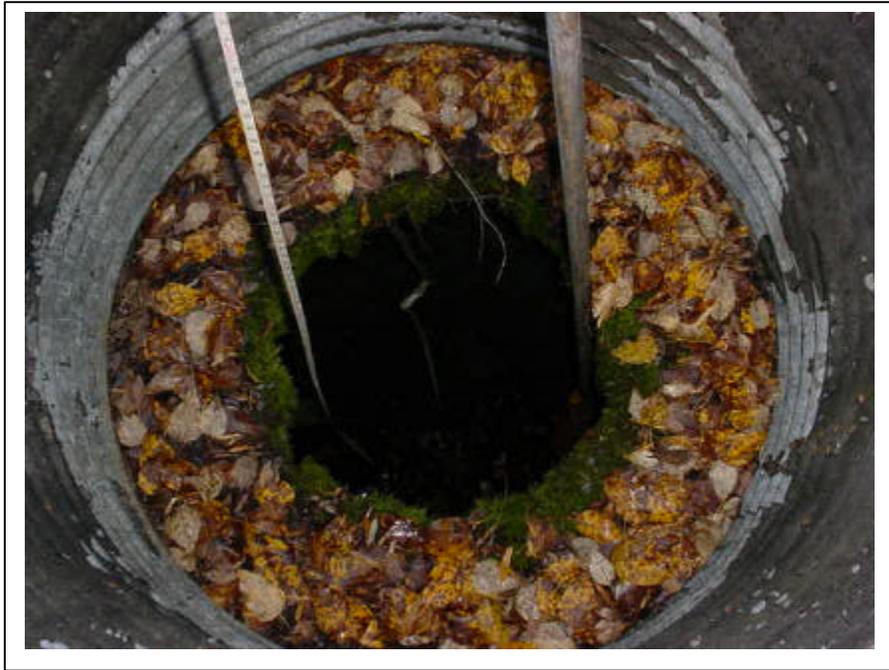
Photograph 11: Looking down into the seepage pit located at the northwest end of the former septic line.

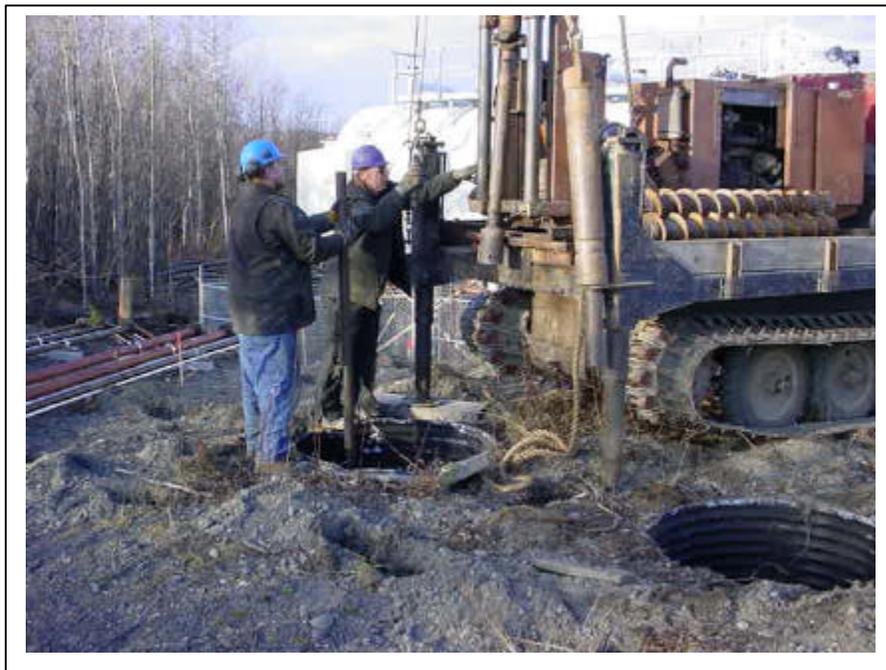
Photograph 12: Looking northwest at CMP2, a split-spoon sampler was used to sample the CMP.

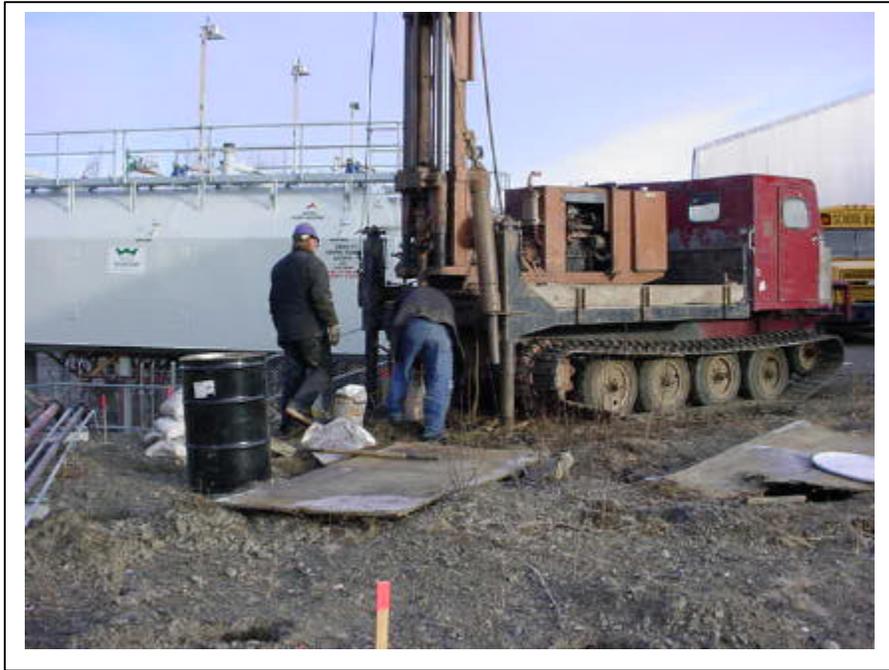
Photograph 13: Looking north, Boring B2 was advanced to the north of the CMPs.

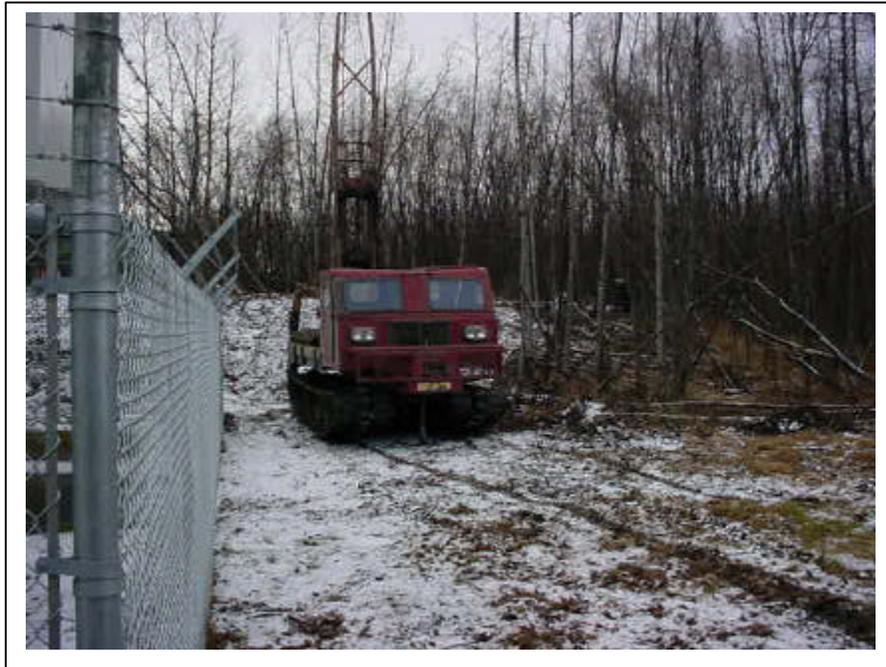
Photograph 14: Looking southwest, Boring B3 was advanced adjacent to the southwest corner of the fuel tank storage fence.

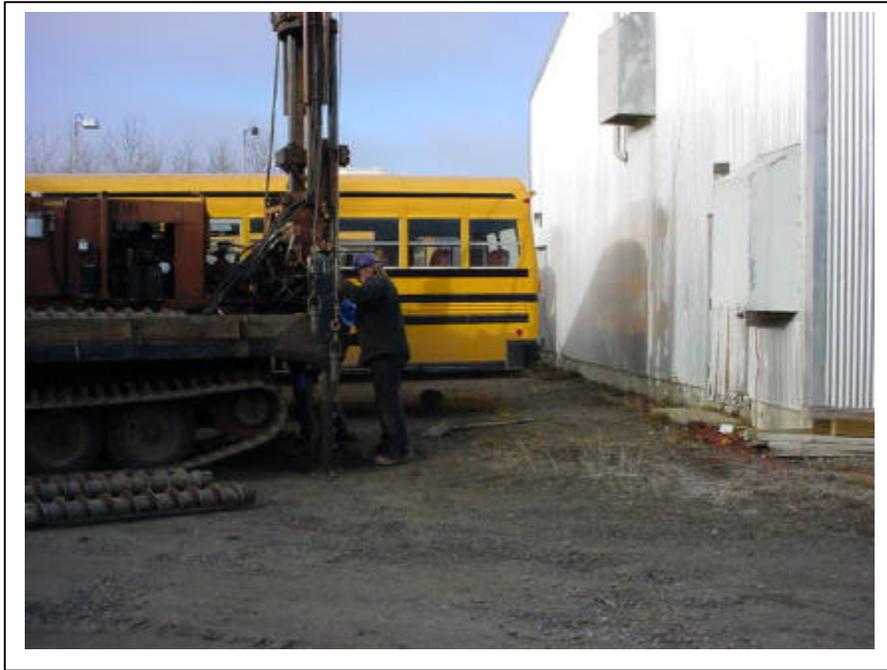
Photograph 15: Looking northwest, Boring B4 was advanced to the south of the KSD maintenance building.

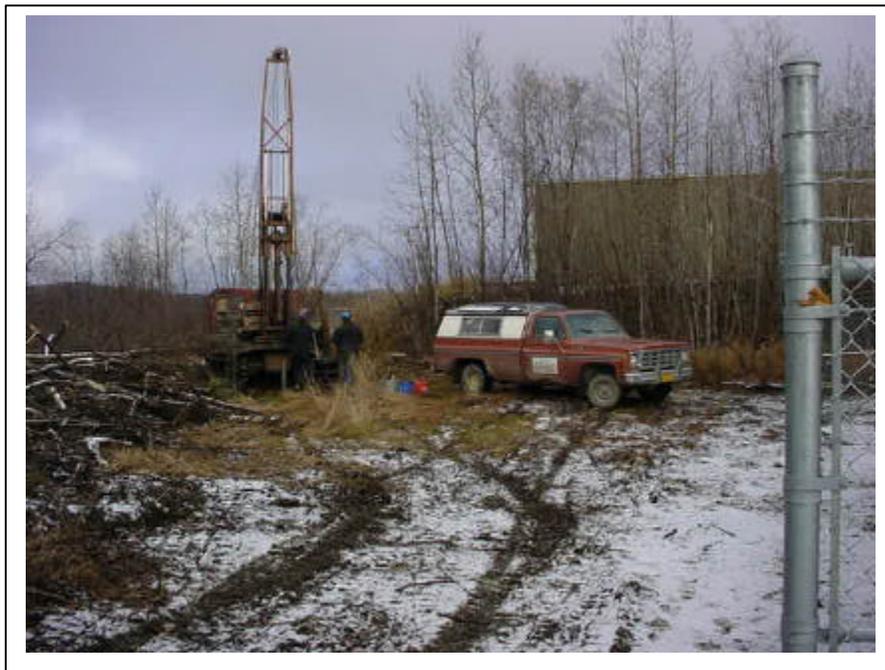
Photograph 16: Looking north, Boring B5 was advanced to the southeast of Area F.

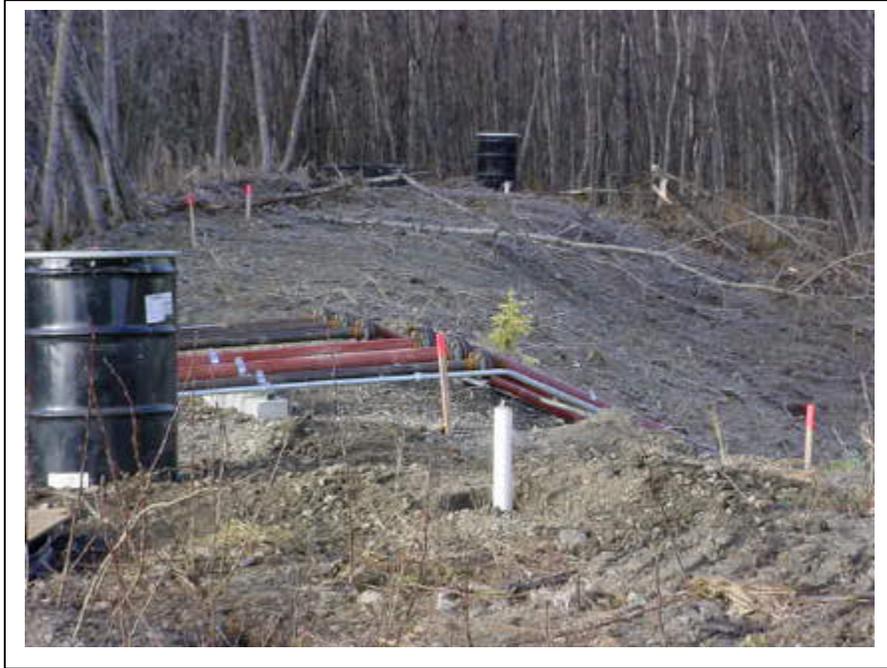
Photograph 17: Looking northwest, Monitoring Wells MW1 (back) and MW2 (front) were installed in Borings B1 and B2, respectively.

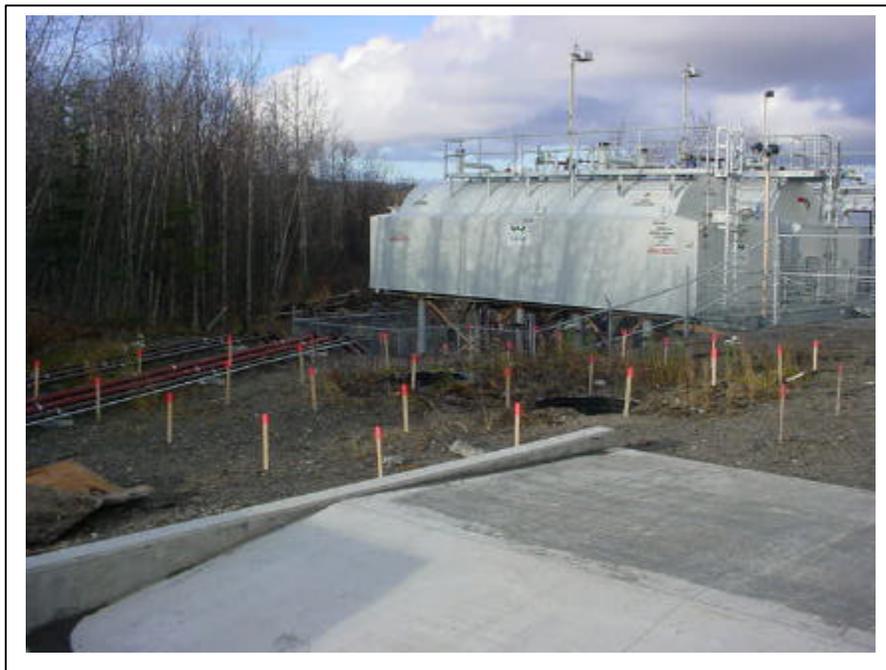
Photograph 18: Looking north, the initial PCB Grid was centered about the 2 CMPs located west of the school.

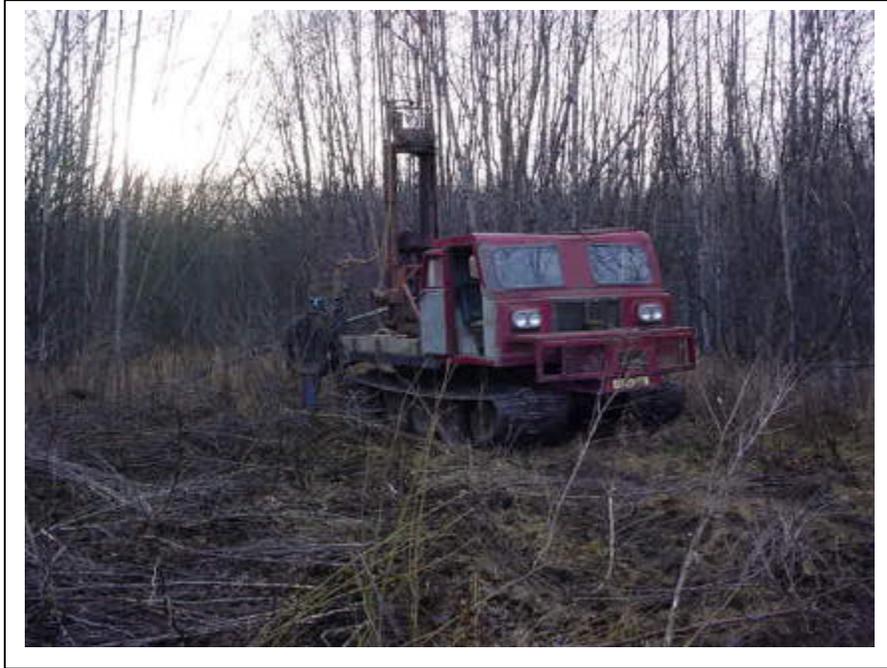
Photograph 19: Looking southwest, Boring FB1 was advanced in the southwest corner of Area F.

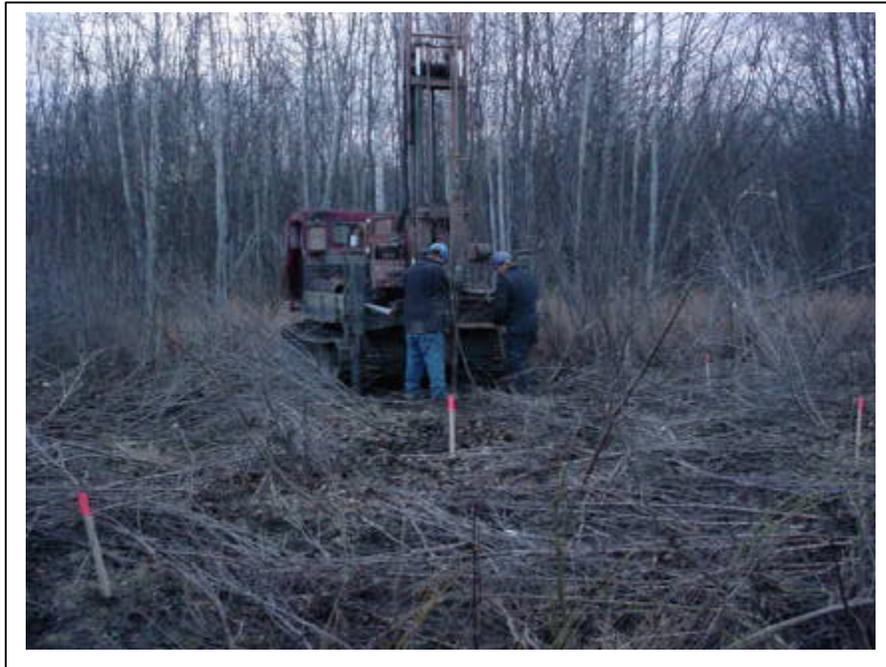
Photograph 20: Looking southwest, Boring FB4 was advanced in the central portion of Area F.
