Alaska Department of Environmental Conservation Spill Prevention and Response

SALT CHUCK MINE, MILL AREA

Database Name: USFS Salt Chuck Mine

Summary updated: Dec. 19, 2013

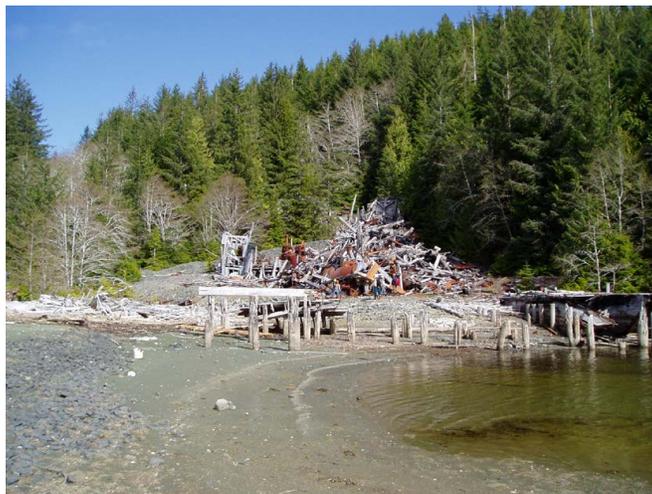
The mill area is shown in May 2009 (above). The mine openings are about a half mile uphill from the mill area. The contaminants from the Salt Chuck Mine include polychlorinated biphenyls (PCBs), copper, lead, mercury, selenium, vanadium, nickel, arsenic, petroleum and polycyclic aromatic hydrocarbons. (DEC photo)

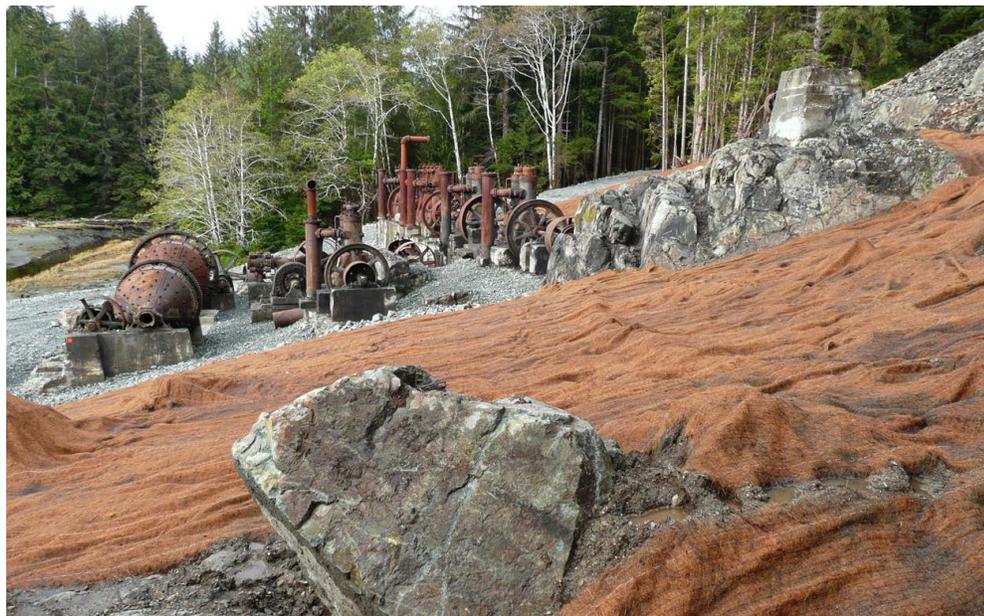
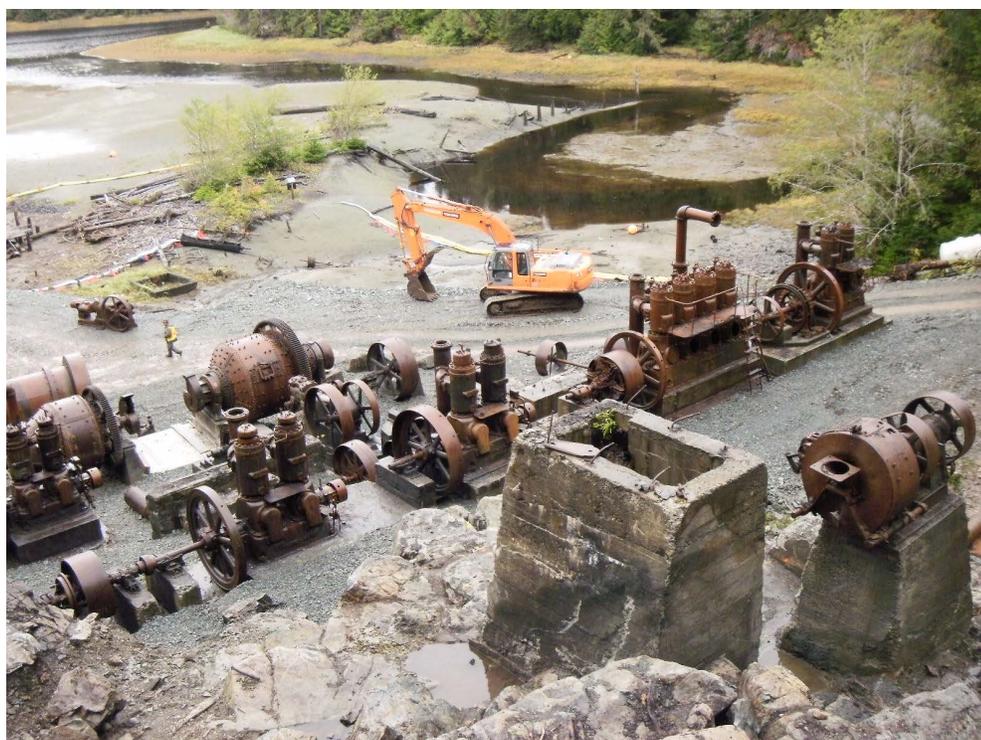
The U.S. Forest Service built a short road to provide access to the site in 2011, removed building debris, drums and tanks, excavated roughly 5,400 cubic yards of petroleum-contaminated soil and metals-contaminated tailings – 8,400 tons of contaminated material, which filled 300 containers averaging 28 tons per load. The material will go to a permitted landfill out of state. The agency set aside the site's historical mining equipment during the excavation, then grouped it in one area, as shown in the photos taken in October 2011 photos (top and bottom). (Photos courtesy of the U.S. Forest Service)

In 2011, the Forest Service used funding from the American Recovery and Reinvestment Act, along with additional funding, to conduct a non-time critical removal action on the uplands. The Forest Service built a short road to provide access to the site, removed building debris, drums and tanks, excavated roughly 5,400 cubic yards of petroleum-contaminated soil and metals-contaminated tailings, and disposed of the excavated material in a permitted landfill out of state. The EPA collected soil, sediment, water and biota samples at the site in 2011 and 2012. Those samples will be used in the Remedial Investigation Report and Risk Assessment Report.

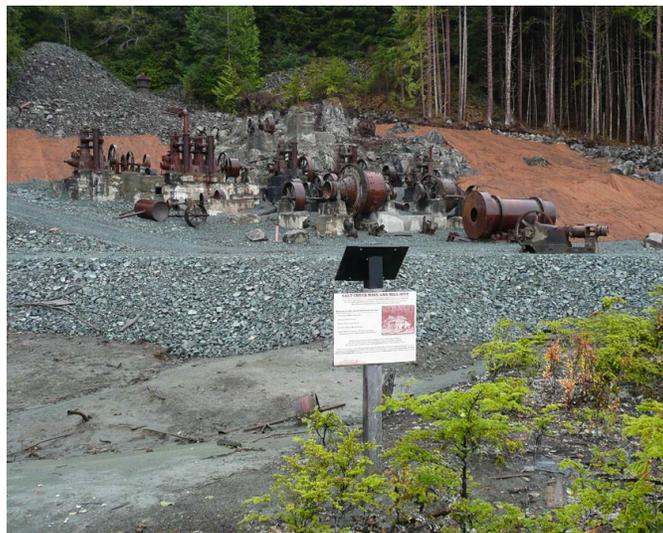
The site's historical mining equipment is now collected in one area, as shown in this October 2011 photo (above). (Photo courtesy of the U.S. Forest Service)

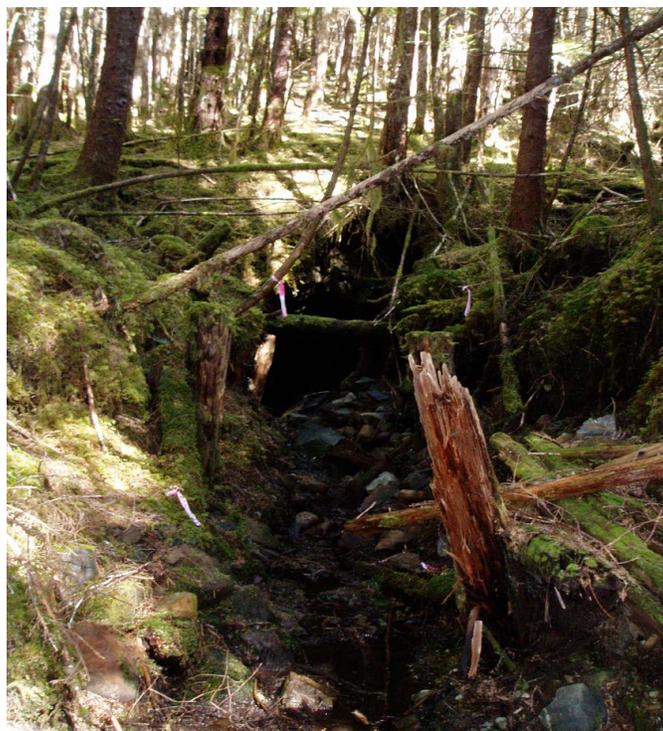
One of the main adits to the mine is shown in this May 2009 photo (above); the adit looked similar in the summer of 2011. An adit is a nearly horizontal passage from the surface to a mine. (DEC photo)

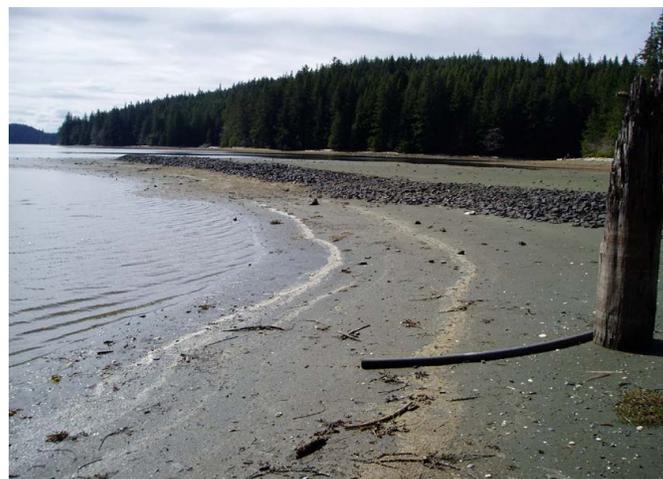
The line of brown rocks and all the sediment on the nearby beach (above) are metals-contaminated tailings. The beach is near the mill area, on Salt Chuck Bay, and the photo was taken in May 2009. The main contaminants of concern in the intertidal area are copper, arsenic and vanadium. (DEC photo)

In May and August, the EPA also conducted a treatability study in the inter-tidal area to determine if certain actions would be effective in reducing erosion. Some tailings were removed to straighten out the small creek to prevent more erosion, and rock was placed to armor the stream bank where it was eroding. Different plants were transplanted at different elevations on the tailings to see if the plants would grow and hold onto the tailings. The EPA will evaluate the progress of the treatability study in 2014.
