# Alaska Department of Environmental Conservation Spill Prevention and Response

## STERLING ZIPMART

Database Name: ZipMart Store - Sterling

Location: Sterling, Alaska

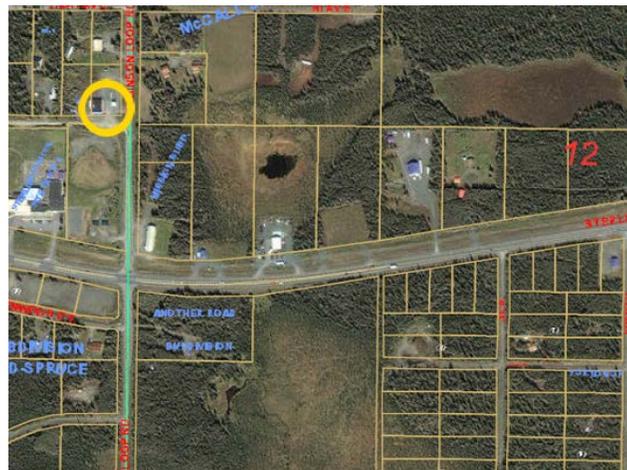
This aerial photo shows the former Zipmart gas station circled in yellow. Contamination from gasoline has spread underground to areas to the right and down (southeast). For a diagram of the estimated plume size and information from sampling wells, see the downloadable file under "More Information" at the bottom of the page. (Photo courtesy of the Kenai Peninsula Borough, 4/03) View more at The [Kenai Peninsula Borough GIS Web page](#).
