TAPS TECHNICAL REPORT JPO No. ANC-06-E-026

Trip Report on Site Visit to Witness the Commissioning of MLU Electric Motor and
Assessment of Functional Check Out Documentation at PS-9 Pipeline Strategic
Reconfiguration Project
30 & 31 October 2006

Technical Report Number ANC-07-E-001

Investigation of the January 6, 2007 PS 9 Tank Farm Fire

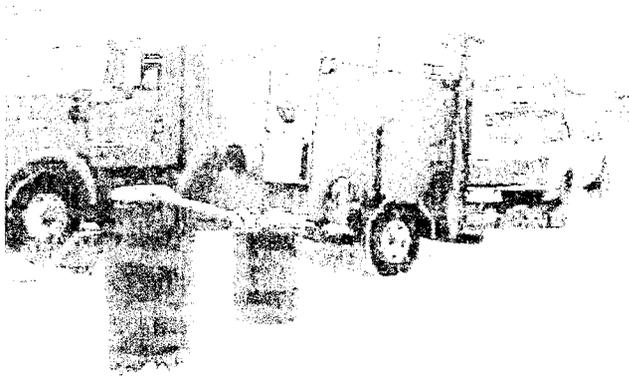
Tooga #35017 was the portable industrial heater that was involved in the fire.

Had the heater been farther from the tank, it is possible the fire may not have occurred or could have been larger because of the additional flammable vapors. An intrinsically safe portable industrial heater may have prevented this incident.

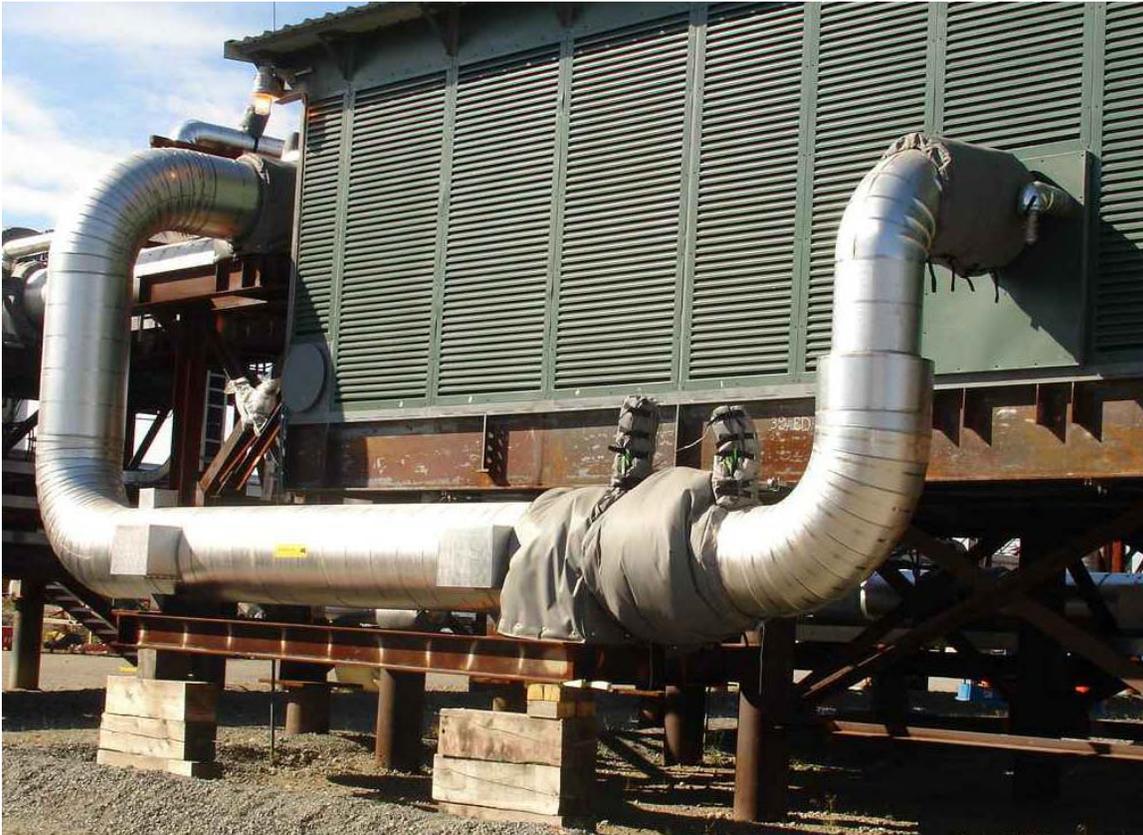
Pump Station 9

**Suction Pipe Supported by Wooden Cribbing
To Protect it from Unanticipated Vibration**
