**Greater Kuparuk Area (GKA)
Western North Slope (WNS)
Corrosion Programs Overview**

March 31, 2009

Commitment to Corrosion Monitoring
9th Annual Report to the Alaska Department of Environmental Conservation

Prepared by
ConocoPhillips Corrosion Team

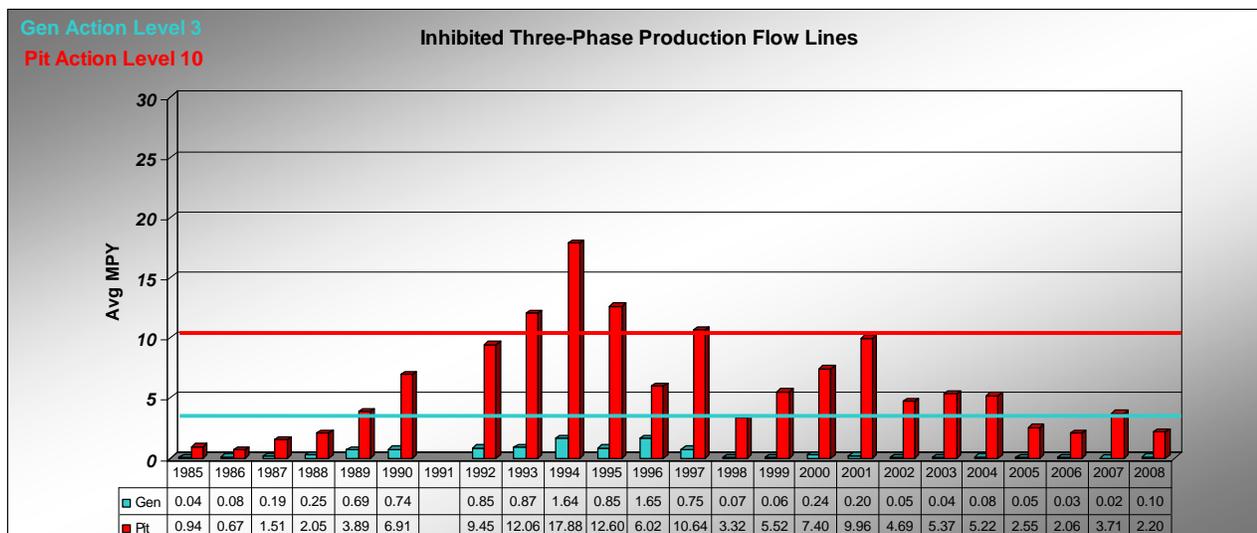
Figure 1. Inhibited Three-Phase Production Flow Line Coupons – general and pitting corrosion rates by year.

Three-phase Production Flow Lines: The monitoring data summarized in Tables 1 and 2 and presented in Figure 1 suggest that general corrosion is under control. The data presented in Tables 1 and 2 and in Figure 1 include corrosion coupon data from the wet oil line system from CPF3 to CPF1 and CPF2.

Recurring corrosion-rate monitoring (CRM) inspections also support the conclusion that corrosion is under control in the three-phase production flow lines. In 2008, 1059 CRM inspections were conducted, with 26 increases found. Other internal inspection data supporting the CRM data are discussed in Section B.1.b, below.

Where corrosion rates exceeded targets, CI concentrations were increased and the amount of inspection was increased. In 2008, coupon, probe or inspection-based corrosion rates exceeded targets or revealed increased damage on 22 lines. In 2008, inspection results indicated minor corrosion had occurred in 15 lines. A complete listing of the lines with coupon/probe corrosion rates that exceeded targets and/or where inspection indicated increased damage is given in Table 3.

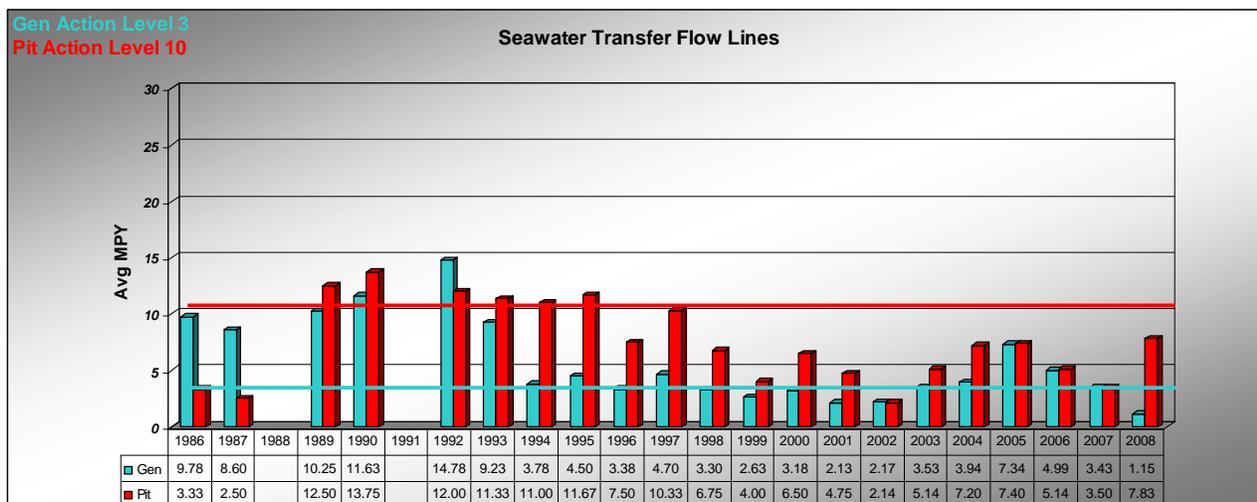
Figure 2. Seawater Transfer Flow Line Coupons – general and pitting corrosion rates by year.

Seawater Transfer Flow Lines: The monitoring data summarized in Tables 1 and 2 and presented in Figure 2, show the average corrosion rates for the SW flow line coupons. Average general corrosion rates have dropped below threshold with inclusion of oxygen scavenger full time at STP and pitting rates for the field are below the threshold. Biocide concentration is currently at 1000 ppm with weekly maintenance pigging. There are two coupon locations on the SW system, one at the STP and one on the SW line that supplies Alpine. The STP coupon on the SW discharge had an average pitting corrosion rate of 11 mpy from oxygen excursions. The Alpine line coupon had an average pitting corrosion rate of one mpy.

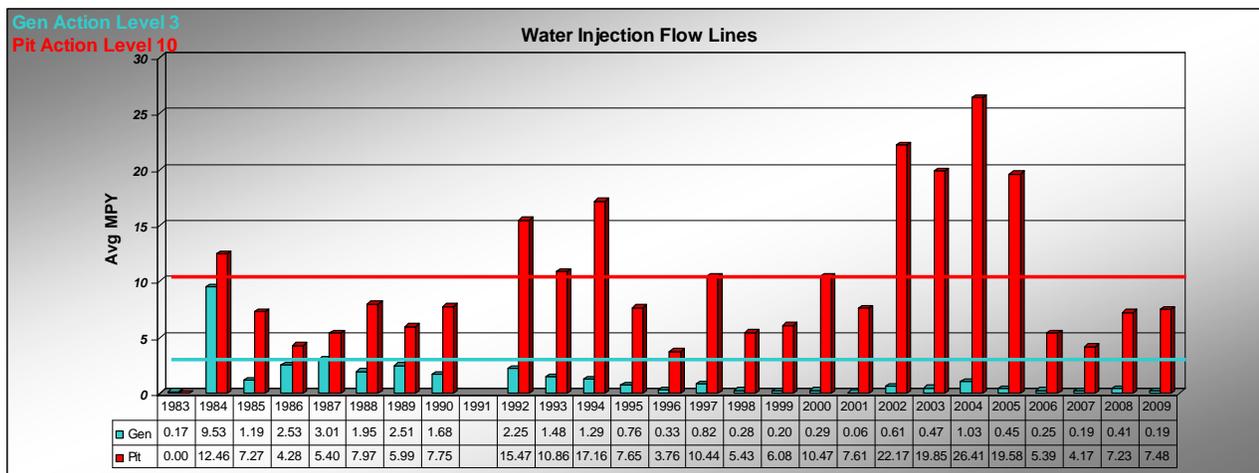
Figure 3. Water Injection Flow Line Coupons – general and pitting corrosion rates by year.

Water Injection Flow lines: The monitoring data summarized in Tables 1 and 2 are presented in Figure 3. Increased pigging and biocide have brought the WI flow lines coupon pitting rates under control. Since SW and PW commingling were suspended at CPF2 in 2005, pitting rates have been reduced markedly. Coupon results are used to prioritize inspection efforts. Additional chemical injection systems have been installed on individual lines at CPF1 and are being installed at the other two CPF's. New cleaning pig styles have been field-tested and additional pigging technology is under evaluation. These lines also benefit from the weekly biocide treatment of the sand jet systems. Data from new coupon locations installed in water injection flow lines during 2007 were available for the first time in 2008. Many of these new coupon locations were at the drill site end of flow lines. Exposed to pigging effluent, the pitting corrosion rates of the new coupons were greater than ten mpy. CPF1 water injection flow lines treated with biocide after pigging for half the year had an average corrosion pitting rate of three mpy.

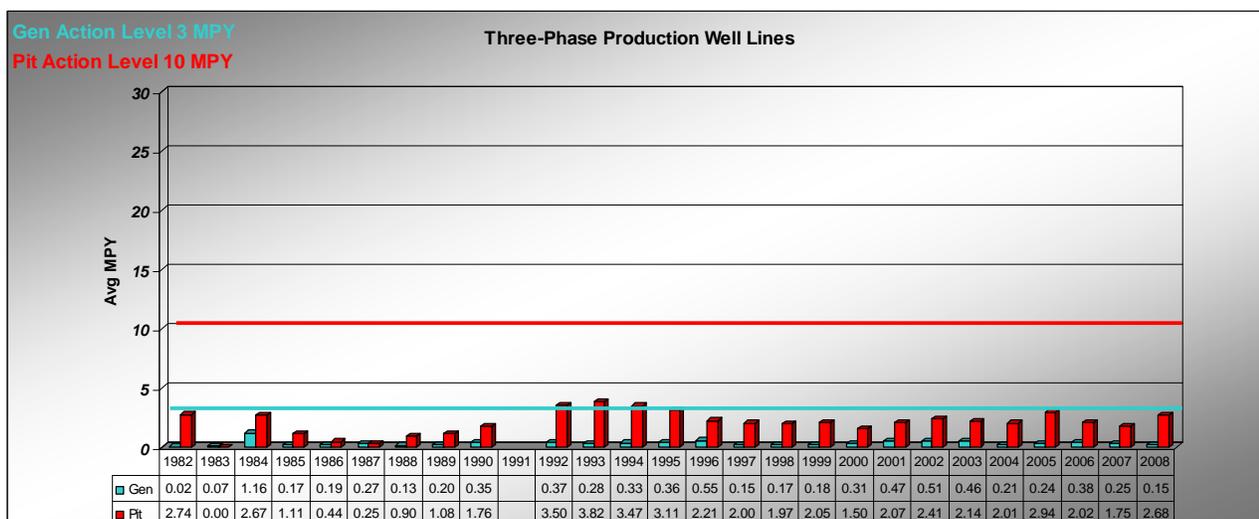
Figure 4. Three-Phase Production Well Line Coupons – general and pitting corrosion rates by year.

Three-phase Production Well Lines: While the monitoring data summarized in Tables 1 and 2 and presented in Figures 4 and 5 suggest that corrosion rates are below targets, inspection data indicate that higher corrosion rates have been experienced historically. The well line inspection data are discussed in section B.1.a, below, and are a good example of why monitoring data alone cannot be relied upon to characterize corrosion in a given system. For three-phase production, coupons monitor free flowing fluid and have not shown the predominant, under-deposit corrosion mechanism.

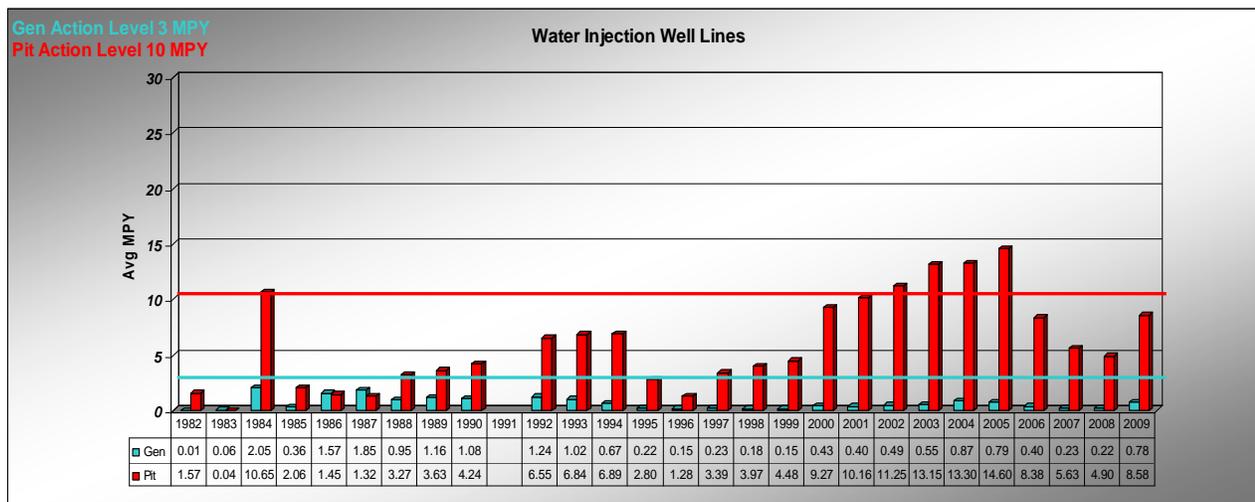
Figure 5. Water Injection Well Line Coupons – general and pitting corrosion rates by year.

Water Injection Well Lines: As discussed in section B.1.a, below, the well line inspection data on water injectors show that there are a significant number of corrosion related repairs. The water feeding this system is treated at the facilities with biocide and is discussed under Figure 3 - Water Injection Flow Line Coupons. We believe that increased velocities from decreasing the riser and well line diameters are contributing to the decrease in coupon corrosion rates.

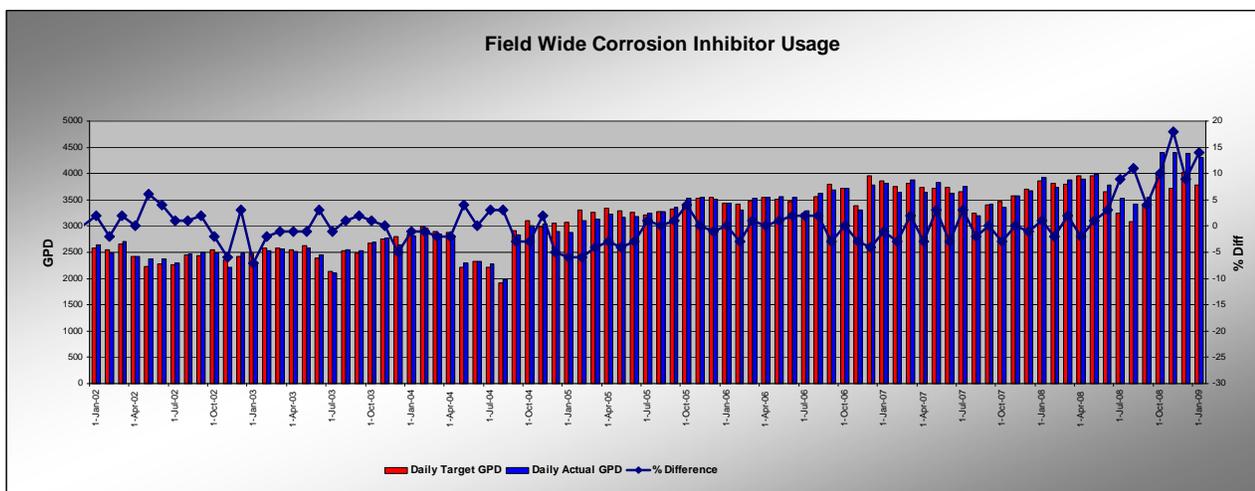
Figure 6. Field-wide Corrosion Inhibitor Use.

Figure 6 shows the actual number of gallons of CI pumped per day, the recommended (target) number of gallons per day and the percent difference between the two. The average deviation for the year was +5%, which is a result of maintaining rates at normal winter volumes during the summer maintenance activities.

Coupon corrosion rate results have reflected maintaining these volumes during these activities. CI use has increased since 2003 because of higher water cuts and solids.

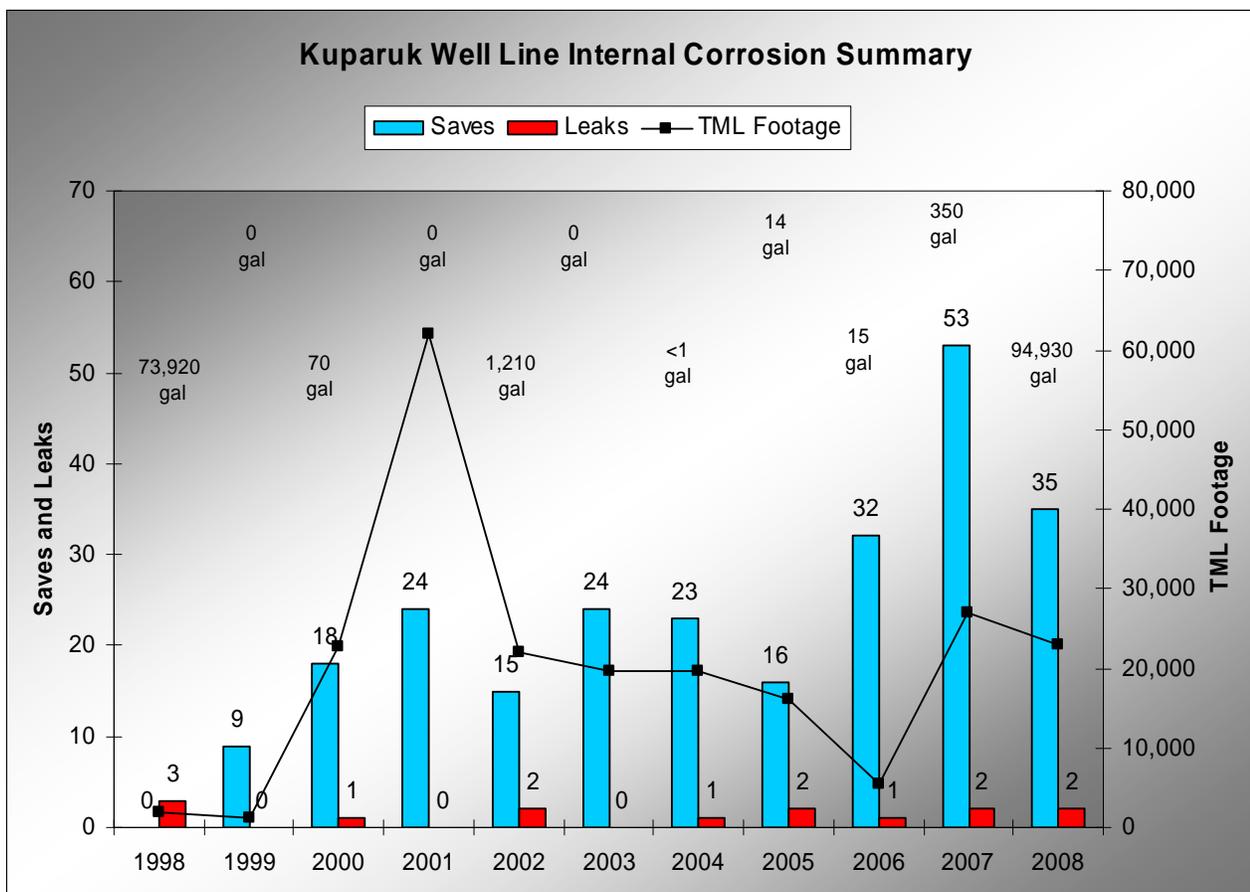
Figure 8. Summary of WI and Three-Phase Production Well Line Internal Corrosion Inspections – RT footage, leaks, and saves by year.

As indicated in Figure 8, below, repair recommendations were initiated on 37 well lines (19 WI and 18 PO) in 2008 because of internal corrosion or a combination of internal and external corrosion damage. The predominant corrosion mechanism was associated with solids (under-deposit corrosion or erosion). More information on the two leaks shown in Figure 8 can be found in Section C.

- The 1L-22 WI well line leaked in December of 2008 because of internal corrosion. The spill volume was determined to be 94,920 gallons of produced water and, except for a light misting, all liquids were confined to the gravel pad. The spill was reported to ADEC and the investigation into the cause of the leak is complete and follow-up actions are ongoing.

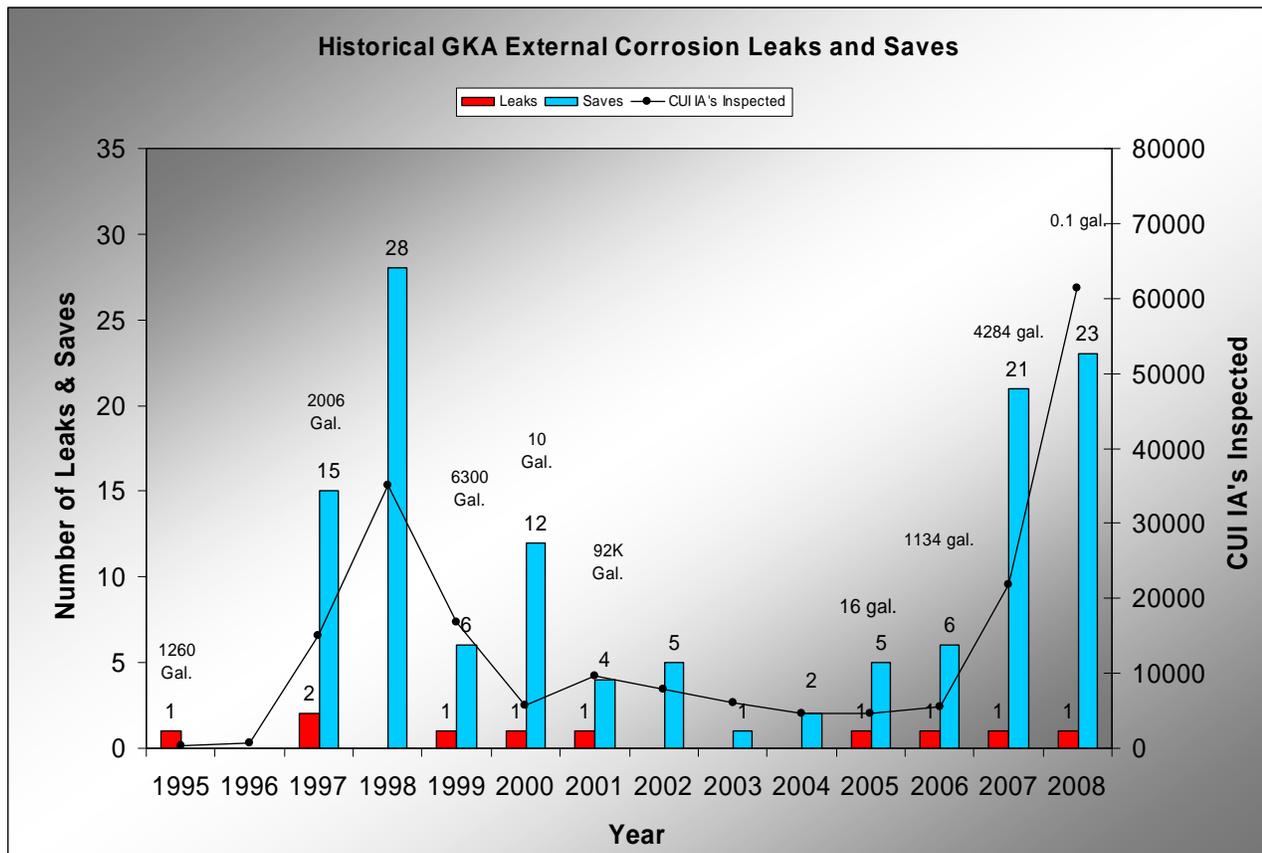
Figure 10. Leaks, saves, number of CUI IA's inspected with TRT, and volumes of leaks by year.

One flow line leak was caused by external corrosion in 2008. The leak occurred on 1YRPO at VSM 675/673 and resulted in a 0.1 gallon spill. The damaged area was identified during the insulation refurbishment process and the location was repaired with a welded pressure-containing sleeve.

- The 1YRPO leaked in September of 2008 because of external corrosion under insulation. The spill volume was determined to be 0.1 gallons of produced crude, some of which contacted the tundra. This spill was reported to ADEC.

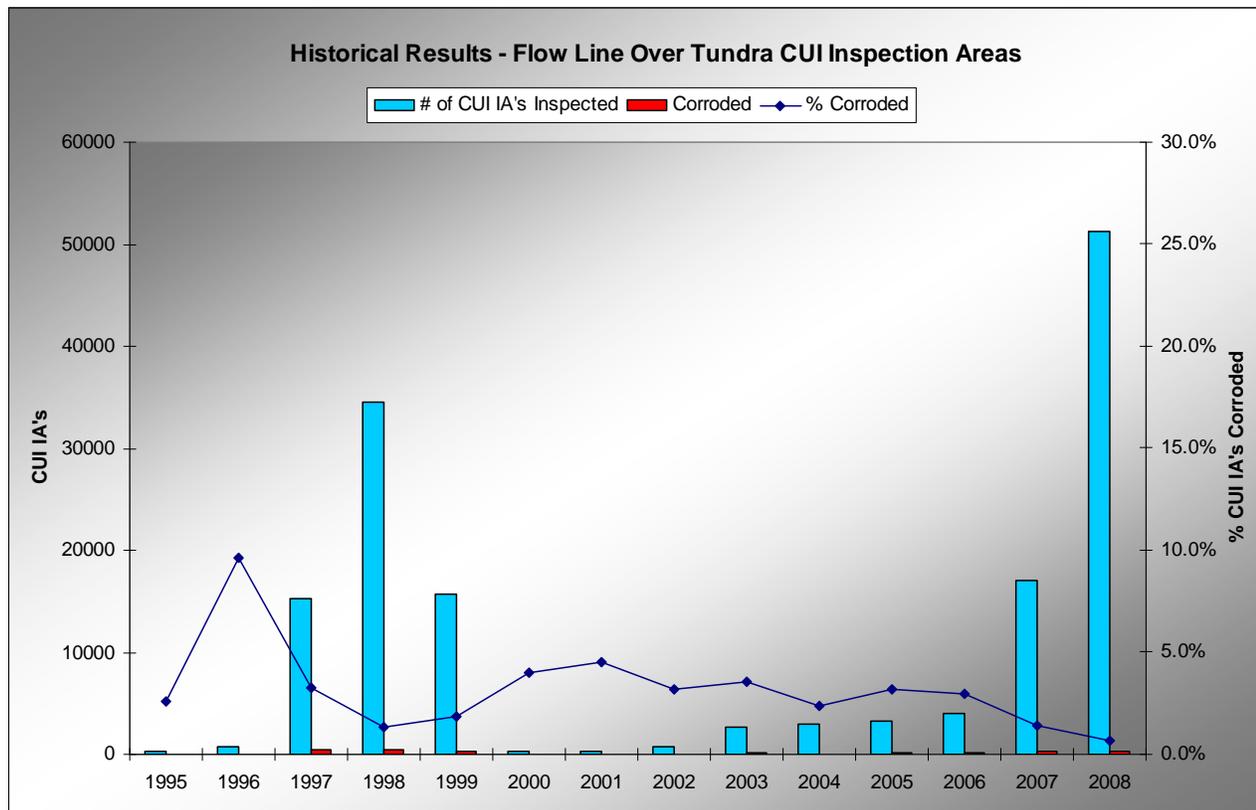
Figure 11. Summary of Flow Line Over-Tundra (off-pad) CUI IA's

Figure 11 illustrates the latest results from the external corrosion inspection program. The 2002 through 2006 values include recur follow-up inspections and clean-up of locations missed or not properly documented during the original base line effort. The increased inspection effort in 2007 and 2008 is representative of our field-wide recur inspection to re-evaluate all locations on a five-year inspection interval. The 2008 data include ILI results on flow lines.

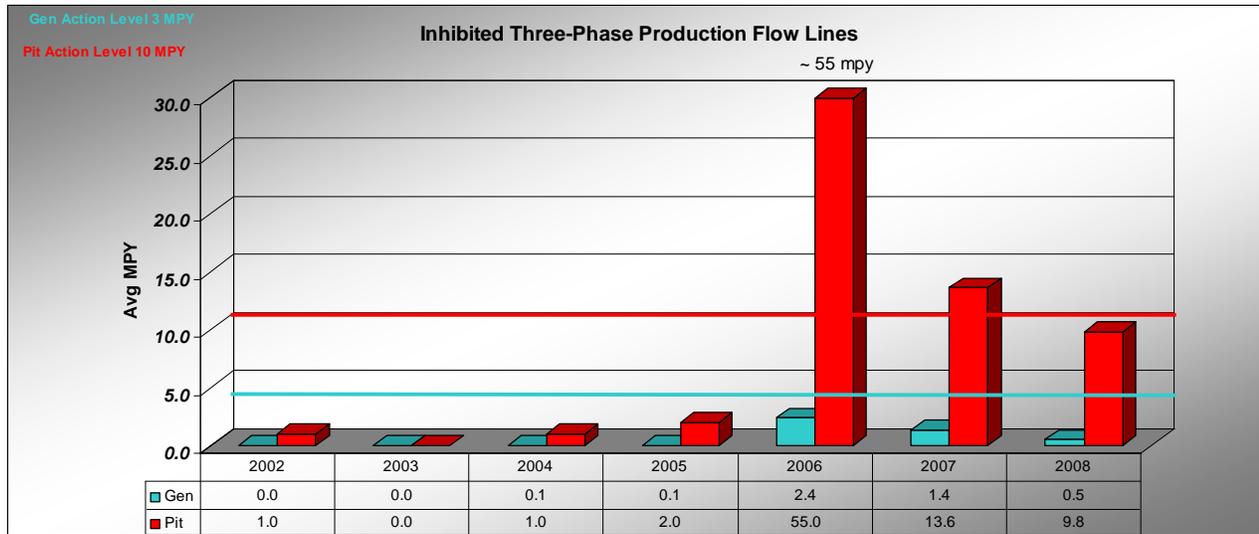
Figure 14. WNS Three-phase Production Flow Line Coupons – general and pitting corrosion rates by year.

Three-phase Production Flow Lines: The monitoring data summarized in Tables 8 and 9 and presented in Figure 14 show that pitting corrosion rates in 2008 are barely below the action level. In response to the coupon and probe corrosion rates, adjustments were made to the CI dosage on the CD2 production line. In addition, a new CI formulation was tested in 2008. Inspection data, discussed in section B.1.b, indicate that significant corrosion damage has not taken place in these lines.

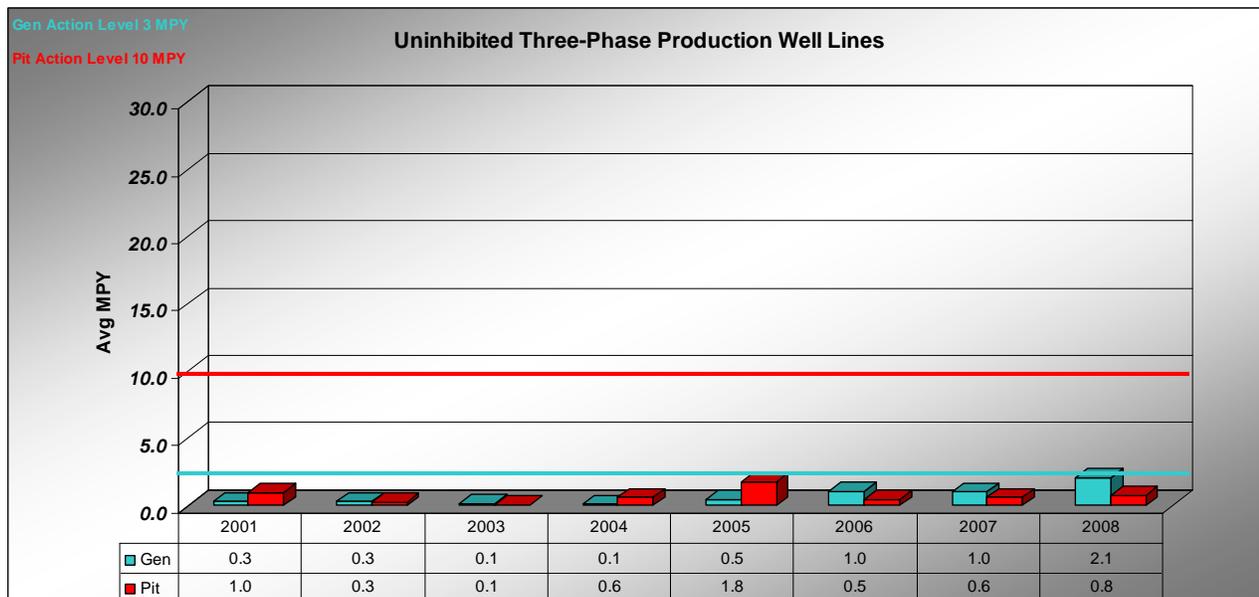
Figure 15. WNS Three-phase Production Well Line Coupons – general and pitting corrosion rates by year.

Three-phase Production Well Lines: The monitoring data summarized in Tables 8 and 9 and presented in Figure 15 show that corrosion rates have not approached action levels in the well lines. Inspection data, discussed in section B.1.a, indicate that significant corrosion damage has not taken place in these lines.

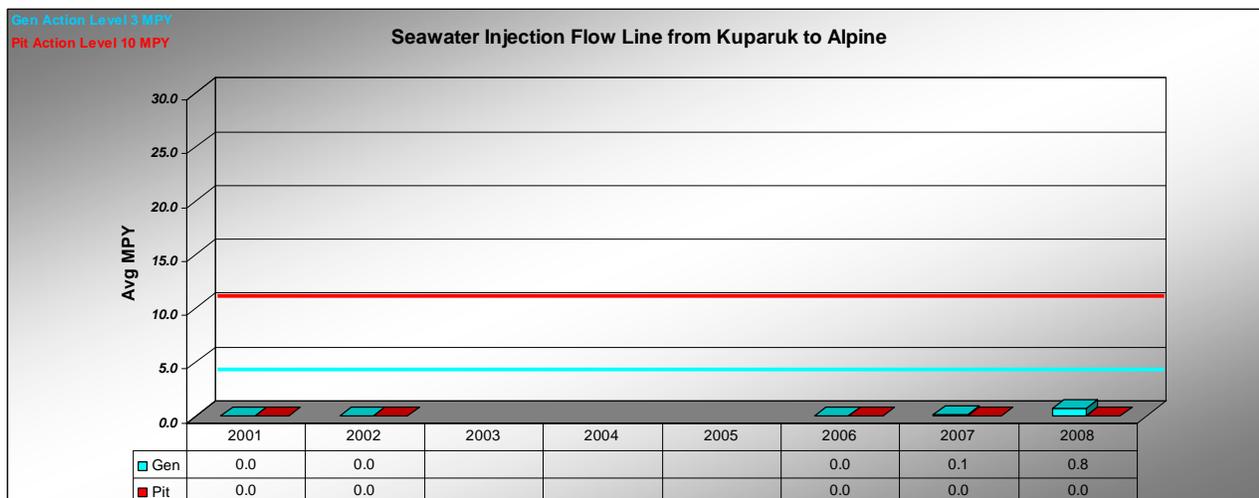
Figure 16. WNS Sea Water Flow Line Coupons – general and pitting corrosion rates by year.

Sea Water Flow Line from Kuparuk to Alpine: The monitoring data summarized in Tables 8 and 9, and presented in Figure 16 above, show the average corrosion rates for the SW flow line coupons. Data collection resumed in 2006 when a coupon fitting was installed to replace the previous location which was obstructed by piping reconfiguration. Average general and pitting corrosion rates for this line are minimal. The biocide treatment at STP is currently three hours at 1000 ppm with weekly maintenance pigging.

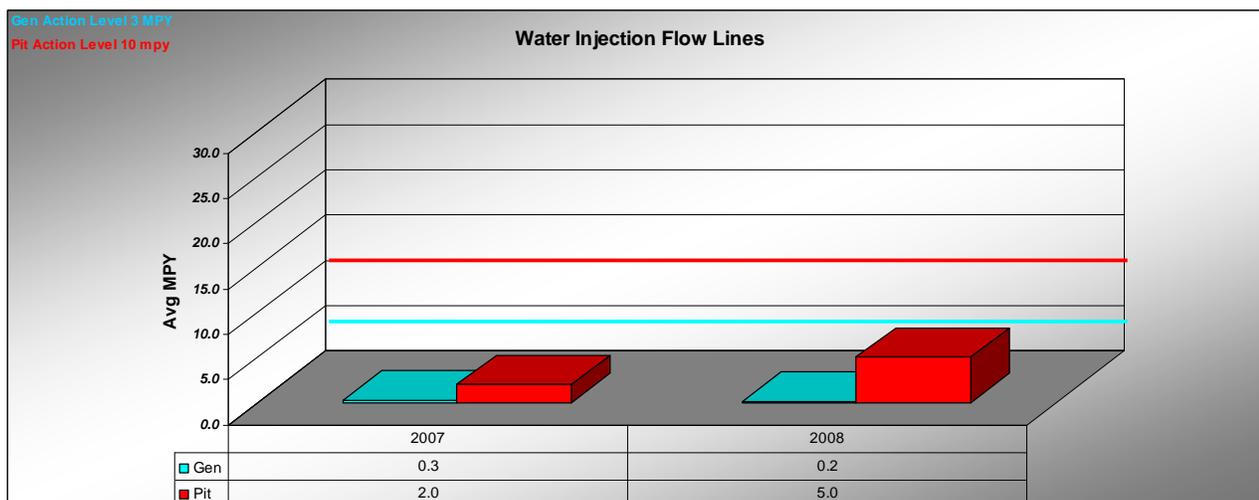
Figure 17. WNS Water Injection Flow Line Coupons – general and pitting corrosion rates by year.

Infield Sea Water Injection Flow lines: The monitoring data summarized in Tables 8 and 9 show the average corrosion rates for the infield WI flow line coupons. In 2007, coupons were installed in WI flow lines as an enhancement to the monitoring program. In previous years, corrosion probes at the outlet of the central facility were used to monitor SW injection system corrosion rates. Average coupon and probe general and pitting corrosion rates for these lines are minimal. Inspection data, discussed in section B.1.b, indicate that significant corrosion damage has not taken place in these lines.

The infield SW lines are treated with a weekly biocide treatment and monthly maintenance pigging. New cleaning pig styles are being tested.

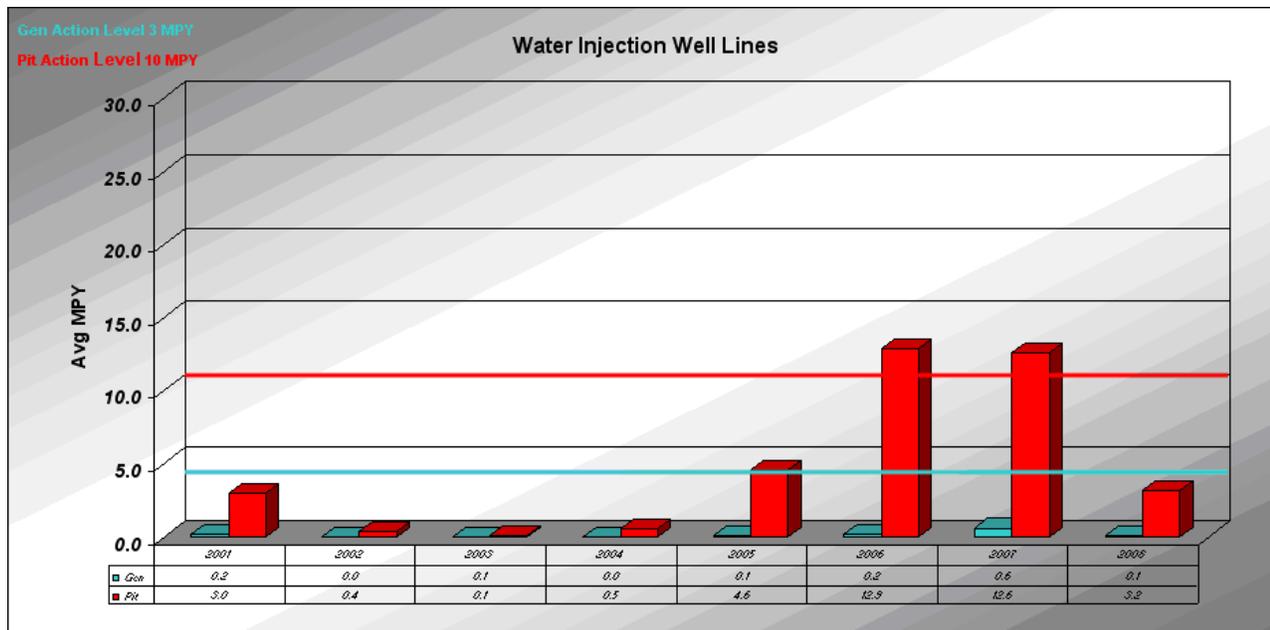
Figure 18. WNS Water Injection Well Line Coupons – general and pitting corrosion rates by year.

Water Injection Well Lines: The monitoring data summarized in Tables 8 and 9 and presented in Figure 18 show that pitting corrosion rates no longer exceed the action level. Inspection data presented in Section B.1.a do not indicate damage in these lines.
