Alaska Dept of Labor & Workforce Development

Office of Pipeline Safety
Research & Special Programs Administration

**JOINT AFTER-ACTION
REPORT
FOR
THE TAPS BULLET HOLE
RESPONSE
(October 2001)**

February 8, 2002

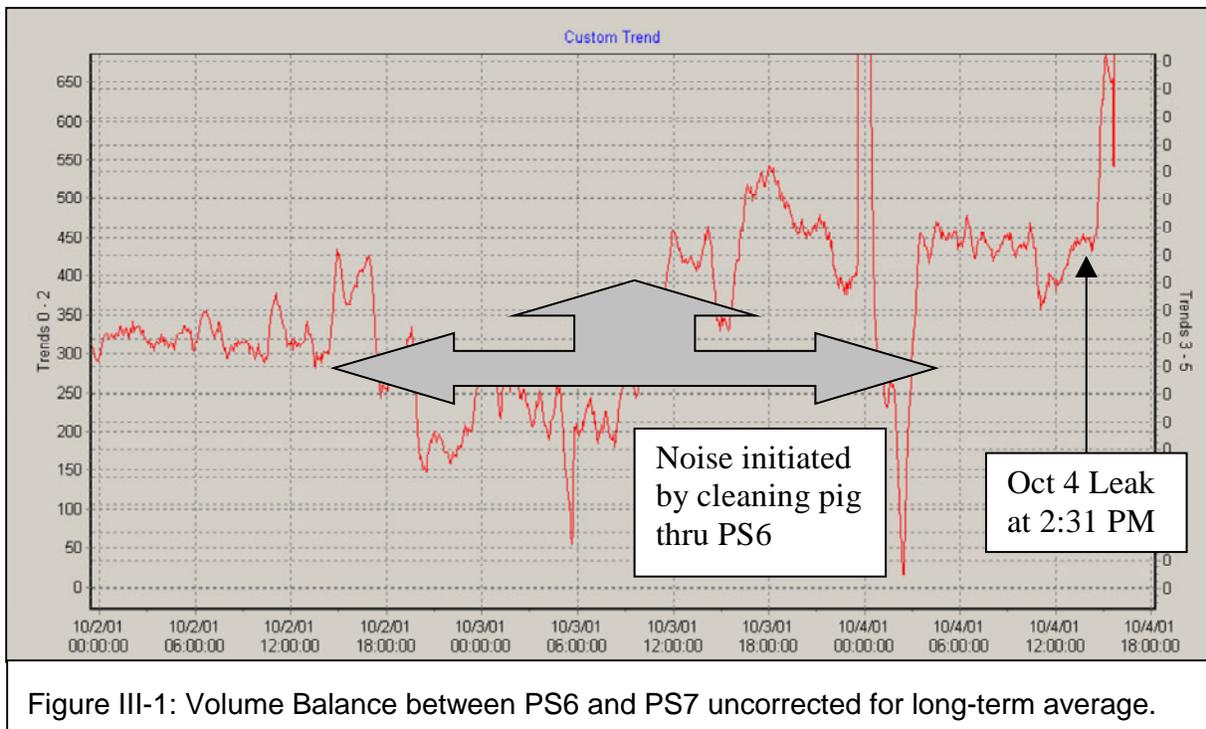
Figure III-1: Volume Balance between PS6 and PS7 uncorrected for long-term average.

APSC has three different leak detection systems in place: 1) Deviation Alarms, 2) Line Volume Balance (LVB) and 3) Transient Volume Balance (TVB). The size of the leak on October 4, 2001 was too small to trigger the Deviation Alarms. The time interval between visual detection and pipeline shutdown was less than the time interval required for LVB to detect and trigger an alarm. The pipeline shutdown was begun within 30 minutes of the onset of the leak. Only the TVB had a theoretical chance of detecting and alarming for a leak of this magnitude in the 30-minute time window between the onset of the leak and pipeline shutdown.

In order to deal with instrument noise, data degradation, and other dynamic operating activities that generate hydraulic transients, the TVB reduces its effective alarm sensitivity for a period of time following such disruptions. This process is called data validation (note: this process is actually a form of statistical analysis to determine the effective alarm sensitivity). Post event analyses shows that the leak was sensed by TVB at 2:44 PM, approximately 13 minutes after the onset of the leak; however, the data validation requirements rejected the event. Figure III-1 clearly shows the initiation of the leak at 2:31 PM. However, it also shows even larger excursions associated with the passage of the cleaning pig through Pump Station 6. The leak would have had to be approximately 350 barrels per hour (BPH) leak rate, to meet the validation conditions existing at 2:44 PM. If the leak had occurred just prior to the pig passage an alarm would have sounded at the pipeline console. Without the leak validation process, the TVB segment between Pump Stations 6 and 7 would have been in an alarm state for much of the time period between October 2, 2001 and October 4, 2001. This time period is associated with the pig passage through this segment and would have been attributed to the flow measurement shift generated by the pigging operation.

Although the TVB did not alarm, it is estimated that LVB would have alarmed within 4 to 10 hours after the start of the leak. The LVB leak detection sensitivity had been reduced earlier in the day by the idling of the North end of the pipeline at 9:58 AM. Prior to this event, the LVB sensitivities were well below the initial 5500 barrels per day (BPD) leak rate caused by the bullet hole.

Recommendation: Continue on-going efforts to improve current systems.

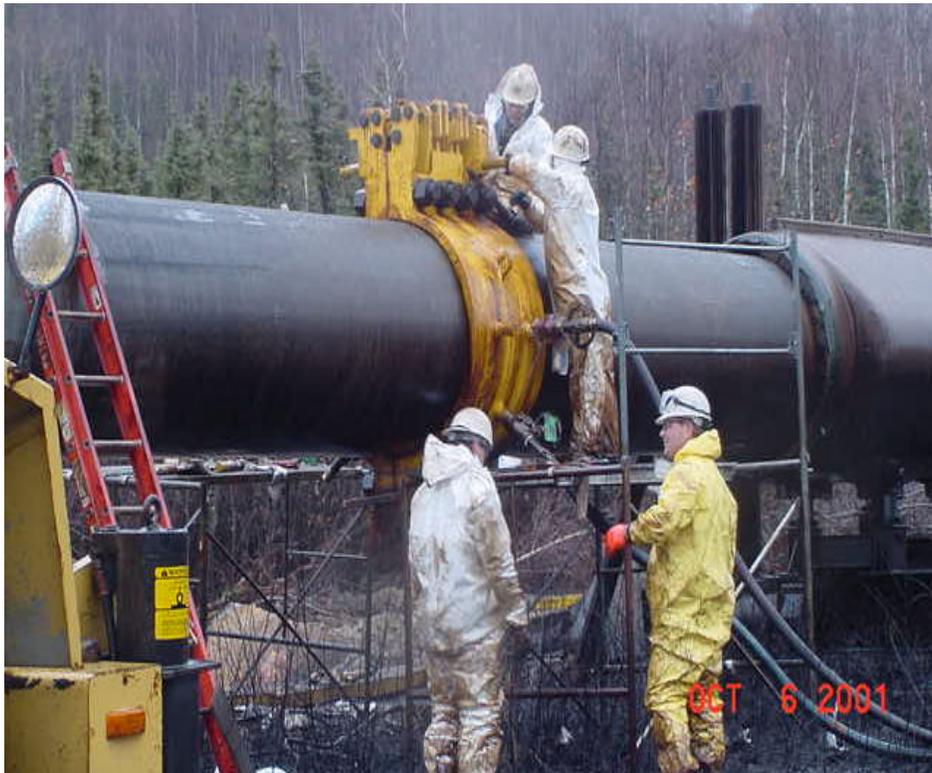
A hydraulic clamp, designed, built and tested for such a leak, was lifted by crane into place within 36 hours after the release. By the next morning, the bullet hole had been permanently plugged, North Slope oil production resumed at the normal pace, and the flow through the pipeline was restored.

Figure IV-1: Response crew installing the hydraulic clamp

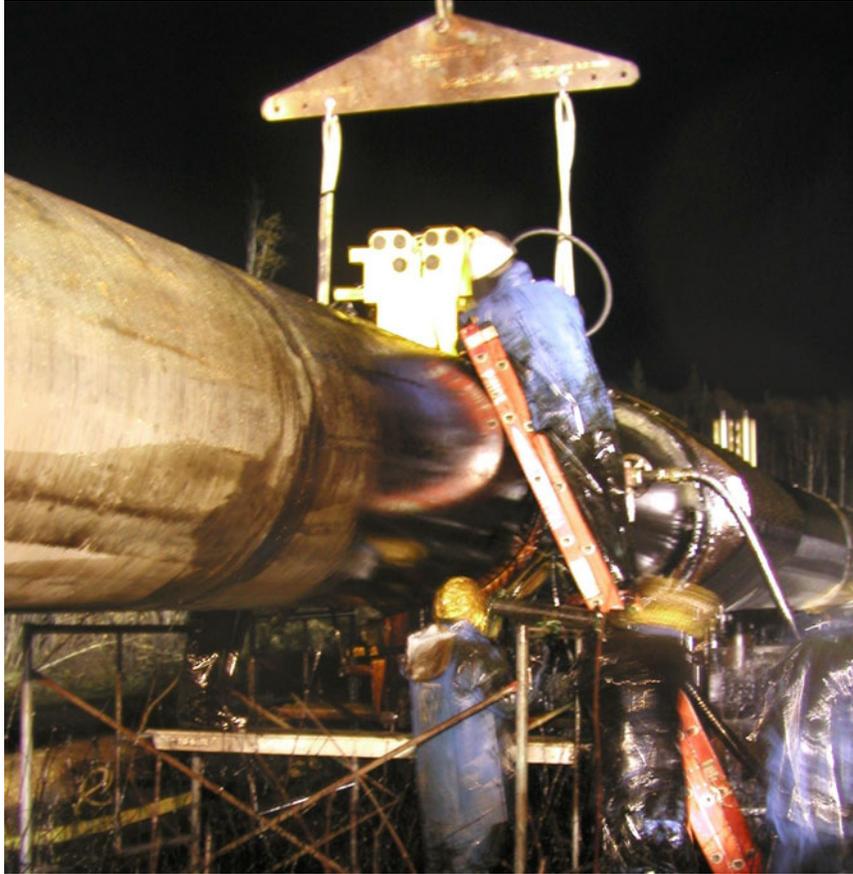
Figure V-1: Workers in protective clothing installing the clamp.

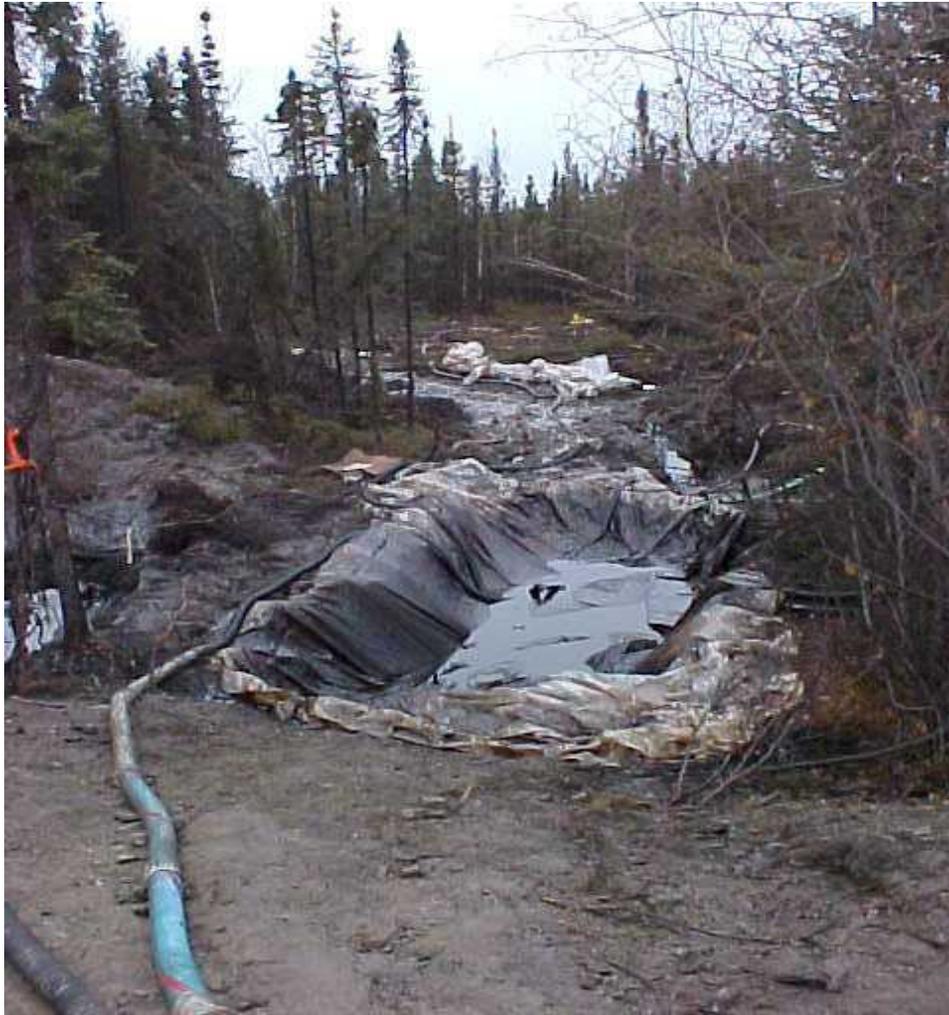
Figure VI-1: Lined containment cell

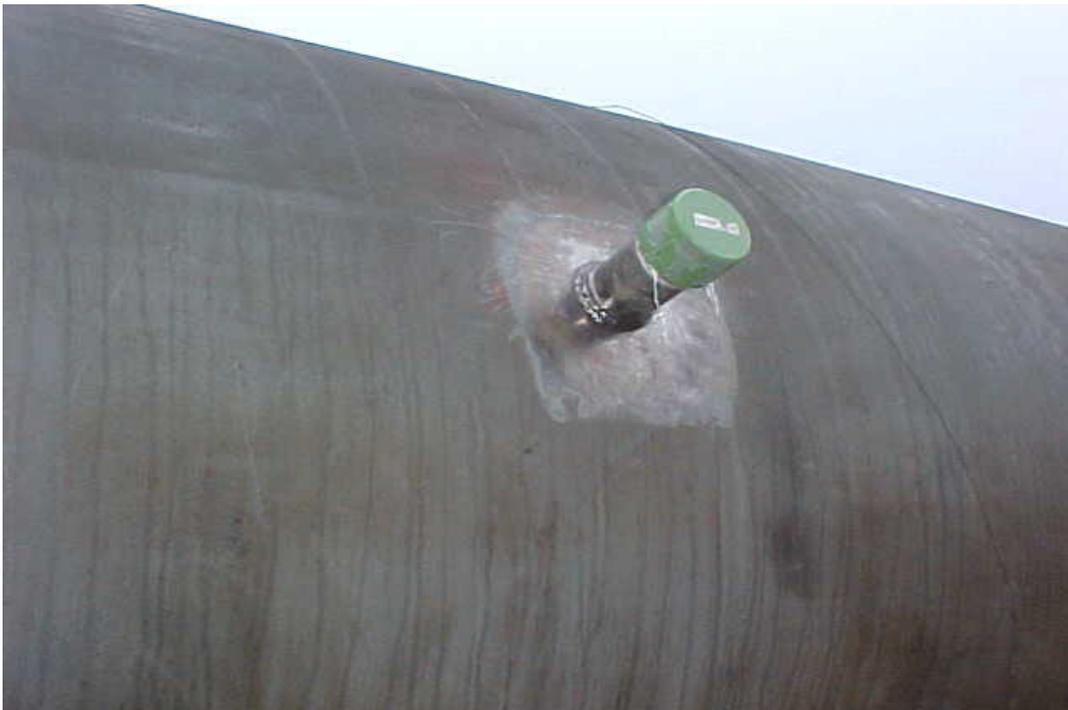
Figure VII-1: Permanent repair (Threaded O-Ring)

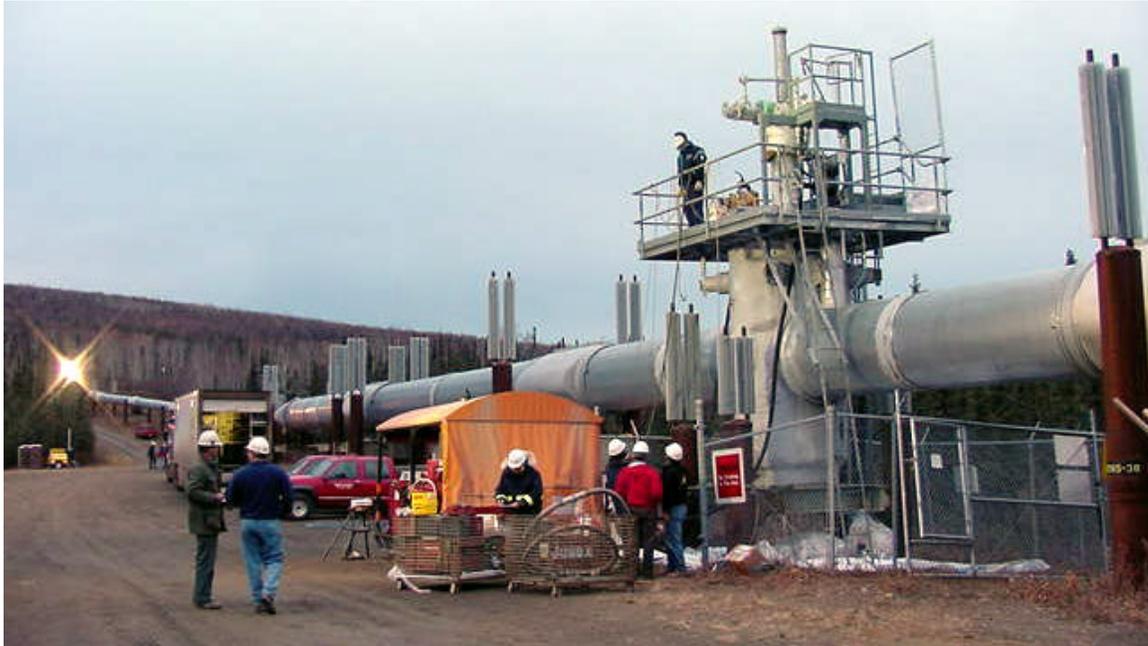
Because of the location of the bullet hole, other techniques were necessary to reduce pressure at the valve. There is currently no mention of the Pump Around Skid that was mobilized at the site and used to reduce the pressure to allow for the application of the clamps.

Figure VIII-1: Alyeska's Pump Around Skid in Operation

Recommendations: Section 1.7.2 of the Cplan should be amended to describe in more detail the considerations and possible consequences should the option to backflow oil to an upstream pump station be taken. The Cplan under this same section should also be amended to include information about the Pump Around Skid as a method of pressure reduction related to source control. Other parts of the plan should identify the personnel required to implement the skid and the appropriate training required.
