**ALASKA DEPARTMENT OF ENVIRONMENTAL CONSERVATION**  
**Division of Spill Prevention and Response**  
**Prevention and Emergency Response Program**

**SITUATION REPORT**

**INCIDENT NAME:** F/V Orcrist

**SITREP #:** 2

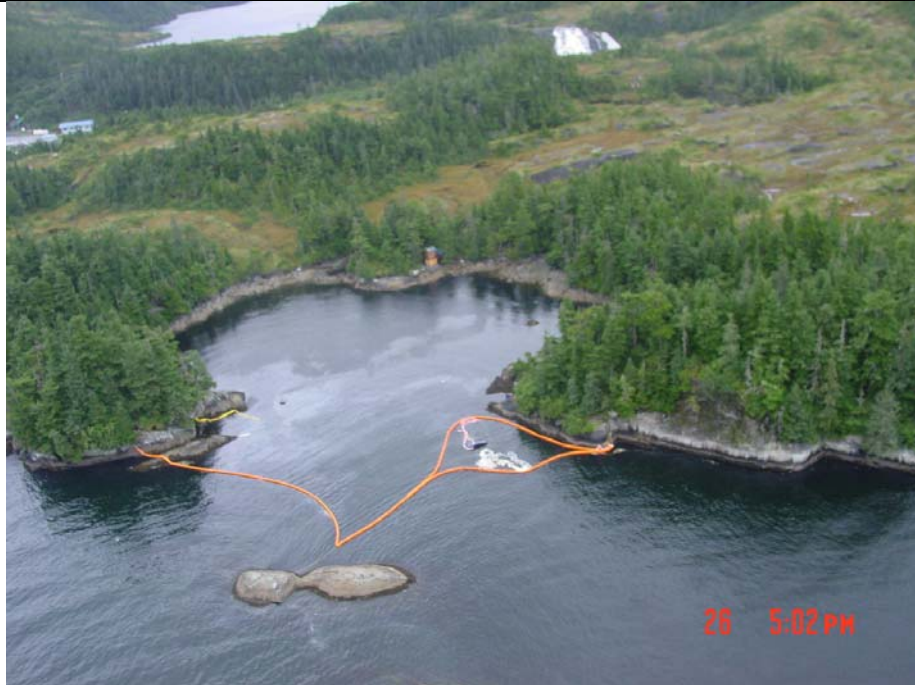
F/V Orchrist stern visible inside loop of orange boom. Lake Bay Hatchery is in the upper left of the photo. ADEC photo
