ALASKA DEPARTMENT OF ENVIRONMENTAL CONSERVATION
Division of Spill Prevention and Response
Prevention Preparedness and Response Program
SITUATION REPORT (SITREP)

BPXA Flow Station 1 Drill Site 2 Well 3 Release

SITREP #: 3

SPILL #: 17399910401

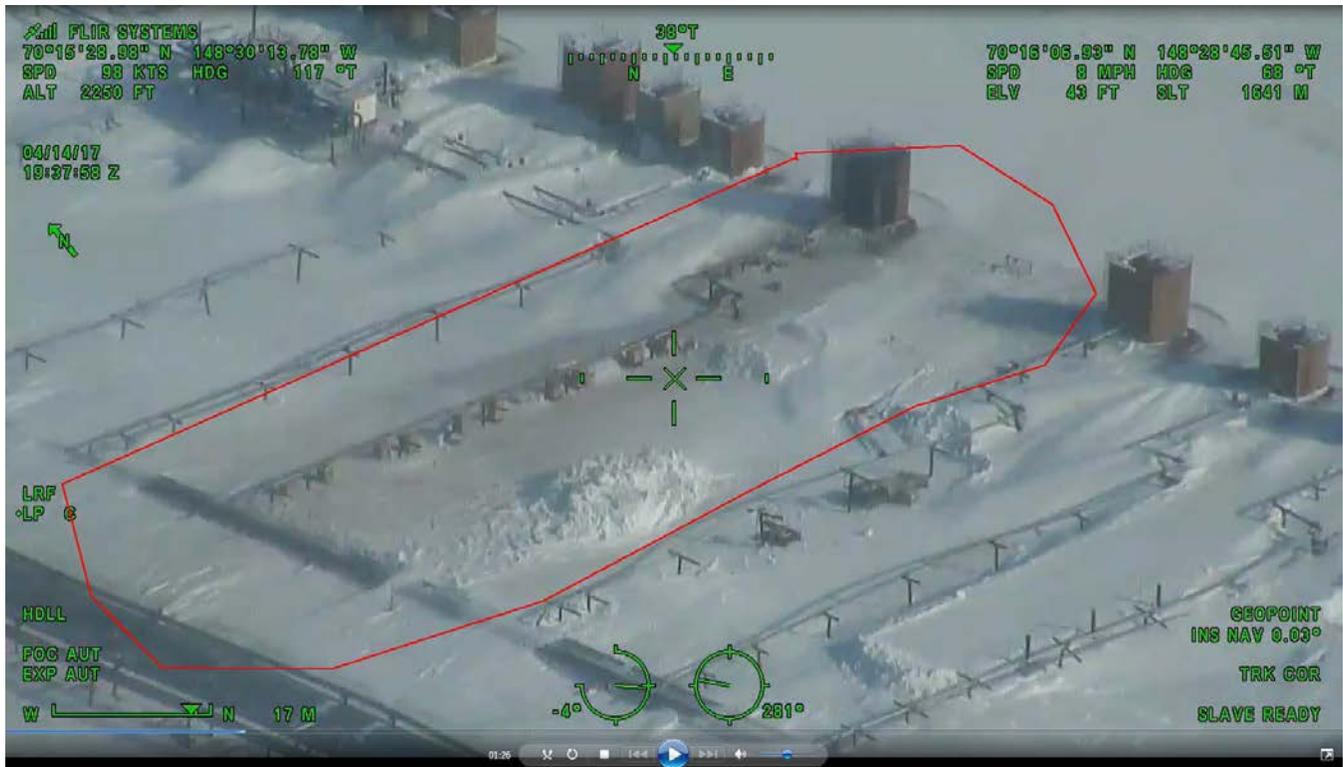
TYPE/AMOUNT OF PRODUCT SPILLED: The well is currently venting gas, which caused **an initial spray of crude oil that impacted** the well pad. **However it is not currently spraying crude oil.** A Forward Looking Infrared (FLIR) overflight shows that the crude spray plume did not leave the pad, however, the situation is not safe yet for responders to access the area and confirm that there have been no impacts to adjacent tundra. No volume estimate for crude spray released is available at this time.

FLIR image from the incident location, taken during an overflight on April 14, 2017. Well 2 and the extent of crude misting is visible on the snow within the red-lined area. [Photo: BPXA]
