December 2014

Excellence. Innovation. Service. Value.  
*Since 1954.*

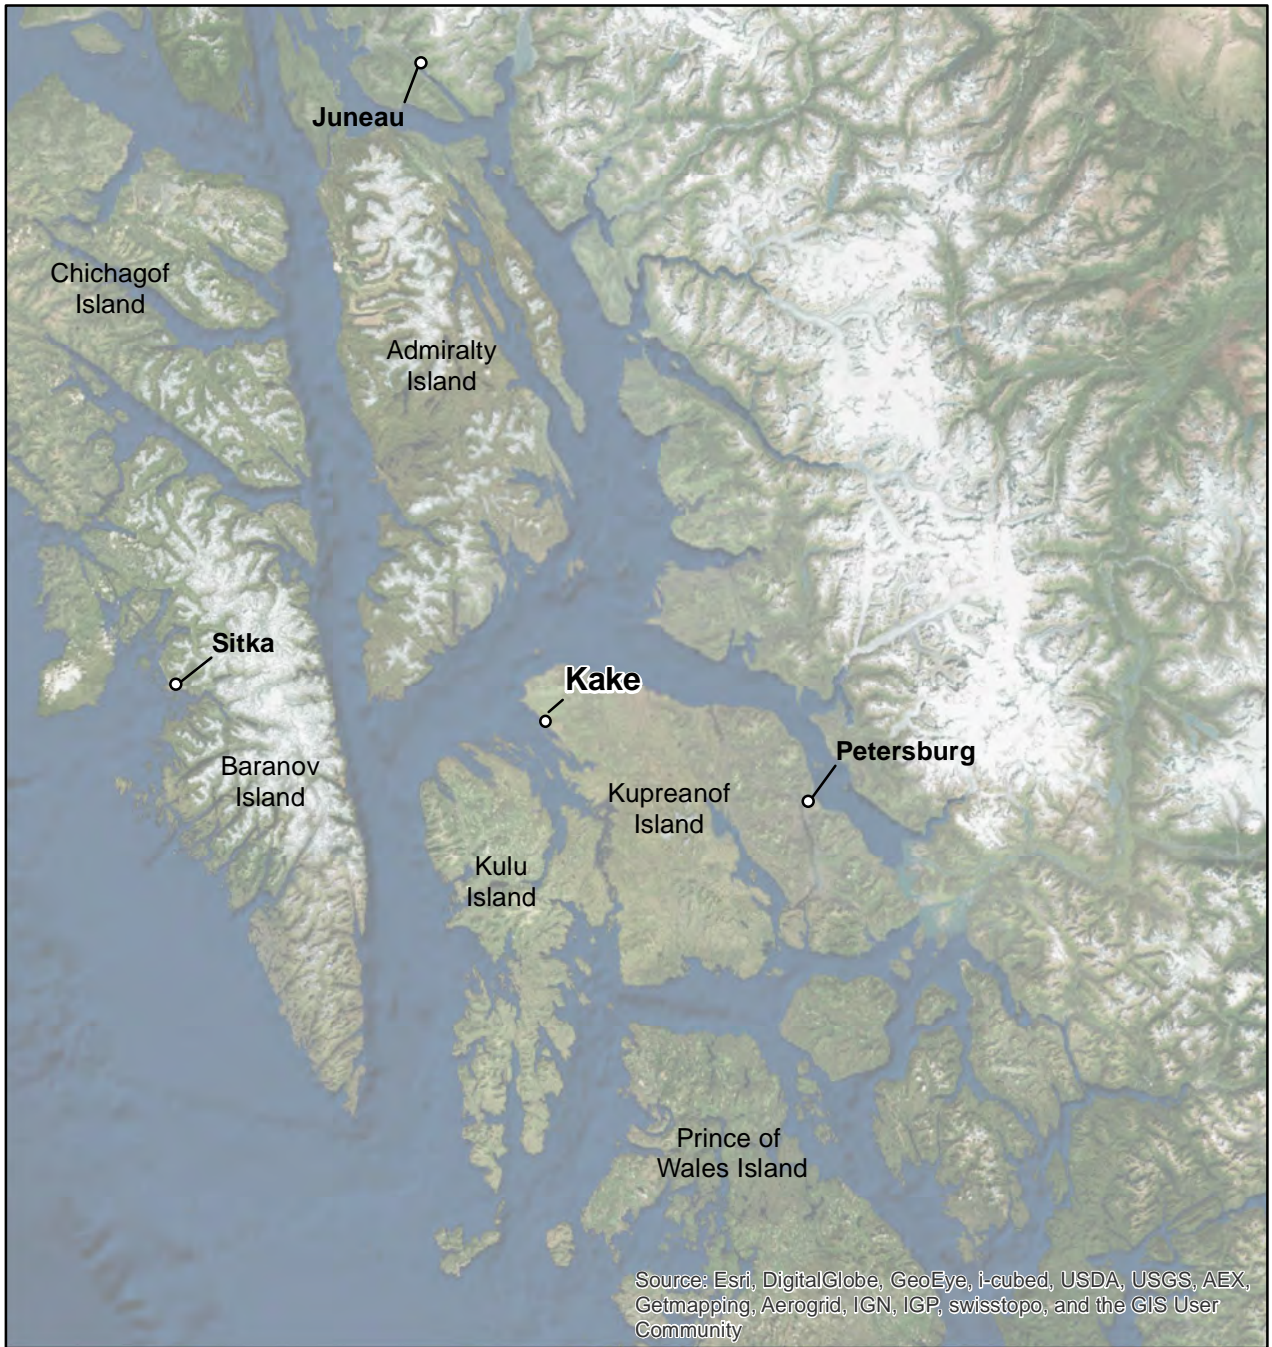
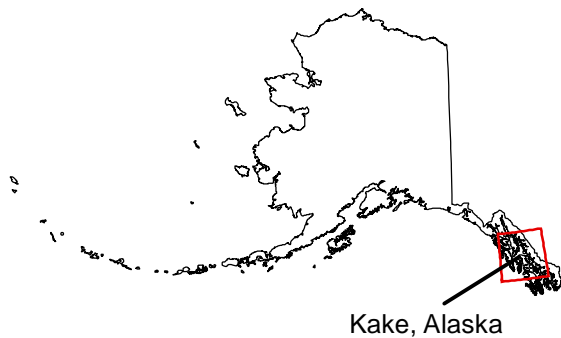
Former Kake Elementary School Kake, Alaska	
<b>VICINITY MAP</b>	
December 2014	32-1-17674

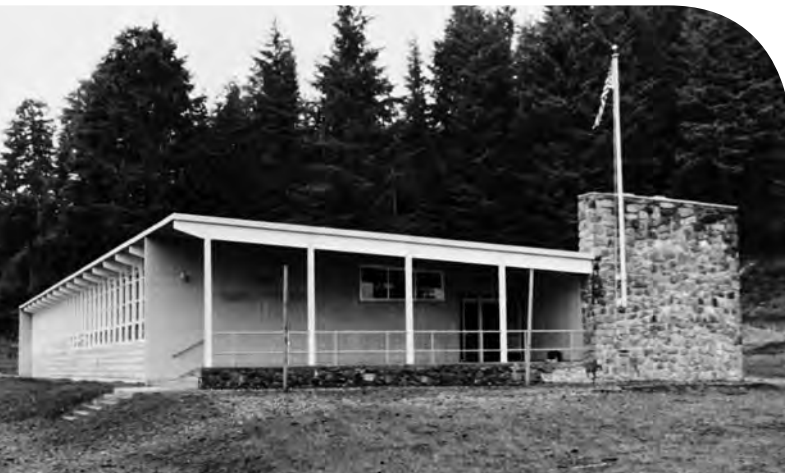
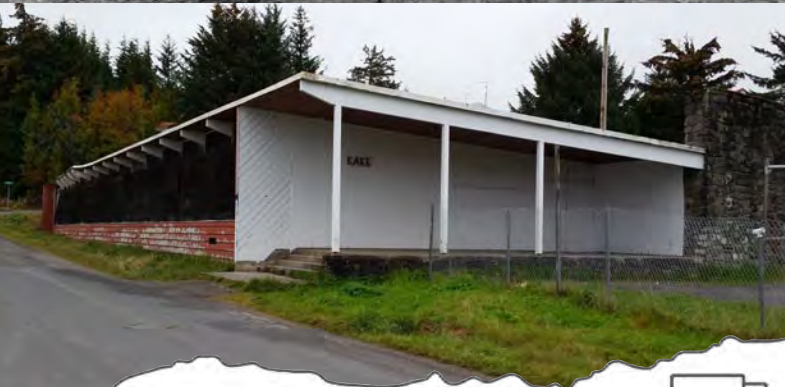
## DETERMINATION OF ELIGIBILITY (DOE) OF THE OLD KAKE ELEMENTARY SCHOOL, LOCATED IN KAKE, ALASKA AND RECOMMENDATIONS FOR ISSUING A SECTION 106 FINDING FOR DEMOLITION AND REDEVELOPMENT

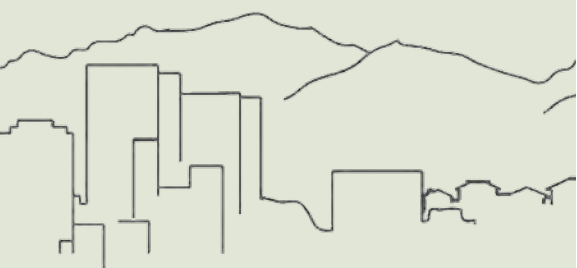
## EXECUTIVE SUMMARY

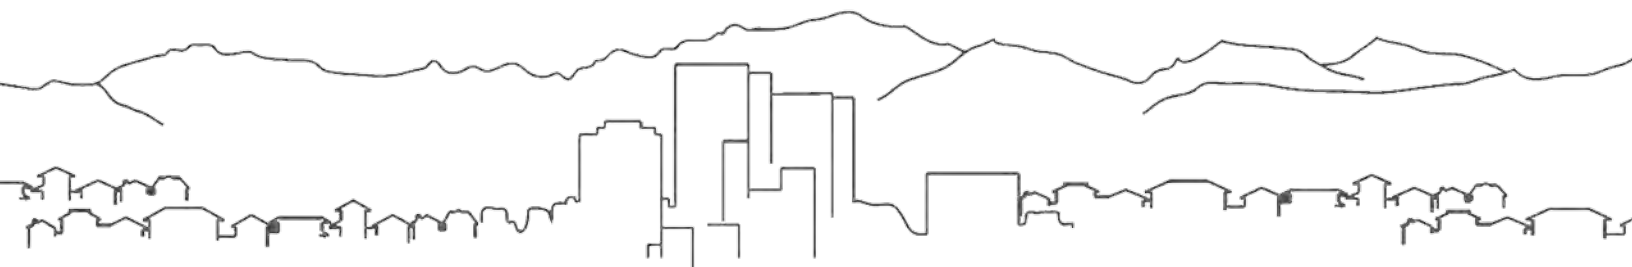
TNSDS initiated its evaluation and assessment by conducting a literature and archival review of previous cultural resources surveys and sites in the area that have been recorded in the Alaska Heritage Resources Survey (AHRIS) database, which was followed by defining a proposed APE and carrying out an intensive survey. Neither the literature and archival review nor the site visit revealed any cultural resources in the project area that constitute historic properties pursuant to Section 106 of the NHPA. As such, a finding of no historic properties affected is recommended for the proposed development of the Old Kake Elementary School.

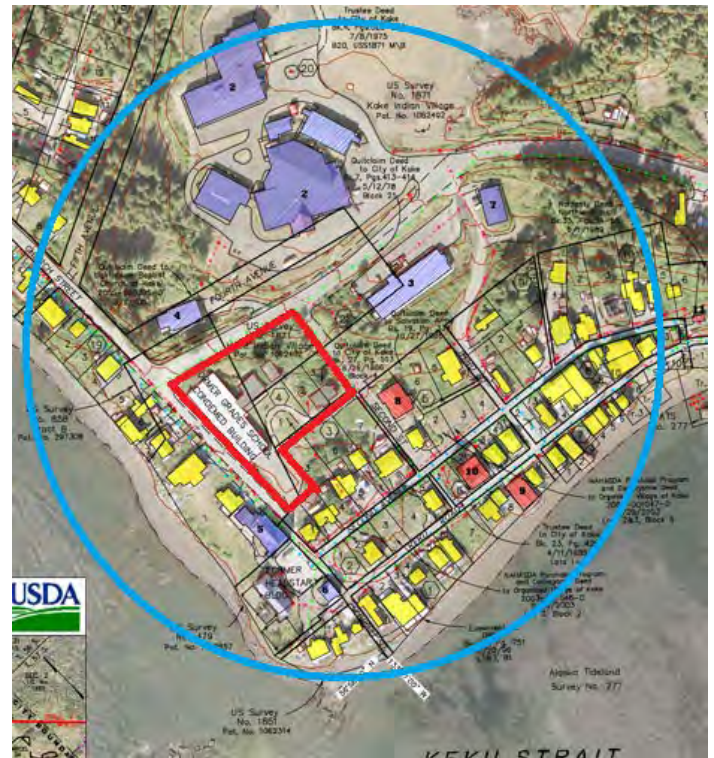
Figure 3. Kake city plat with the direct APE noted in red, indirect APE noted as blue circle.

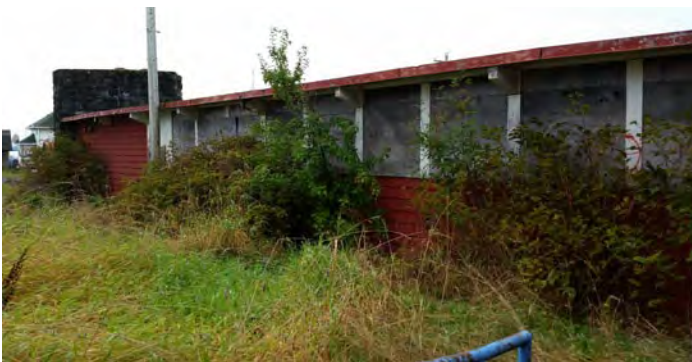
Figure 8. The Old Kake Elementary School, east façade and chimney; note window fenestration (©TNSDS 2014).

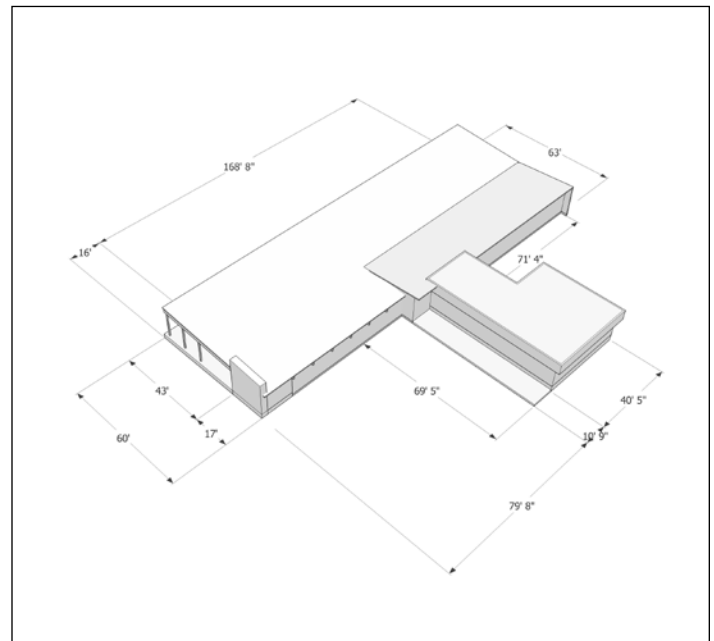
Figure 9. Plan-view of the Old Kake Elementary School with measurements. Shaded areas are additions (© Olberding White Architects 2014).

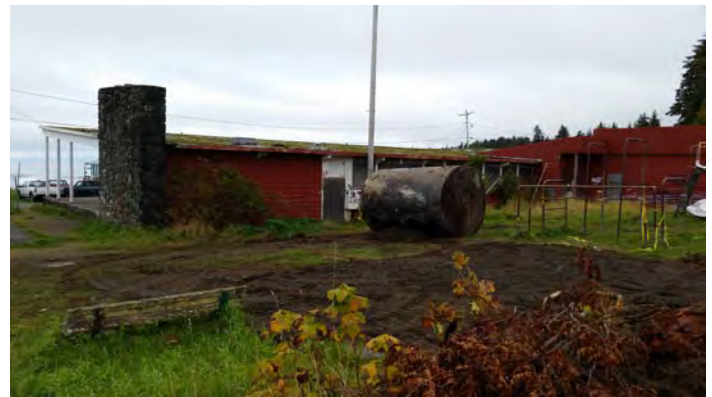
Figure 15. East façade of original building and junction with south façade of second addition, view to the northwest; note partial courtyard with playground (©TNSDS 2014).

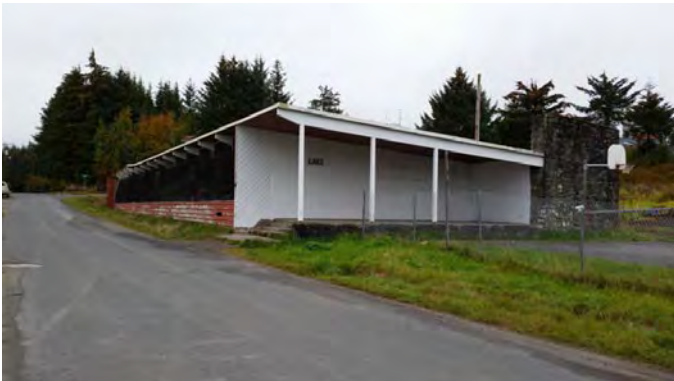
<p>Old Kake Elementary School, south and west facades ©TNSDS 2014.</p>

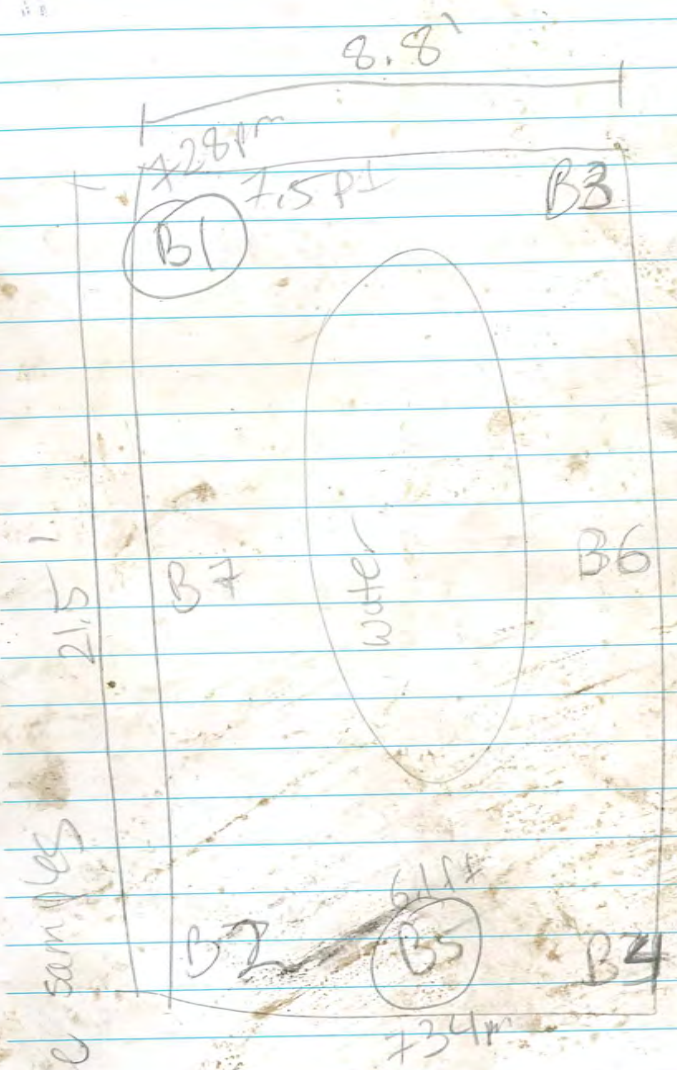
gwe 3.7 ft bags after tank pull on 9/17/14
