Hilcorp Alaska, LLC

**Beluga River Unit Site Characterization and
Groundwater Sampling Work Plan**

June 2021

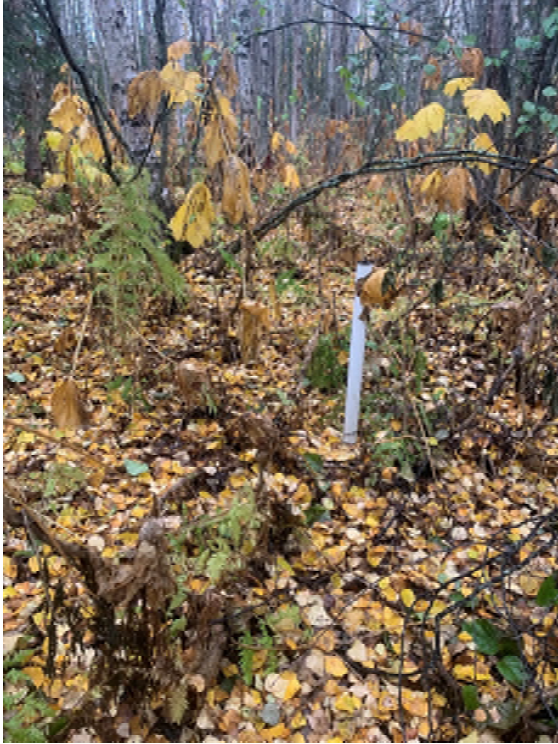
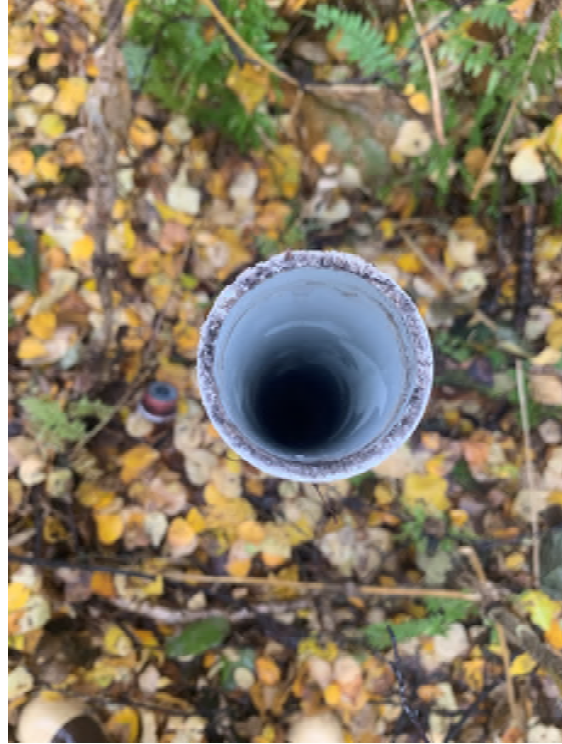
ATF10 surroundings
Facing North

ATF10 Overhead

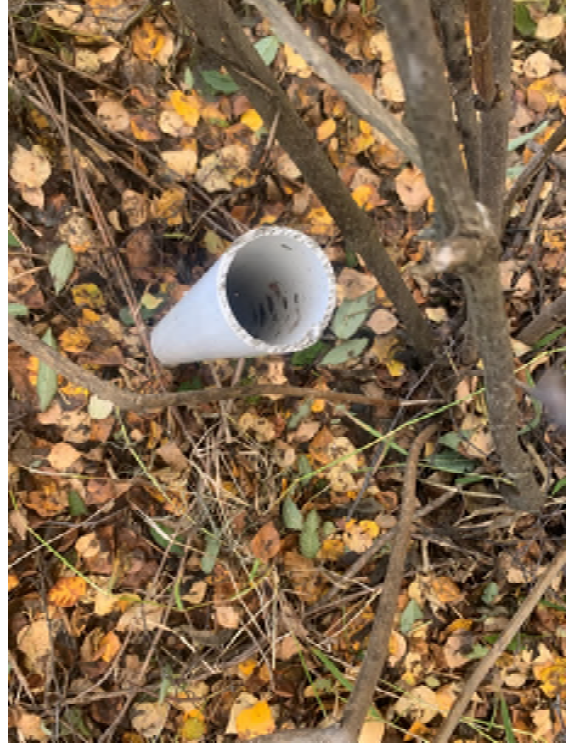
the survey, only one of the priority monitoring wells (HOS-5) was located and found to be in potentially usable condition. This well did not have a cap in place and had a petroleum odor. Accumulation of dirt/debris in this well is possible, which could impact the ability to properly redevelop and collect a groundwater sample from this well. Historically this monitoring well had the highest benzene concentration at the site and, if usable, shall be used to assess the potential for contamination remaining onsite. Monitoring well HOS-11 is not a priority well and was located cross gradient to HOS-05. This well was not assessed during the 2019 survey and its current condition is unknown. The field team will attempt to locate the HOS-11 and if found will collect a groundwater sample at this location as well.

HOS-5	Former Beluga River Tank Farm (P&S Yard)	yes	stick up	no	no	no	No outer casing, crooked (frost jacked/pushed)	No obstruction	12.85	2.05	18.2	Odor present
HOS-6	Former Beluga River Tank Farm (P&S Yard)	no	N/A	N/A	N/A	N/A	N/A	N/A	N/A	N/A	N/A	
HOS-9	Former Beluga River Tank Farm (P&S Yard)	no	N/A	N/A	N/A	N/A	N/A	N/A	N/A	N/A	N/A	
HOS-10	Former Beluga River Tank Farm (P&S Yard)	no	N/A	N/A	N/A	N/A	N/A	N/A	N/A	N/A	N/A	
HOS-13	Former Beluga River Tank Farm (P&S Yard)	no	N/A	N/A	N/A	N/A	N/A	N/A	N/A	N/A	N/A

Assumed former location/remains of HOS-5
Facing East

HOS-5 surrounds
Facing North

Closeup/overhead of HOS-5

If contaminated groundwater is found in monitoring well HOS-5, then an additional well located further downgradient (Figure A-7) will be installed, developed, and sampled to determine the extent of groundwater contamination since the last round of sampling. Samples will be analyzed for DRO, GRO, and BTEX. The location(s) of any additional monitoring wells will be based on the results of the initial groundwater sampling. Additional monitoring well installation will be conducted during a second mobilization to the site.

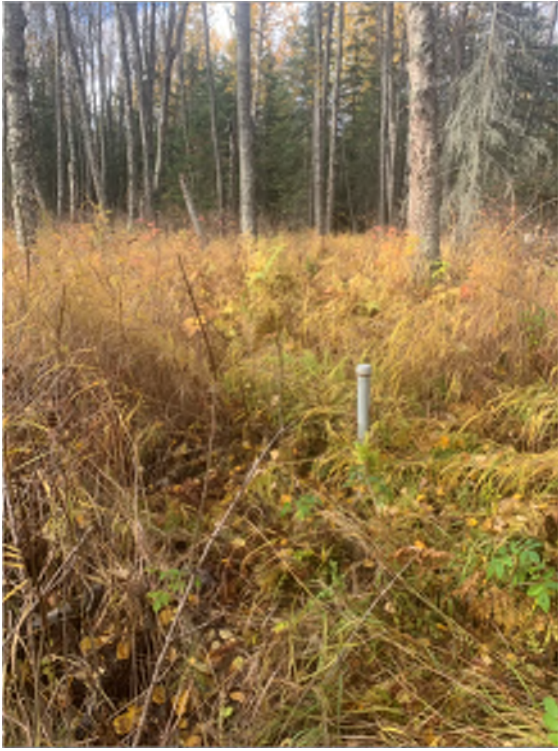
FG-25 surroundings
Facing roughly North

FG-25 Closeup
