**FINAL
Limited Site Assessment and
Hazardous Building Materials Survey
Former Arctic Village Power Plant
Arctic Village, Alaska**

April 2017

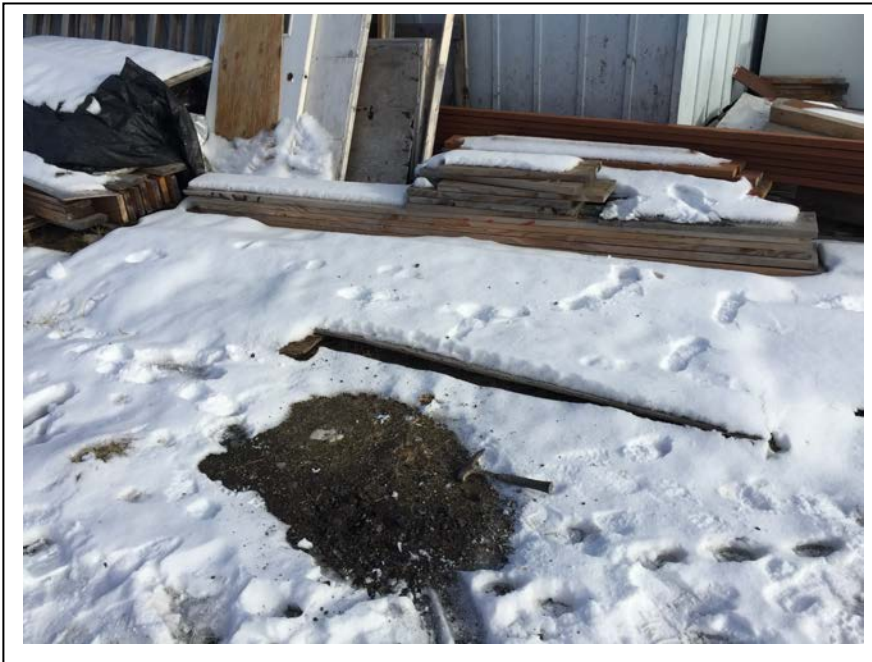
Photograph 3: Potential staining and the location of Sample SS1.
(September 22, 2015)

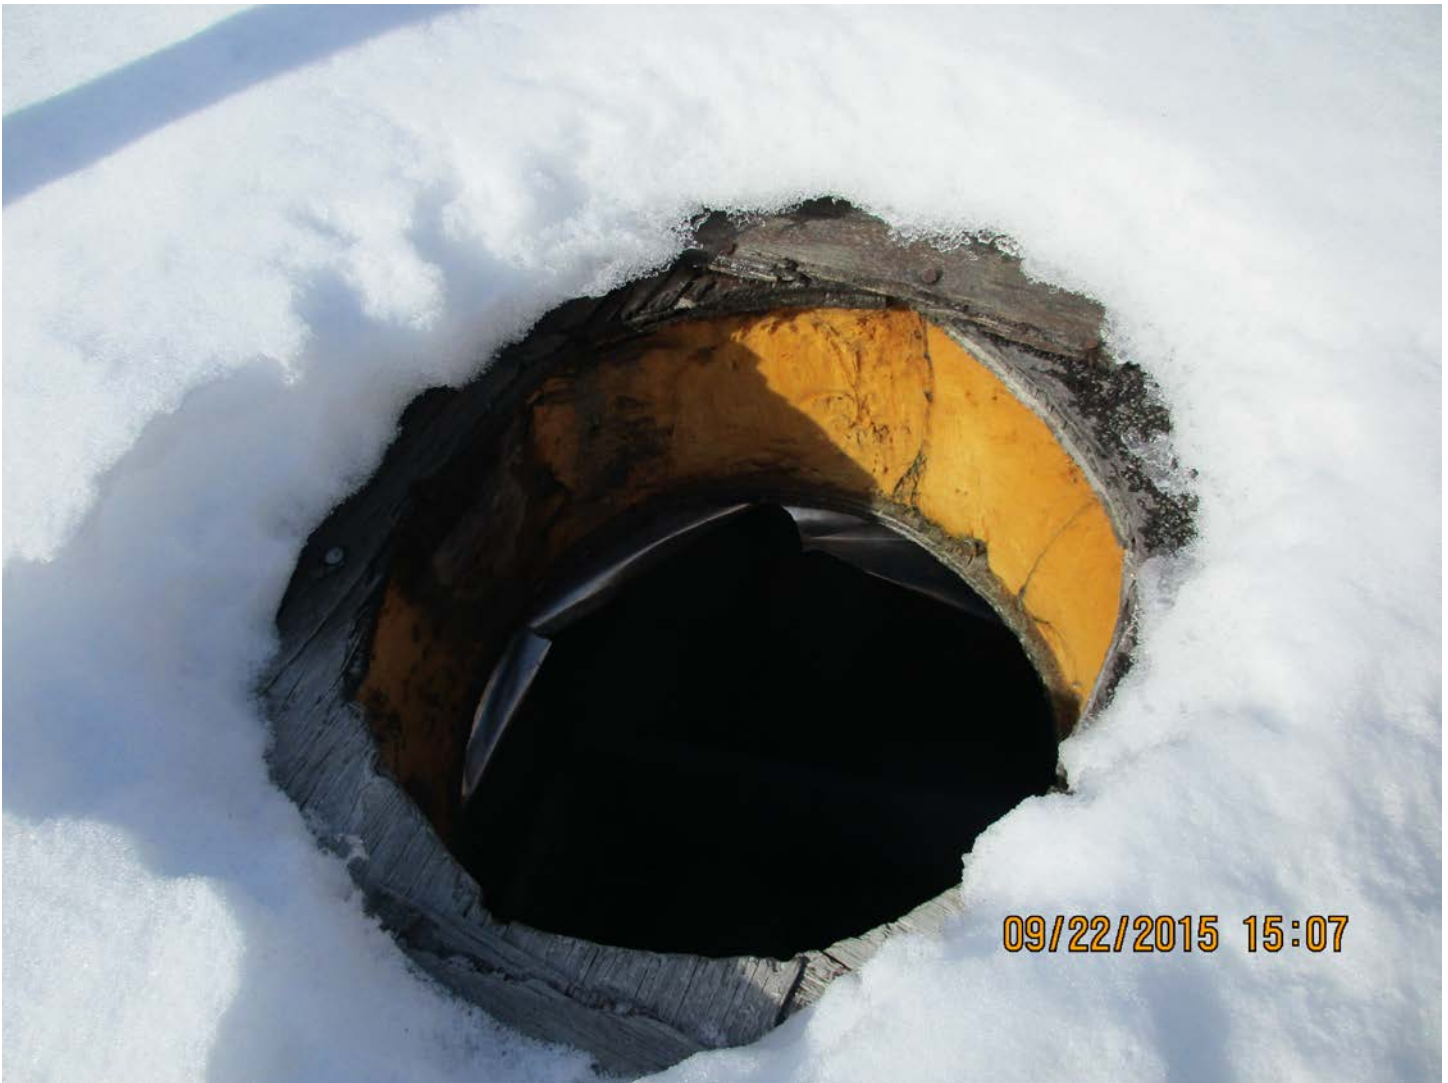
Figure 9 – Missing roof flashing directly above the mechanical room.
