FIRST CERCLA FIVE-YEAR REVIEW FOR SITE SS001 AND SECOND CERCLA FIVE-YEAR REVIEW FOR SITE SS003 AT THE NORTH RIVER RADIO RELAY STATION UNALAKLEET, ALASKA

Final December 2021

United States Air Force Joint Base Elmendorf-Richardson, Alaska

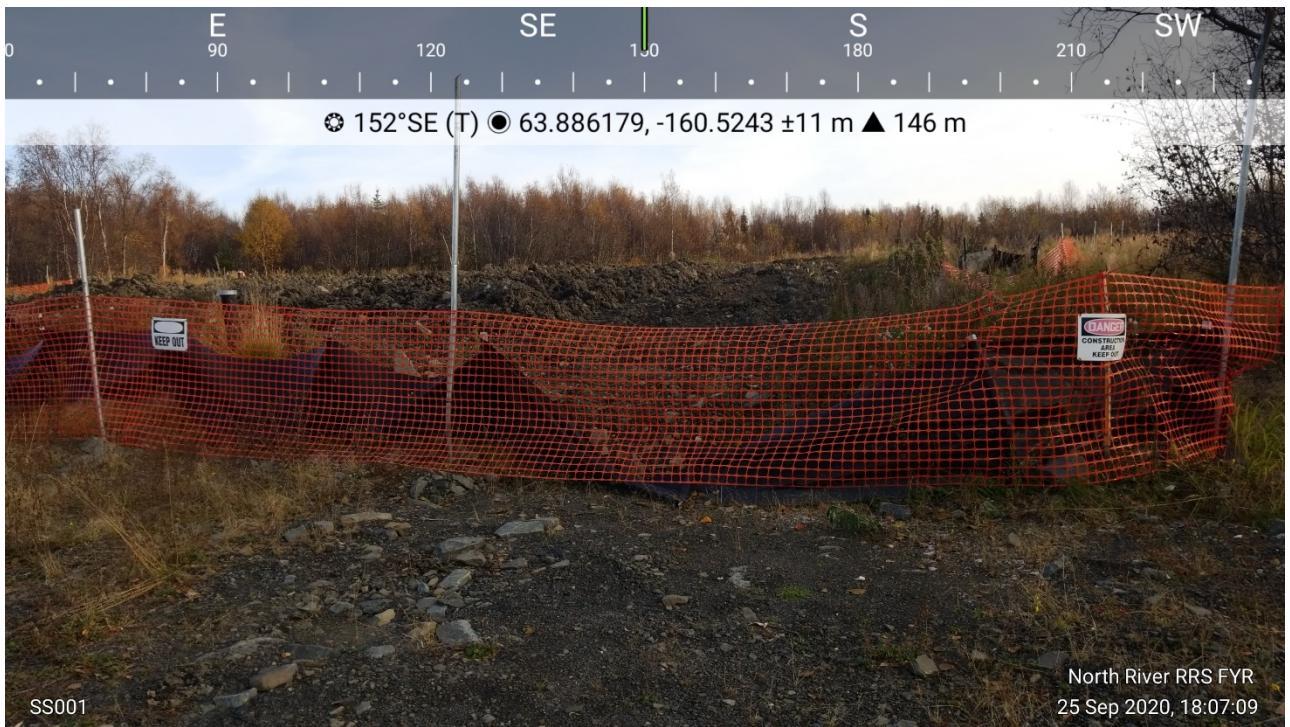
Site SS001 – Construction fencing with general warning signage in front of the Site SO001 soils being landfarmed on the surface of Site SS001.

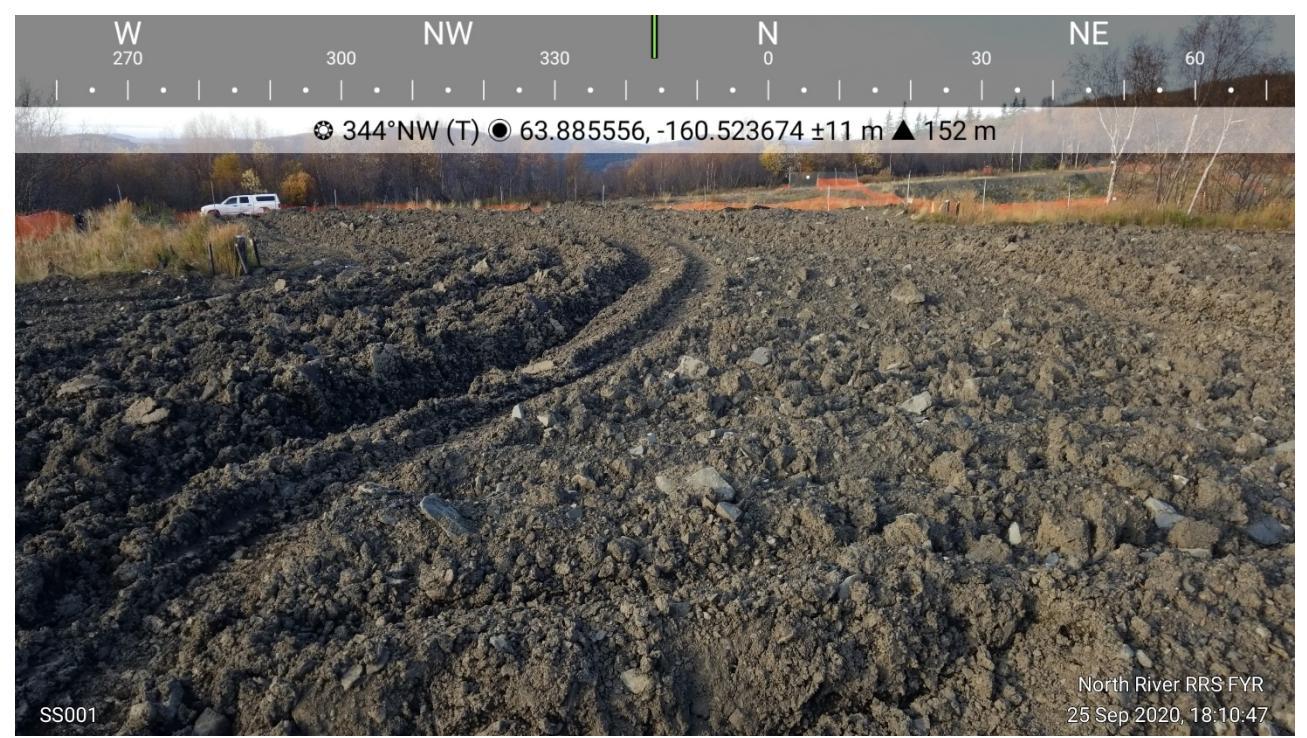
Site SS001 – Soils from Site SO001 being landfarmed on the surface of Site ST001.

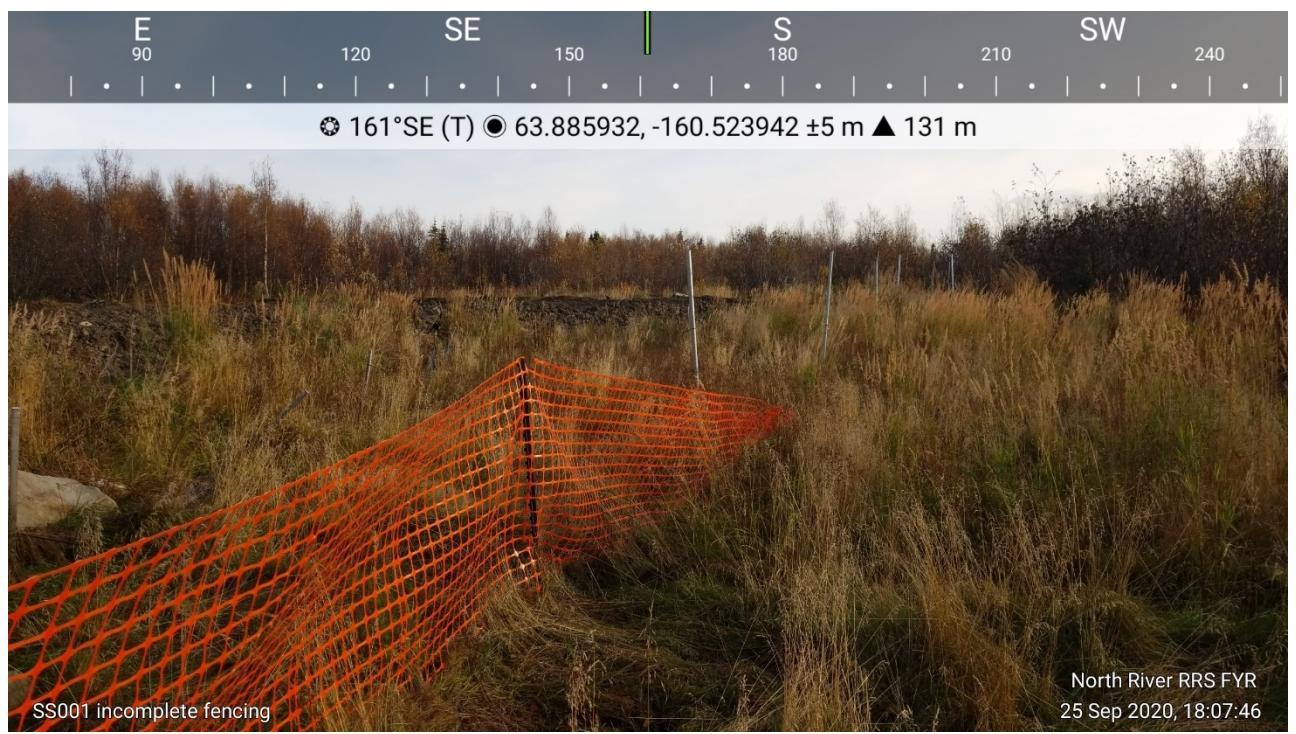
The surface of SS001 is currently being used for landfarm treatment of soil from Site SO001. The landfarm area had orange plastic construction fencing on the northwestern, southwestern, and northeastern perimeters. The fence was ripped and stretched in multiple locations. The only signage present was attached to the construction fence outlining "Keep Out" and "Danger Construction Area Keep Out". The landfarming activities encompass the capped area of Site SS001. There was no observed evidence that soil disturbance work, other than tilling of the soil being landfarmed, has occurred that would disturb the SS001 cover. Vegetation growth is occurring along the perimeter of the soil being landfarmed. An exterior inspection of monitoring wells at SS001 did not indicate any damage and the well lids were locked.

Site SS001 – Incomplete fencing around the site.

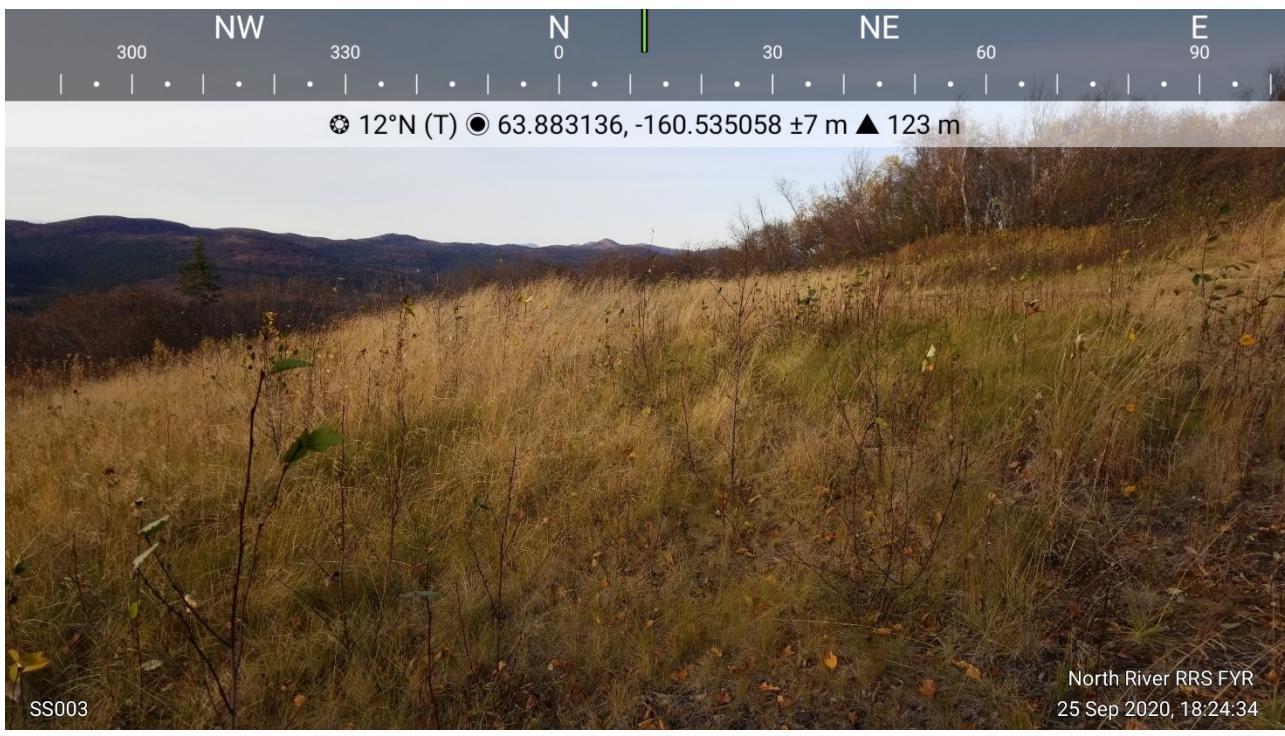
Site SS003 – Vegetation growing over the capped area.

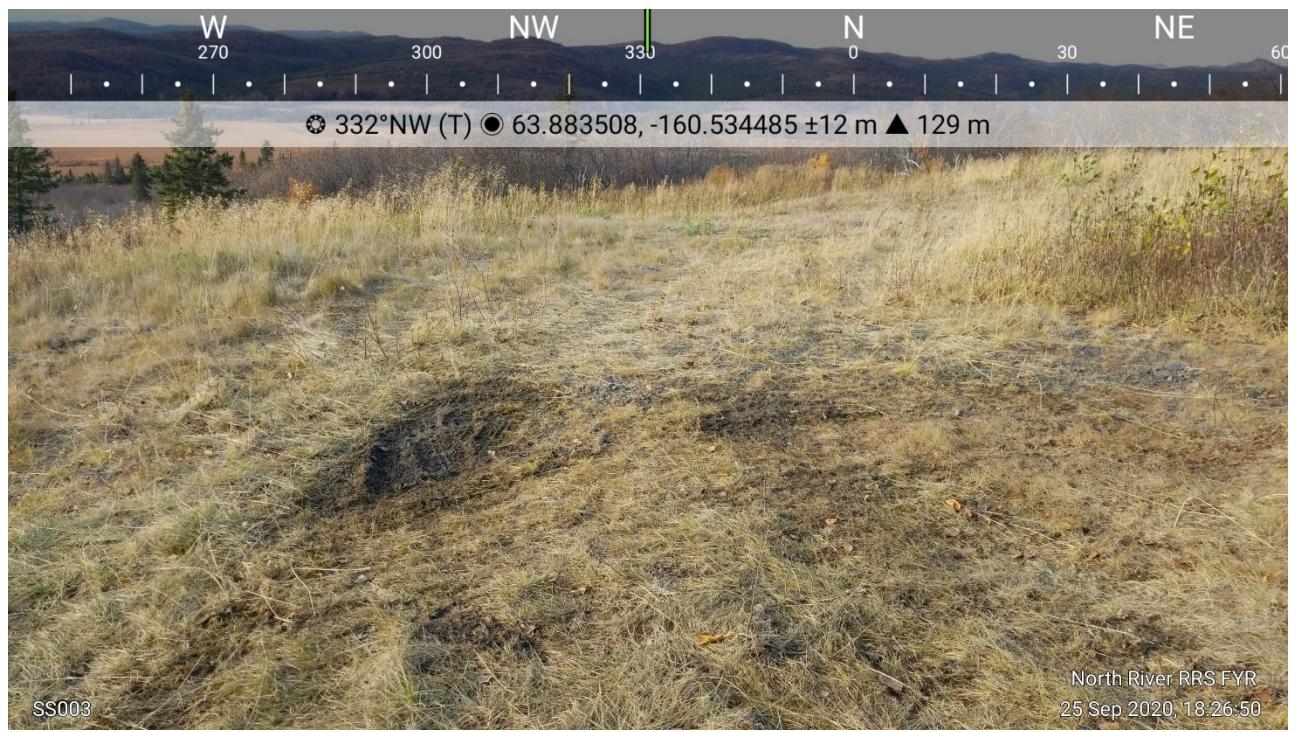
Site SS003 – Tire marks on the vegetative cover.

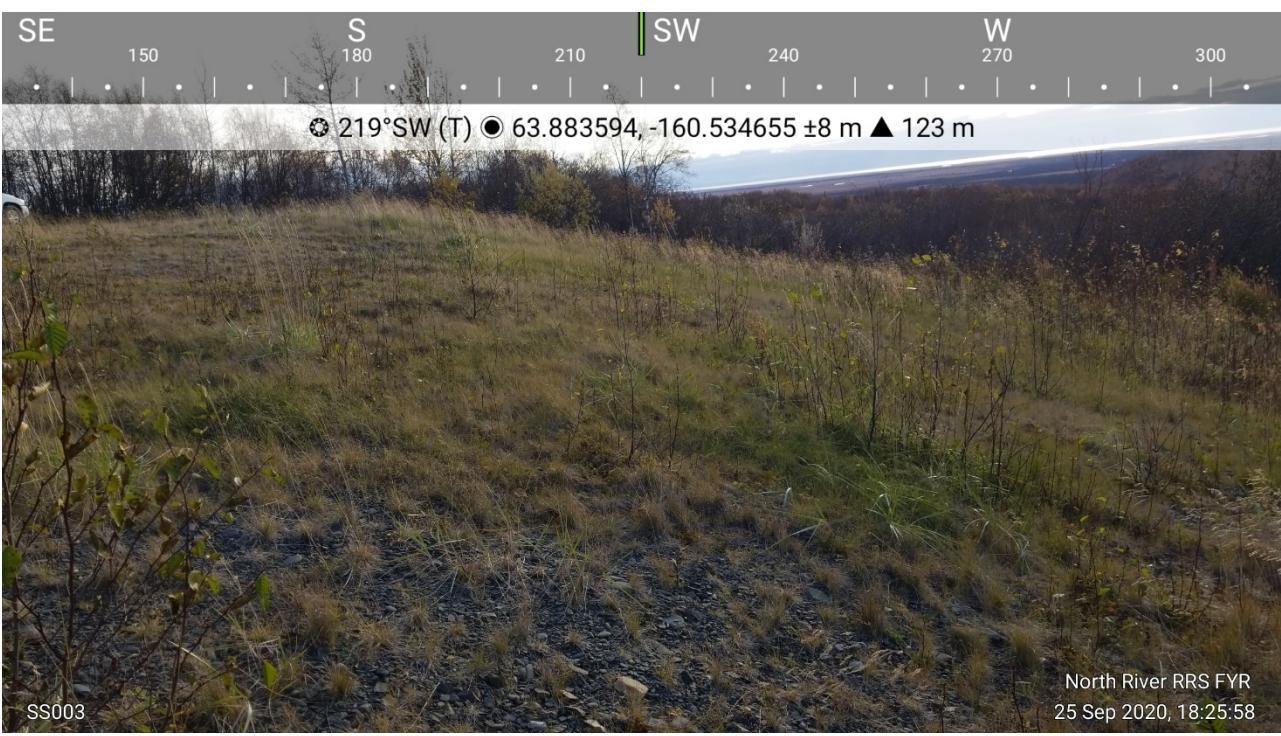
Site SS003 is an open area with vegetation throughout. There was no signage present indicating the presence of SS003. There were patches of limited vegetation where the surface was primarily aggregate, however, grasses and brushes were growing on the aggregate. There were vehicular tire marks on the cover and limited rutting of the immediate surface soil. There was no observed evidence that soil disturbance has occurred that would disturb the Site SS003 cover and no erosion was observed.

Site SS003 – Vegetation is limited in some areas, but appears to be infilling.
