Salt Chuck Mine and Mill Area Prince of Wales Island, Alaska

History

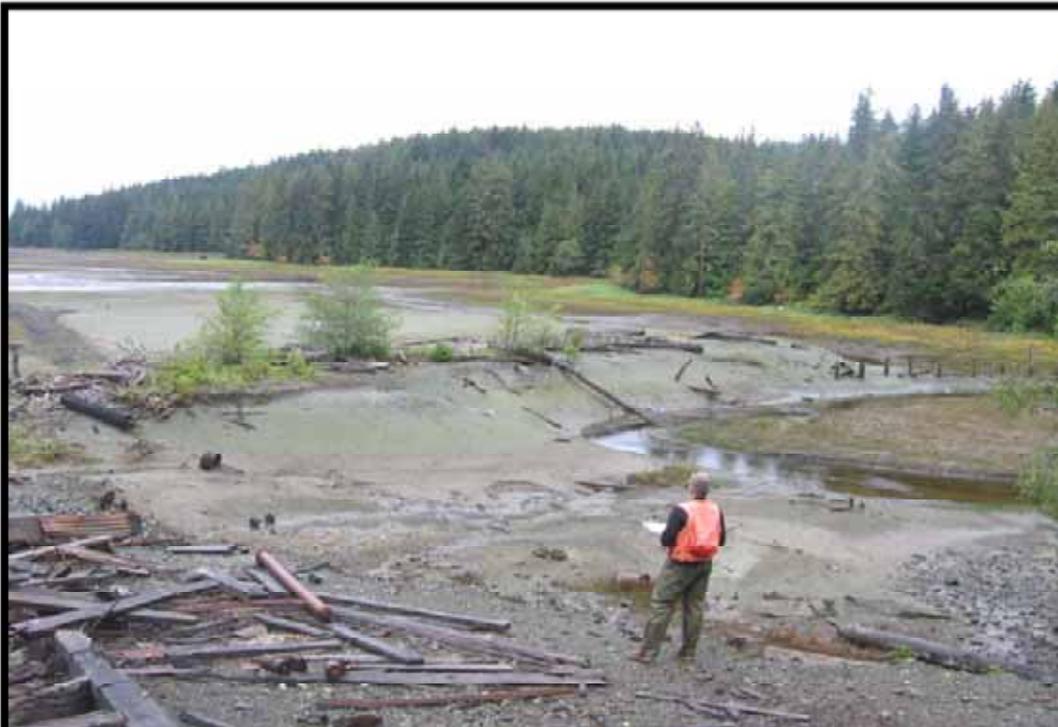
Several piles of tailings exist in the uplands area near the mill and next to the unnamed stream that flows through the site. Elevated levels of copper were found in all of the tailings, and mercury, selenium, and PCBs in tailings in various locations.

In the intertidal area, the main contaminants of concern in the extensive area of tailings are copper and vanadium. Samples were collected of tailings, sediment below and downgradient of the tailings, and biota, including several species of clams and mussels. PCBs are present in the tailings closest to the mill and tend to be less prevalent farther into the bay. The sediments below the tailings and out in Salt Chuck Bay also showed elevated levels of copper and vanadium as well as arsenic and isolated hotspots of mercury, PCBs and polycyclic

Tailings and tailings spit looking southwest.

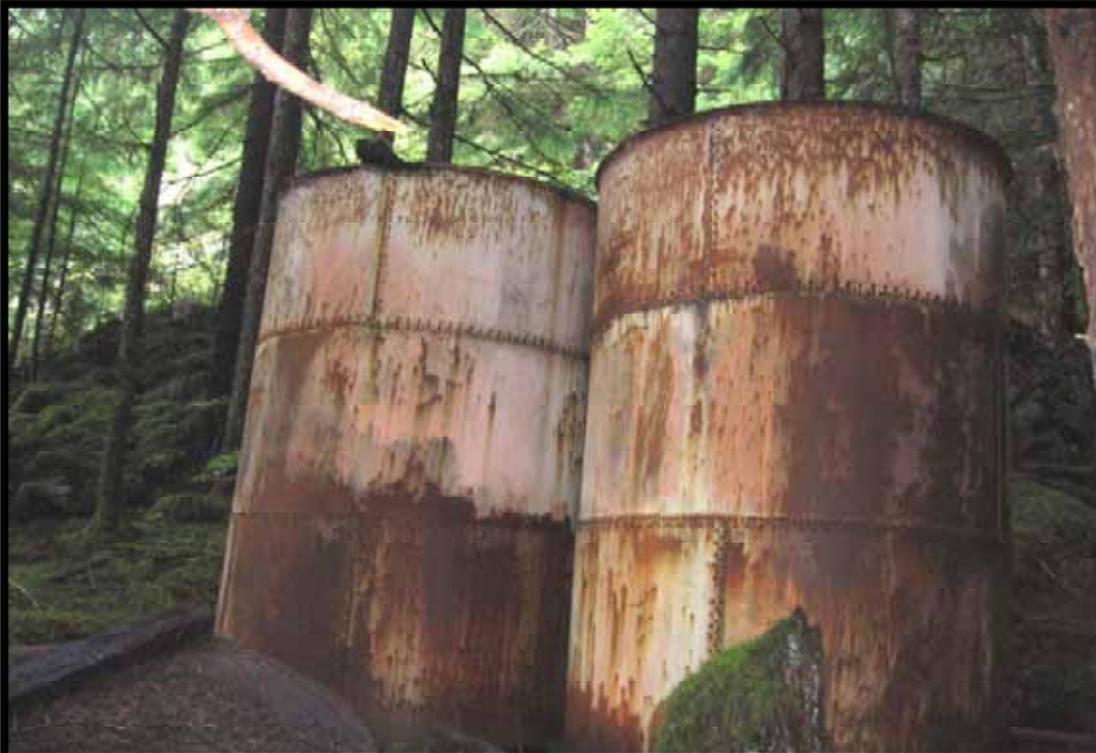
Petroleum-contaminated soil is present near the aboveground storage tanks, drum caches and in the sludge on the floor of the mill. The sludge has also migrated to the tailings and intertidal area.

Above-ground fuel storage tanks near mill site.

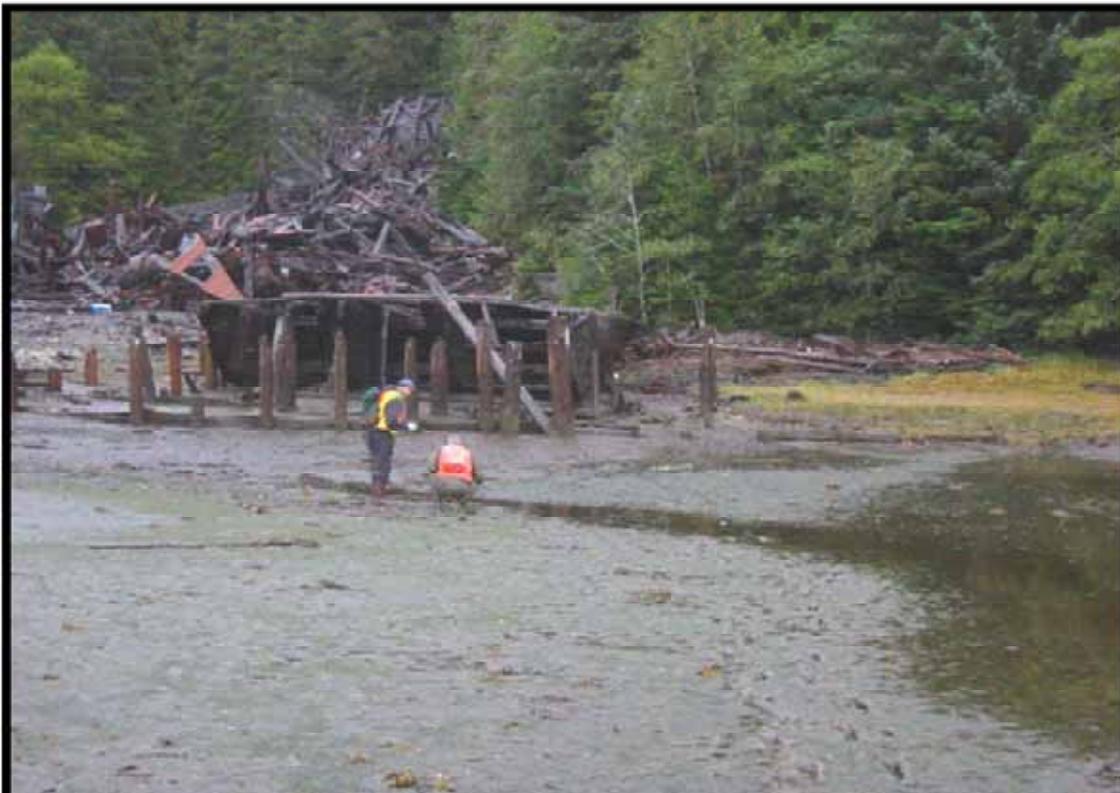
Collecting water sample from tailing seep.
