Waterbody Assessment

Alaska Department of Environmental Conservation

**PEDERSON HILL CREEK**

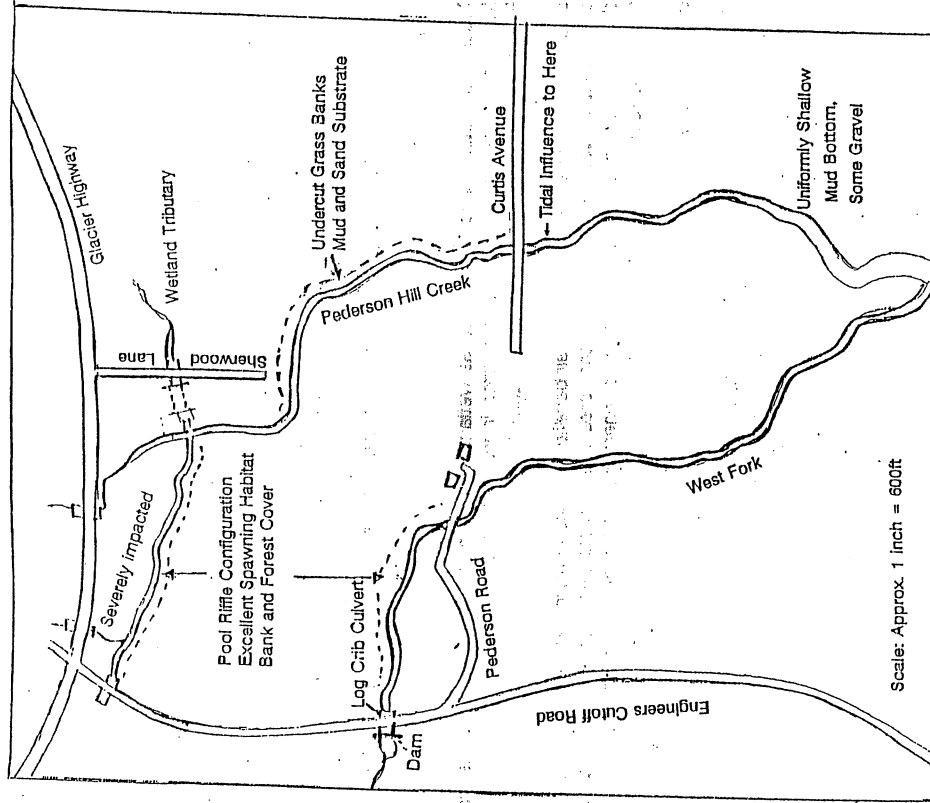
Figure 2. Habitat Map and Area Features

Although the Pederson Hill Creek is not a major fish producing stream, it provides good habitat for salmon fry from other local streams. The stream is located within a high density urban area, with an ever increasing demand for accessible fishing spots. To preserve both fishing spots and fish habitat uses, it is important that water and sediment quality are preserved. Of concern are future habitat impacts to the stream bed, resulting from additional road or driveway construction and other developmental activities. Clearing of trees adjacent to the creek to make room for construction projects could lead to a decrease in shade cover at the mid to upper portions of the tributaries, resulting in the degradation of salmon habitat. Figure 2 identifies habitat areas and pollutant sources.

The main water quality impacts to Pederson Hill Creek have been documented to be from fecal coliform bacteria contamination. Other contributions to water quality impacts to Pederson Hill Creek may result from sedimentation as a result of non-point source site runoff, wetland fills, and stream bank disturbances and variety of construction activities in the past and present. Potential pollutant sources for coliform bacteria, chemical and sediment runoff are identified earlier in Figure 2.

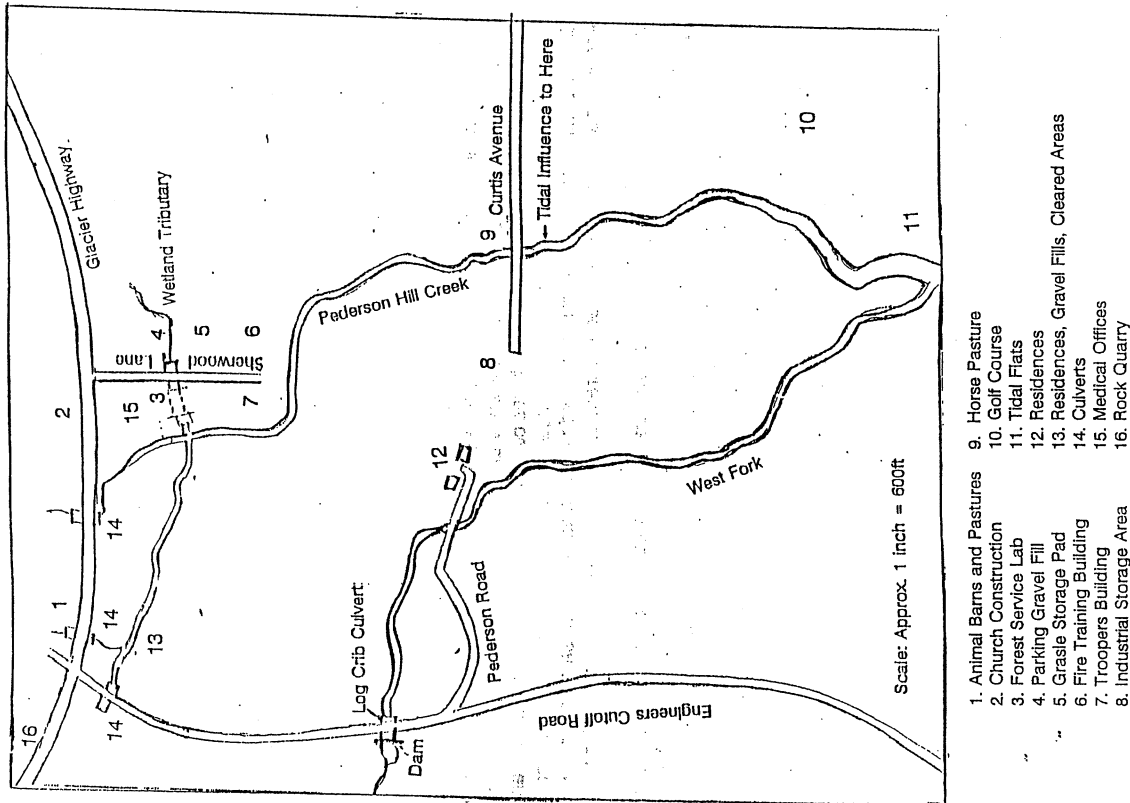
Figure 3. Identification of Sources and Landmarks

On May 20, 1993, a cursory site survey was conducted, to document existing commercial activities, ongoing construction and general features of the terrain. The survey also included an assessment of residences along Engineers Cutoff and Mendenhall Peninsula Roads. During the survey, the stream bed of the upper tributaries were not identified. The exact location of the culverts draining runoff from the animal barn, rock quarry and a church construction site across Glacier Highway (1, 2, 16) were obscured by dense vegetation. Figure 3 identifies landmarks and observations of the site survey.

Water in Pederson Creek between location 9 and 10 was brackish with a thin white/translucent emulsion floating on the surface. This floating material was also observed further down from this location. It is likely that this sheen originated from organic plant matter; the same emulsified white material was observed in water from containers holding flowers picked from a nearby area.

The gravel pad storage area (8) was identified as a potential site for spills or runoff. Items stored on this site included trucks, a railroad container, storage tanks and cylinders of unknown contents.

Two horse pastures (9), separated by a dirt road (Curtis Avenue), were identified as potential sources for coliform contamination of the lower portion of the stream.

The parking areas behind the commercial buildings (3,7) were identified as a source for non-point runoff - no drainage ditches or vegetation barrier separates the parking area from the creek.

Potential problem areas exist between Engineers Cutoff Road and Pederson Hill creek (13), some old residences and structures, gravelly areas and freshly cleared woods could impact the creek.
