Peterson Creek Watershed Protection and Assessment

Project Report

Mendenhall Watershed Partnership

ACWA Grant 05-12

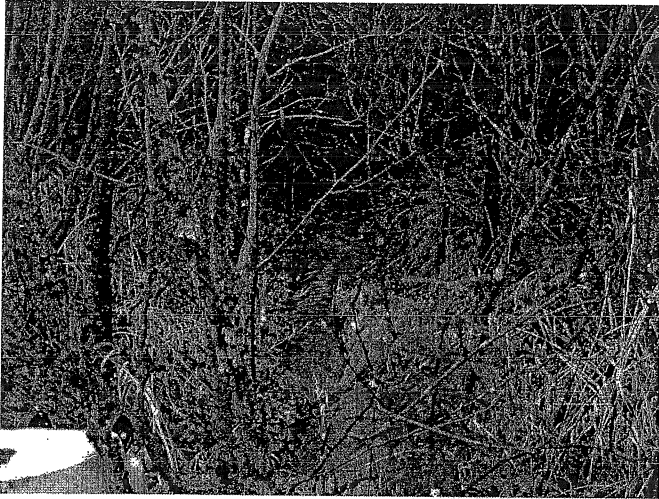
Site 2, below Glacier Highway, High flow during winter rain event.

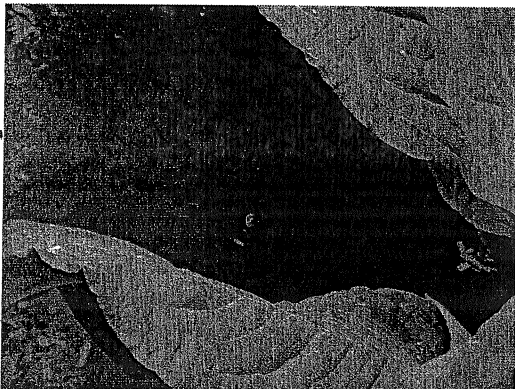
Site 3. Low flow on 5/12/05: unnamed tributary to Pederson Hill Creek

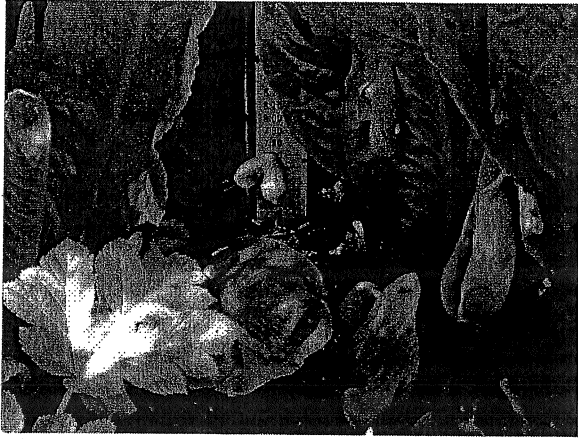
Site 4. Gauging Station at low flow (<5L/sec).

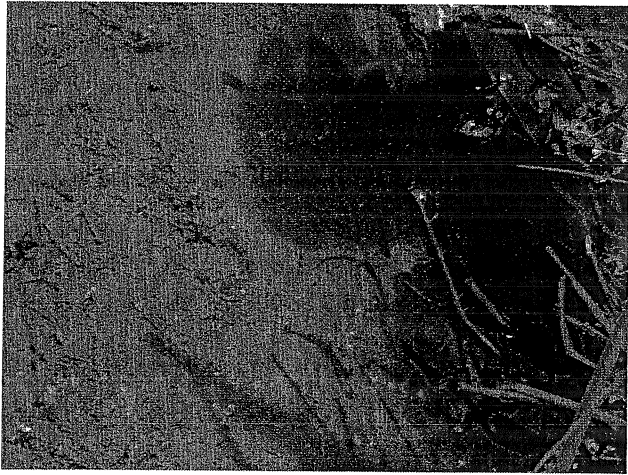
Site 4 low flow pool with coho fry (young of year).
