Alaska Department of Environmental Conservation

Waterbody Field Report

Pederson Hill Creek, Juneau, Alaska

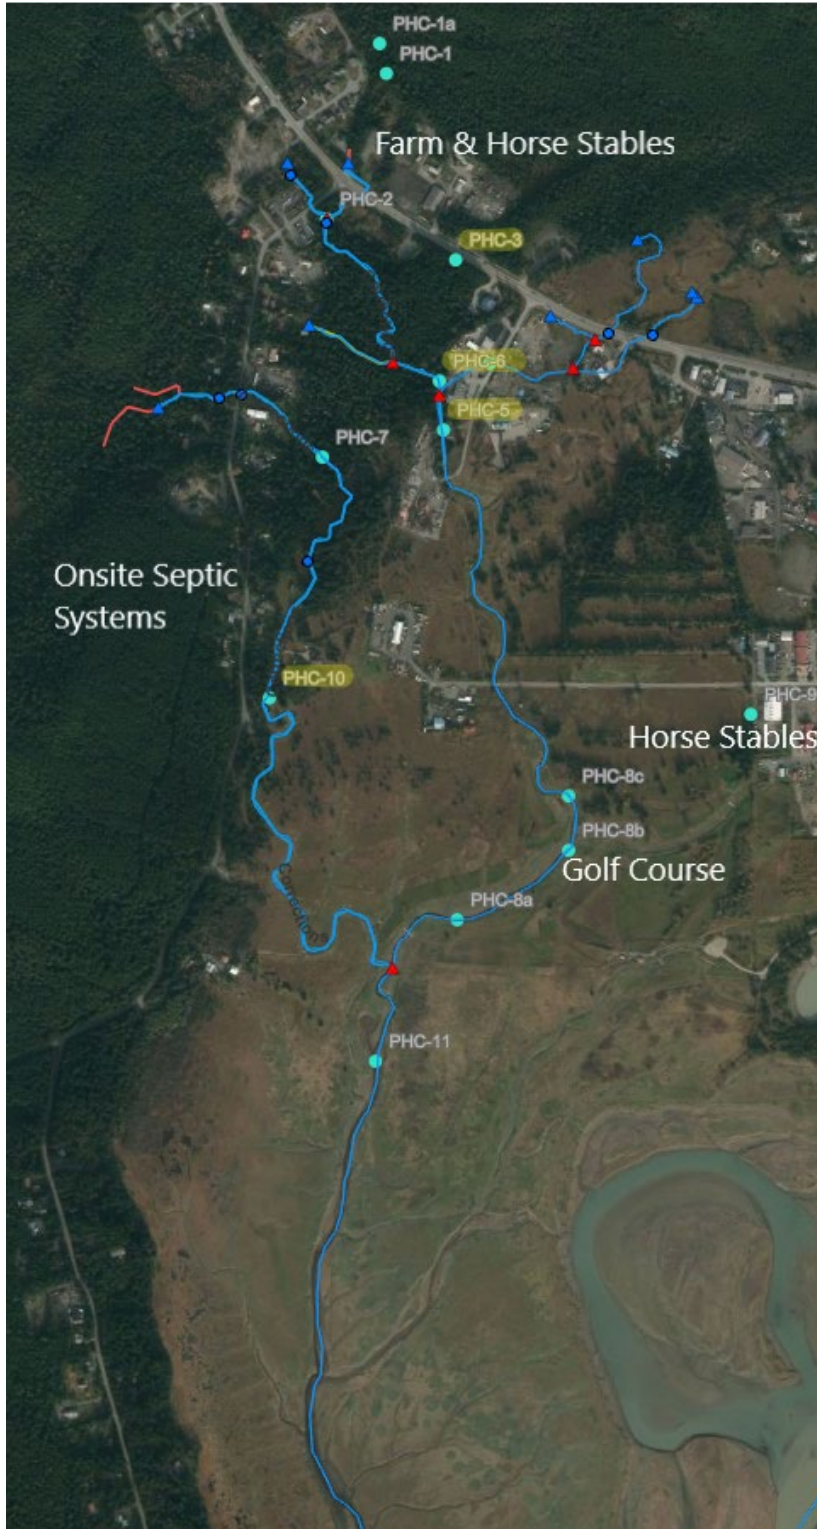
Figure 2. Pederson Hill Creek site locations with potential fecal bacteria pollution source areas.⁴

Based on the results of this water quality assessment, Pederson Hill Creek continues to be impaired for pathogens with several potential sources identified. Fecal bacteria pollutants from urban development and stormwater runoff are present within the three areas of the watershed as highlighted on Figure 2: upper east fork (downstream of farm and horse stables), mid-east fork (downstream of onsite septic systems), and west fork (downstream of on-site septic systems). Human DNA markers were detected in the upper east fork and along the lower west fork (downstream of onsite septic systems); dog DNA markers were detected in the most downstream sample site (along a popular dog walking trail); and horse DNA markers were detected in the upper east fork (downgradient of farm and horse stables) as shown on Figure 5. Field measurements show limited WQS exceedances and generally represent healthy stream concentrations.

Levels of fecal coliform and E.coli bacteria above WQS continue to be present in the Pederson Hill Creek watershed. As a result, additional best management practices (BMPs) are necessary to reduce bacteria levels in the creek. Potential bacteria sources have been identified and could be the focus of future BMP work. DEC will conduct future water quality sampling after additional BMPs have been implemented to measure water quality improvements in the creek.

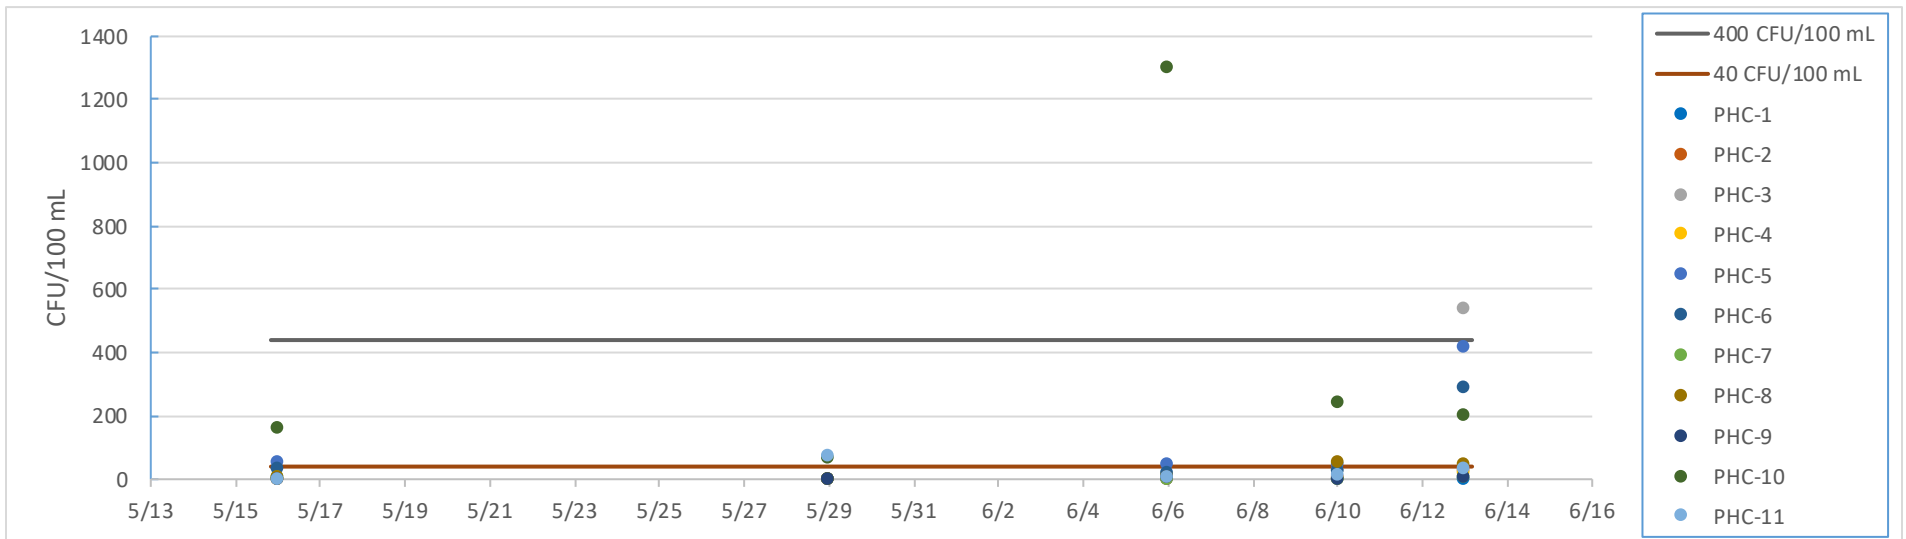
Water samples collected from the 11 locations in Pederson Hill Creek during a 30-day period in May to June were analyzed for fecal coliform and E.coli bacteria. Fecal coliform and E.coli exceeded bacteria criteria in the upper east fork (PHC-3, downstream of farm and horse stables), the mid-east fork (PHC-5 and PHC-6, downstream of onsite septic systems), and the west fork (PHC-10, downstream of onsite septic systems). Fecal coliform also exceeded bacteria criteria in east fork (PHC -8, within golf course area) and in the lower watershed segment (PHC-11, most downstream sample site).

Figure 3. 2019 Fecal Coliform Bacteria water results

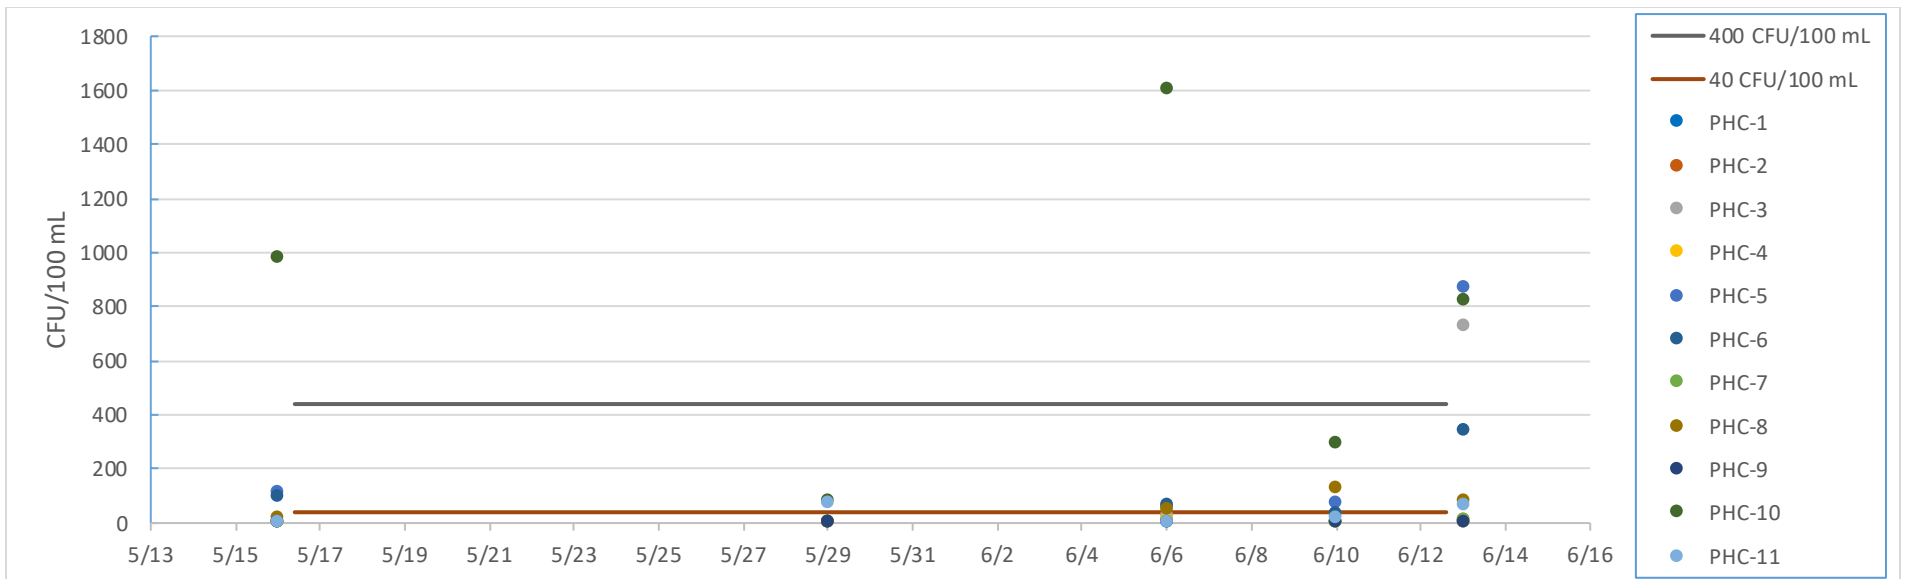
Figure 4. 2019 E.coli Bacteria water results

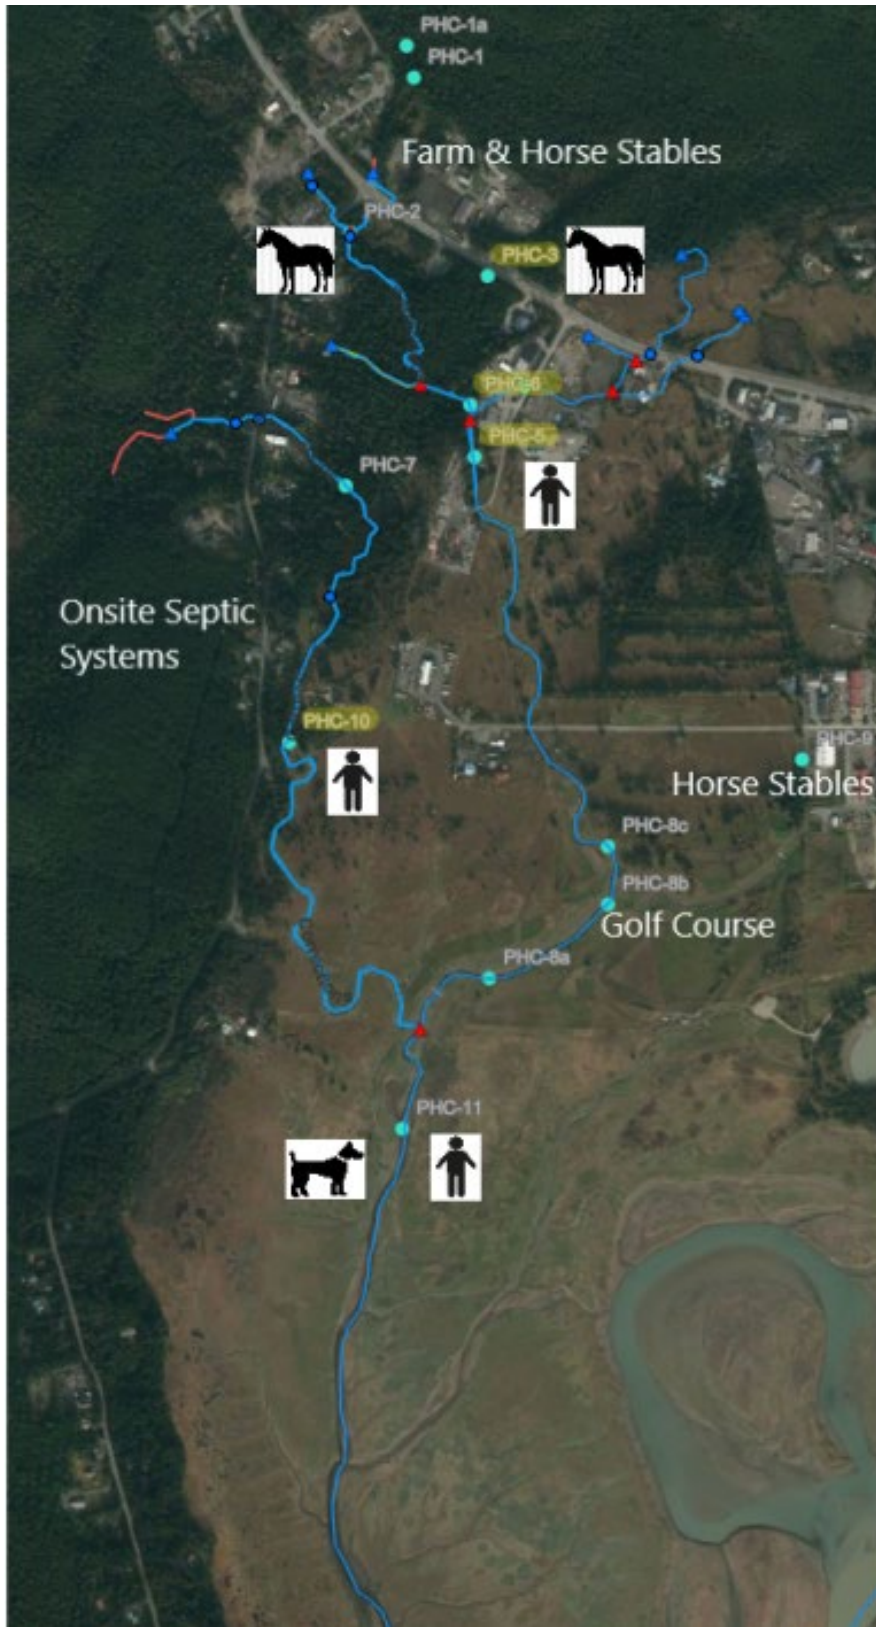
Water samples collected from the 11 locations in Pederson Hill Creek during the June sampling event were all analyzed for microbial source tracking. DNA host marker analysis included human, dog, horse, goose, and ruminant deer. The host markers examined for each sample depended on the most likely bacteria source(s) for that monitoring location based on the surrounding landscape and potential sources. Microbial source tracking revealed human DNA in the upper east fork, west fork, and the most downstream site (PHC-5, PHC -10 and PHC-11 respectively). PHC-11 is downstream of known on-site septic systems. Dog DNA was found in the most downstream site PHC-11, along a popular dog walking trail; and horse DNA in the upper east fork (PHC-2 and PHC-3, downgradient of farm and horse stables).

Figure 5. Pederson Hill Creek site locations with MST host markers of human, horse and dog
