# Alaska Department of Environmental Conservation Waterbody Field Report Fairbanks Elodea Project, Fairbanks, Alaska

Prepared by: M. Brown<sup>1</sup>

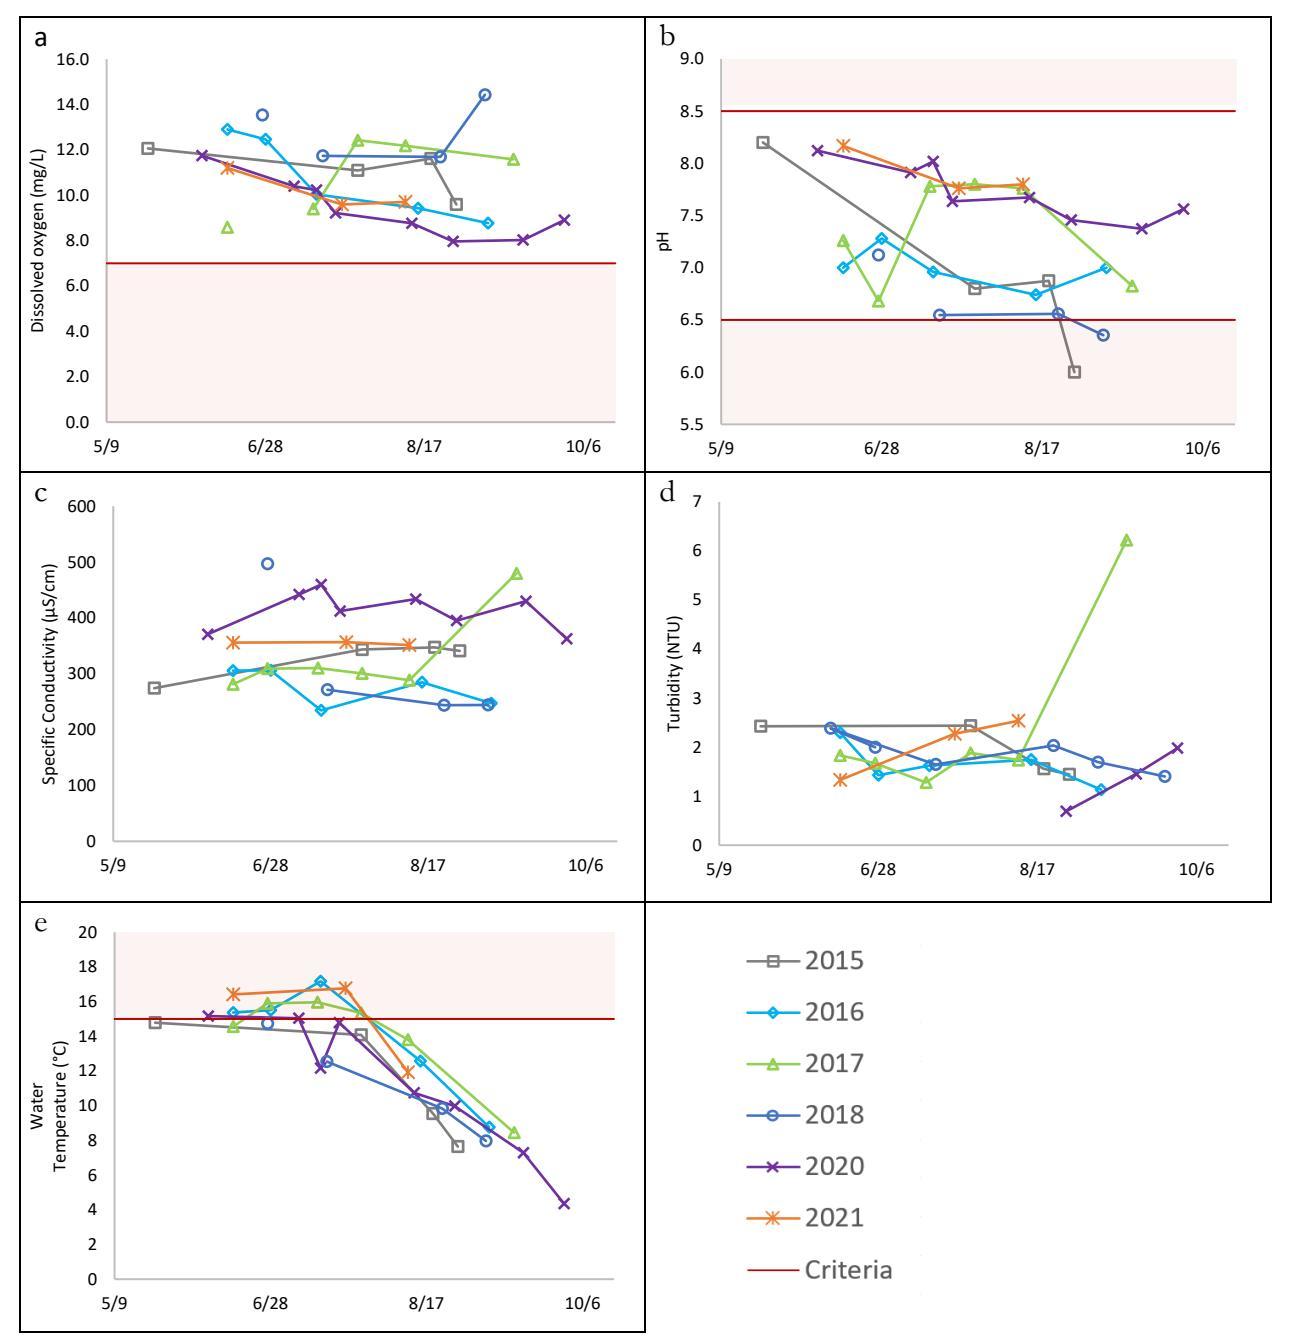
*Figure 5. Daily average (a) dissolved oxygen, (b) pH, (c) specific conductivity, (d) turbidity, and (e) water temperature at Chena Slough across all sites from 2015 – 2021 (no monitoring occurred in summer 2019).*

All parameters were relatively similar across sampling years in Chena Slough from 2015 – 2021 (Fig. 5). Conductivity and dissolved oxygen were at expected stream water levels to support diverse aquatic life. Some pH values fell below the aquatic life criteria, but this may be a natural condition due to groundwater or wetland inputs. Some measurements of temperatures were at levels that could cause stress to aquatic life at the peak of the summer. This may be due to multiple road crossings restricting flow and increasing urban runoff. The slough was clear and turbidity measurements were consistently low.

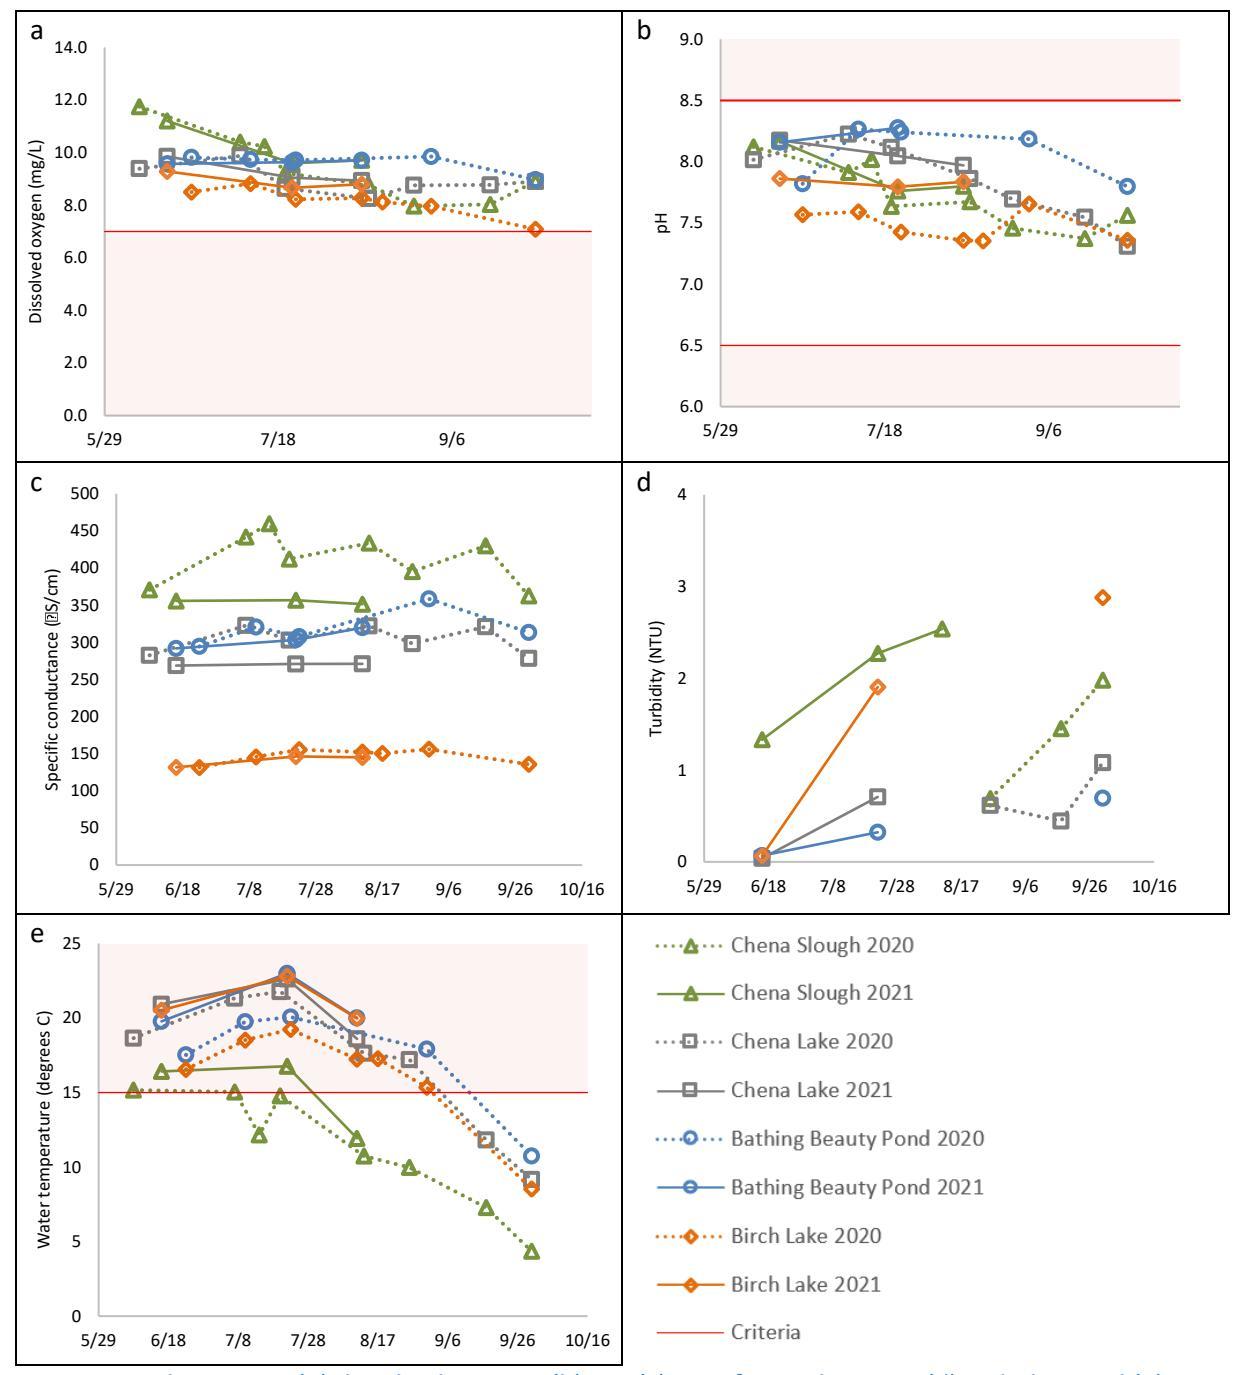
Figure 6. Daily average (a) dissolved oxygen, (b) pH, (c) specific conductivity, (d) turbidity, and (e) water temperature at Chena Slough, Chena Lake, Bathing Beauty Pond, and Birch Lake in 2020 (dotted lines) and 2021 (solid lines).

Parameters were also relatively similar across sites in 2020 and 2021. Dissolved oxygen, conductivity, and pH were at levels expected to support diverse aquatic life at all sites (Fig. 6) and turbidity was consistently low. Temperatures in Chena Lake, Bathing Beauty Pond, and Birch Lake were above 15 degrees C, which could cause stress to aquatic life, but this is likely because measurements were taken in shallow water near the shore due to logistical constraints.
