FINAL  
LOWER JORDAN CREEK  
RIPARIAN ASSESSMENT

Organization Name: Juneau Watershed Partnership/Southeast Alaska Watershed Coalition

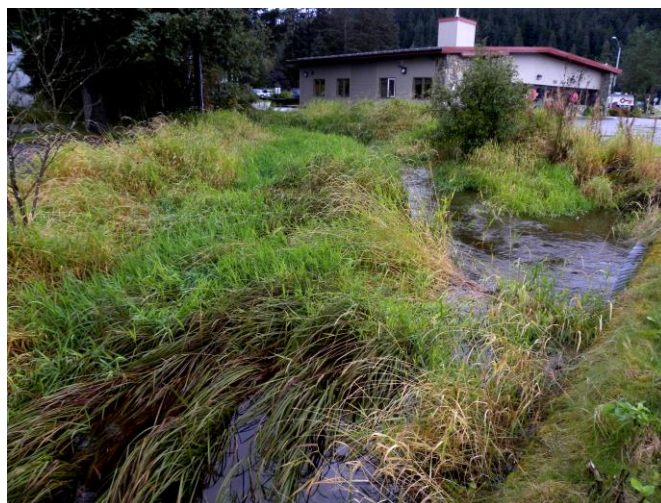
**Figure 13.** Reed canarygrass blocking one of the Jordan Creek Glacier Highway culverts during a high flow event. The culvert being blocked is in the center foreground of the photo, to the left of the culvert passing water.

Most often, herbicide use is recommended for treatment of reed canarygrass, as mechanical methods are labor intensive and require long-term investment. Use of herbicide may be controversial if not supported by all stakeholders. However, an integrated approach using multiple control methods is usually the most effective. Other methods include: shading with native plants, covering with shade cloth or sheet mulch, cutting or mowing (this alone will not eradicate an infestation), or tilling. The effectiveness of these methods can be tested by implementing and monitoring test sites in the Jordan Creek watershed.

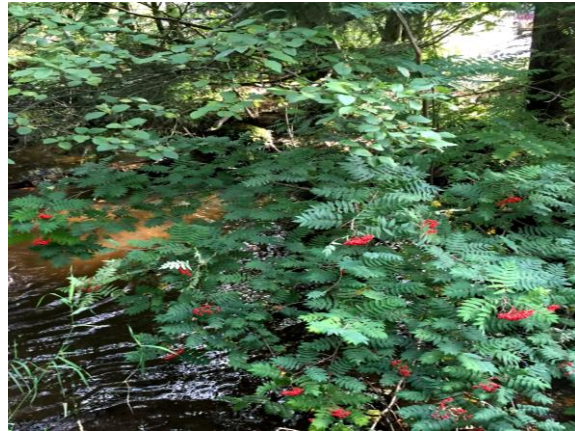
**Figure 14.** European mountain ash in lower Jordan Creek.

European mountain ash and bird cherry are also prevalent in the lower watershed. However, control measures for European mountain ash and bird cherry are largely untested. Most trees can be treated by girdling, though there have been mixed results using this method on European mountain ash along lower Jordan Creek. European mountain ash can re-sprout (form secondary replacement trunks) when cut, allowing it to spread more across the canopy, so this is not a recommended practice unless the trunk can be removed.

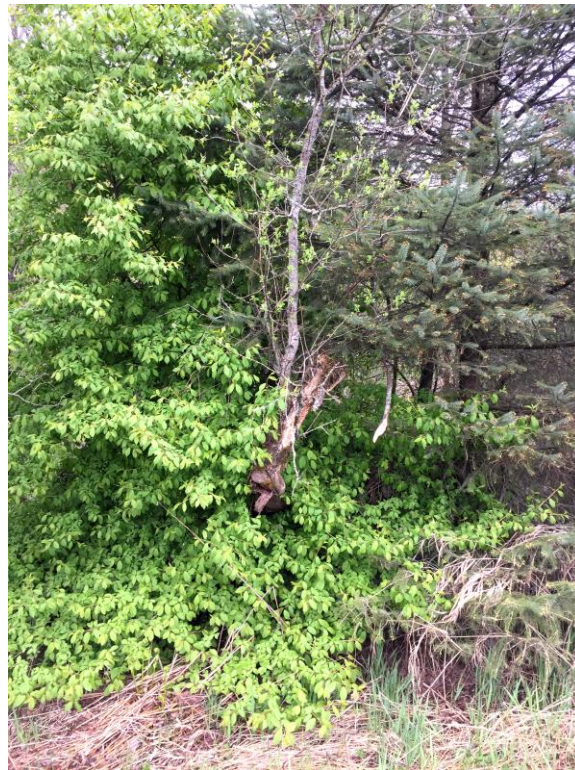
**Figure 15.** European bird cherry in lower Jordan Creek.

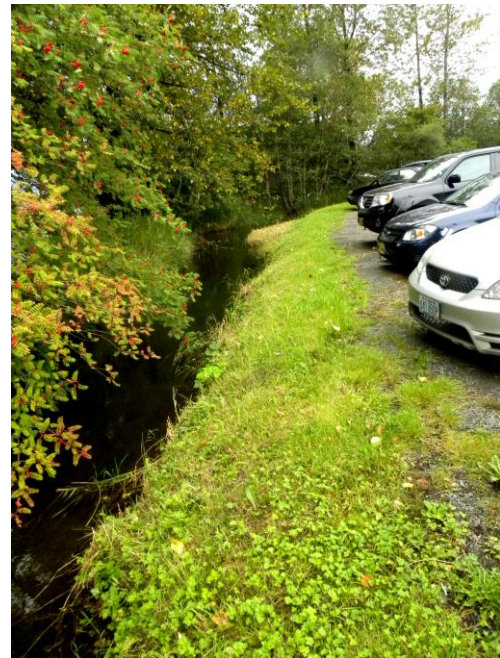
Impervious surfaces are surfaces that do not allow water to infiltrate into the underlying ground. Types of impervious surfaces include rooftops, streets, sidewalks and parking lots. There is a positive relationship between the amount of impervious surface within a watershed and stream degradation. This is because impervious surfaces result in impacts such as increased pollutant loads from stormwater, altered hydrology (e.g. increased run-off rates), decreased bank stability, increased water temperatures, reduced habitat and reduced biodiversity. Some of these impacts are apparent in the streamside setbacks of lower Jordan Creek where impervious surfaces encroach on the stream (Figure 18).

**Figure 18.** An example of encroaching development on lower Jordan Creek.

Reestablishing a 25-foot vegetated setback should be a priority in restoring riparian zone ecological functions. Where landowners are unable or unwilling to restore the 25-foot setback, one alternative is encouraging replacing impermeable pavement with green infrastructure that allows water to infiltrate the ground while serving similar purposes to pavement such as turf-reinforced mats or permeable pavers. This would provide some similar benefits to a natural riparian buffer such as reducing run-off rates and pollutant discharges. In addition, this option could reduce problems with standing water. The pros and cons of establishing a natural buffer versus green infrastructure are provided in Table 13. Note that this doesn't present every type of green infrastructure that might be suitable for this purpose, but merely gives examples of some techniques that can be employed.

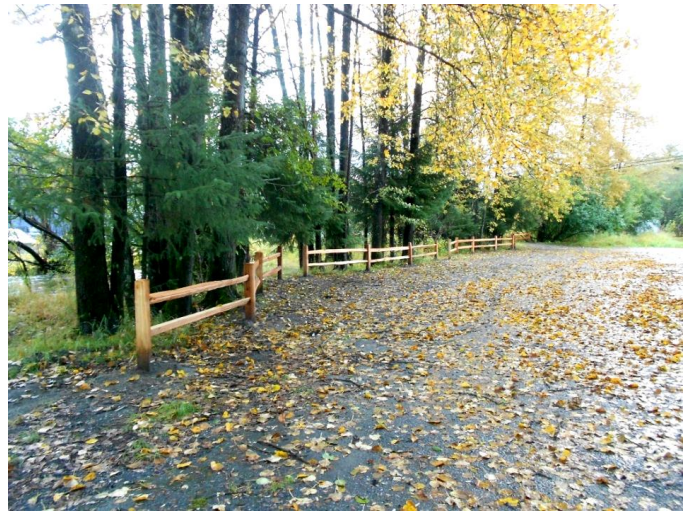
**Figure 20.** Successful riparian fencing installed on Jordan Creek at the Edward K. Thomas building owned by the Central Council of Tlingit and Haida.

Fencing-off riparian areas would discourage activities that could damage riparian vegetation and streambanks such as foot traffic, parking, construction encroachment, and plowing snow into the riparian area or stream. Fencing could also be used to address access concerns. At the very least, fencing could be installed along the 25-foot setback, though protection of more than the 25-foot setback would increase the benefits. Use of fencing and other barriers have been used successfully throughout the Jordan Creek watershed to protect riparian areas (Figure 20). The JWP/SAWC is willing to work with interested landowners to seek grant funding to install protective barriers.

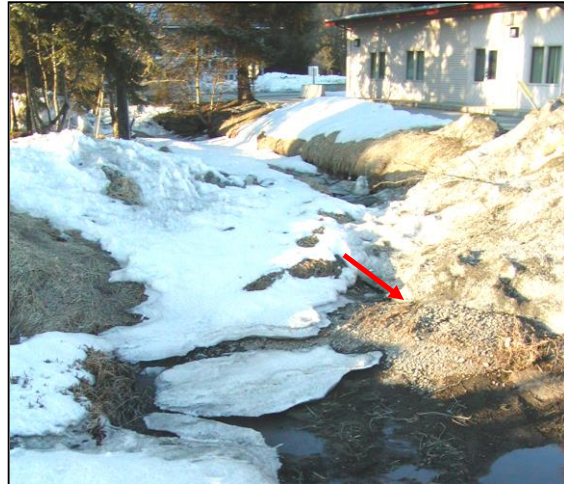
**Figure 21.** Snow storage at First National Bank causing riparian impacts and sediment deposition in Jordan Creek.

The riparian area is often used for snow storage because they are usually outside of heavy traffic areas. However, plowing snow into the riparian area impacts vegetation through soil disturbance, removal of vegetation or damage from the weight of the snow or by the plow. In addition, plowed snow often contains debris, hydrocarbons, deicing chemicals, and sand or gravel used for traction on roads and driveways. When stored in or directly adjacent to streams, these pollutants enter the system as the snow melts. Stream-side residents and business owners should be encouraged to store snow away from the stream, outside of the riparian area, and to implement best management practices on their properties to reduce transport of pollutants in meltwaters. State and local government crews involved in snow management should also be encouraged to improve snow management practices.

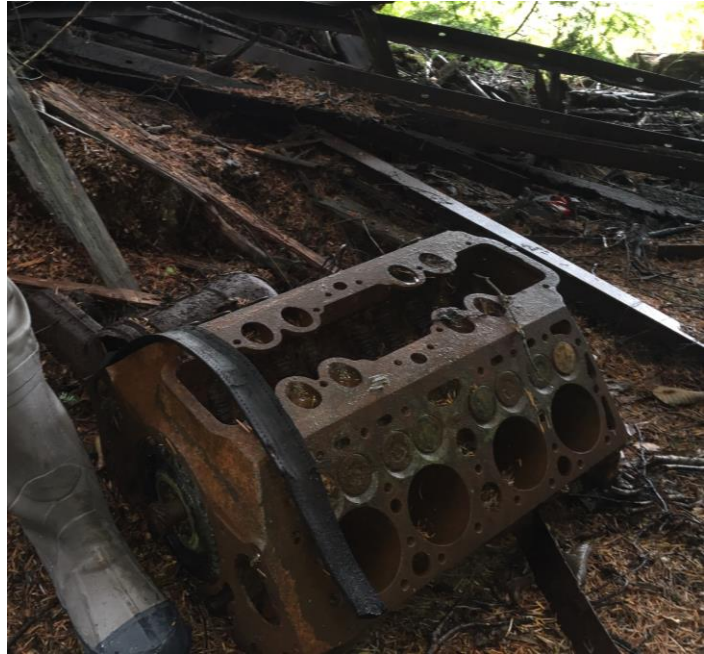
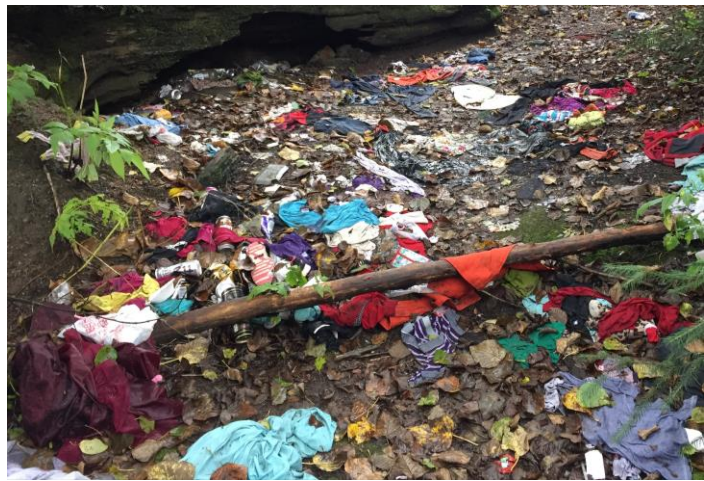
**Figure 22.** Examples of some of the debris and litter in the lower Jordan Creek riparian area.

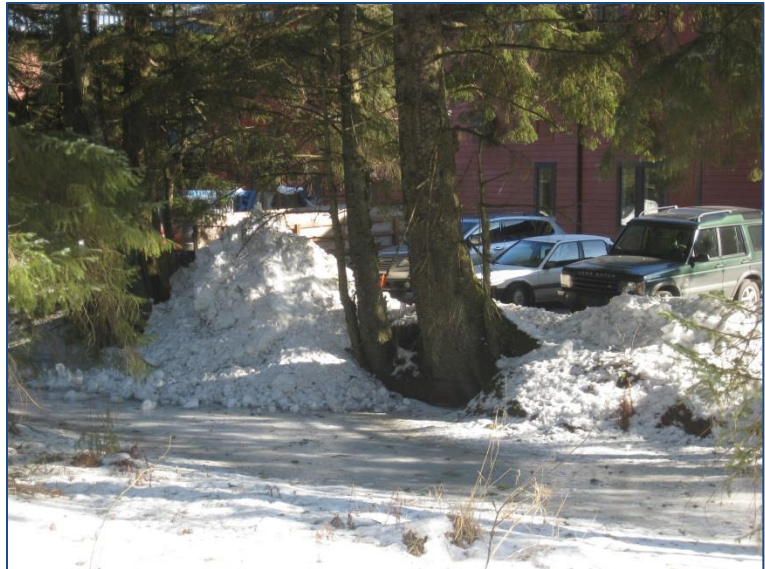
**Figure 1.** Snow being pushed into Jordan Creek.

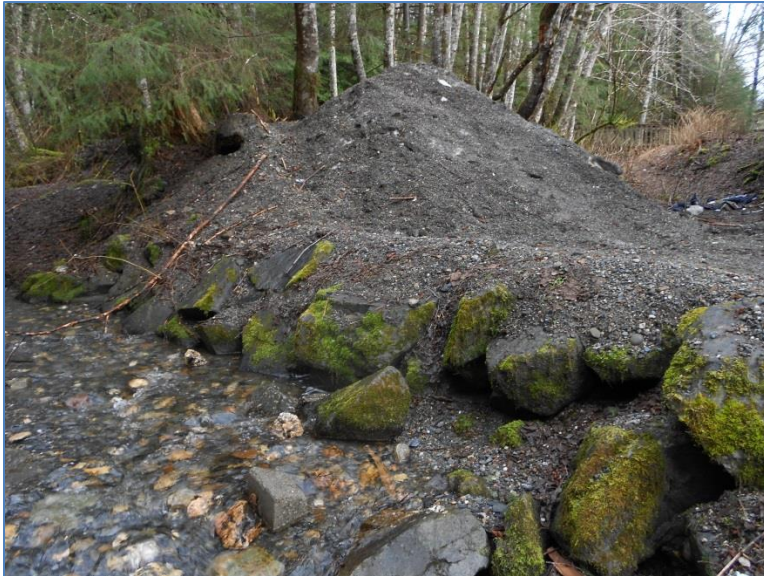
Snow storage operations are impacting the stream and riparian vegetation. Sediment is discharging into the stream and trees are being damaged from having snow plowed up against their trunks. A berm would be most appropriate perimeter control option on this site, since it is small and has limited storage space.
