UNIFIED INCIDENT COMMAND NEWS RELEASE #2

Incident Name: BPXA Flow Station 1 Drill Site 2 Well 3 Discharge, Prudhoe Bay, Alaska

Unified Command Announces BPXA Well 3 Gas and Oil Leak Stopped

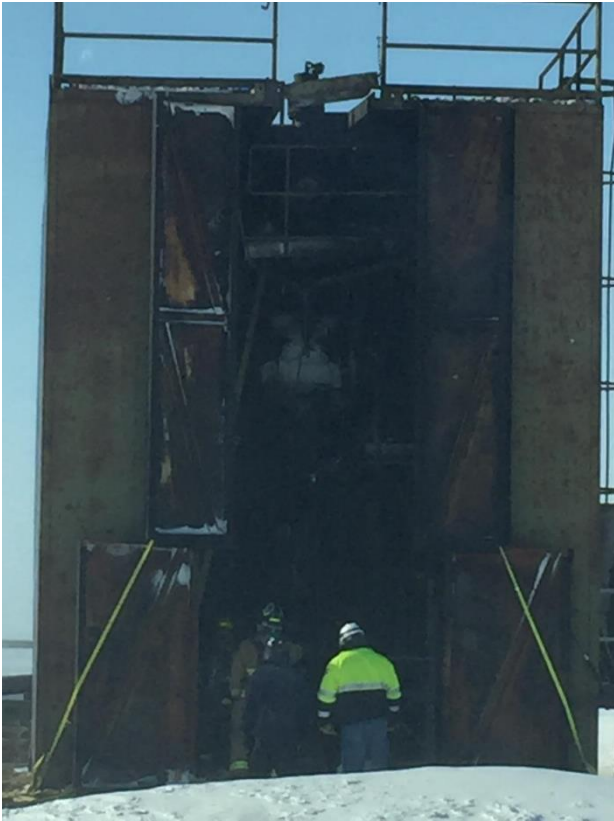
Yesterday, responders from the well control contractor, Boots and Coots, were able to safely enter the well house and place a plug in the damaged aboveground piping (riser) coming off the well head. The plugging of the damaged aboveground piping allowed for responders to pump a salt water solution into the well which killed it.

Emergency responders inside BPXA Well 3 well house, April 16, 2017 (EPA)
