107-10-10300  
BASELINE AQUATIC SURVEY

1. Stream Name Black Bear Creek 2. ADF&G Catalogue No. 107-10-30  
3. USGS Map No. Craig C-1 4. Legal Location R86E,T71S,S-12  
5. Latitude and Longitude 55°43'<sup>35"</sup>27", 132°<sup>10'00"</sup>9'<sup>50"</sup> 6. Agency Unit 05

BASELINE (LEVEL TWO) AQUATIC SURVEY FORM

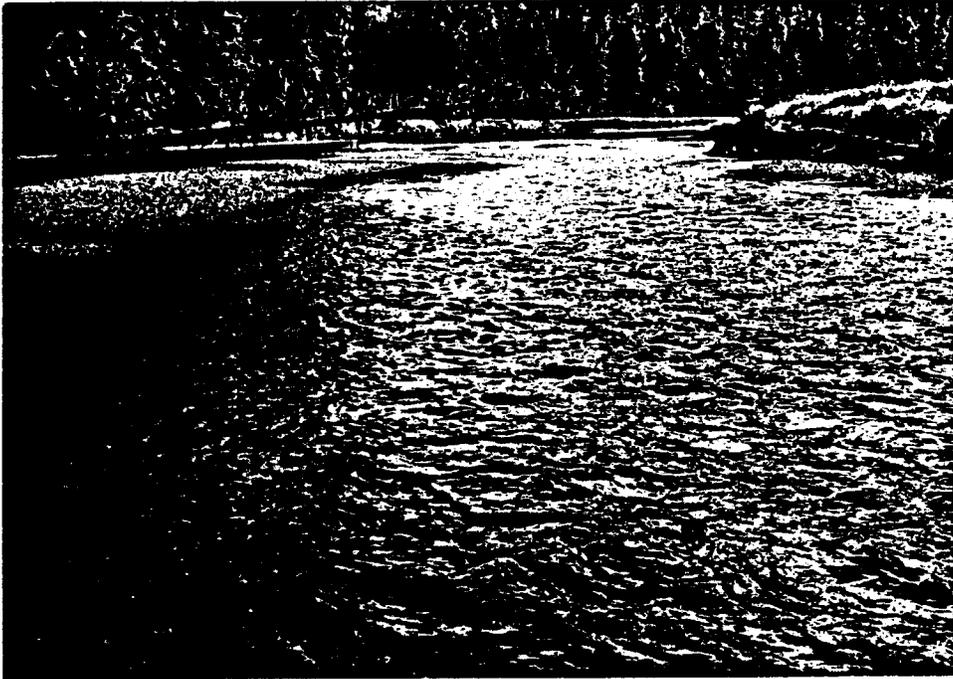
1. Excellent riffle in the upper ITZ.

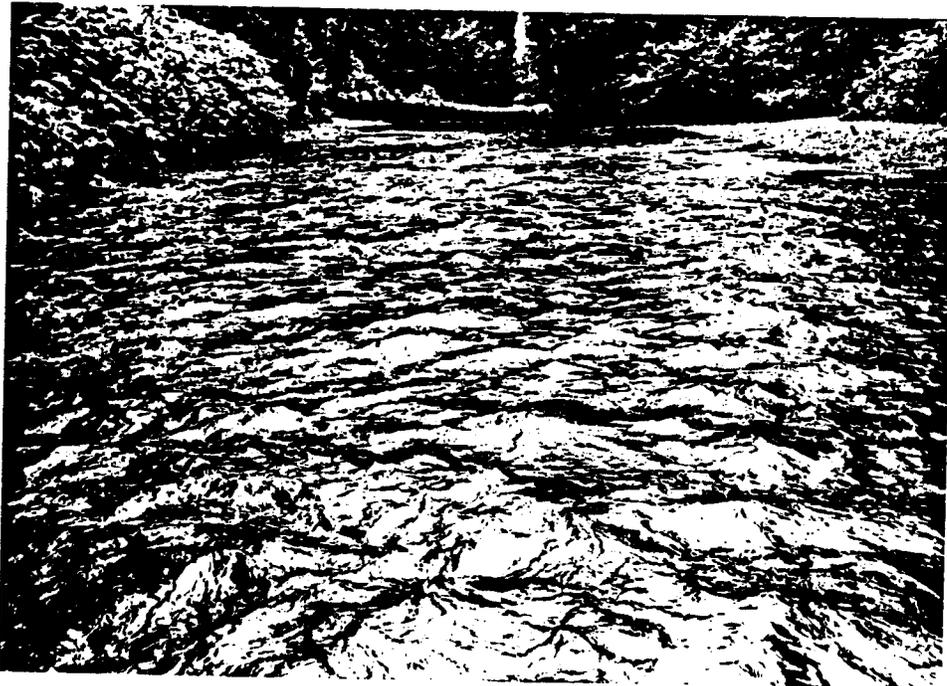
2. Excellent ASA in Section #14.

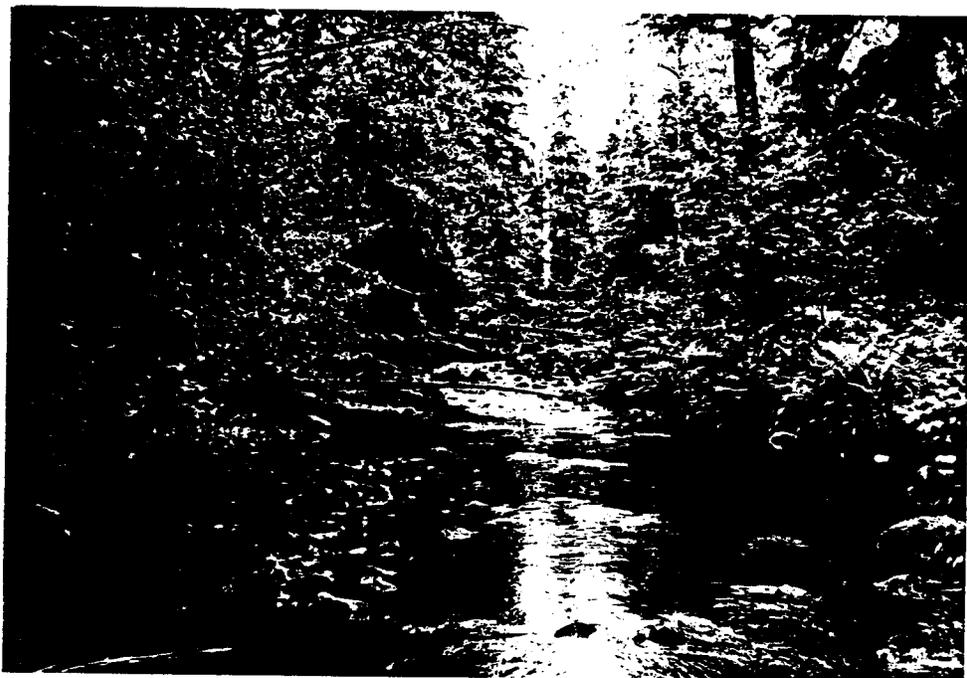
6. Section 50: The ASA and rearing habitat decline immensely at the end of the survey.

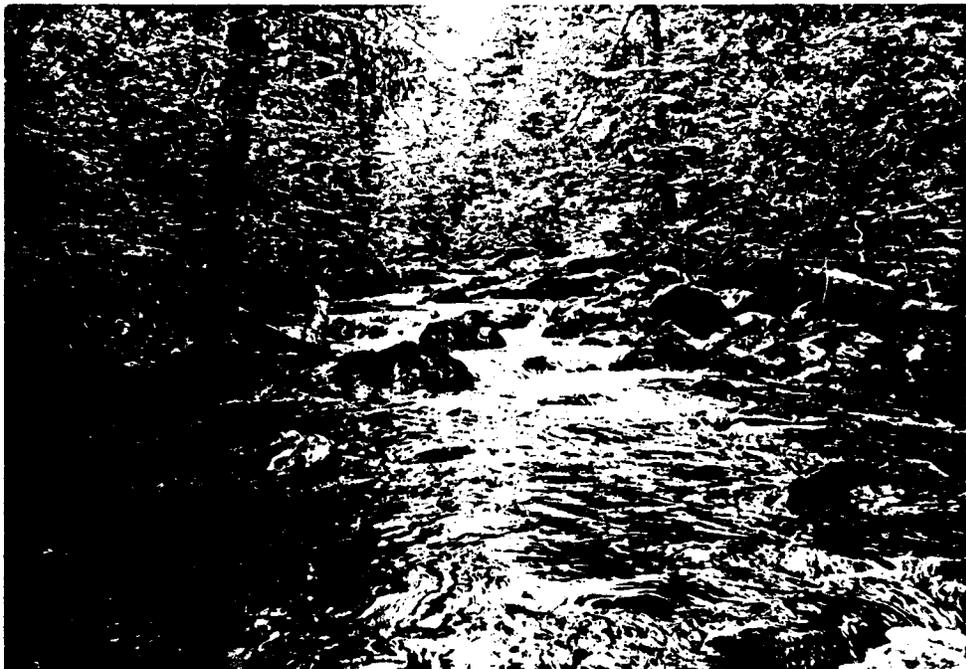
8. Large boulder and bedrock substrate 400 m. beyond Section 50.

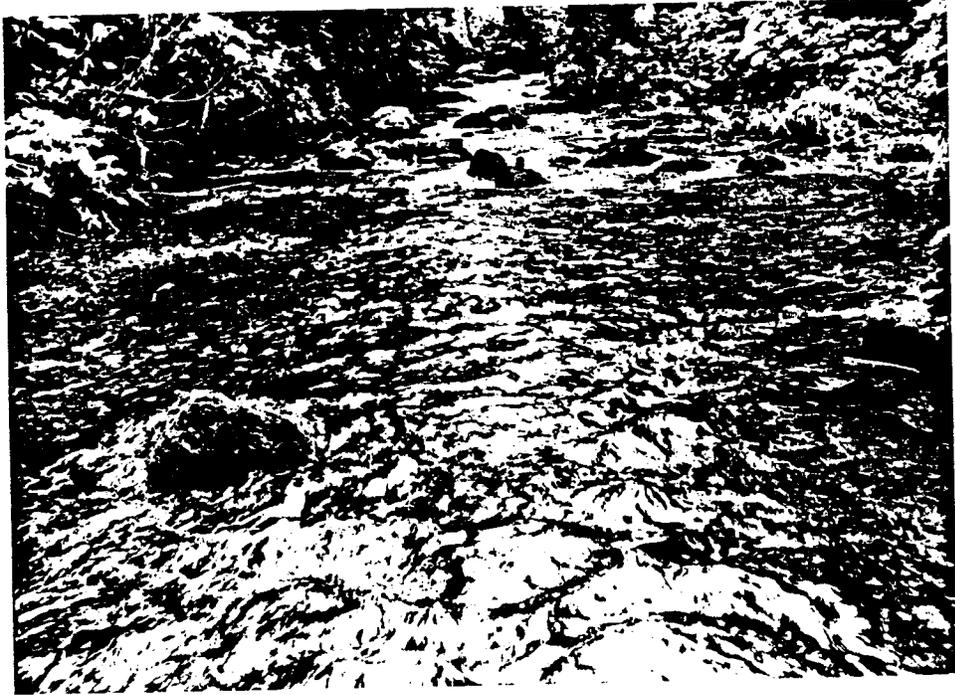
1. Typical habitat in the lower reach.

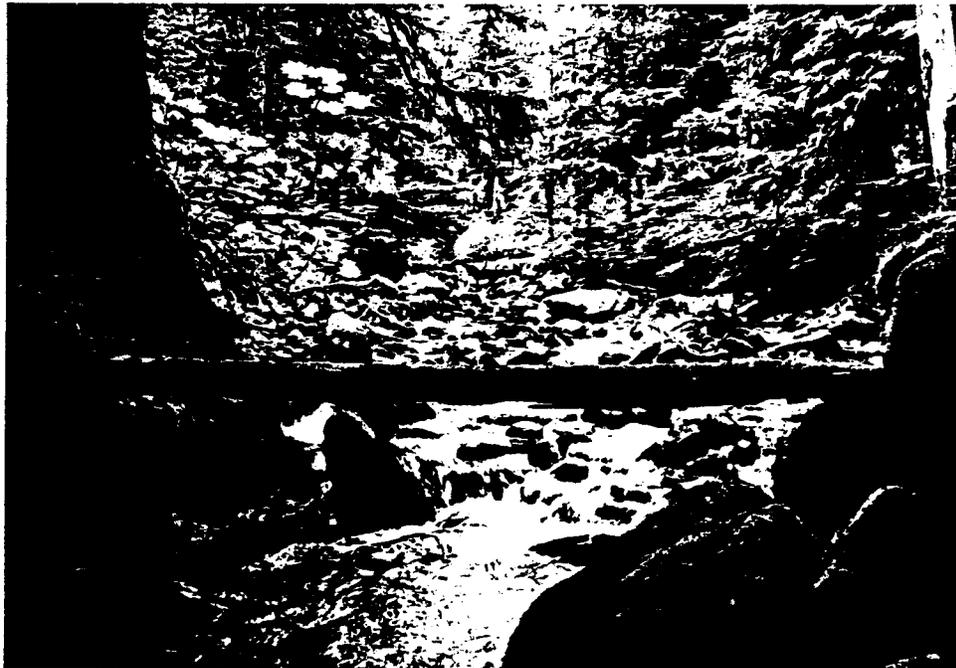
2. Section 7: Large boulder substrate at the end of the survey.

Section 7: The survey was discontinued at the end of the Section. The gradient has increase substantially and the fisheries habitat has diminished. There has been no barrier observed yet, but there is little ASA or rearing habitat present.
