RE: Preliminary Survey of the Tenakee Tank Farm

On November 11, 2003, I conducted a preliminary survey of the bulk fuel storage facility currently owned by Kadashan Bay Corporation and operated by the Snyder Mercantile Company of Tenakee.

#### Tenakee Springs -- Bulk Fuel Facility Summary of Field Screening Results November 11, 2003 Site Survey Enclosure 2

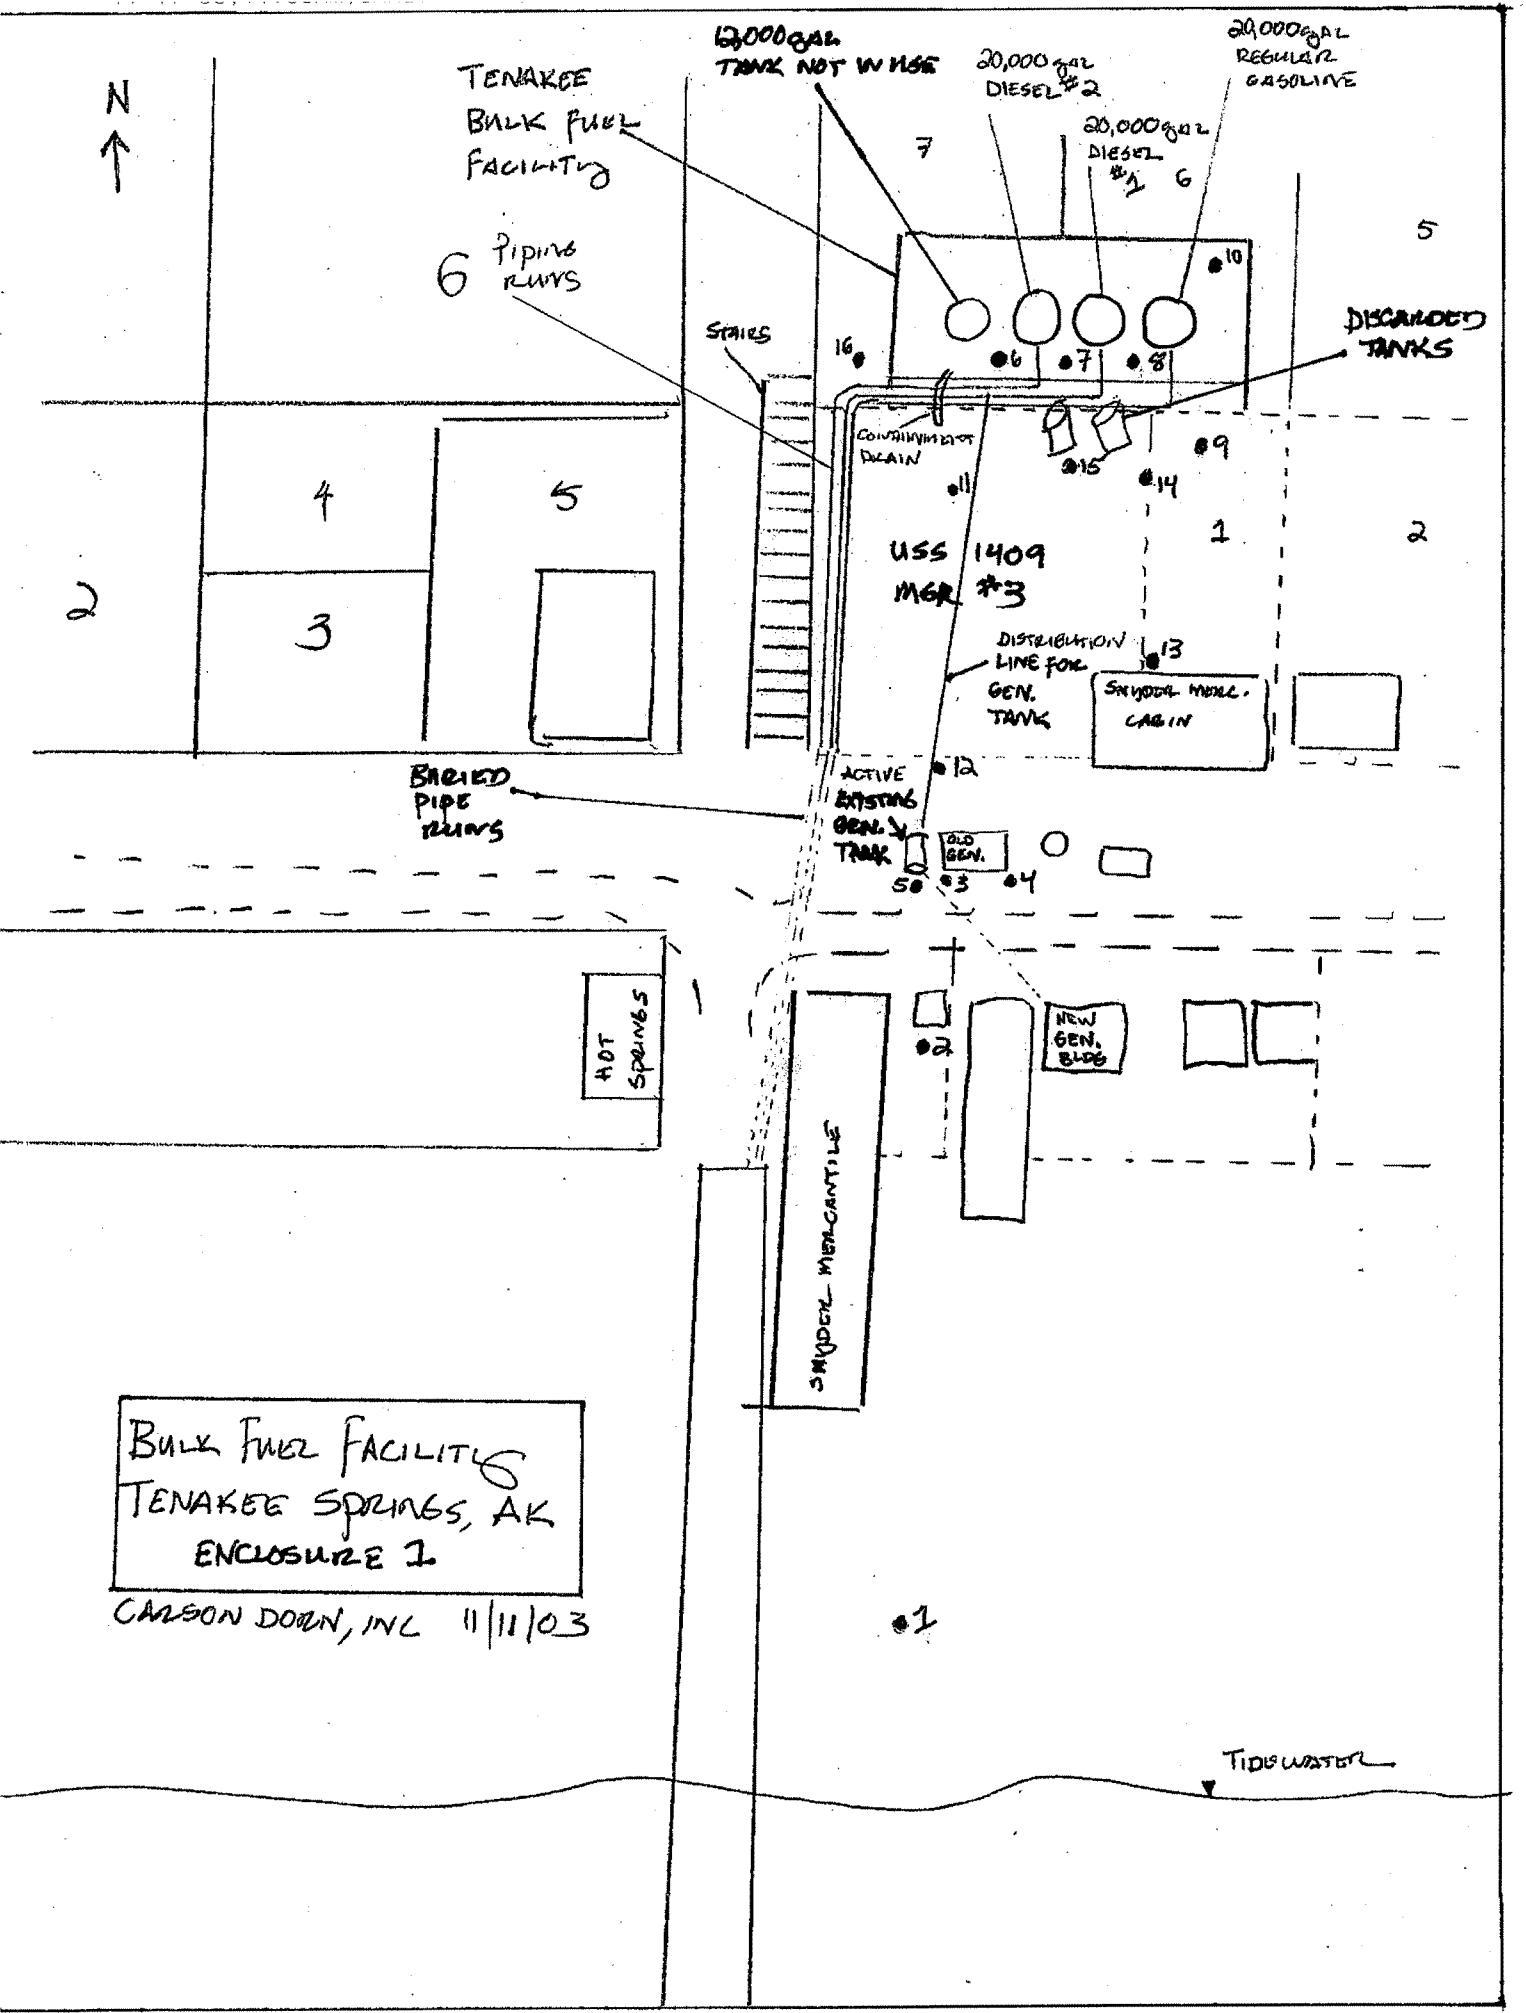
The survey effort consisted of hand-digging sixteen holes throughout the tank farm property and around the perimeter to attempt to identify the presence and extent of any contamination. Assisting me in the effort were community members Ron Flinn, JC Thomas, Paul Scriber, and Terry Kennedy. The holes were dug with shovels, picks and a post-hole digger. The depths of the holes ranged from 1-3 feet. Enclosure 1 provides a site sketch of the facility showing locations of all test holes.
