Hilcorp Alaska, LLC

**Beluga River Unit Site Characterization and
Groundwater Sampling Work Plan**

June 2021

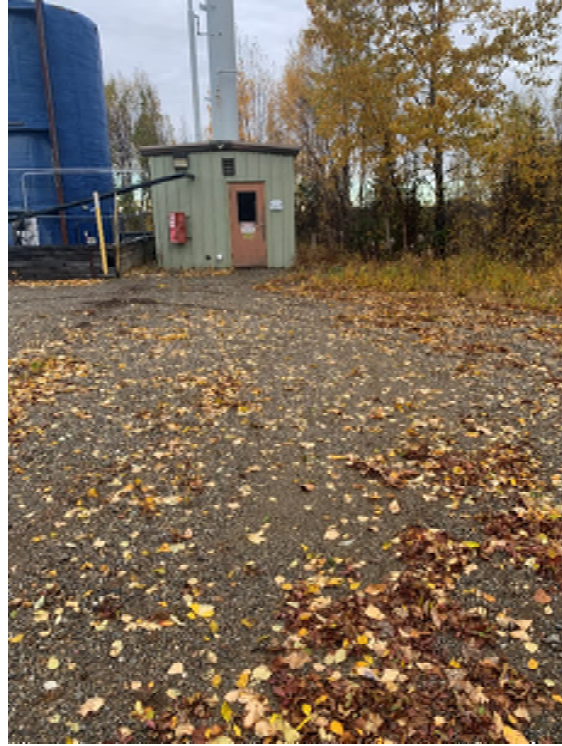
Well 224-13-2 to the right of green facility
Facing West

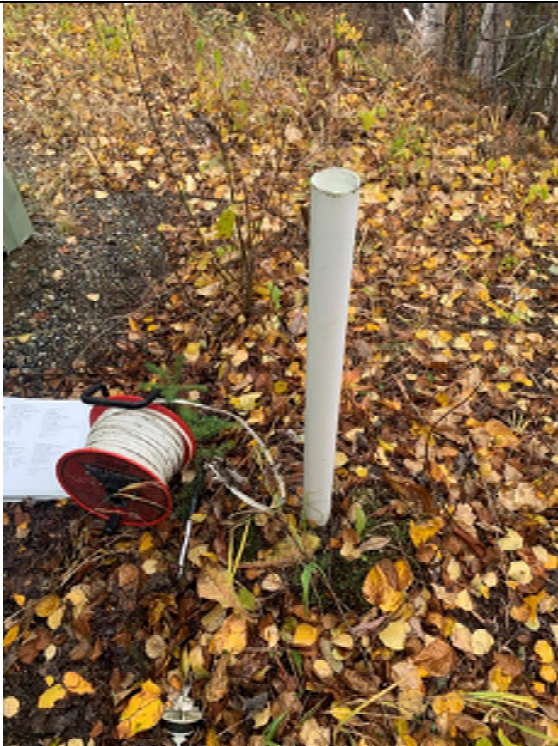
Closeup of well 224-13-2
Facing West

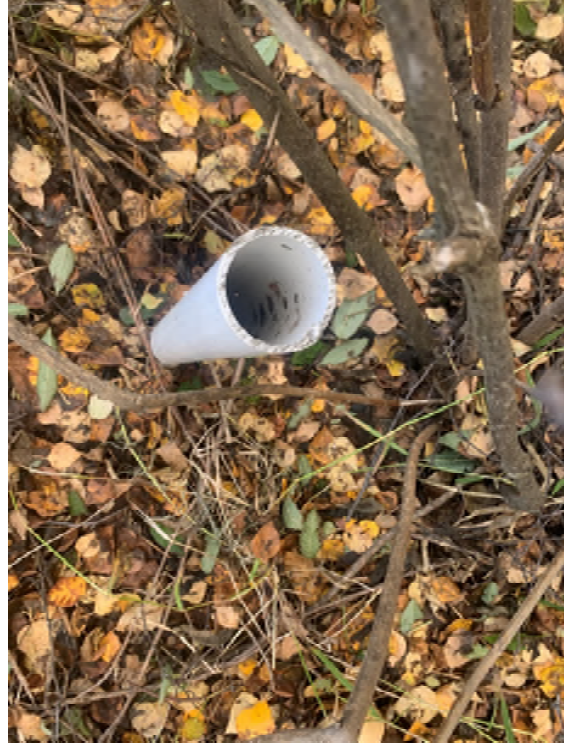
the survey, only one of the priority monitoring wells (HOS-5) was located and found to be in potentially usable condition. This well did not have a cap in place and had a petroleum odor. Accumulation of dirt/debris in this well is possible, which could impact the ability to properly redevelop and collect a groundwater sample from this well. Historically this monitoring well had the highest benzene concentration at the site and, if usable, shall be used to assess the potential for contamination remaining onsite. Monitoring well HOS-11 is not a priority well and was located cross gradient to HOS-05. This well was not assessed during the 2019 survey and its current condition is unknown. The field team will attempt to locate the HOS-11 and if found will collect a groundwater sample at this location as well.

Closeup/overhead of HOS-5

If contaminated groundwater is found in monitoring well HOS-5, then an additional well located further downgradient (Figure A-7) will be installed, developed, and sampled to determine the extent of groundwater contamination since the last round of sampling. Samples will be analyzed for DRO, GRO, and BTEX. The location(s) of any additional monitoring wells will be based on the results of the initial groundwater sampling. Additional monitoring well installation will be conducted during a second mobilization to the site.

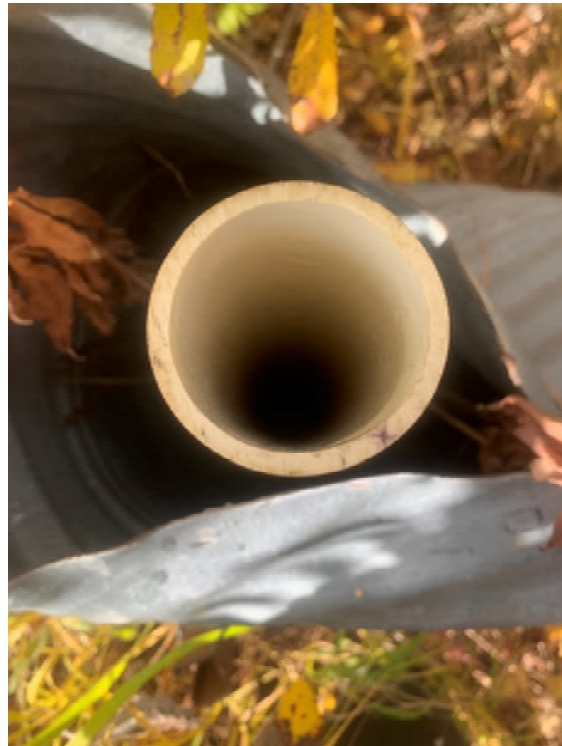
FG-15 overhead shot – note crushed protective
culvert, well undamaged

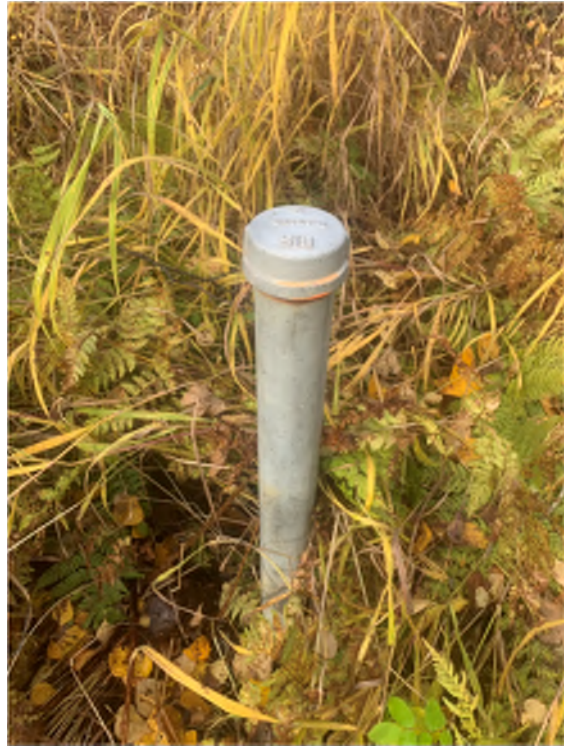
FG-25 Closeup
