Hilcorp Alaska, LLC

**Beluga River Unit Site Characterization and
Groundwater Sampling Work Plan**

June 2021

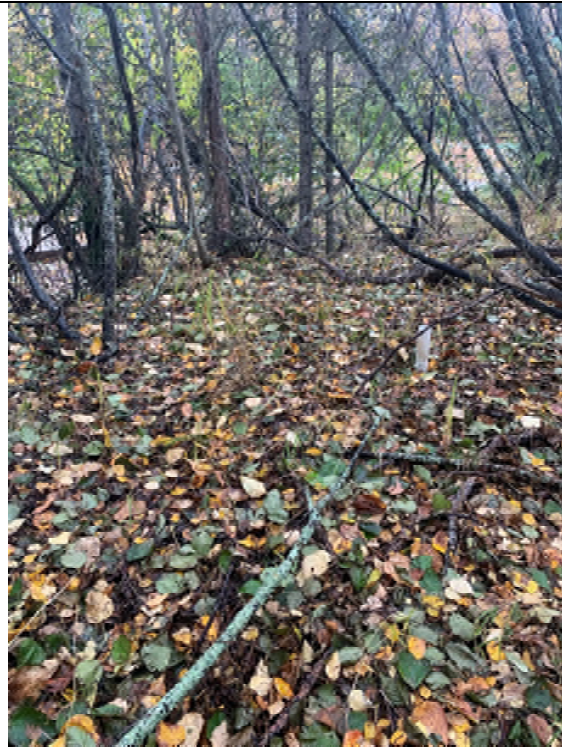
The October 2019 survey located three of the four monitoring wells in usable condition (ATF3, ATF8, and ATF10 – see Figure A-5) that were within the previous contaminated groundwater plume or downgradient of the plume. Historically, monitoring well ATF3 had the highest DRO concentration and will be used to determine the current status of groundwater contamination. Monitoring wells ATF8 and AFT10 are downgradient of the release area and could be used to determine the current extent of contamination. Monitoring well ATF1, which was not located during the October 2019 survey, was positioned cross-gradient of the abandoned tank farm and historically had a DRO concentration approximately half that of monitoring well ATF3.

Closeup/overhead of ATF3

Well ATF3 Surroundings
Facing North

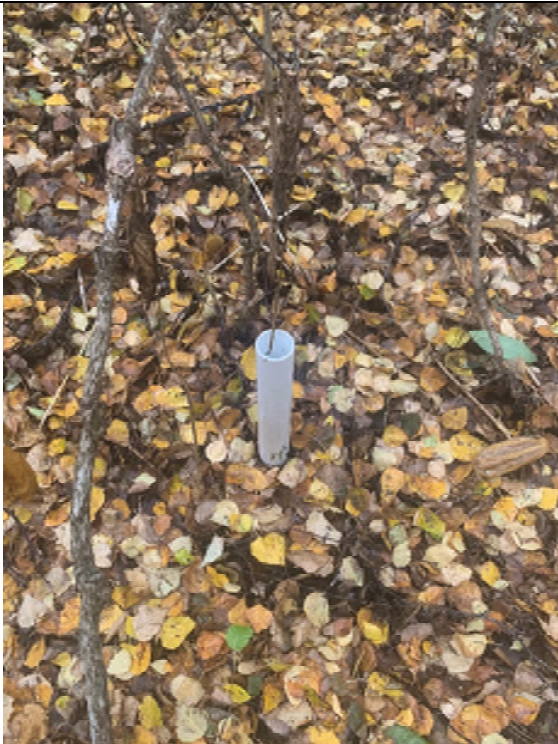
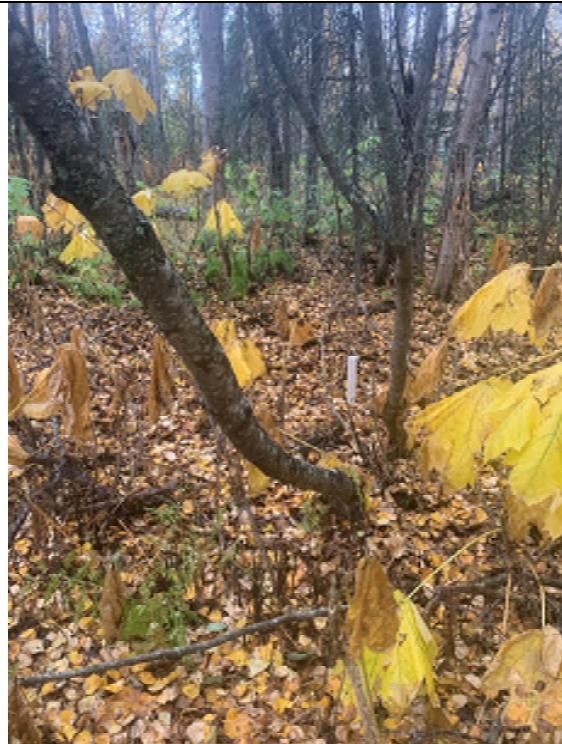
Closeup of ATF 8
Facing North

ATF8 surroundings
Facing North

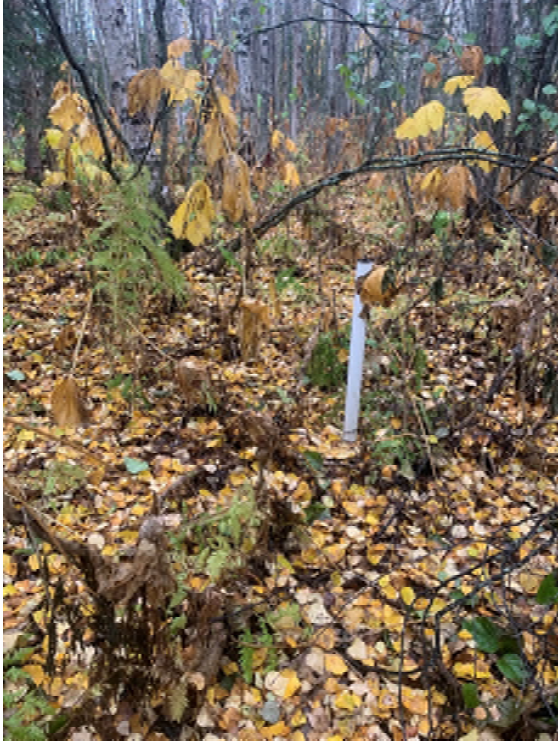
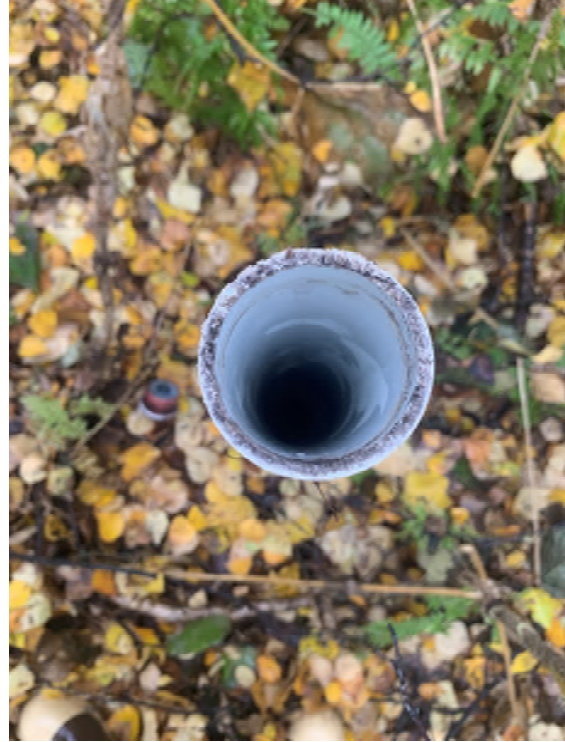
ATF10 surroundings
Facing North

ATF10 Overhead

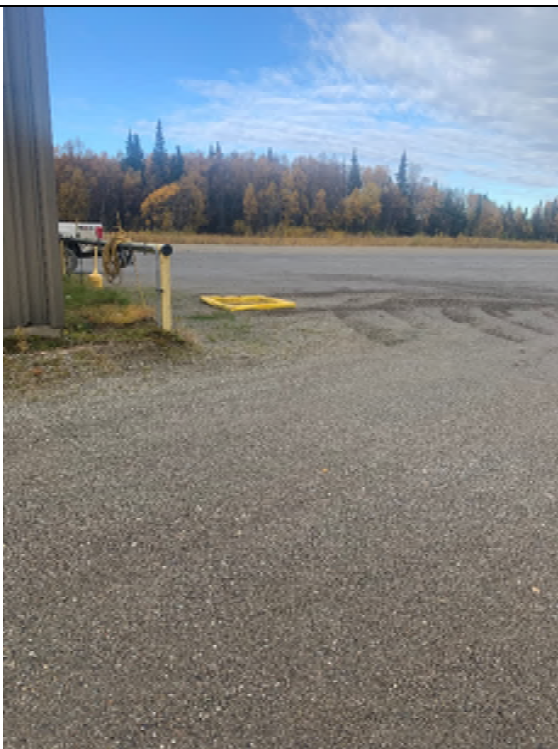
Assumed former location of HOS-1
Facing North

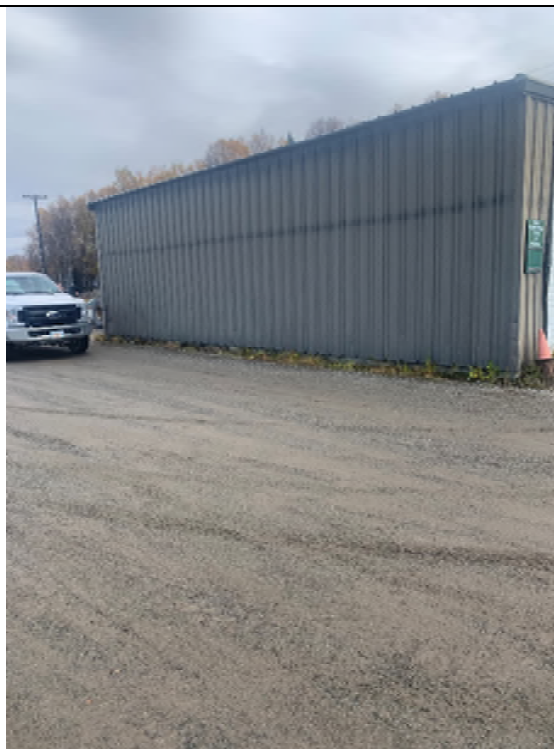
Assumed former location of HOS-3
Facing East

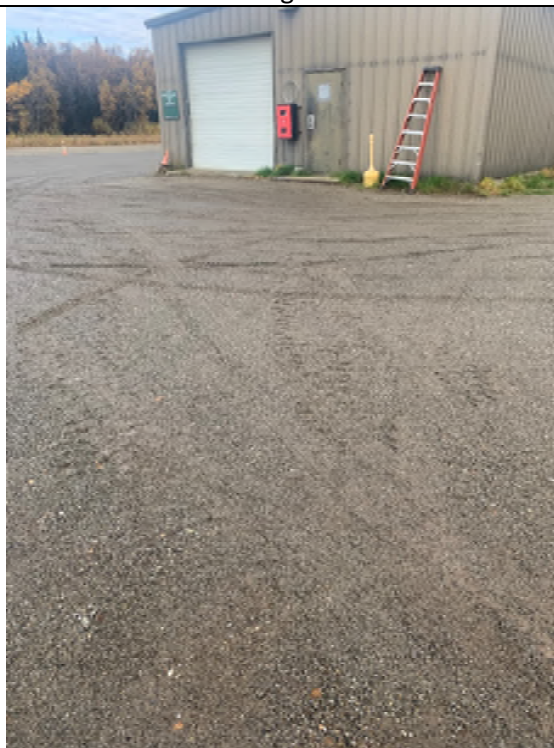
Assumed former location of HOS-6
Facing North

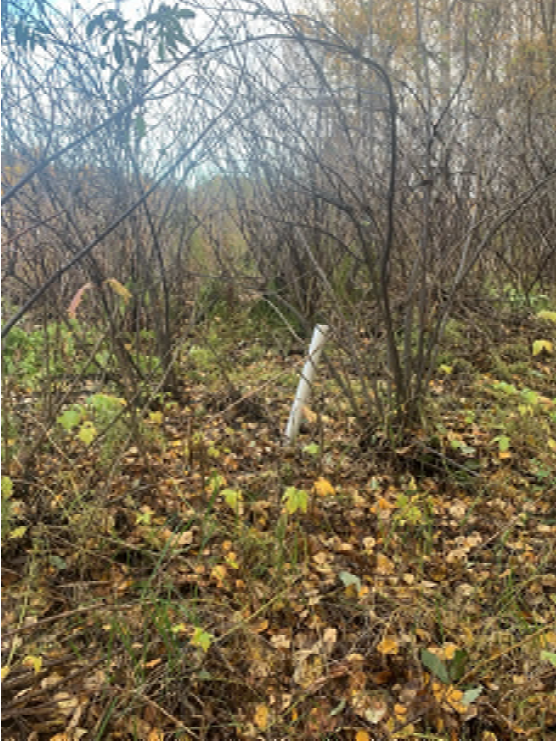
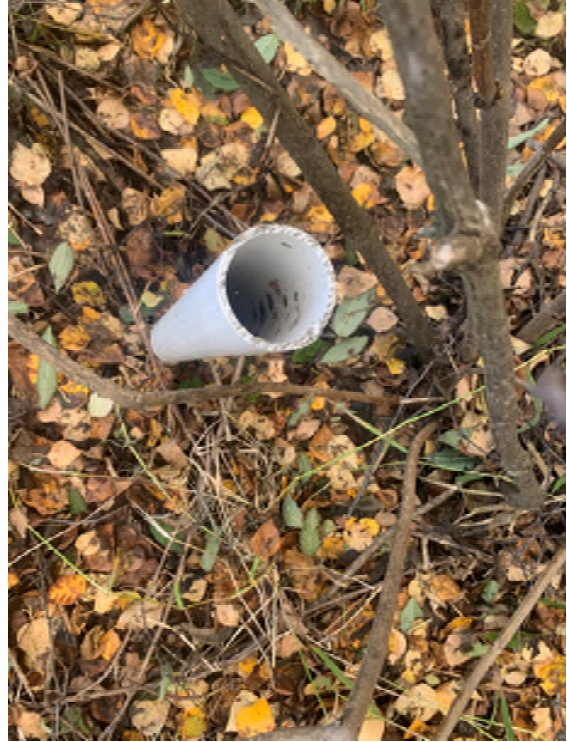
the survey, only one of the priority monitoring wells (HOS-5) was located and found to be in potentially usable condition. This well did not have a cap in place and had a petroleum odor. Accumulation of dirt/debris in this well is possible, which could impact the ability to properly redevelop and collect a groundwater sample from this well. Historically this monitoring well had the highest benzene concentration at the site and, if usable, shall be used to assess the potential for contamination remaining onsite. Monitoring well HOS-11 is not a priority well and was located cross gradient to HOS-05. This well was not assessed during the 2019 survey and its current condition is unknown. The field team will attempt to locate the HOS-11 and if found will collect a groundwater sample at this location as well.

HOS-5	Former Beluga River Tank Farm (P&S Yard)	yes	stick up	no	no	no	No outer casing, crooked (frost jacked/pushed)	No obstruction	12.85	2.05	18.2	Odor present
HOS-6	Former Beluga River Tank Farm (P&S Yard)	no	N/A	N/A	N/A	N/A	N/A	N/A	N/A	N/A	N/A	
HOS-9	Former Beluga River Tank Farm (P&S Yard)	no	N/A	N/A	N/A	N/A	N/A	N/A	N/A	N/A	N/A	
HOS-10	Former Beluga River Tank Farm (P&S Yard)	no	N/A	N/A	N/A	N/A	N/A	N/A	N/A	N/A	N/A	
HOS-13	Former Beluga River Tank Farm (P&S Yard)	no	N/A	N/A	N/A	N/A	N/A	N/A	N/A	N/A	N/A

Assumed former location/remains of HOS-5
Facing East

HOS-5 surrounds
Facing North

Closeup/overhead of HOS-5

If contaminated groundwater is found in monitoring well HOS-5, then an additional well located further downgradient (Figure A-7) will be installed, developed, and sampled to determine the extent of groundwater contamination since the last round of sampling. Samples will be analyzed for DRO, GRO, and BTEX. The location(s) of any additional monitoring wells will be based on the results of the initial groundwater sampling. Additional monitoring well installation will be conducted during a second mobilization to the site.

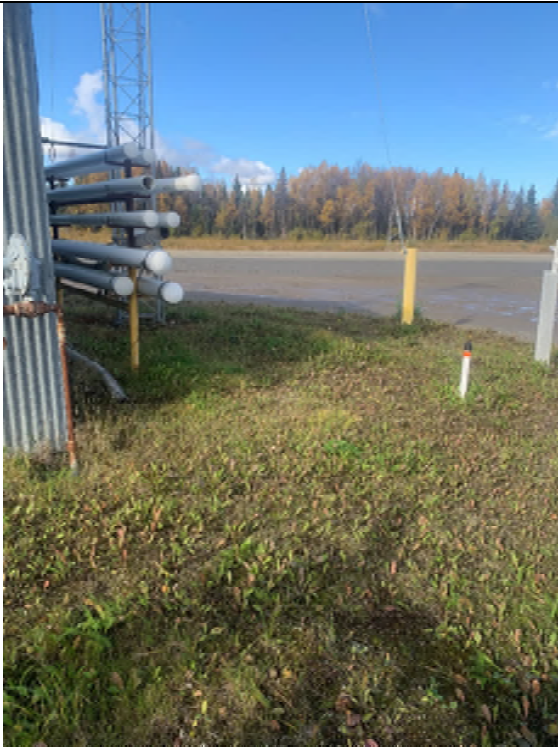
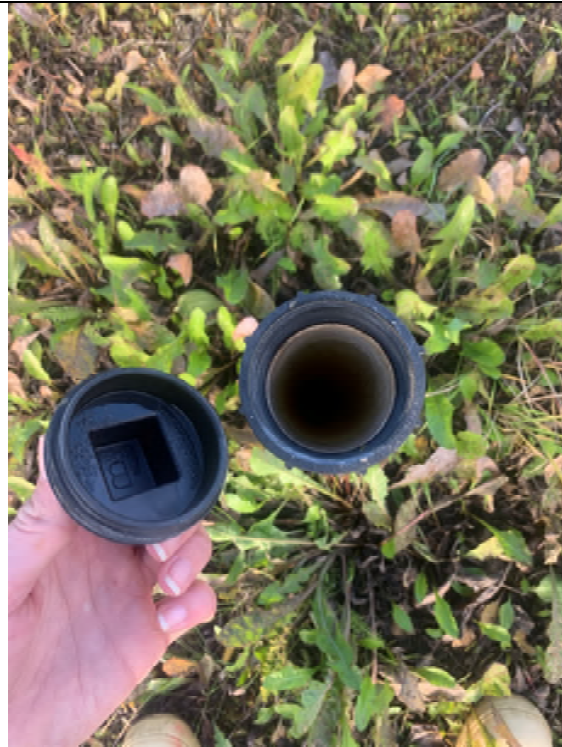
- FG-03 – Good condition, no obstruction
- FG-08 – Located but monument was knocked over and the top of well is crushed
- FG-14 – Good condition, no obstruction
- FG-15 – Good condition with no obstruction but no water was present in the well, possibly due to the dry summer
- FG-20 – Good condition, no obstruction
- FG-21 – Good condition, no obstruction but slightly sunken
- FG-23 – Good condition, no obstruction
- FG-24 – Located but unable to open cap
- FG-25 – Located but unable to open cap

FG-03 surroundings
Facing North

FG-03 closeup/overhead

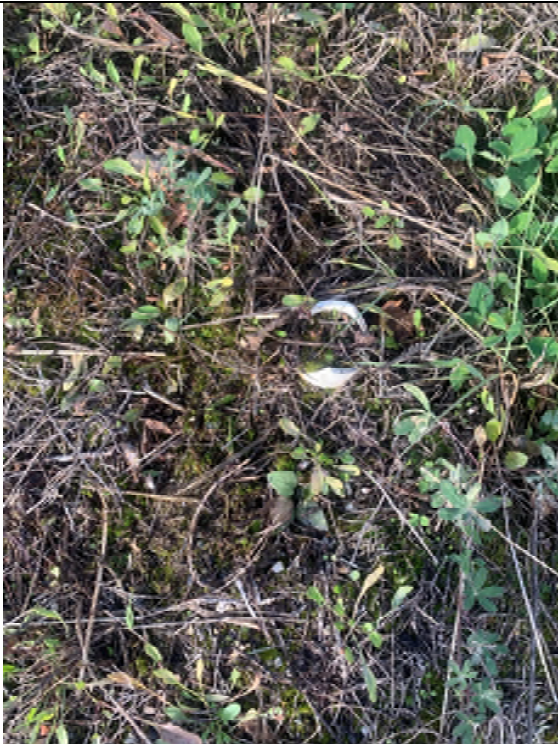
Monitoring well FG-08 historically had the highest DRO and benzene concentrations from the western plume but found to be damaged during the 2019 survey. Two downgradient monitoring wells (FG-14 and FG-21) were located (Figure A-6), but a third (FG-11) could not be located. Monitoring wells FG-24 and FG-25, within the eastern plume, could not be fully assessed due to stuck caps. FG-25 historically had the highest DRO concentration from the eastern plume. The upgradient monitoring wells FG-20 and FG-23 were both located and usable.

Crushed remnants of FG-08
Overhead shot

Monitoring wells FG-03, FG-14, and FG-21 will be sampled from the western plume. Additionally, the field team will attempt to repair and sample FG-08 and find and sample FG-10. If successful, each well will be redeveloped and then sampled. Monitoring wells FG-20, FG-23, FG-24, and FG-25 will be redeveloped and sampled from the eastern plume. All samples will be analyzed for DRO, GRO, and BTEX. The field team will attempt to find and sample wells FG-01 and FG-02 and determine the location and sampling protocol for the current potable water well serving camp.

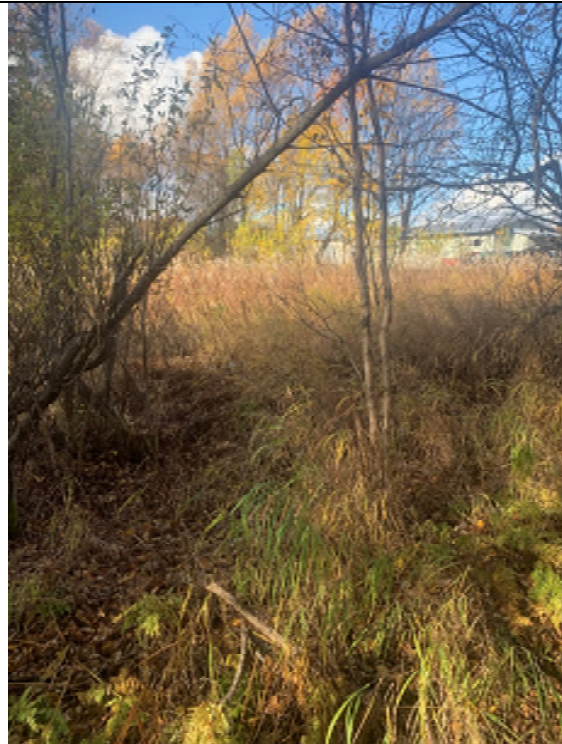
Assumed former location of FG-011
Facing North

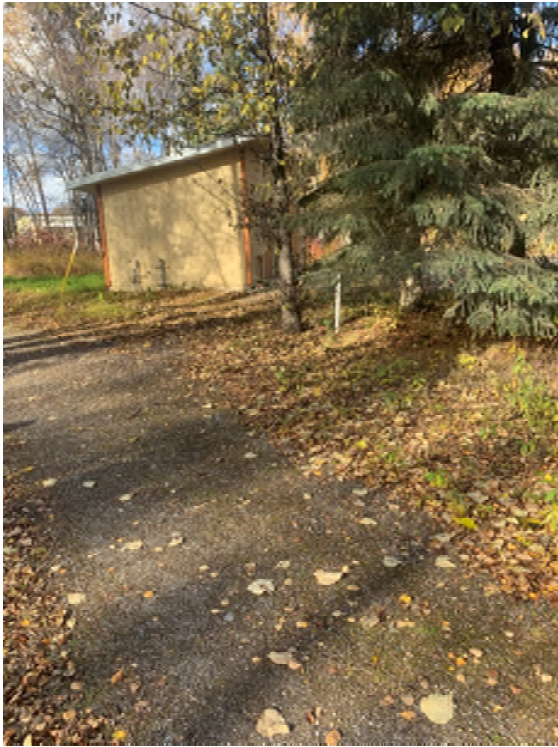
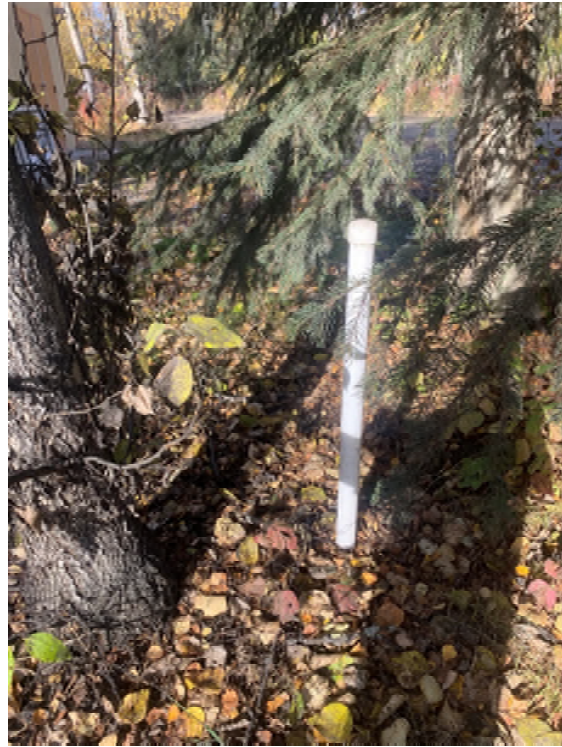
FG-14 surrounding
Facing North

FG-14 closeup
Facing East

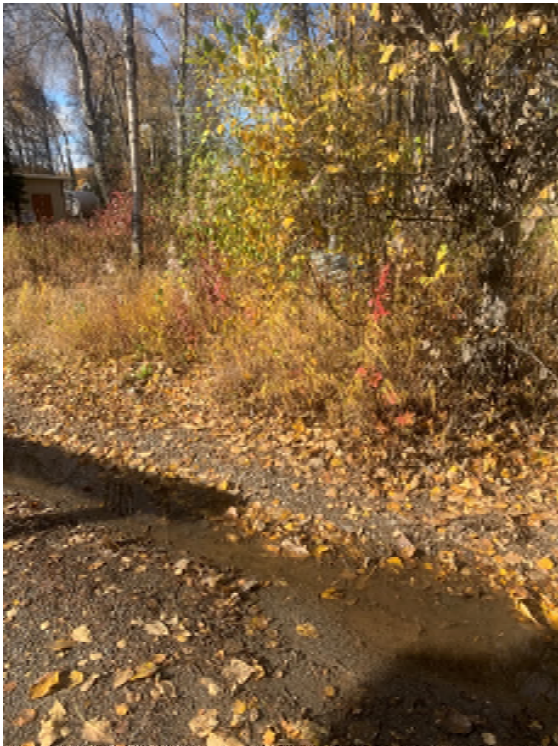
FG-15 surroundings
Facing North

FG-15 overhead shot – note crushed protective
culvert, well undamaged

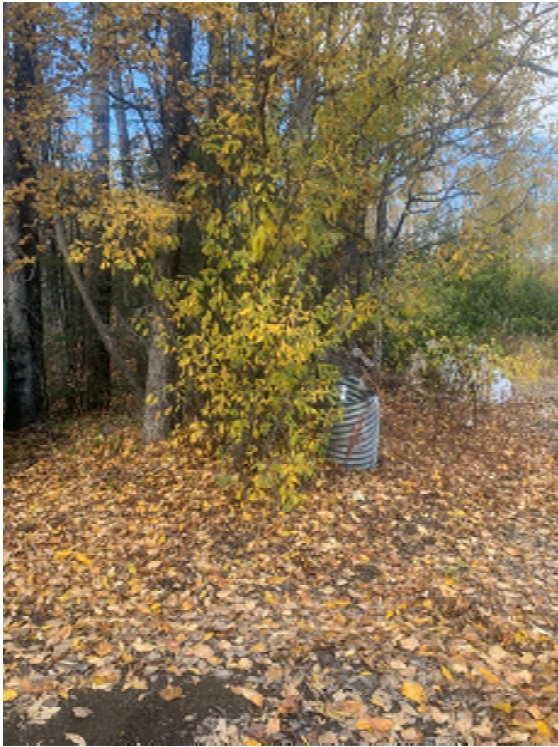
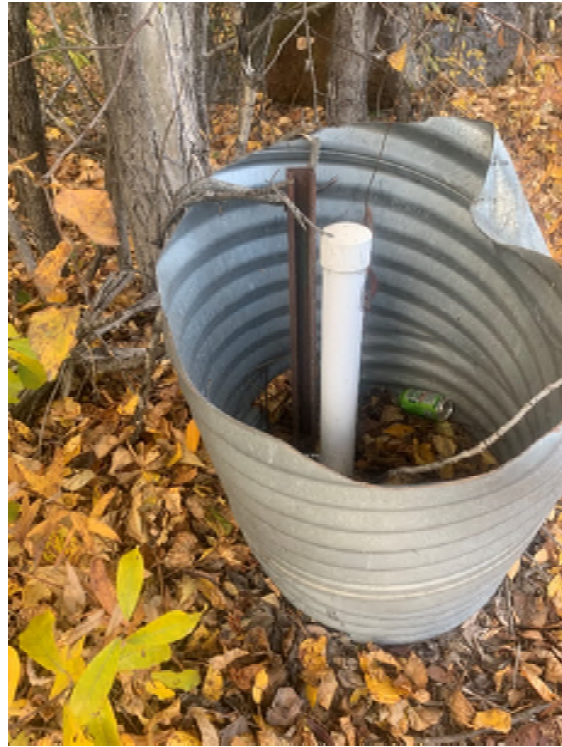
FG-20 surroundings
Facing North

FG-20 closeup

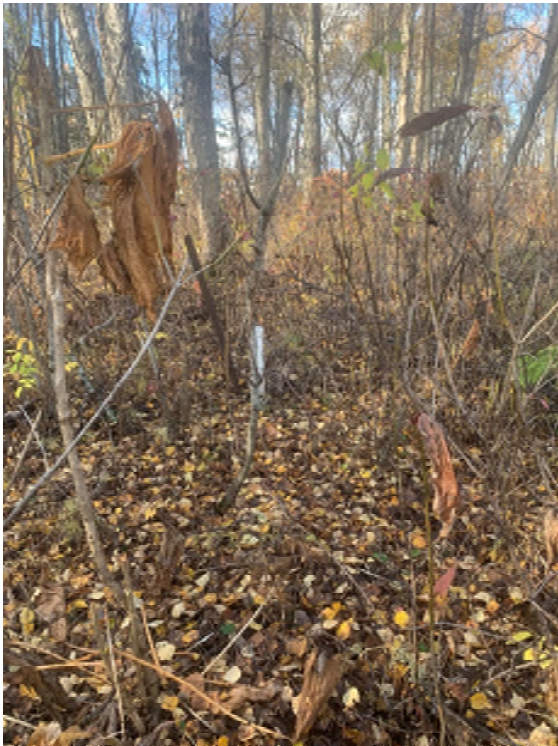
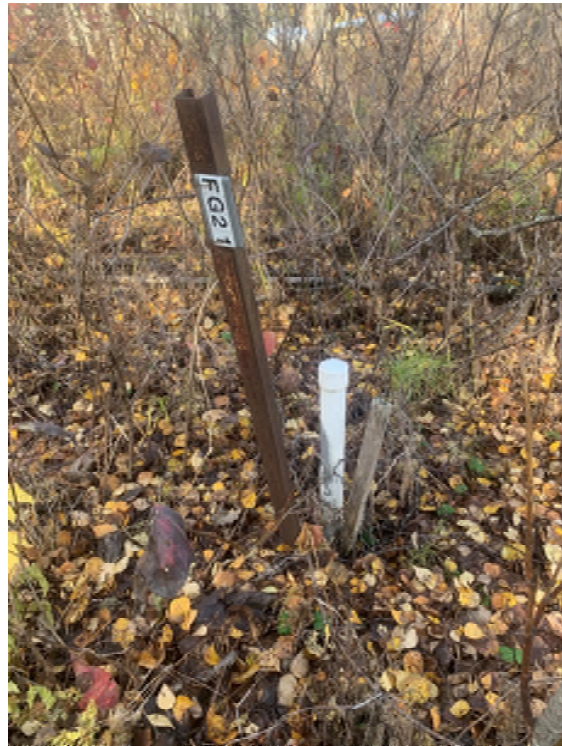
FG-21 surroundings
Facing roughly North

FG-21 closeup

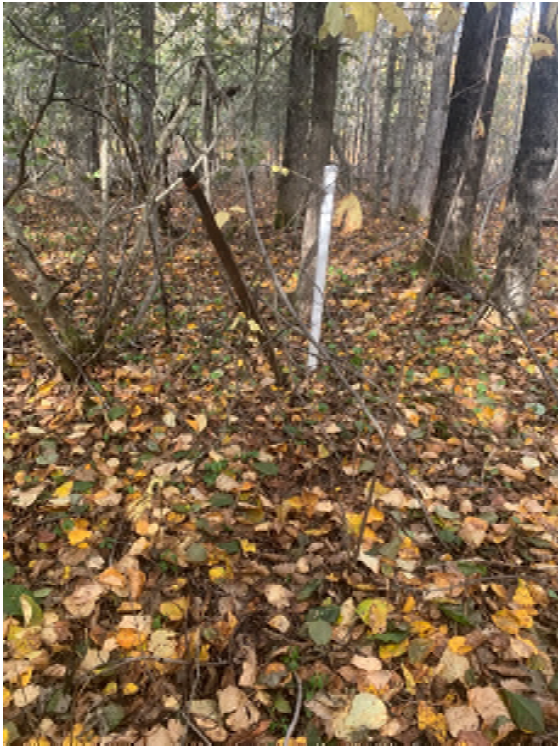
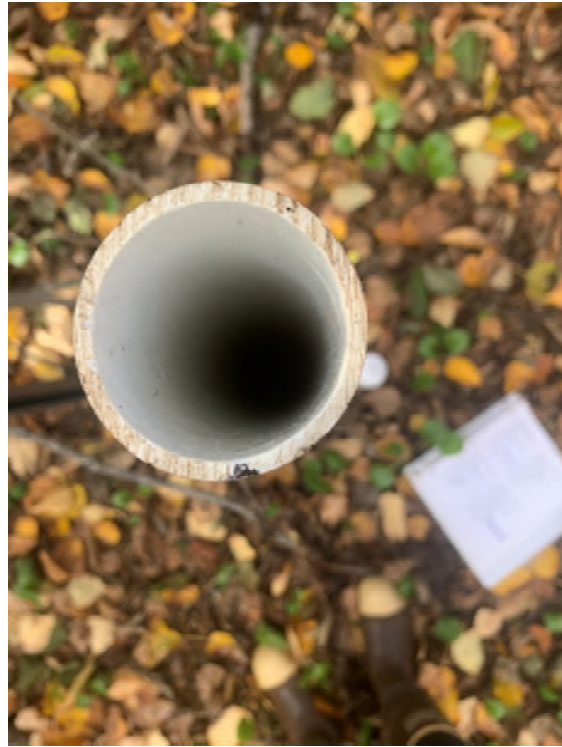
FG-23 surroundings – post has well ID
Facing North

FG-23 overhead

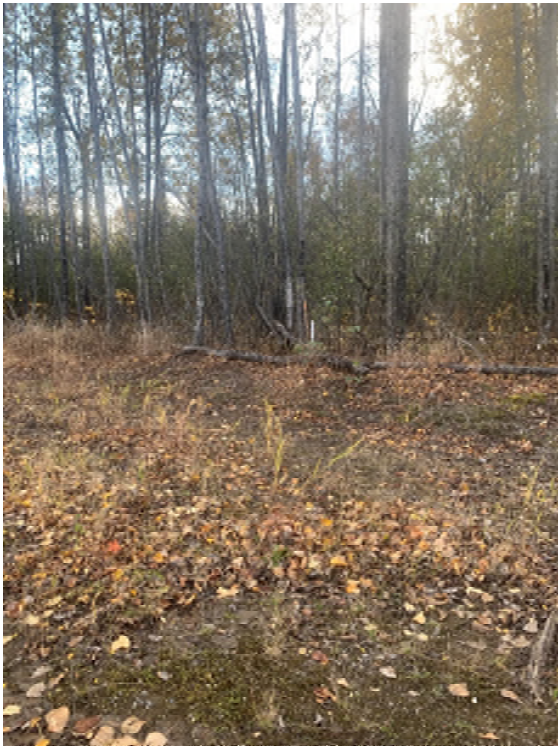
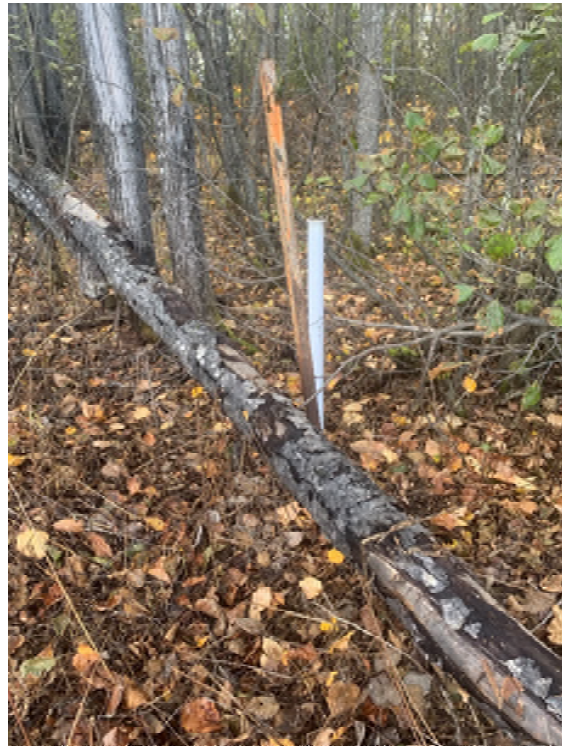
FG-24 surroundings
Facing South

FG-24 closeup
Facing South

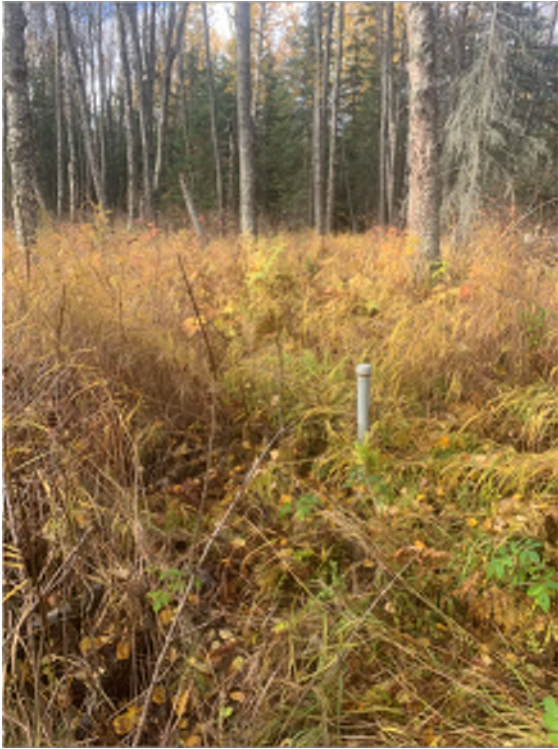
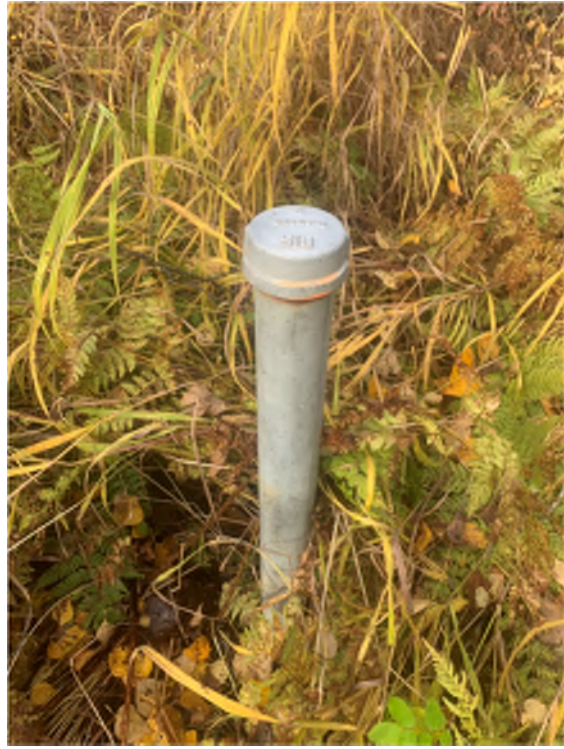
FG-25 surroundings
Facing roughly North

FG-25 Closeup
