**Hilcorp Alaska, LLC**

**Beluga River Unit Site Characterization and  
Groundwater Sampling Work Plan**

**June 2021**

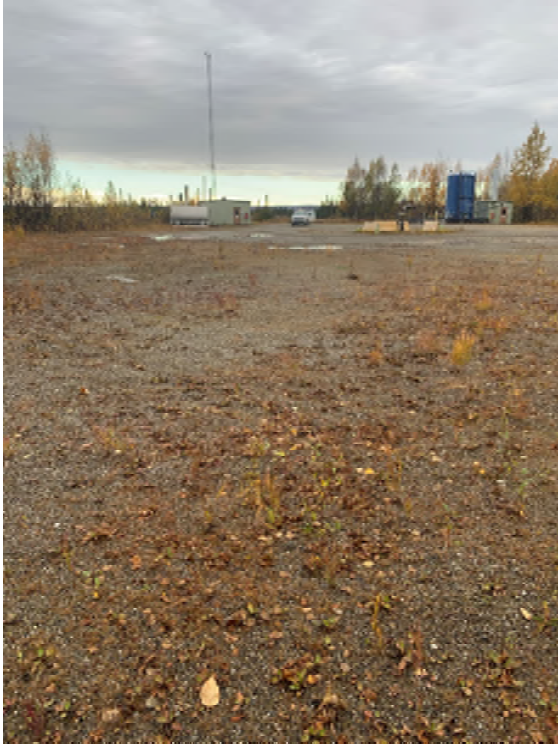
During the October 2019 survey, only one of the two monitoring wells was located in usable condition (well 224-13-2, located in the northwest portion of the pad – see Figure A-4). The other monitoring well (224-13-1) was positioned west of the wellhead building but was not located during the October 2019 survey.

Assumed location of missing well 224-13-1  
Facing West

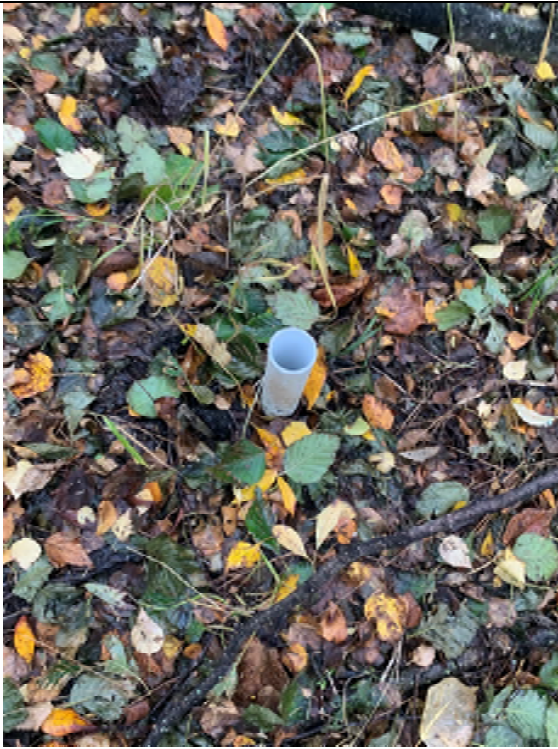
Closeup/overhead of ATF3

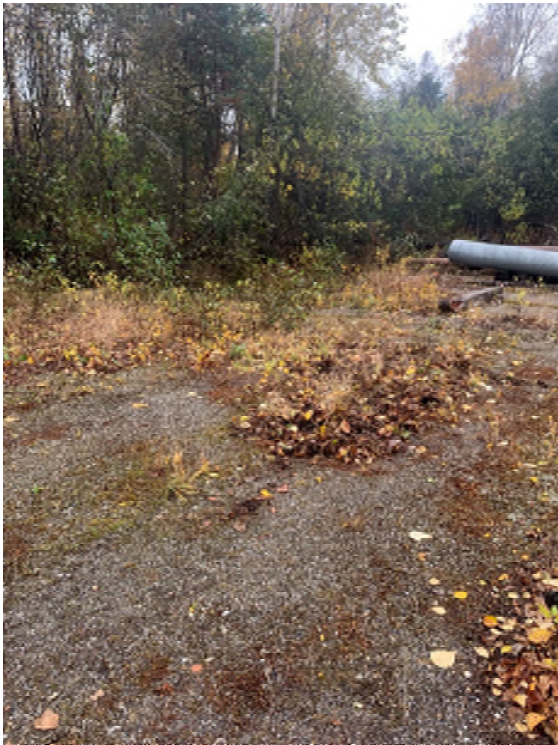
Assumed former location of ATF1

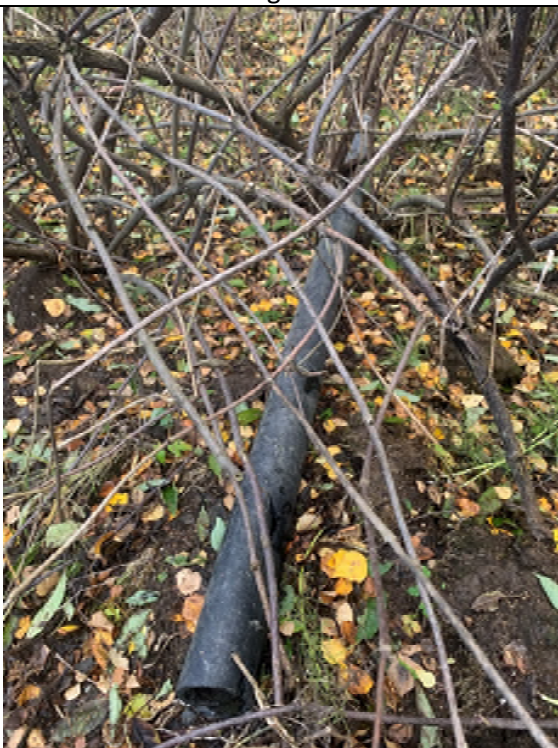
Assumed former location/remains of HOS-5  
Facing East

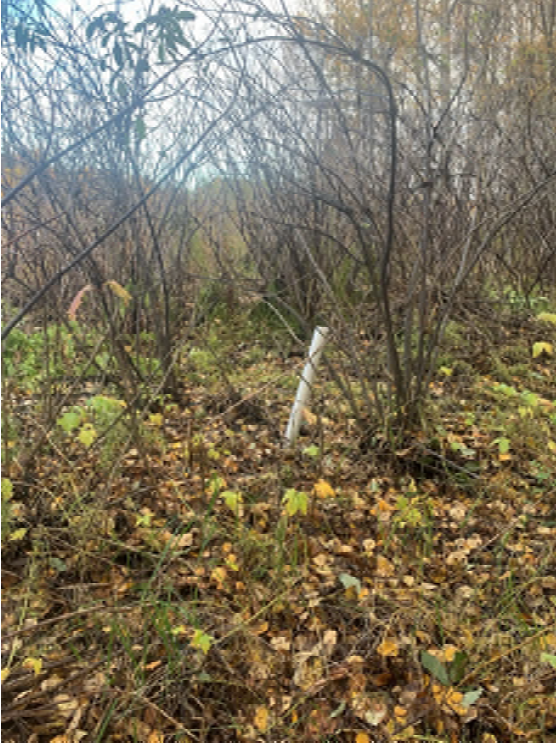
the survey, only one of the priority monitoring wells (HOS-5) was located and found to be in potentially usable condition. This well did not have a cap in place and had a petroleum odor. Accumulation of dirt/debris in this well is possible, which could impact the ability to properly redevelop and collect a groundwater sample from this well. Historically this monitoring well had the highest benzene concentration at the site and, if usable, shall be used to assess the potential for contamination remaining onsite. Monitoring well HOS-11 is not a priority well and was located cross gradient to HOS-05. This well was not assessed during the 2019 survey and its current condition is unknown. The field team will attempt to locate the HOS-11 and if found will collect a groundwater sample at this location as well.

HOS-5 surrounds  
Facing North

If contaminated groundwater is found in monitoring well HOS-5, then an additional well located further downgradient (Figure A-7) will be installed, developed, and sampled to determine the extent of groundwater contamination since the last round of sampling. Samples will be analyzed for DRO, GRO, and BTEX. The location(s) of any additional monitoring wells will be based on the results of the initial groundwater sampling. Additional monitoring well installation will be conducted during a second mobilization to the site.

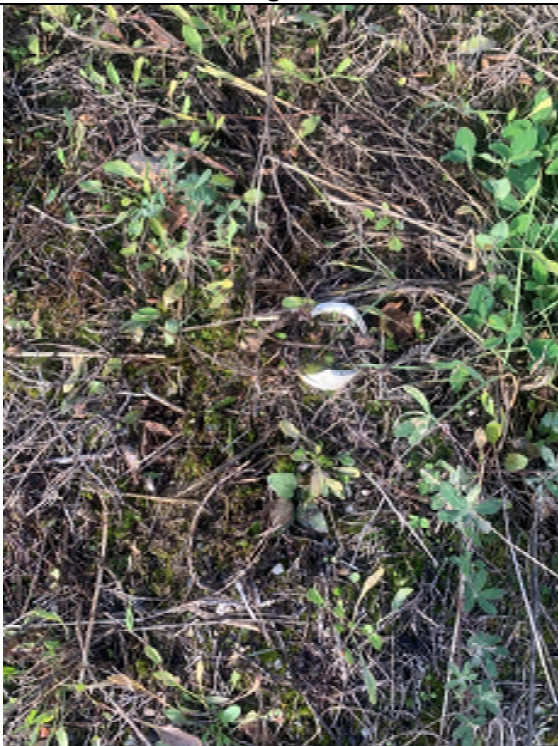
Monitoring well FG-08 historically had the highest DRO and benzene concentrations from the western plume but found to be damaged during the 2019 survey. Two downgradient monitoring wells (FG-14 and FG-21) were located (Figure A-6), but a third (FG-11) could not be located. Monitoring wells FG-24 and FG-25, within the eastern plume, could not be fully assessed due to stuck caps. FG-25 historically had the highest DRO concentration from the eastern plume. The upgradient monitoring wells FG-20 and FG-23 were both located and usable.

Crushed remnants of FG-08  
Overhead shot

Monitoring wells FG-03, FG-14, and FG-21 will be sampled from the western plume. Additionally, the field team will attempt to repair and sample FG-08 and find and sample FG-10. If successful, each well will be redeveloped and then sampled. Monitoring wells FG-20, FG-23, FG-24, and FG-25 will be redeveloped and sampled from the eastern plume. All samples will be analyzed for DRO, GRO, and BTEX. The field team will attempt to find and sample wells FG-01 and FG-02 and determine the location and sampling protocol for the current potable water well serving camp.

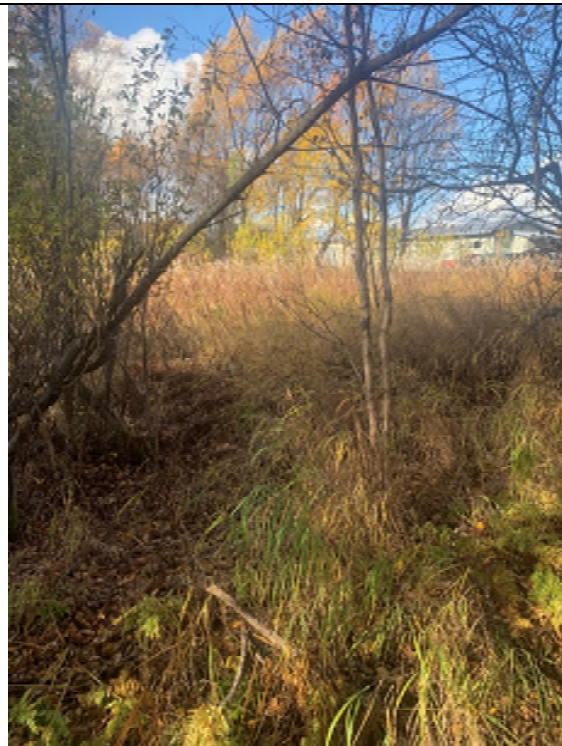
Assumed former location of FG-011  
Facing North
