**Subject:** RE: TBPf Dig 15 Release Update - 08192021

**Subject:** TBPF Dig 15 Release Update for 8/9/2021

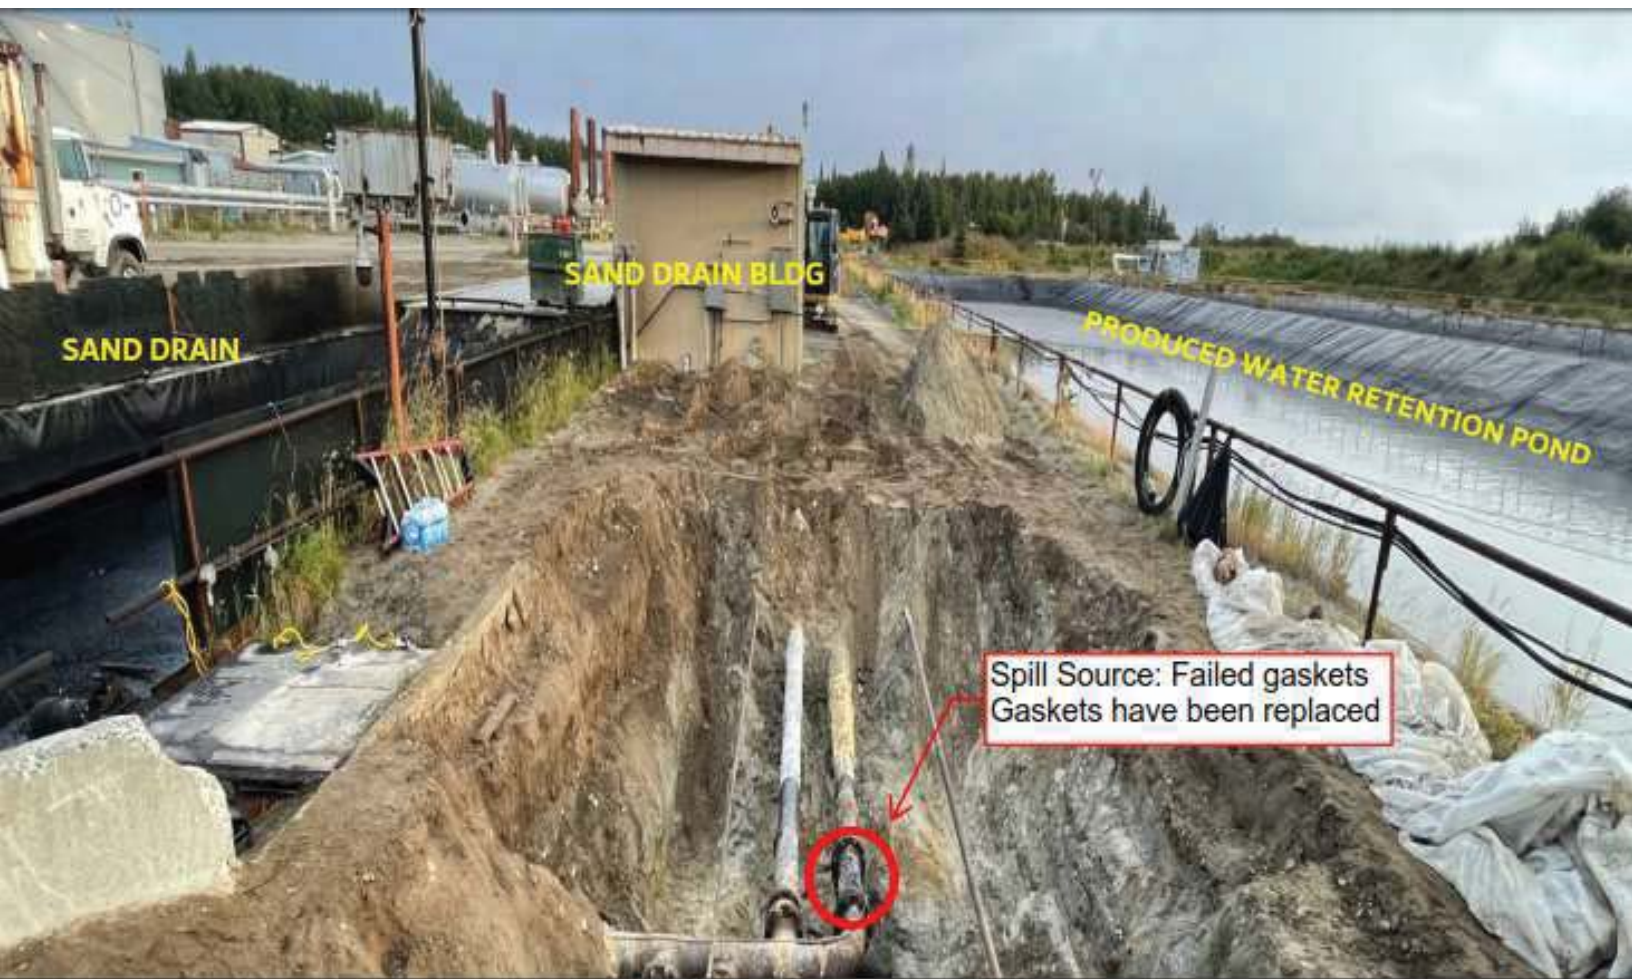
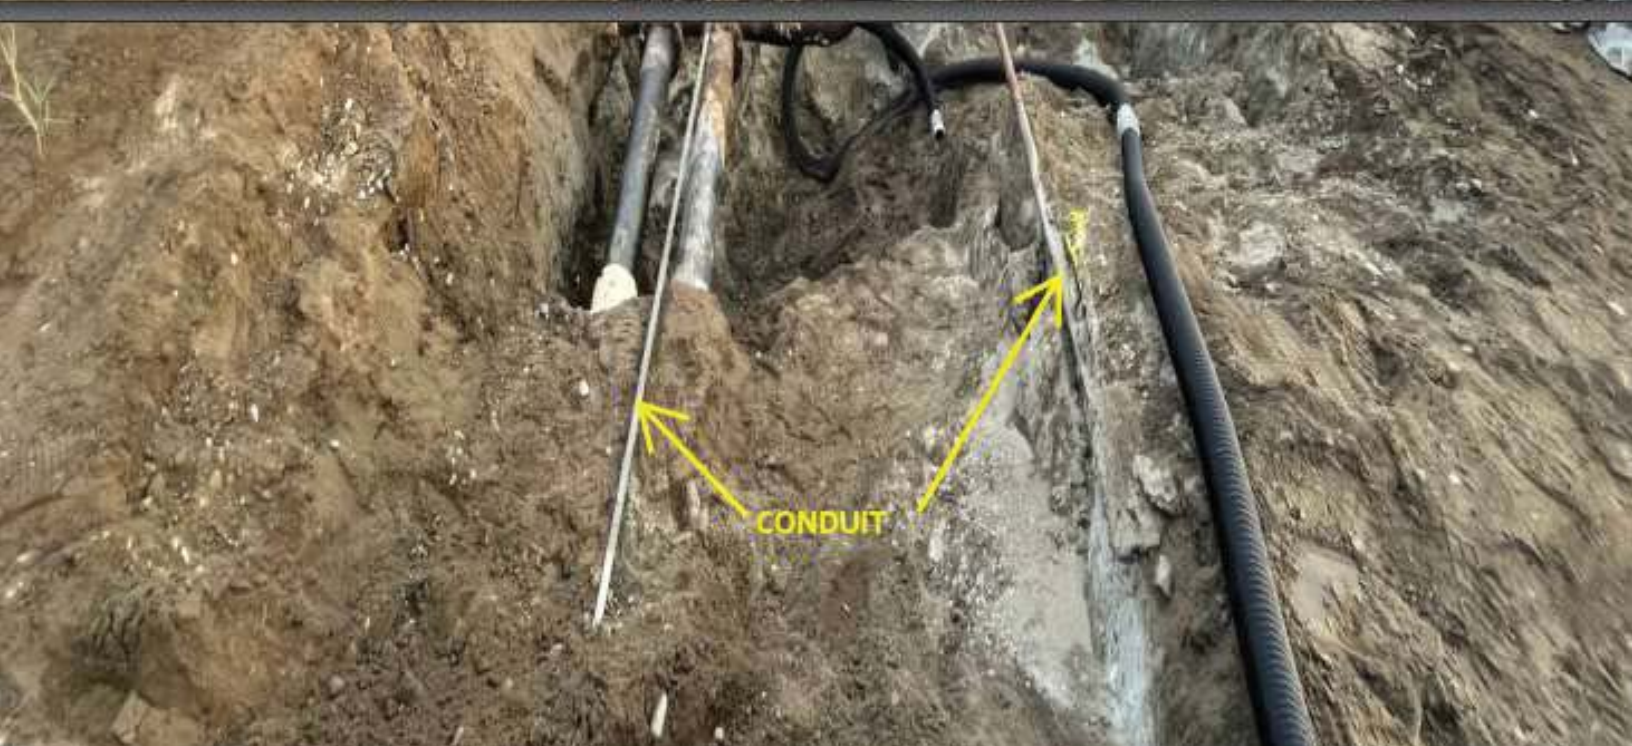
Earlier this afternoon, I had a Teams call with the acting Lead Op and the QEP providing response support. Attached is a photo of the excavation that the QEP took and scanned and to which I added feature labels and a North arrow. I've also attached a second photo that was taken from the opposite direction.

As you can see in the photos, we are reaching the practicable extents of the excavation due to existing infrastructure. The main part of the excavation, upon reaching the practicable extents, will measure approximately 12 feet by 21 feet by 11 feet deep; however, substantial benching has been needed for safe access. The surface excavation extents are therefore significantly larger. The volume of the release has been revised to 55 gallons.

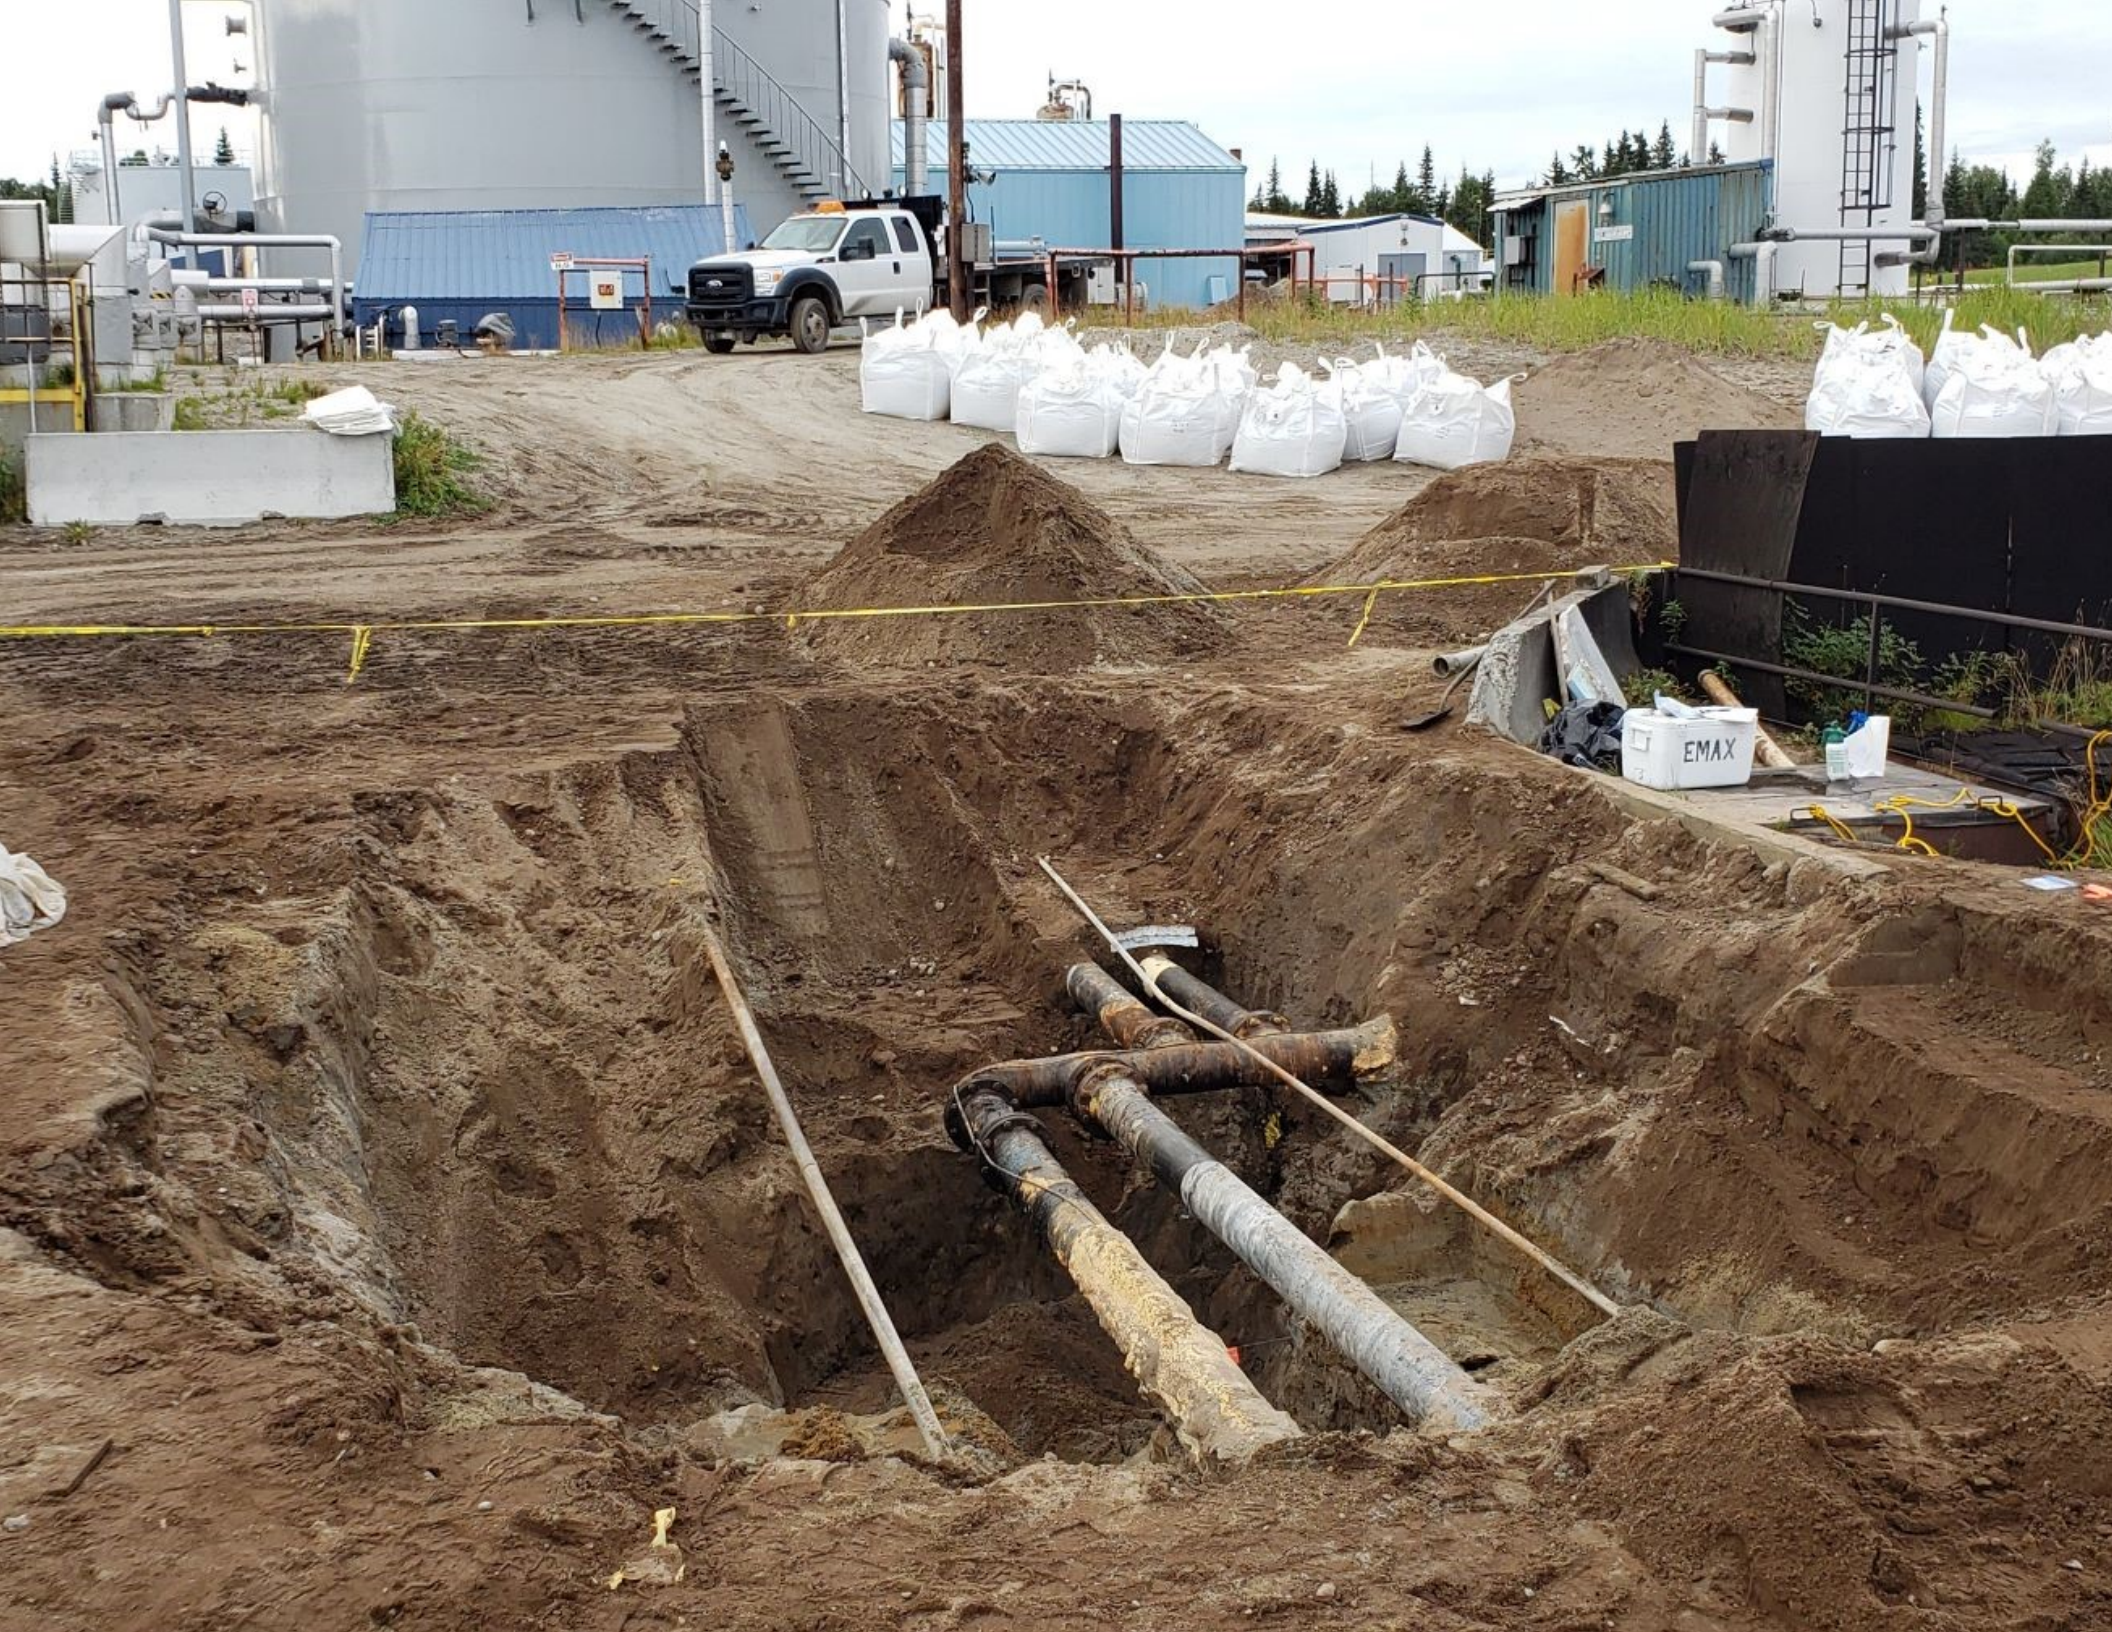
Additionally, the photo you provided (TBPf Dig 15 Release\_08122021.pdf) indicates that two leaking flange gaskets, on what appears to be a spool piece on a section of piping, were replaced. The photo shows four other flanges that are presumed to have similar gaskets.

On Thursday, August 5, 2021, while conducting excavation activities to inspect buried facility oil piping, crews observed wet spots on the piping insulation at Inspection Dig #15. The insulation was removed, revealing a seeping flange. The gasket on the flange had failed. The gasket was replaced. An estimated release volume was determined to be 5 gallons of slop oil. The oil was headed to the Sand Drain from Battery 2 via gravity-fed steel piping. On 8/9/2021, additional digging along the line uncovered another flange on the line about 2 feet from the repaired gasket. This flange also had a failed gasket and it was replaced that same day.

1. Has Hilcorp inspected those gaskets to determine suitability for continued service?
2. Has there been consideration for replacing those gaskets as preventative maintenance?
