FINAL FIRST FIVE-YEAR REVIEW REPORT FOR SITES SS002, SS007, AND SS010 AT DRIFTWOOD BAY RADIO RELAY STATION, ALASKA

United States Air Force Joint Base Elmendorf-Richardson, Alaska

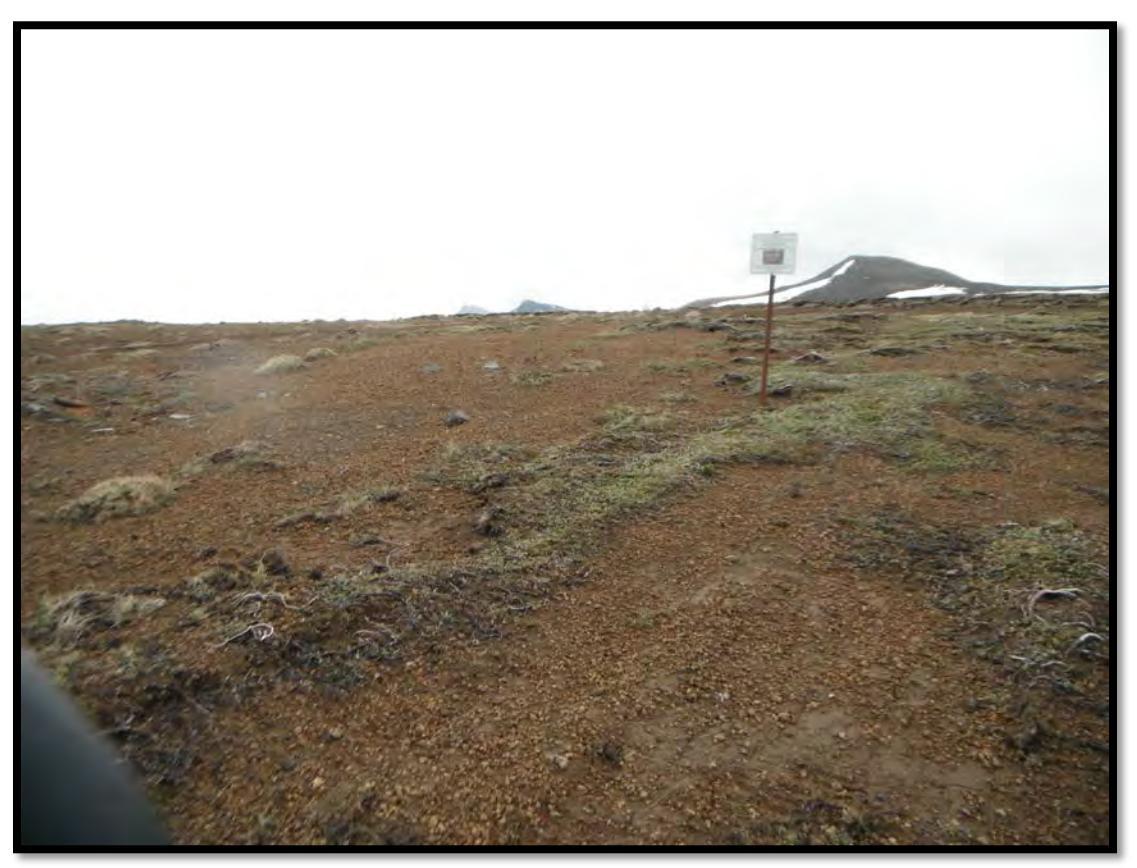
Photograph 1: SS002 Land use controls signage, view South.

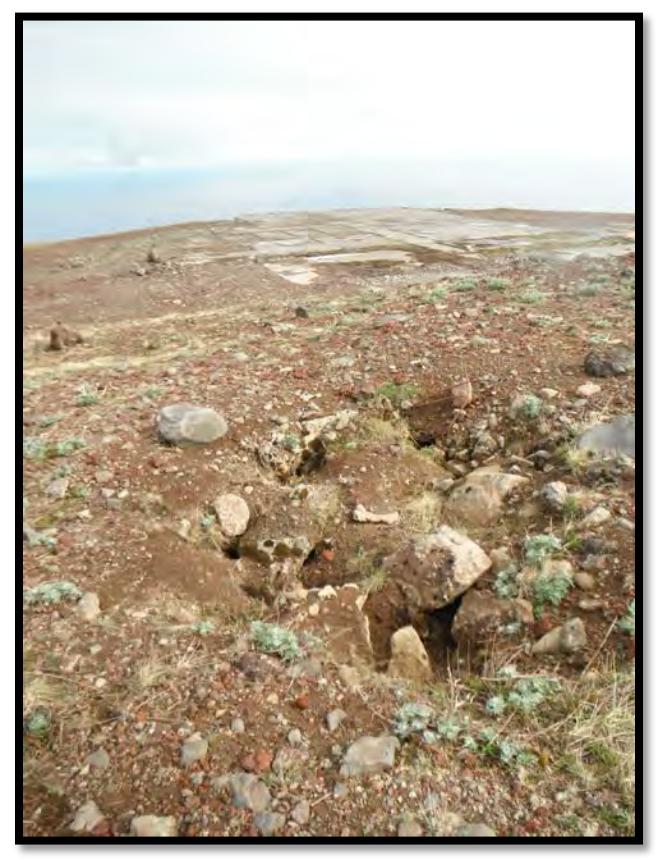
During the 2015 IC inspection, landfill debris was observed protruding through the variable thickness landfill cover at Site SS002 and subsidence was noted near the water tank (USAF, 2016b). In addition, recreational users (all-terrain vehicle users) and wildlife (a fox) were observed at Site SS002 (USAF, 2016b). In 2016, subsidence of the landfill cover was observed at several areas, most notably near the water tank, as in 2015. The 2016 inspection identified substantional erosion in ephemeral overland drainage tracts which, in several locations, cross the entire length of the landfill. Each drainage tracts is characterized by subsided land surface, exposed landfill debris, and minimal vegetative cover. The condition of the landfill cap is the only issue that affects the protectiveness of the remedy identified at Site SS002.

Photograph 2: SS002 Water cistern subsidence area with Composite Building Foundation in the background, view North.

For Site SS002, deficiencies, including protruding debris and subsidence, were documented in the landfill cap. This issue affects the protectiveness of the Site SS002 remedy. Although ICs are in place to minimize exposure to onsite contaminants, corrective actions to repair the landfill cover and restore its integrity are required.

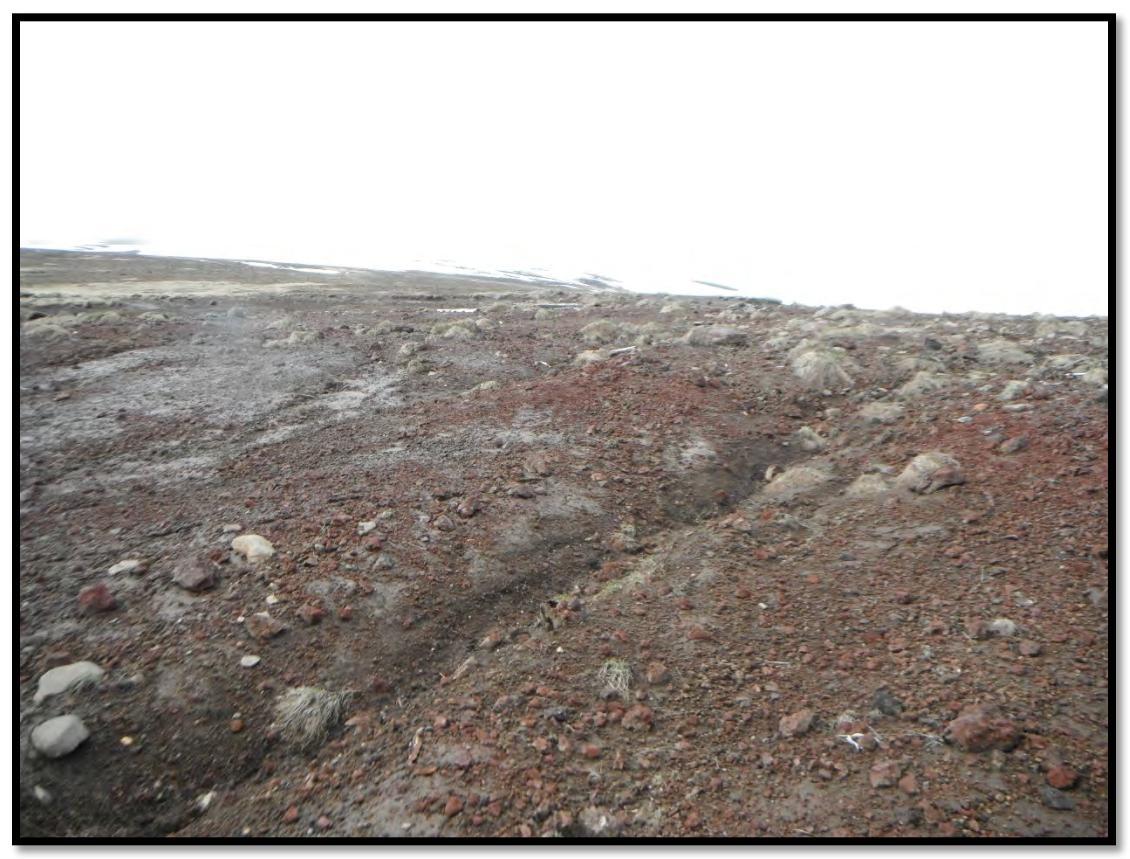
2.	Cracks Lengths Remarks	□ Location shown on site map Widths Depths	Cracking not evident
3.	Erosion Areal extent Remarks:	⊠ Location shown on site map Depth:_0 to 3+ feet	\Box Erosion not evident

Photograph 3: SS002 Example erosional features bisecting landfill cap, view South.

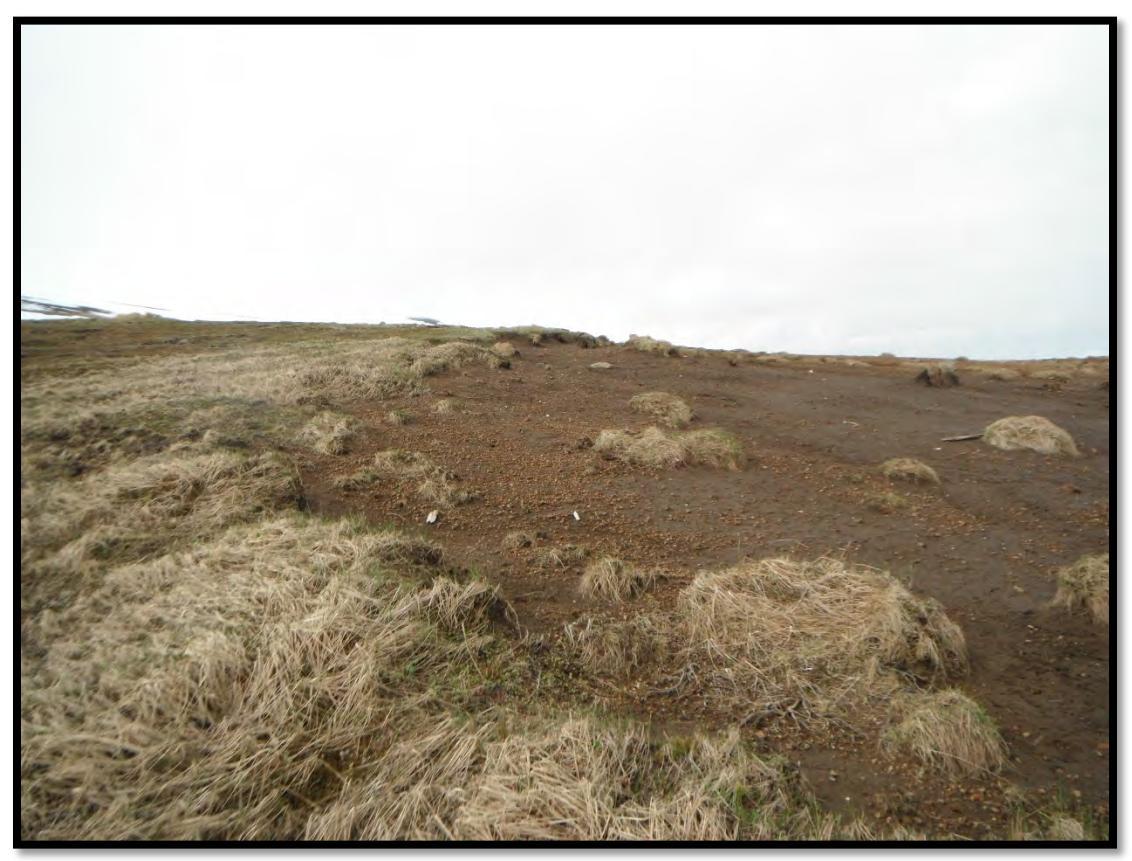
Photograph 4: SS002 Southern landfill boundary, vegetation marking undisturbed land, view West.

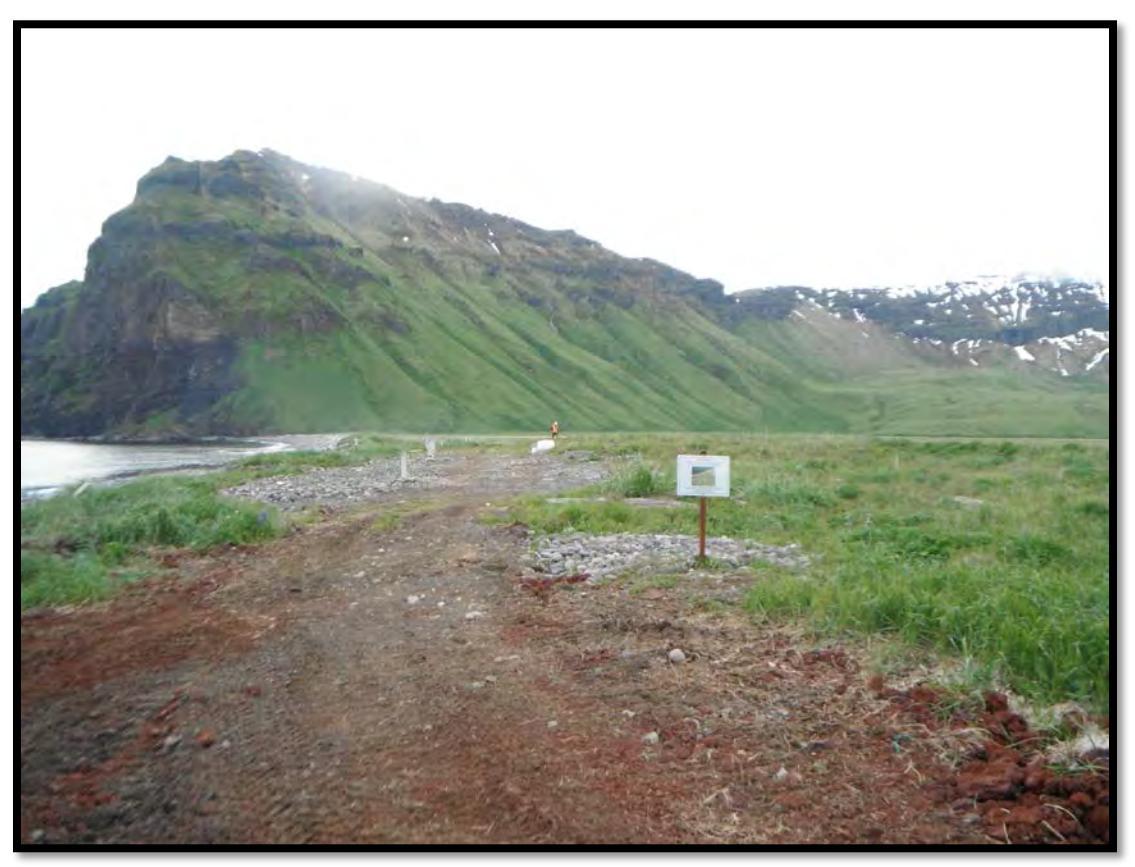
Photograph 5: SS007 Land use controls signage, view East. Monitoring wells in background.

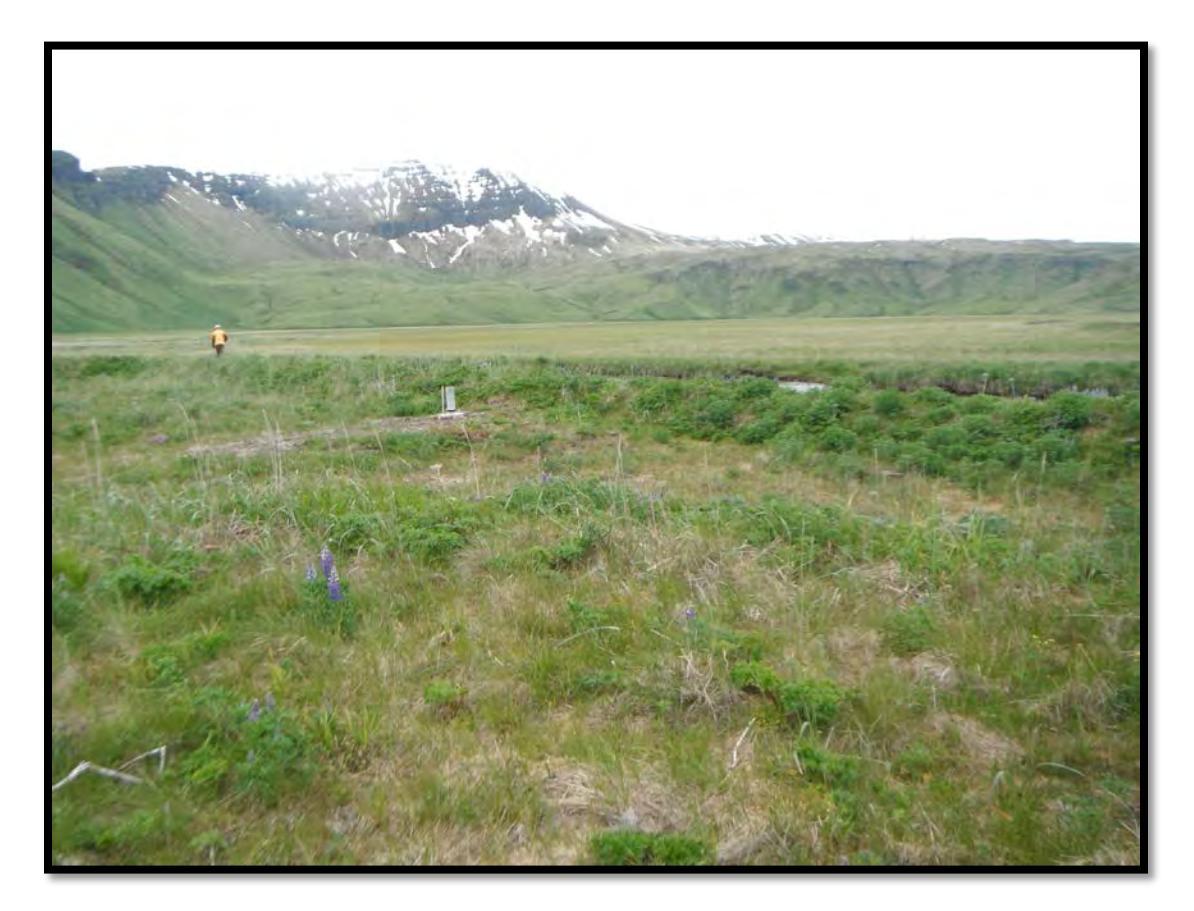
Photograph 6: SS007 Monitoring Well 6, with containment berm and Snuffy Creek immediately to the South, view South.

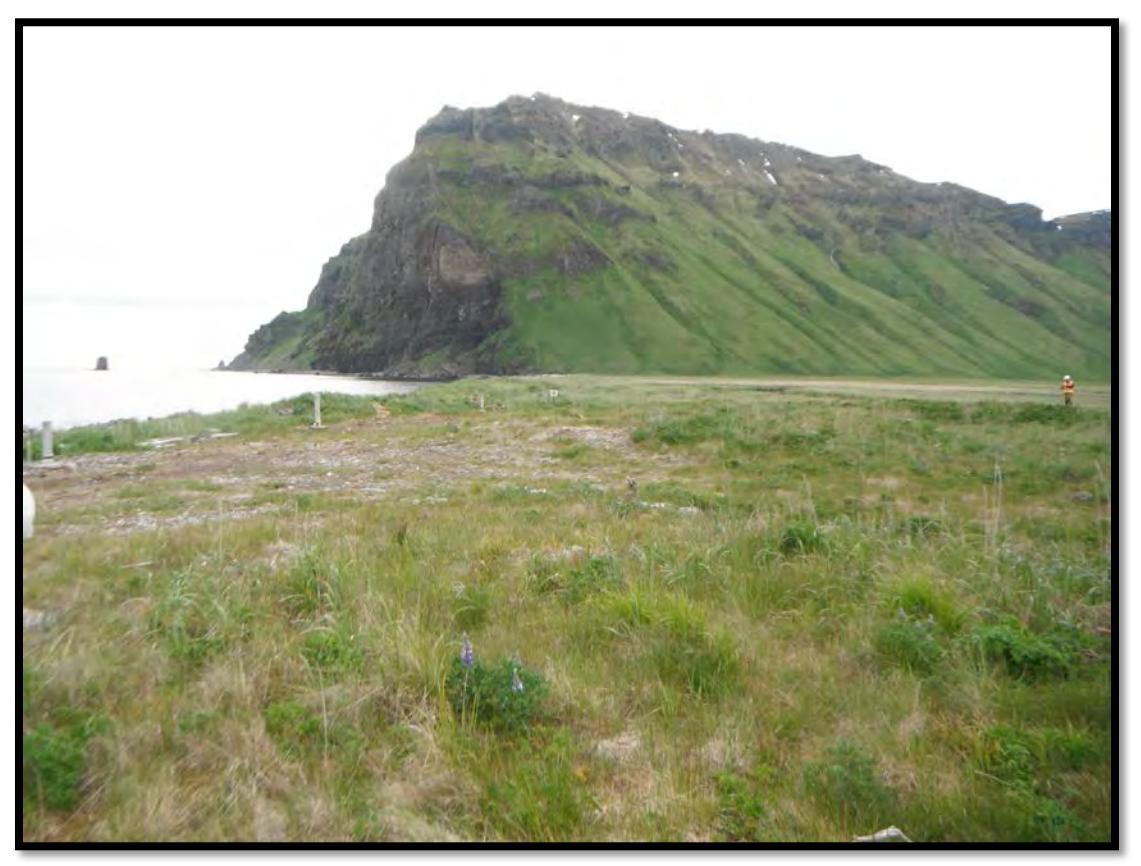
Photograph 7: SS007 Land use controls signage background, view East. Monitoring wells distributed along beach ridge to the North. Site worker standing on containment berm at South.

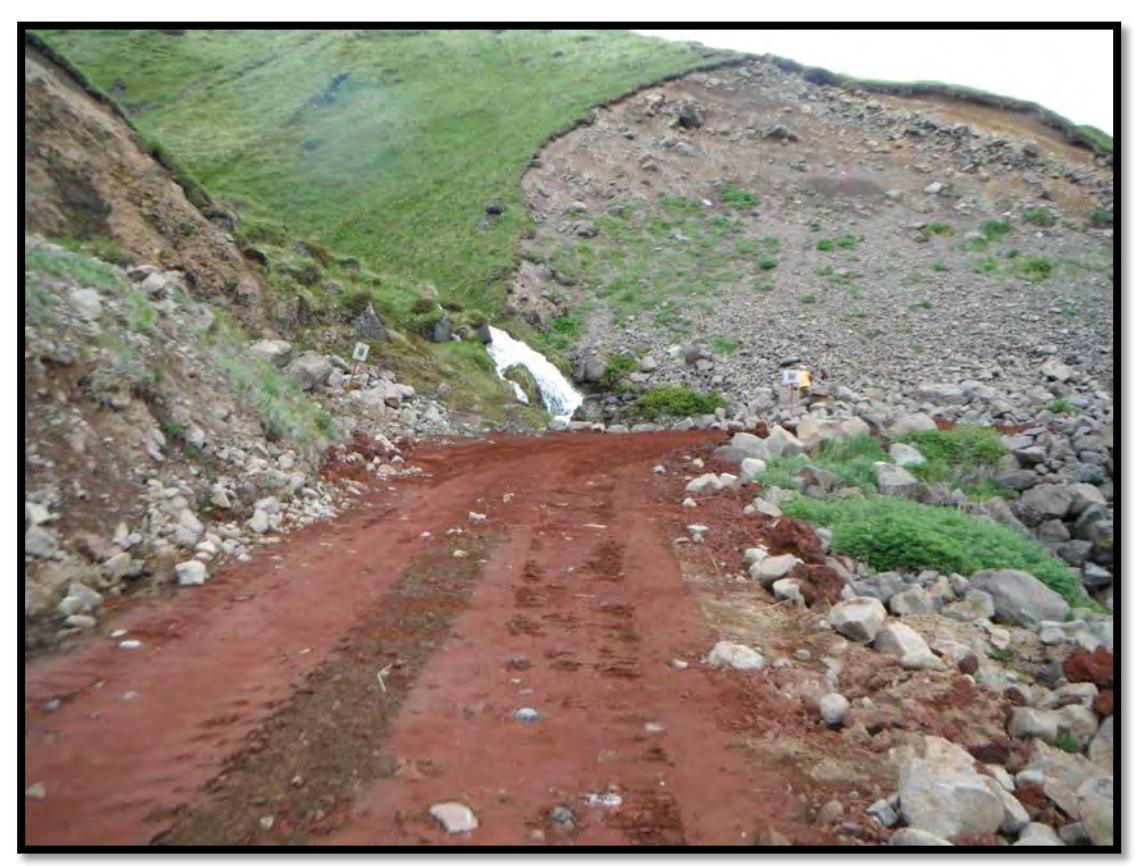
Photograph 8:
 SS010 Land use controls signage background, view West. Site work pictured at the approximate location of the former Water Supply Pumphouse Foundation.

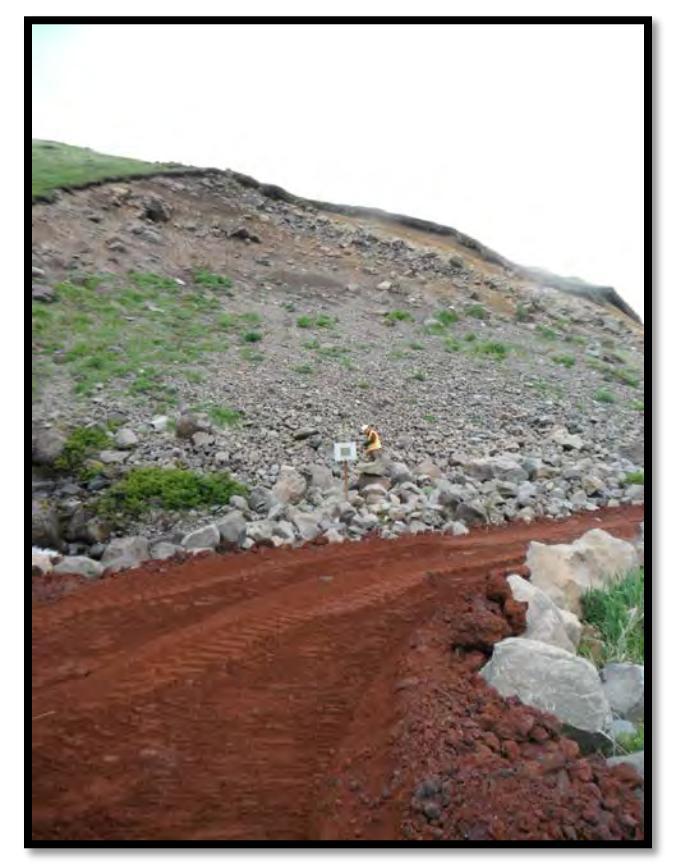
At Site SS007, the monitoring wells were noted to be in good condition and there were no signs of unauthorized site access. The LUC signage was also observed to be in good condition at Site SS007. At Site SS010, slope stability continues to create a site access issue. The area upslope from Site SS010 continues to subside and be actively be eroded, and the site appears to be an area of deposition. No issues were found during the 2015 IC inspections or the 2016 site inspections at Sites SS007 or SS010 that would affect the protectiveness of their remedies. These two sites require no corrective action, and no changes to the IC Plan are warranted.

Photograph 9: SS010 Land use controls signage and slope subsidence area at the former Water Supply Pumphouse Foundation, view West.

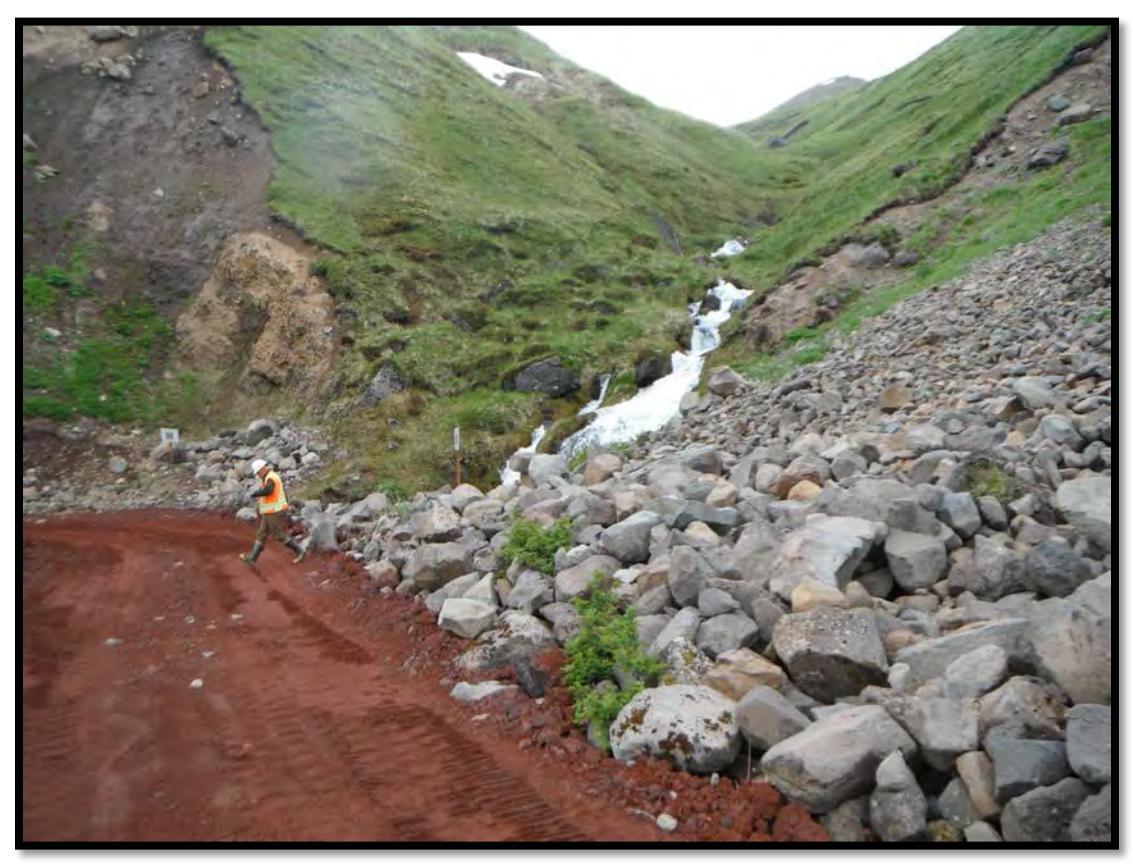
Photograph 10: SS010 Drainage running through former site, view South of West.
