# Department of Environmental Conservation

DIVISION OF SPILL PREVENTION AND RESPONSE

Re: Decision Document: Residence – 2822 Marsha Avenue Cleanup Complete Determination

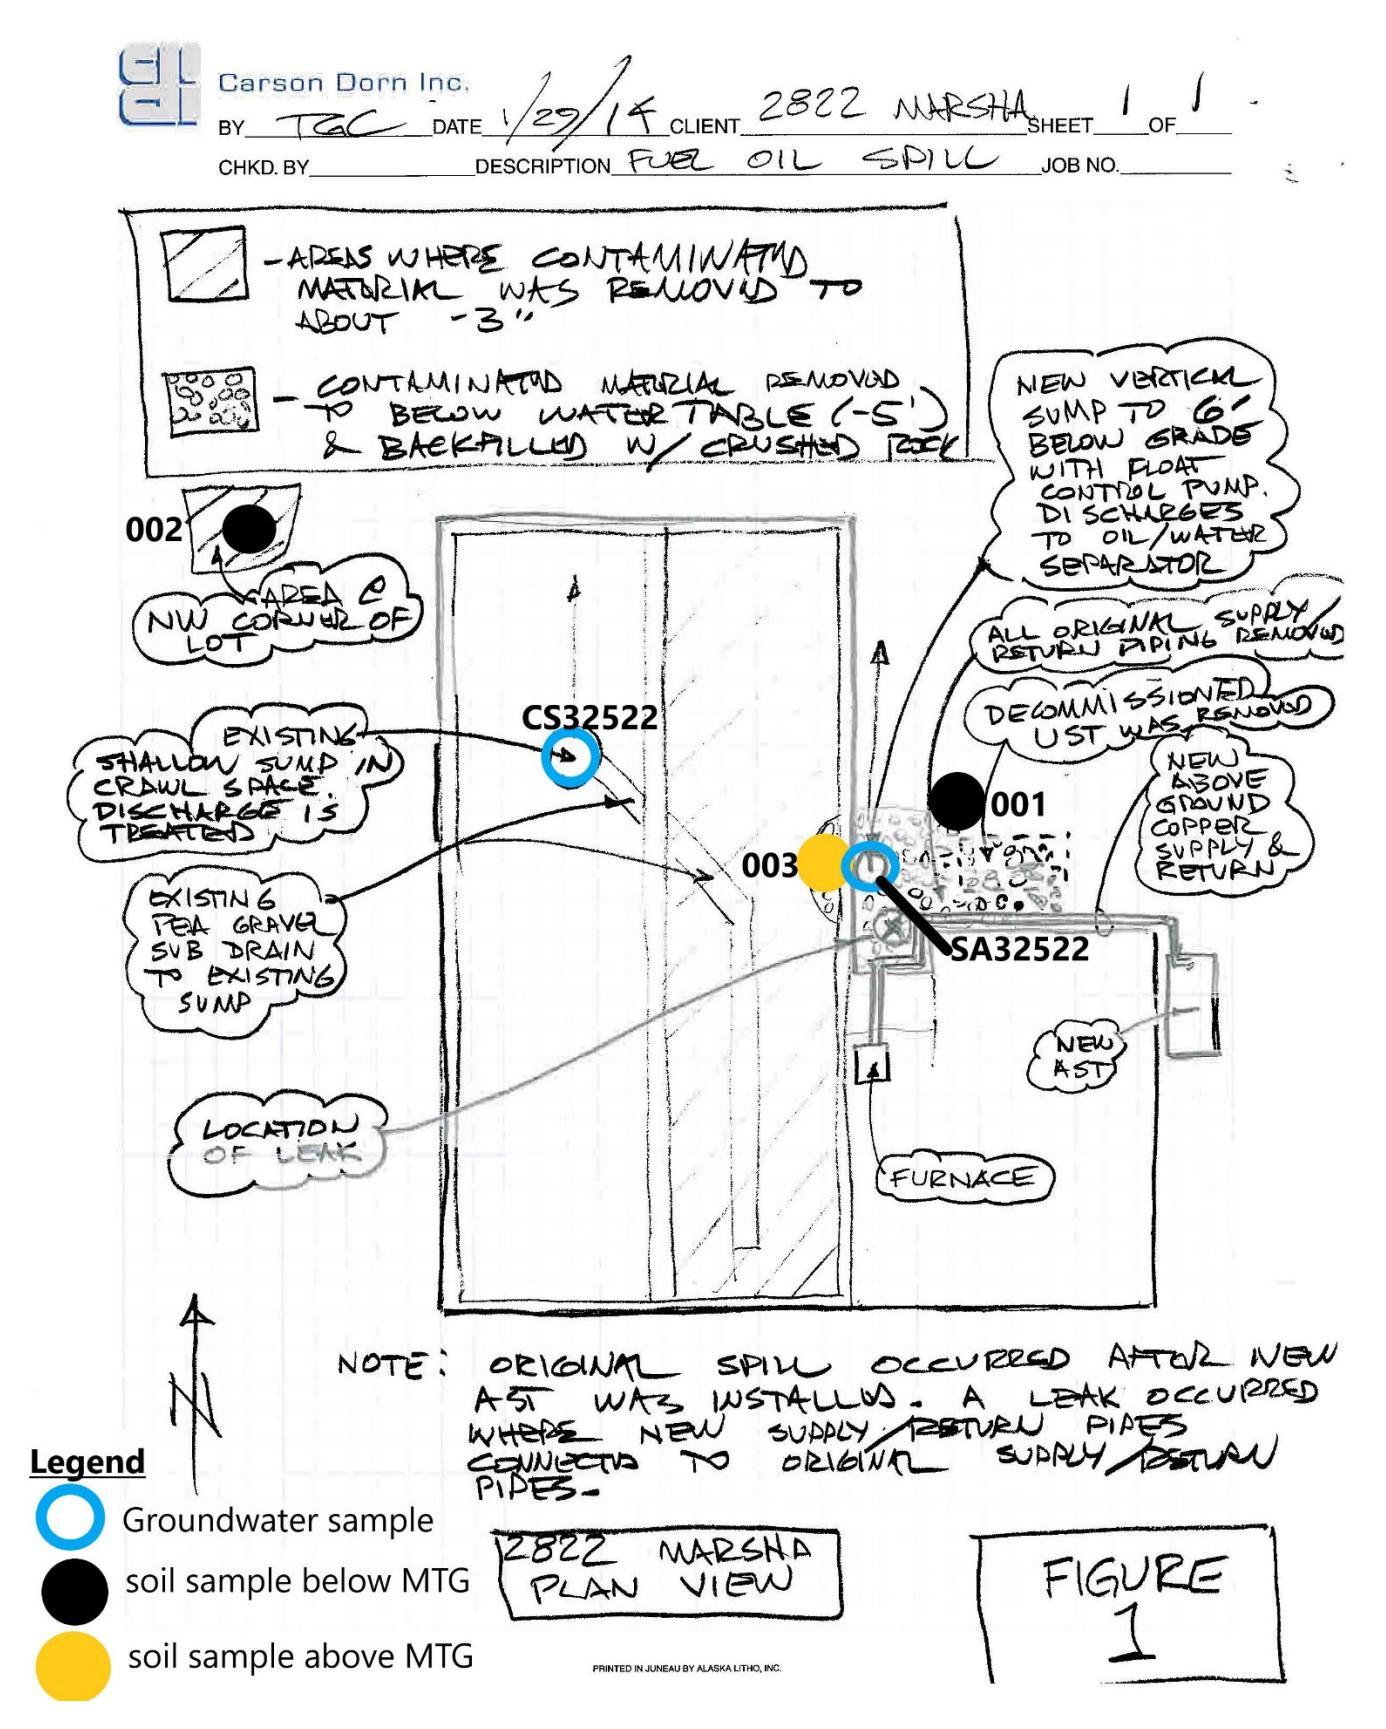
2, several soil samples were collected during this field effort. One soil sample was collected from the bottom of the excavation in the northwest corner of the property. This sample was analyzed for diesel range organics (DRO) and residual range organics (RRO) which were not detected. The second soil sample was collected from the crawl space at the edge of the source area excavation under the concrete footing and analyzed for DRO and RRO. DRO (1,060 mg/kg) exceeded the migration to groundwater (MTG) cleanup level of 250 mg/kg. The third soil sample was collected from the edge of the backfilled excavation and adjacent to the former location of the underground heating oil tank at 1.5 feet bgs. DRO and RRO were not detected.

Two groundwater samples were collected from the site as seen in Figure 2. One groundwater sample was collected from the outfall of the crawl space sump and the second from the source area sump. The samples were analyzed for DRO, VOCs, and PAHs. None of the sample analytes were detected above the most stringent cleanup level.

Soil contamination above the MTG but below human health cleanup levels for DRO remains near the source area. Contaminants of concern were not detected in either groundwater sample above DEC Table C groundwater cleanup levels or vapor intrusion target levels.

**Figure 2.** A site figure prepared by Carson Dorn in 2014. The two blue circles represent the two sumps. The yellow circle represents analytical soil samples that were above the migration to groundwater (MTG) cleanup level. The black circles represent soil samples that were below the MTG cleanup level.
