From: [Charlie Hampton](#)
To: [Wiegiers, Janice K \(DEC\)](#)
Cc: [Ryan Kingsbery](#)
Subject: RE: GTE / BJ Fuels
Date: Wednesday, March 13, 2024 1:50:14 PM
Attachments: [image001.png](#)
[image004.png](#)
[image005.png](#)
[image006.png](#)
[GTE-BJ's Fuel Closure Report 3-13-24.pdf](#)

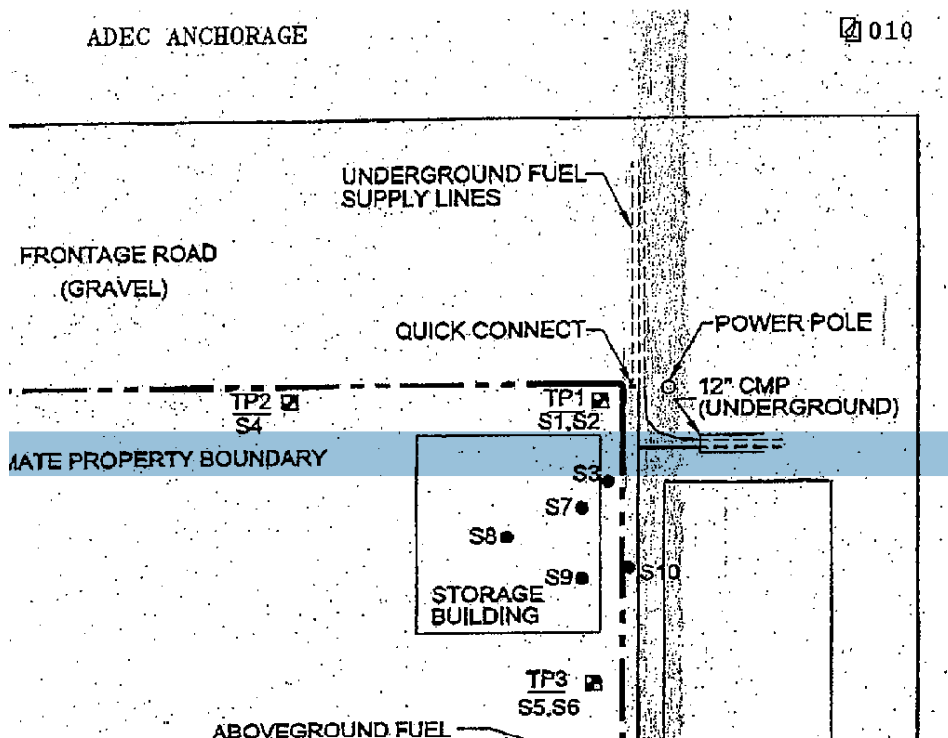
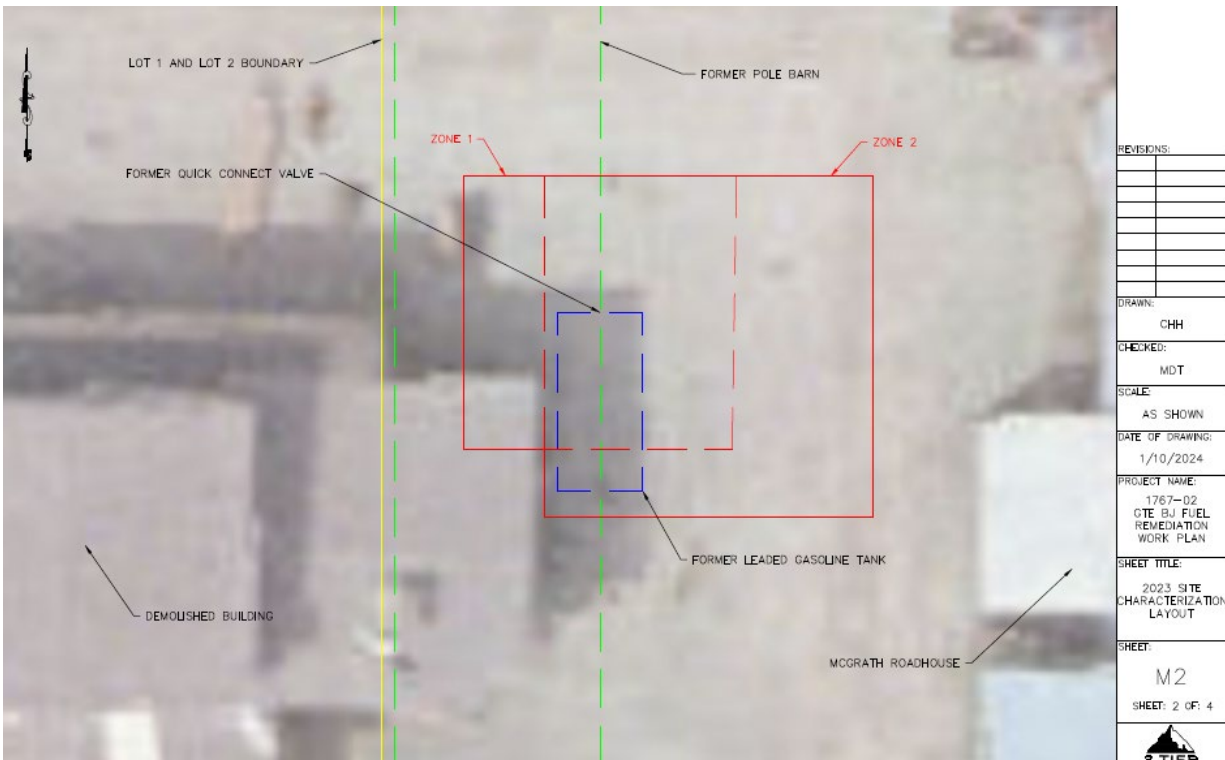
Regarding the accuracy of the pole barn location in Figure M2, I do not believe the figure is accurate. As a reminder, I created this figure based on a verbal description of the pole barn in the field, recalled from a 25-year-old memory.

The east/west location of the pole barn is relatively accurate, but the northern extent of the pole barn is certainly not accurate. Based on the figure in the AGI report, we know that the pole barn did not extend all the way to the quick connect, but we do not know how far it extended. We excavated

approximately 10-20 feet from the edge of pavement (photo attached). The AGI report shows that the quick connect is directly on the property line. However, AGI did not survey the property to verify this location, and we do not know on what basis they established a property line. It appears the property line was based on the location of a power pole, which is no longer in place for me to use to reference the location in the AGI figure. We do not know where the property line is located relative to the existing edge of pavement, thus it is difficult to say with certainty where my excavation lay relative to the location identified by AGI as a quick connect. Based on this uncertainty and the location of my excavation within approximately 20 feet from the edge of pavement, it is possible that our "Zone 1" included or abutted the vicinity of the quick connect.

I'm still finding some inconsistency with the available information that makes me question the sampling location. According to the text, maps, and photos in the 1999 and 2003 reports, Area 1 was in the area of that former power pole and the T or bend in the fuel supply lines from the runway where AGI observed something they described as a quick connect. Based on that information, I would expect Area 1, where contamination was found which was not excavated, to be north of and on the west side of the former pole barn location. Based on Figure M2 in your report, Mr. Magnuson appears to have directed the work to a more central location in Lot 2, underneath and toward the east side of the pole barn. I understand that lot lines are questionable in the older reports, but I would expect some accuracy with respect to the landmarks (pole barn location).

Does Figure M2 seem accurate with respect to the location of the pole barn and the quick connect observed by AGI? I'm including part of the figure from the 1999 AGI investigation, and Figure M2 from your recent report below.
