Alaska Department of Environmental Conservation

Structural Assessment for Remedial Design

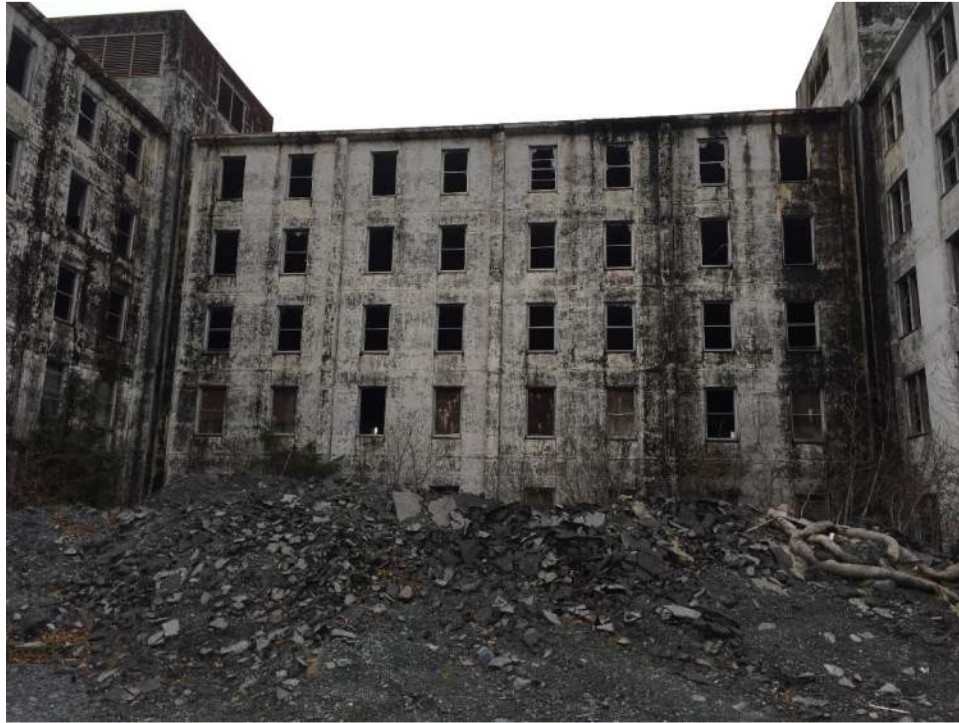
Figure A1 – Typical southern building elevation with perforated concrete shear walls and missing windows

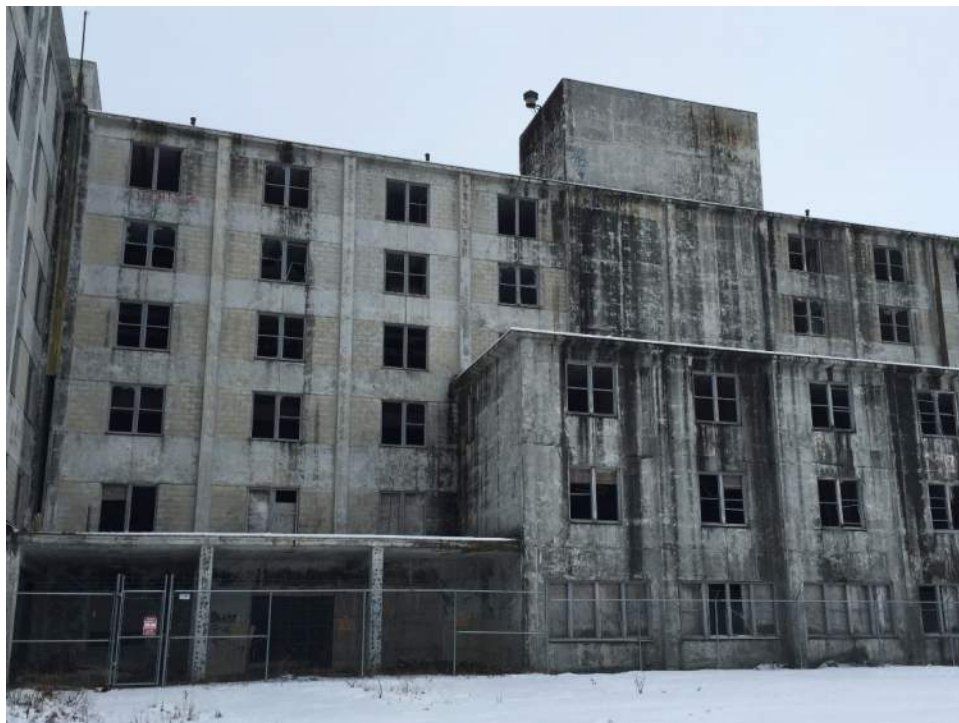
Figure A2 – Typical northern building elevation with concrete columns, concrete spandrel beams and CMU infill.

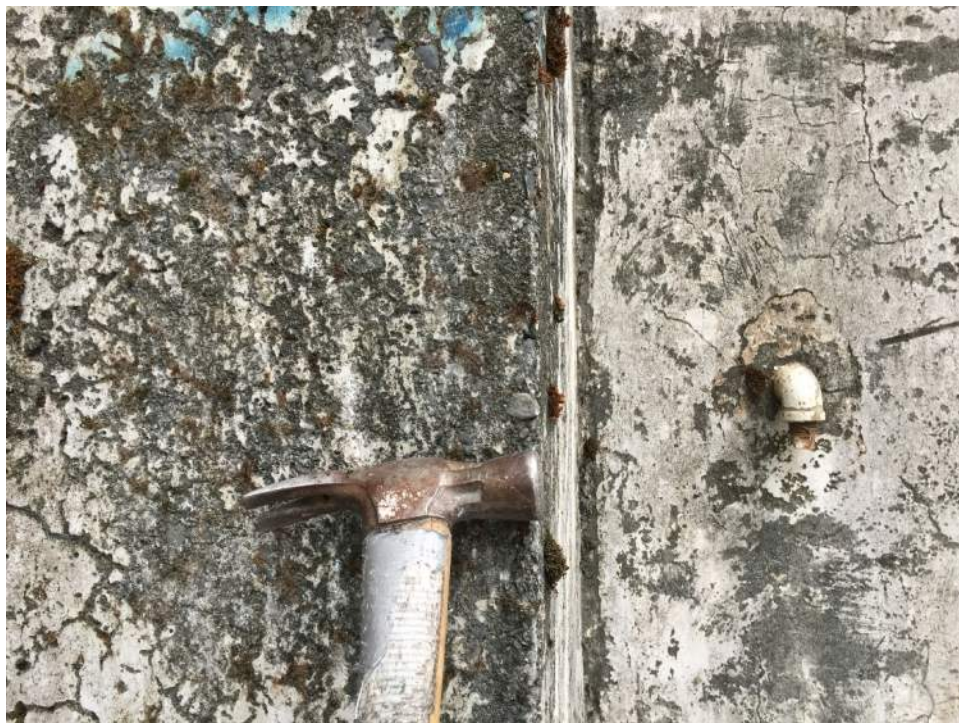
Figure A4 – Example of surface defect beneath moss growth on exterior wall

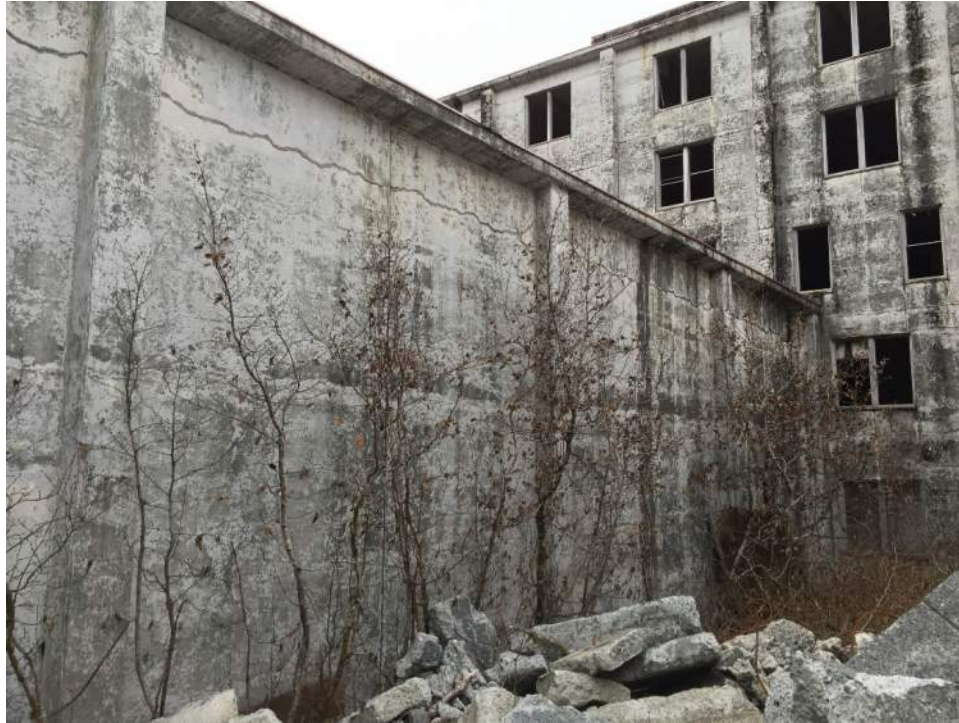
Figure A5 – East wall of theatre with large crack for the full wall length at approximate location of the roof joist bottom chord attachment.

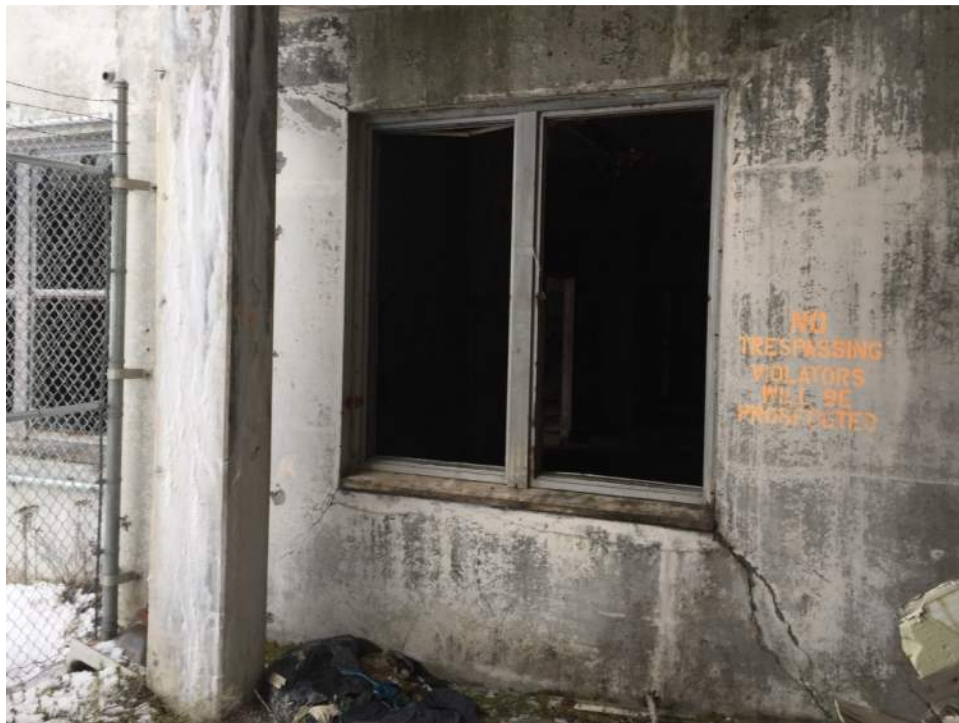
Figure A6 – Concrete shear wall with diagonal crack protruding from upper left and lower right window corners.

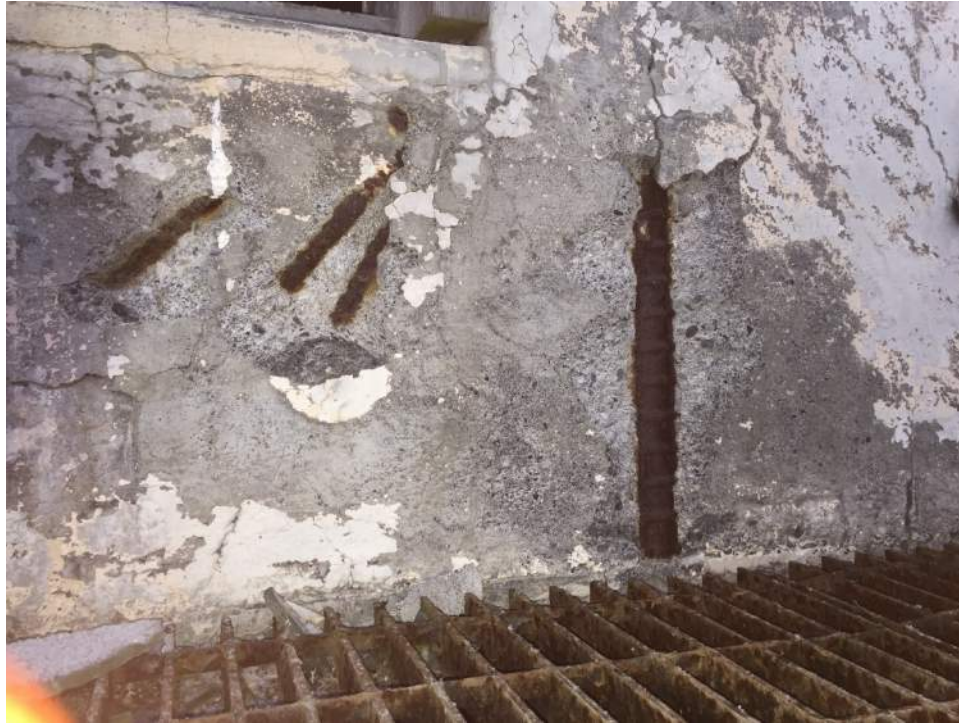
Figure A7 – Example of exposed exterior wall rebar at egress stair landing.

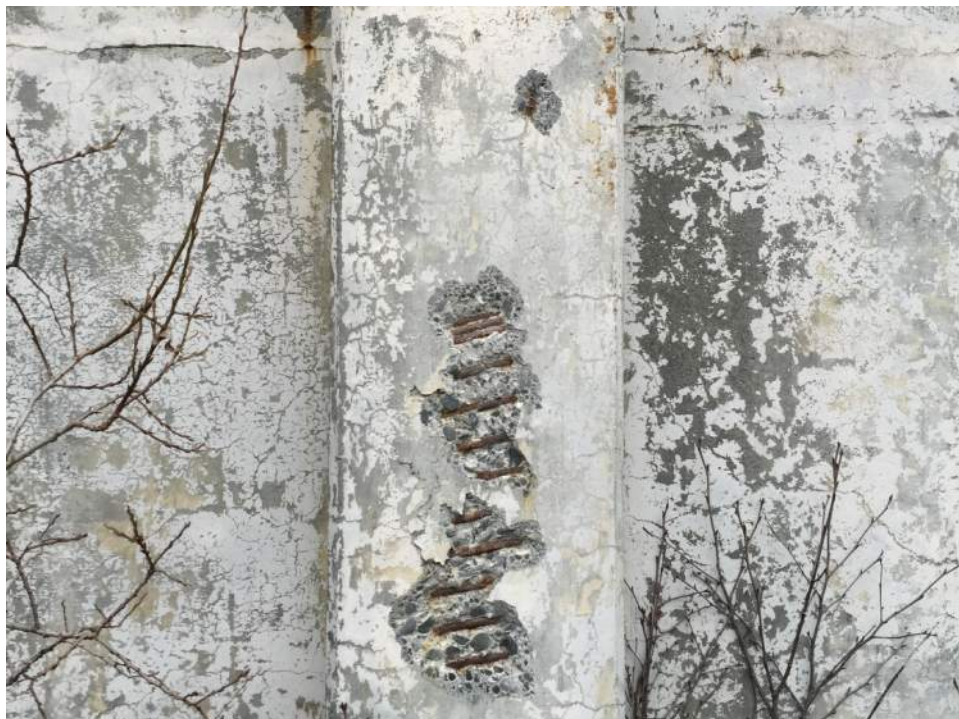
Figure A8 – Example of exterior concrete column with exposed, corroded spiral ties.

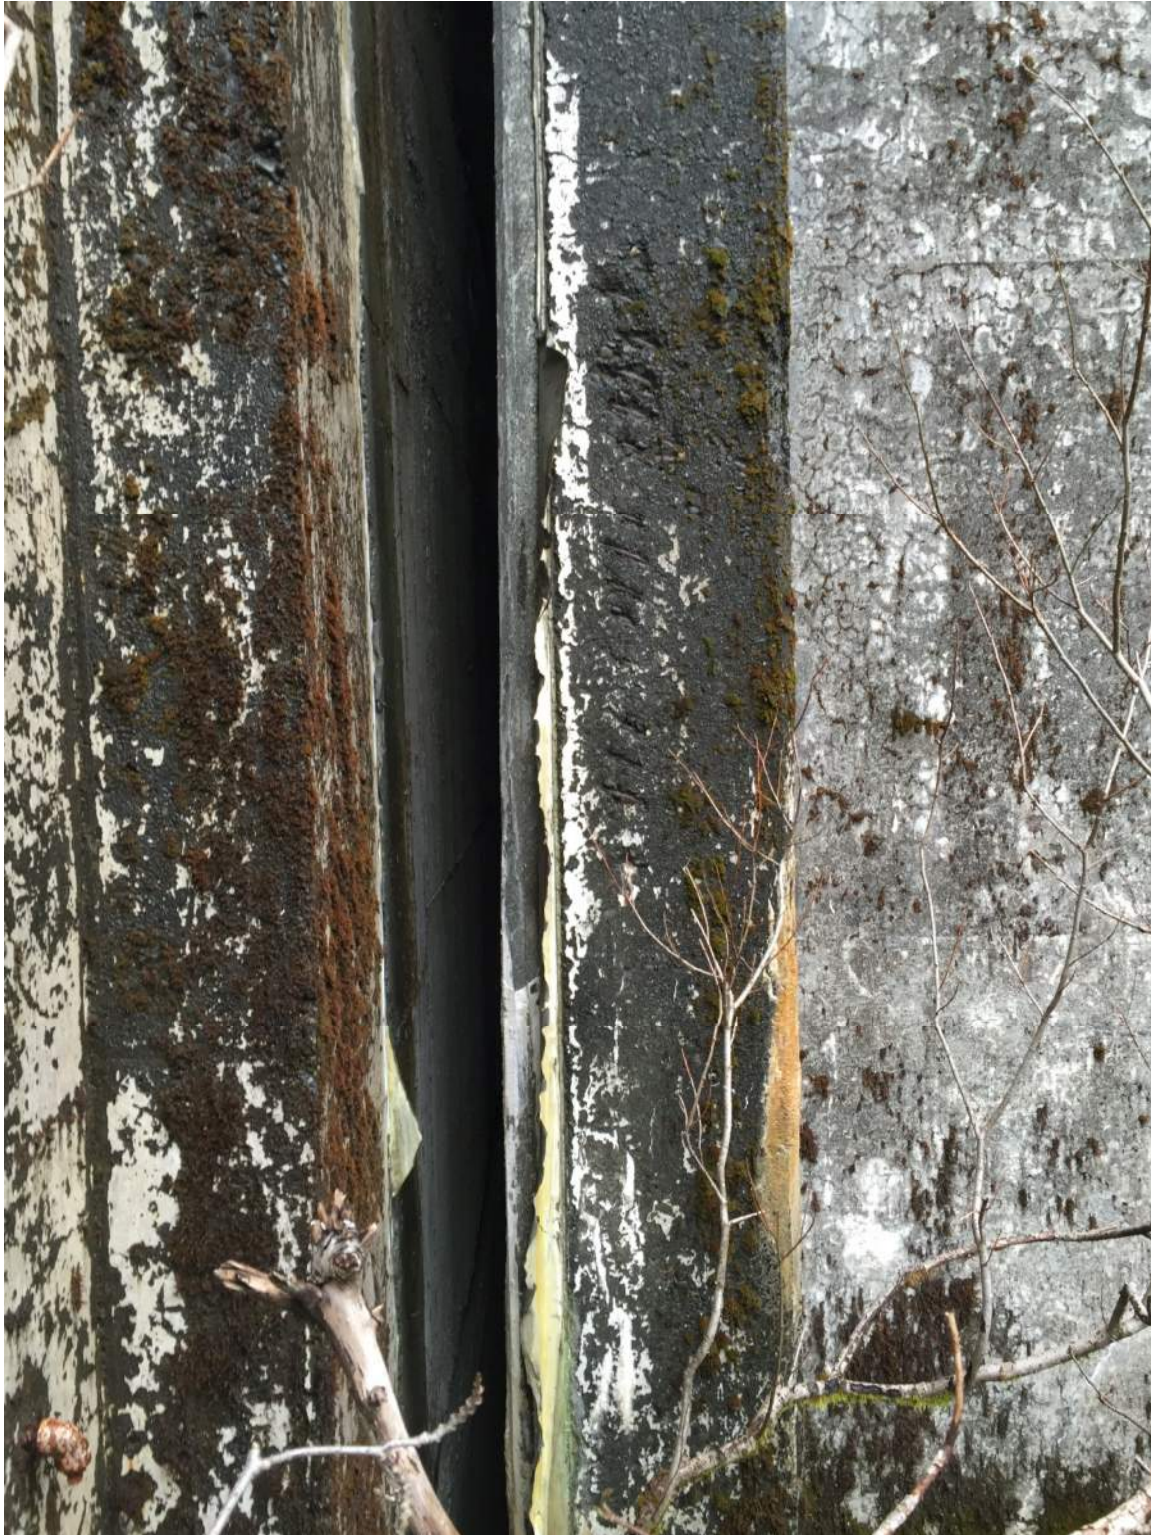
Figure A9 – Exposed column spiral ties, moss growth and other concrete defects at seismic joint.

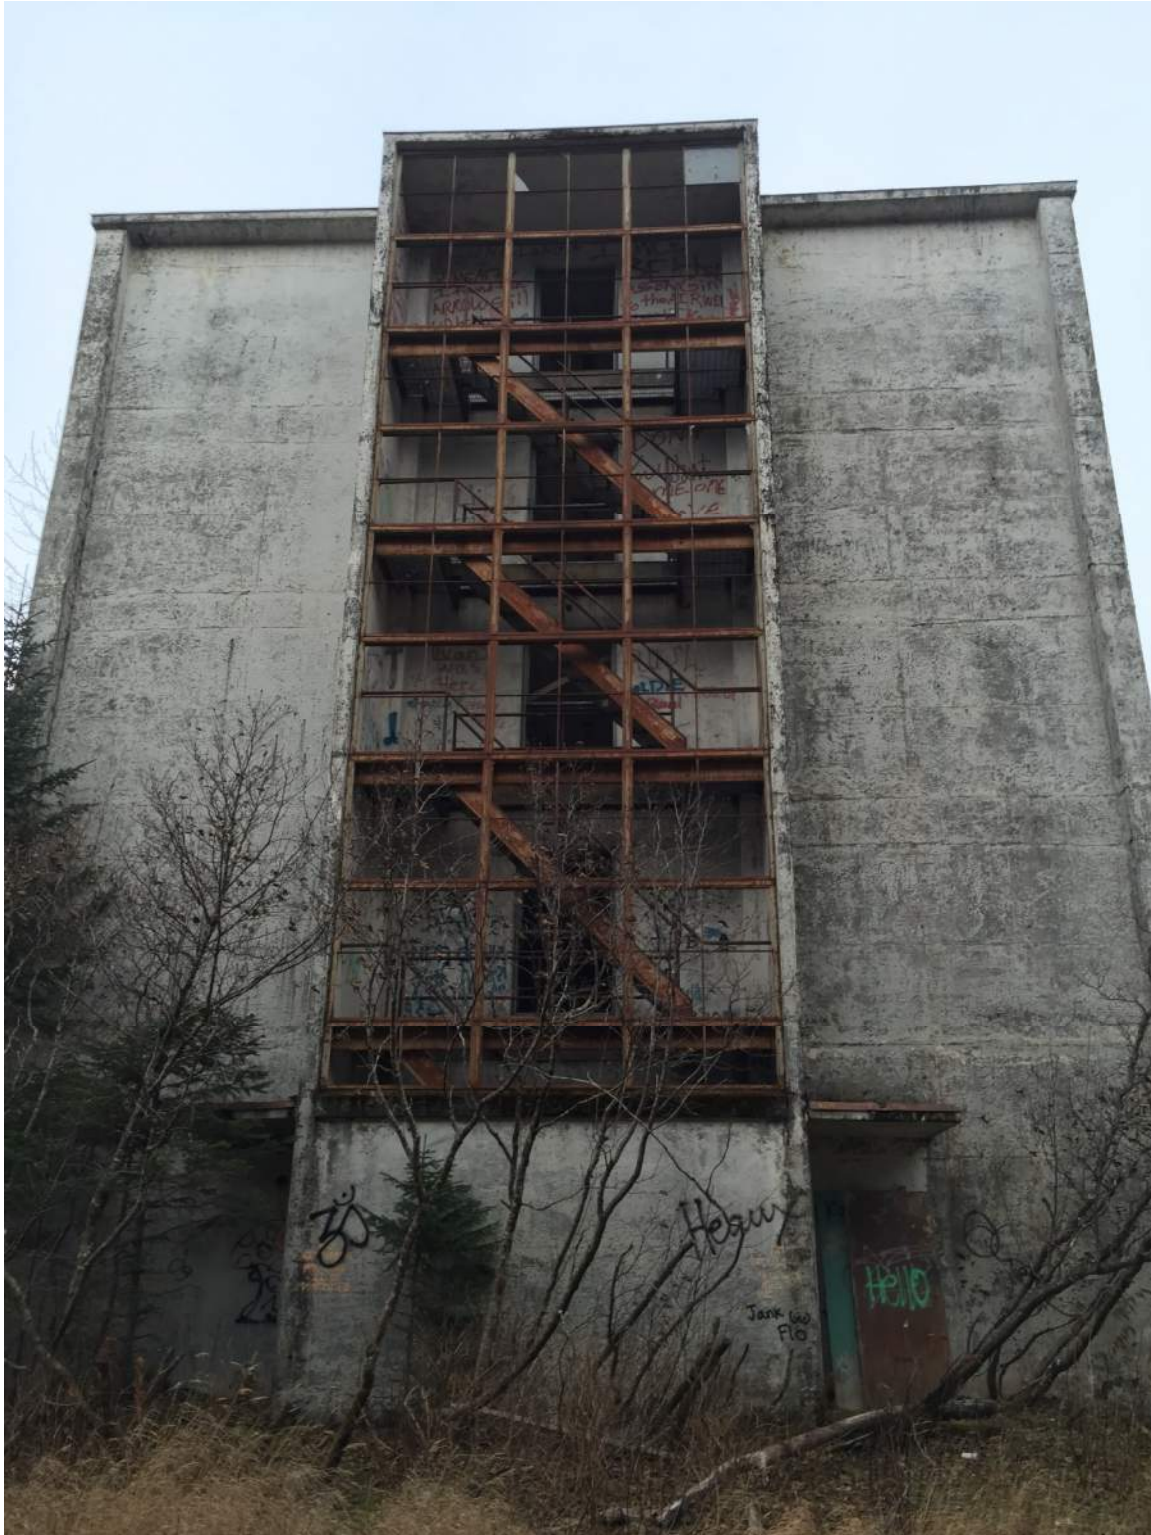
Figure A10 – Typical egress stair where curtain wall glass is gone and steel exposed to weather has corroded.

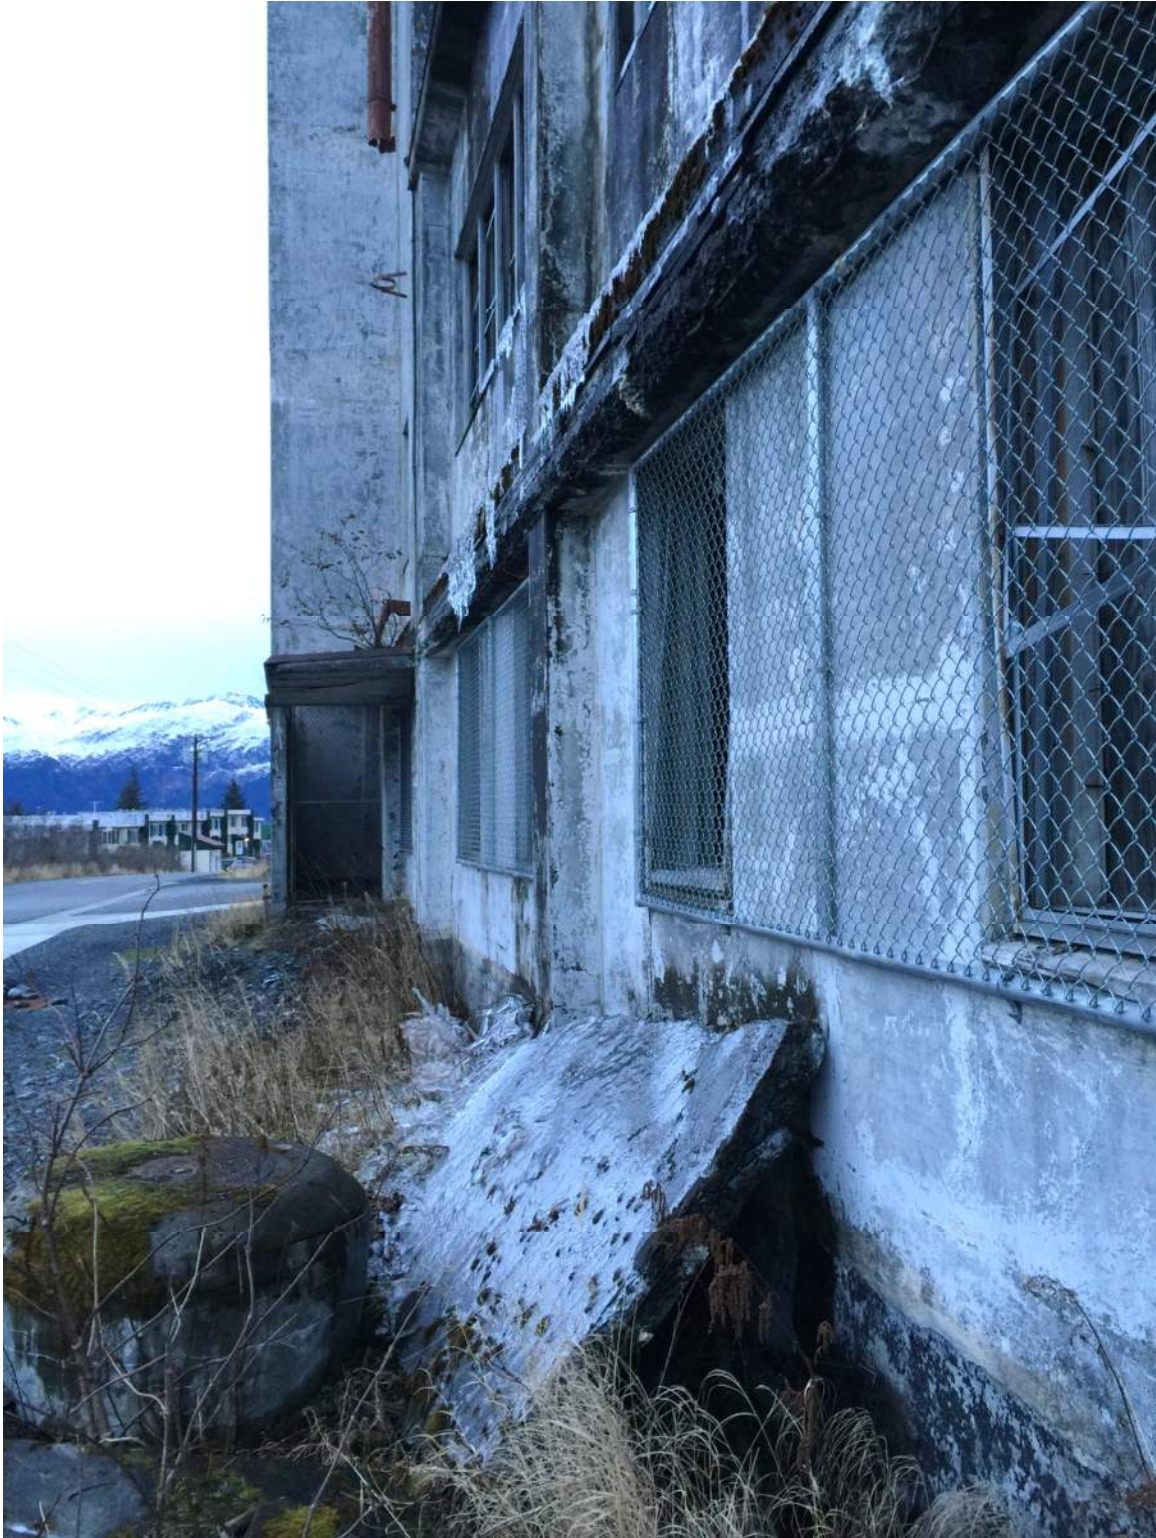
Figure A11 – Collapsed portion of concrete canopy on north façade.

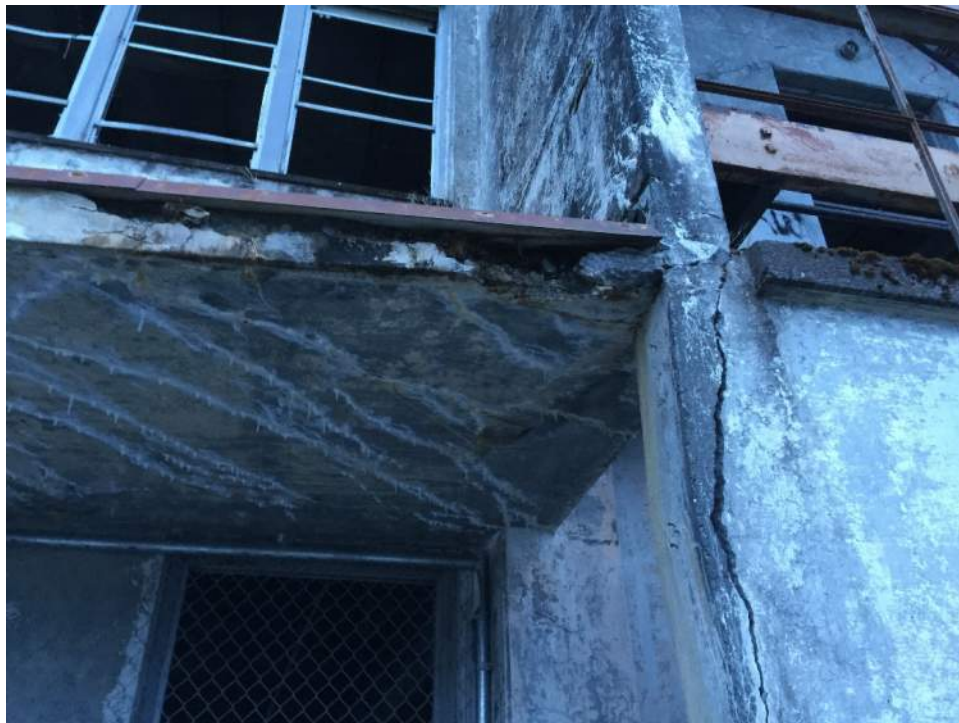
Figure A13 – Large crack at concrete wall / canopy attachment. Failure appears imminent.

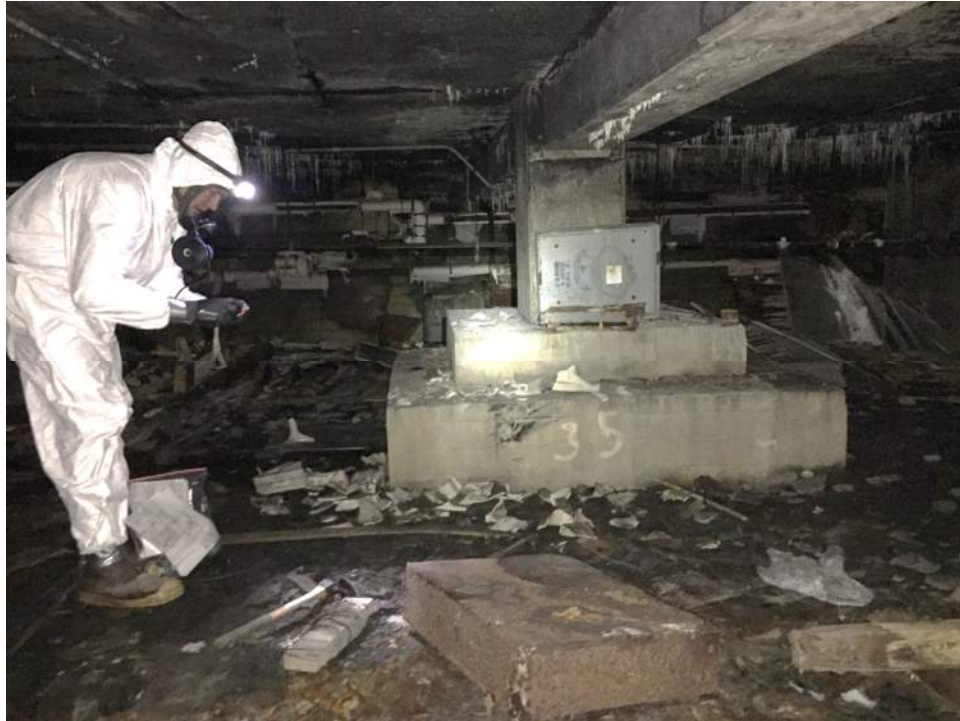
Figure A14 – Example of isolated column footing in crawlspace.

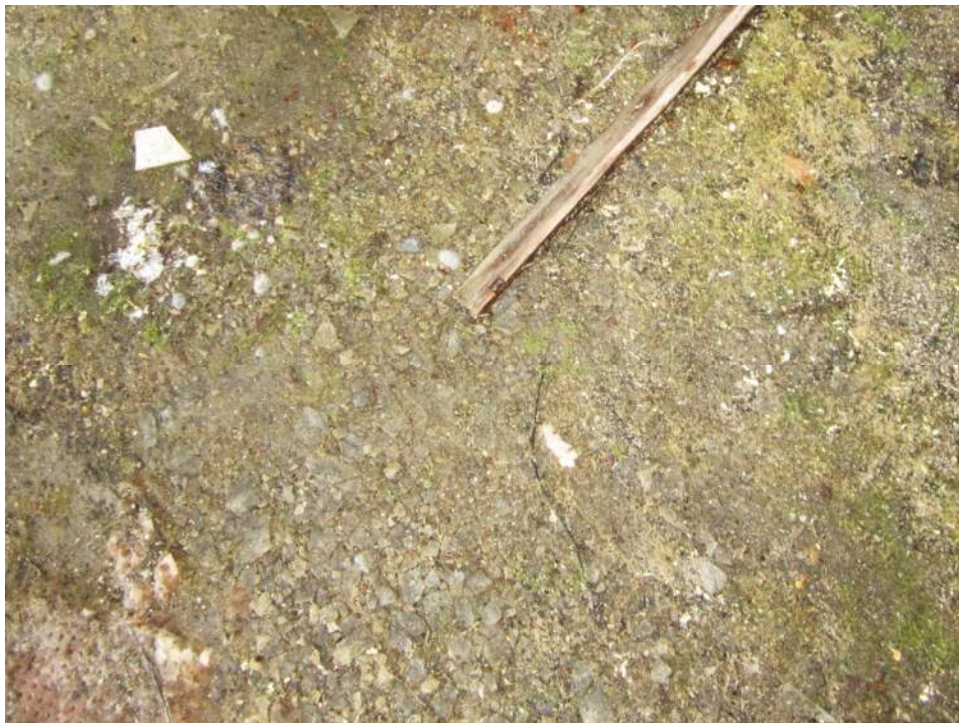
Figure A27– Close up view of basement floor with moss growth and spalled concrete slab surface.

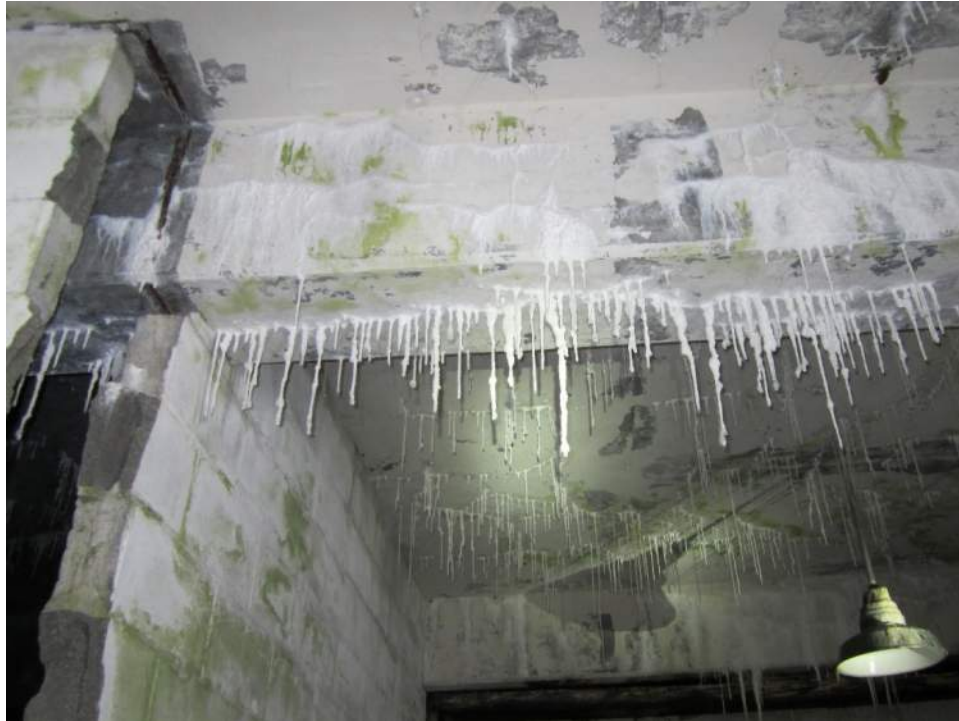
Figure A28 – Basement floor beam with stalactites and damaged CMU wall.

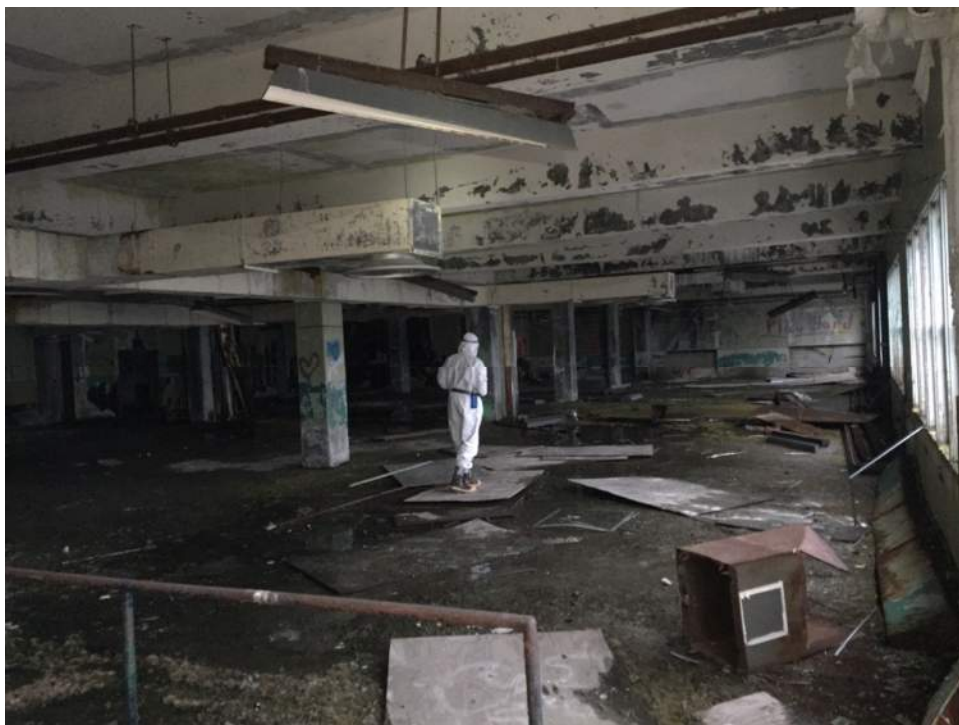
Figure A29 – Mess hall at the north side of the ground floor.

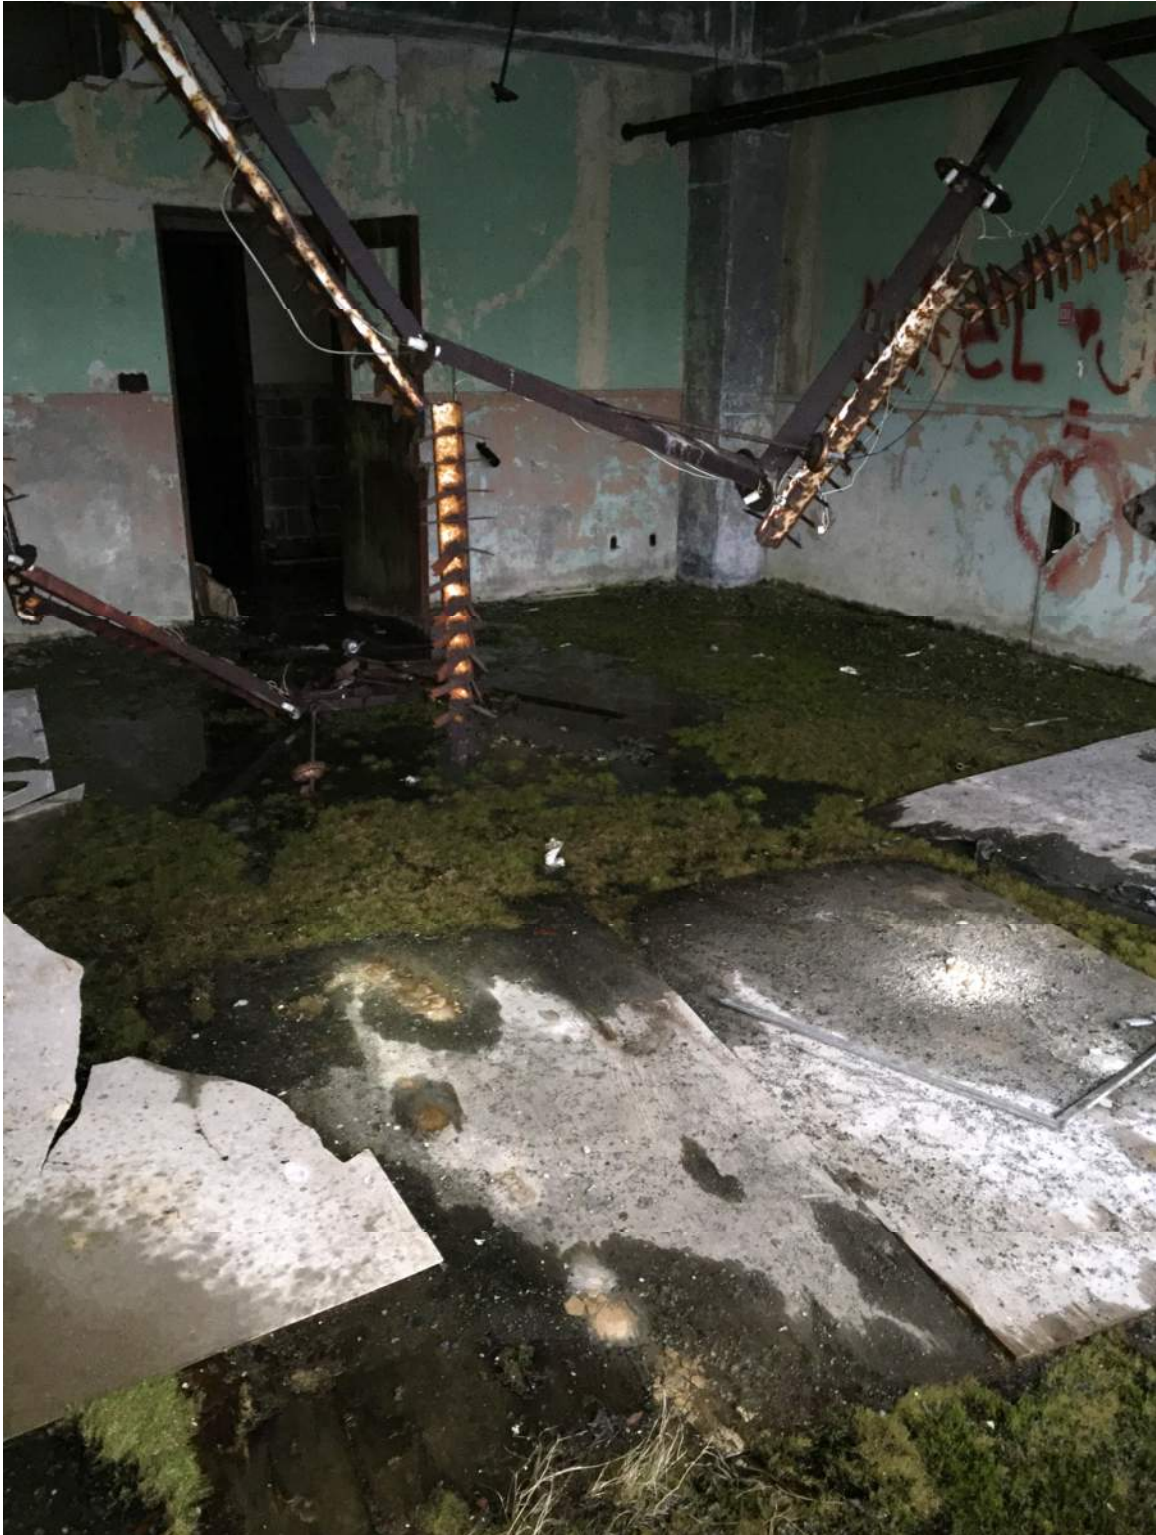
Figure A30 – Typical ground floor office with floor flooded from water infiltration and heavy moss growth on slab.

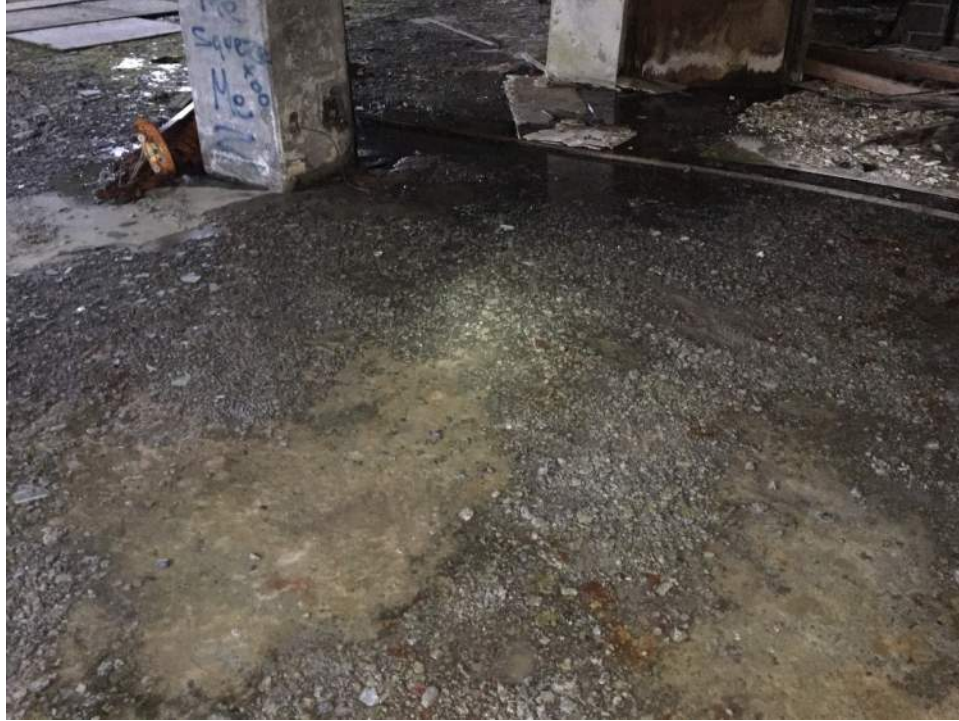
Figure A31 – Ground floor, elevated slab with severe spalling.

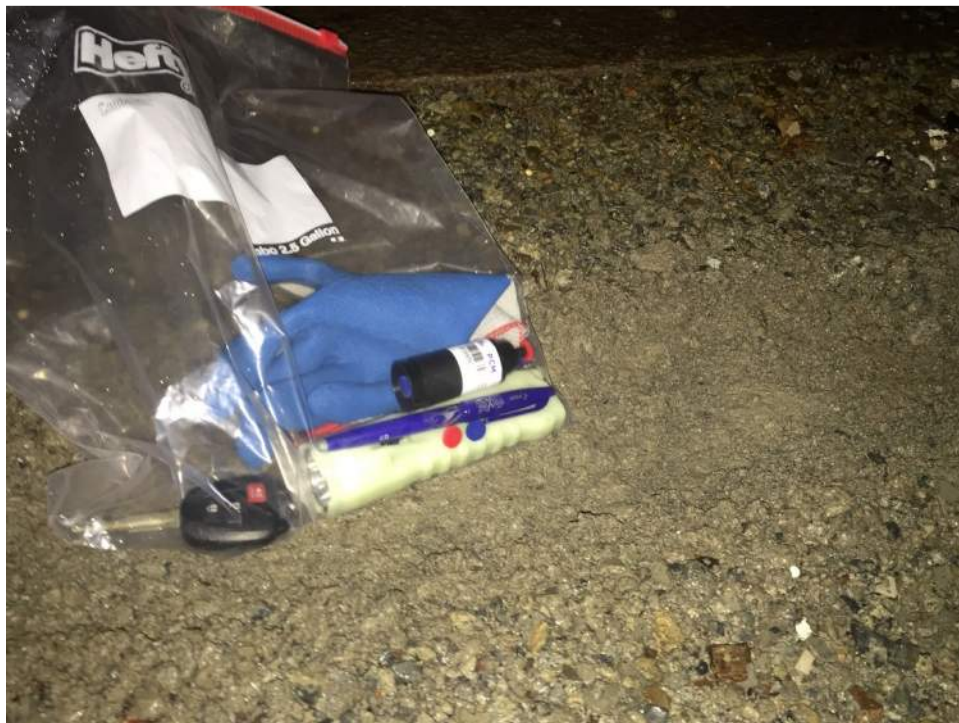
Figure A32 – Ground floor, close up of severely deteriorated slab surface.

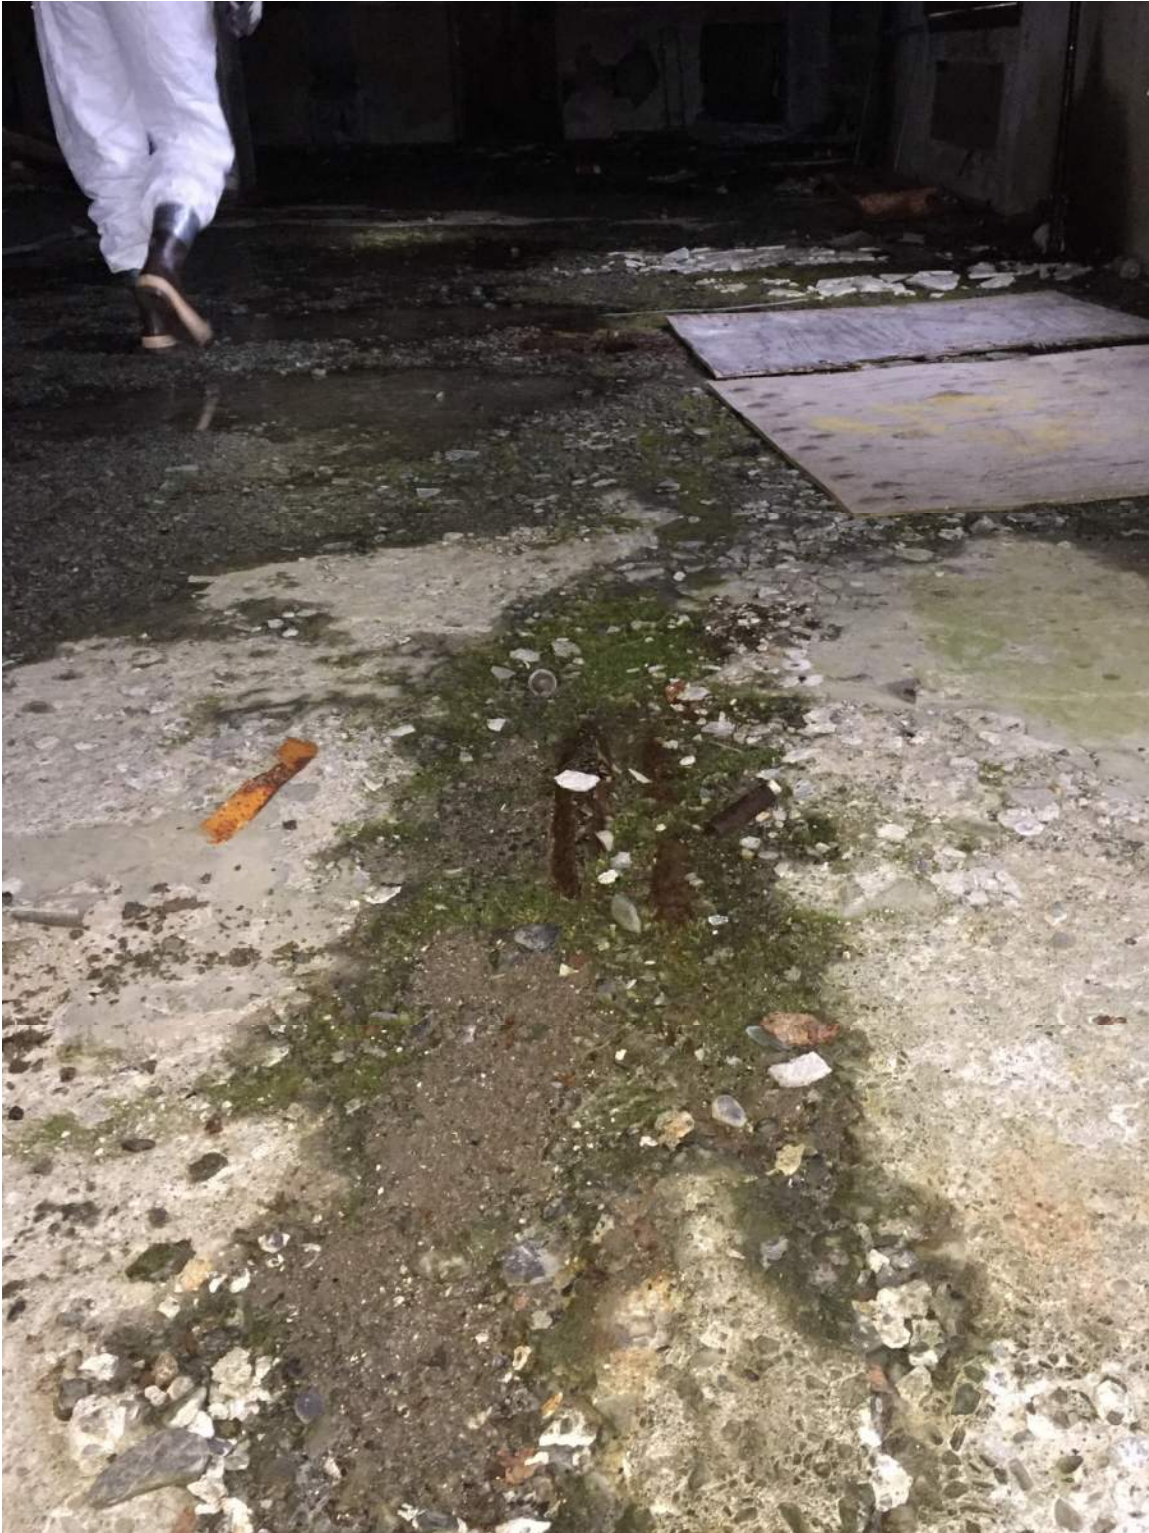
Figure A33 – Pipes embedded ground floor slab that have ruptured from frozen water and damaged the floor slab.

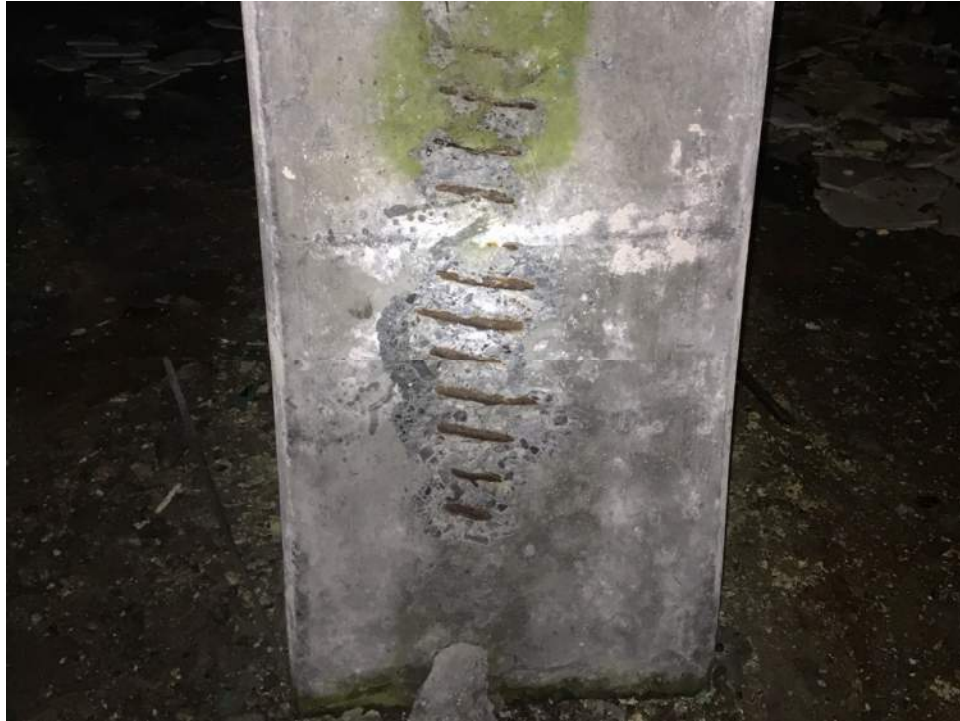
Figure A34 – Ground floor interior column with exposed ties.

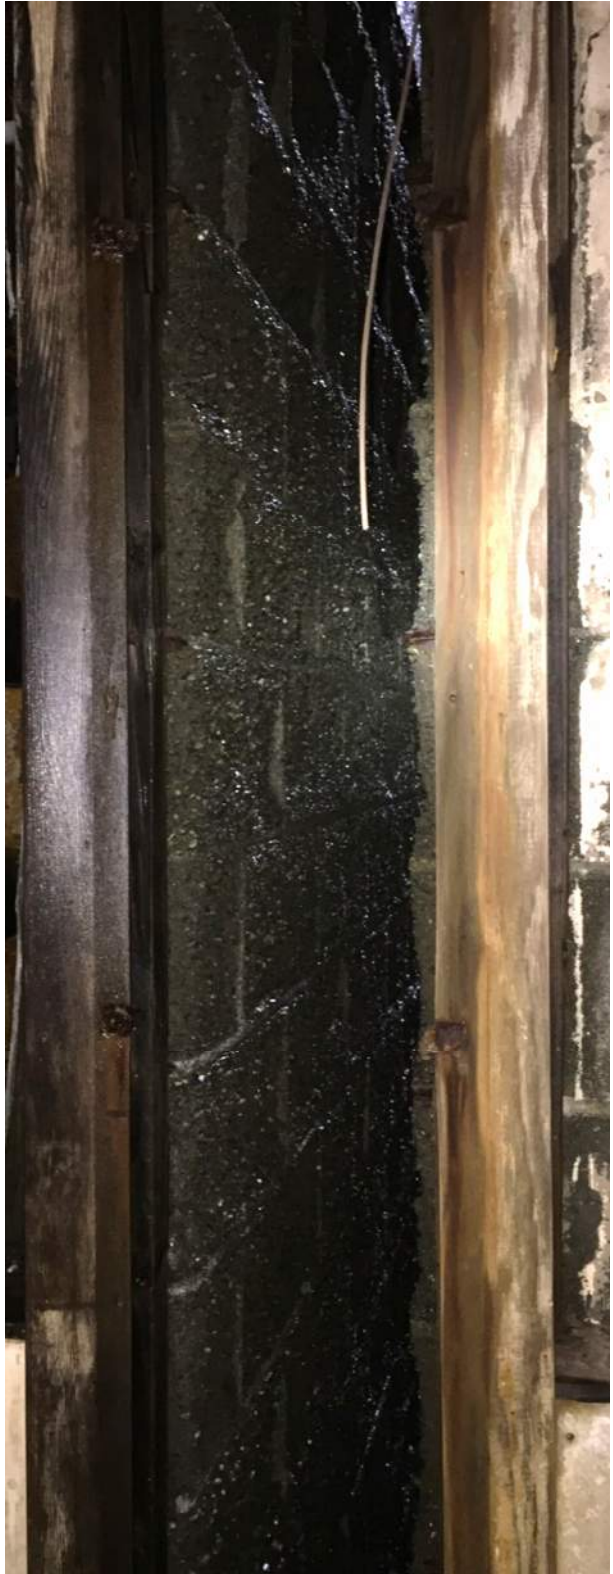
Figure A39 – Ground floor CMU, extremely deteriorated at seismic joint.

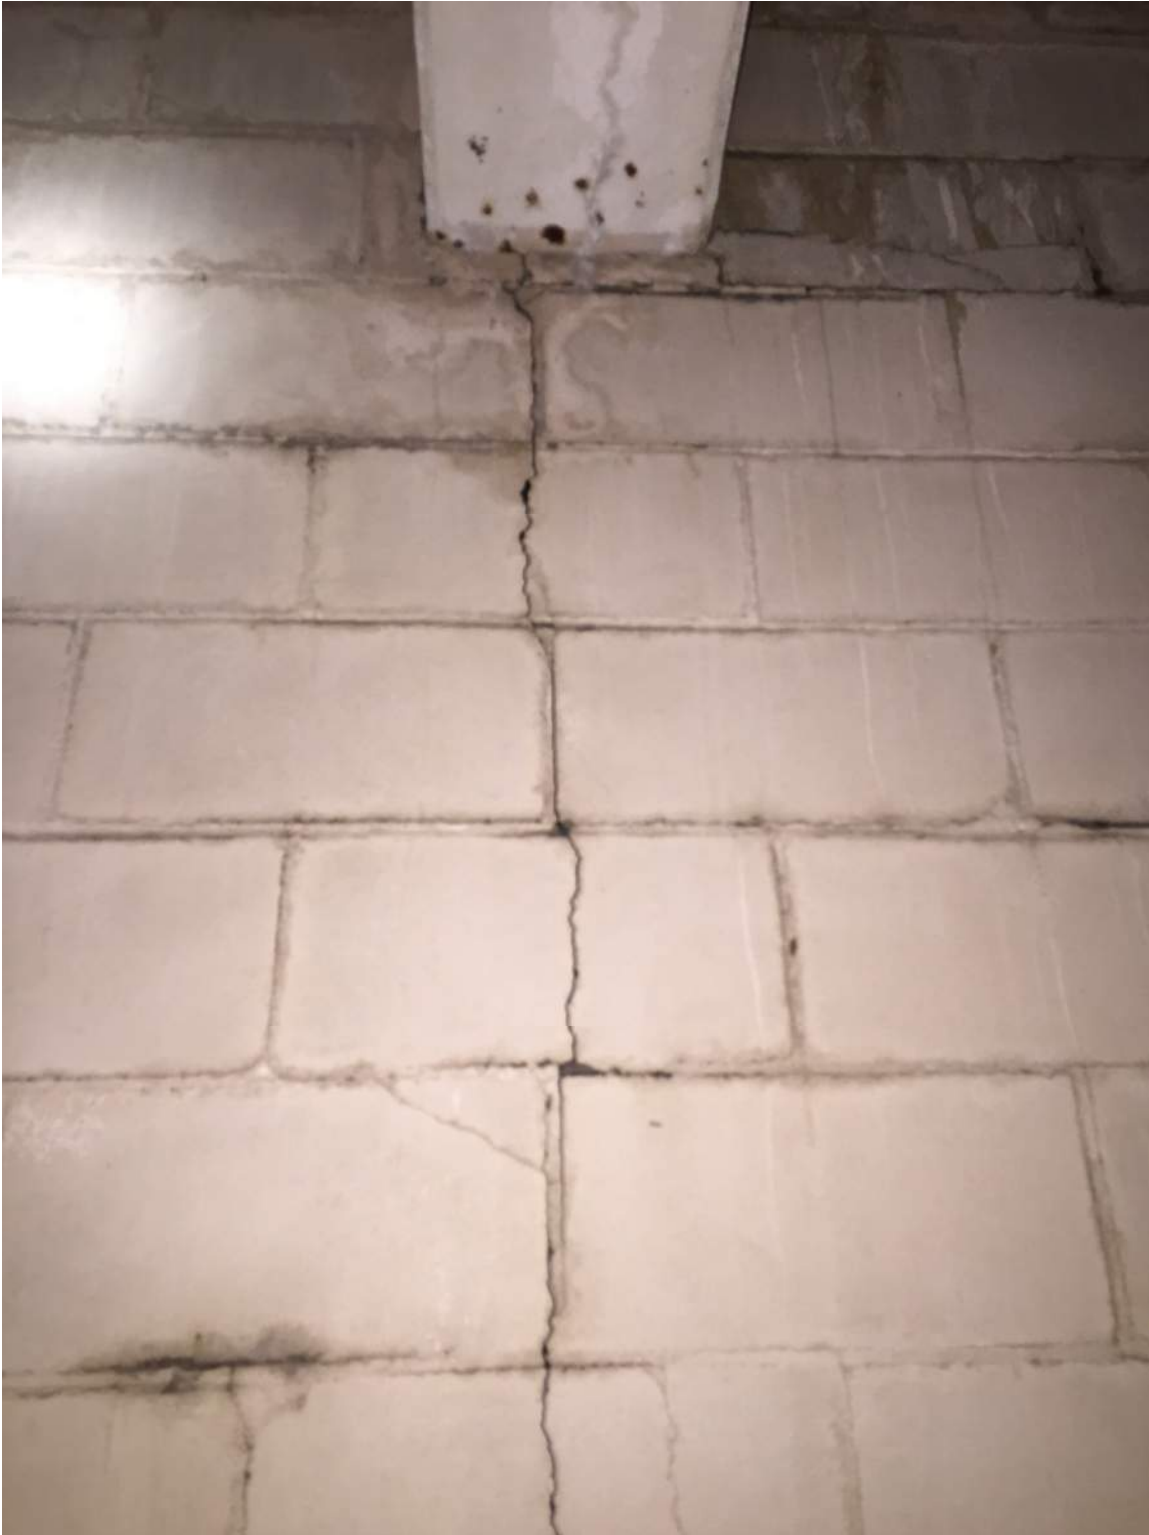
Figure A40 – Cracked CMU ground floor corridor wall at floor beam penetration.

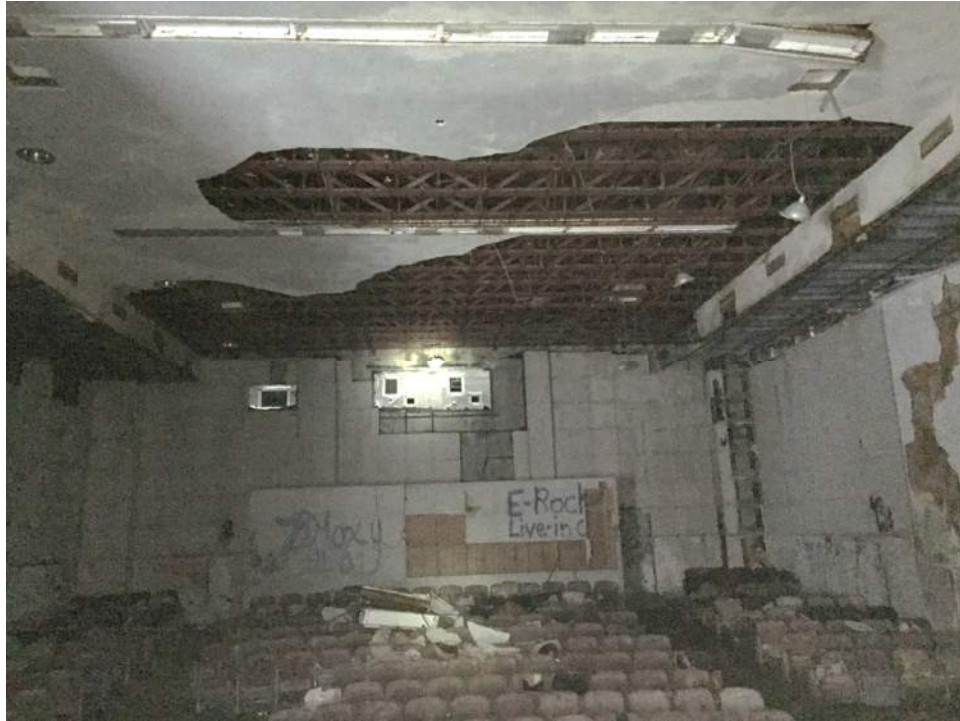
Figure A41 – Theatre
