Alaska Department of Environmental Conservation

Structural Assessment for Remedial Design

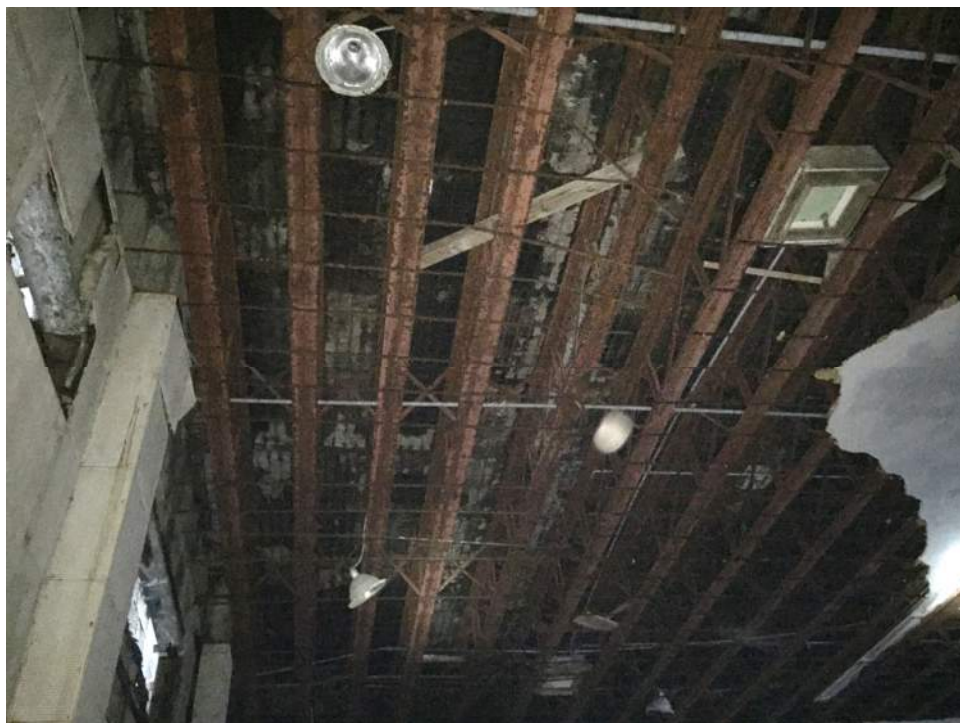
Figure A42 – Corroded steel open web roof joists at the theatre.

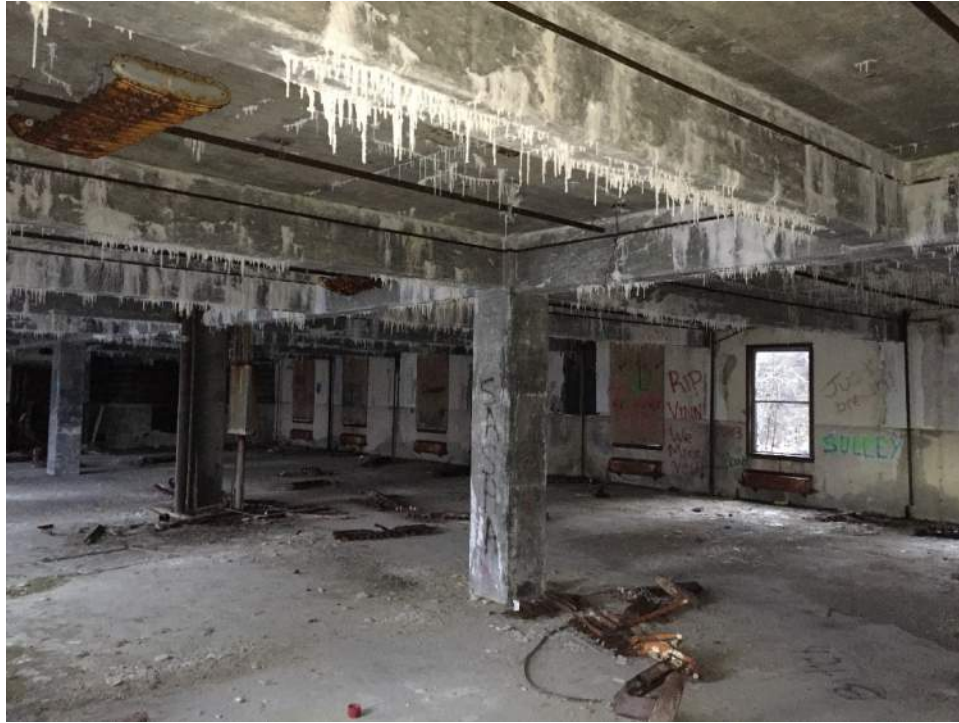
Figure A43 – Typical 1st floor Day Room.

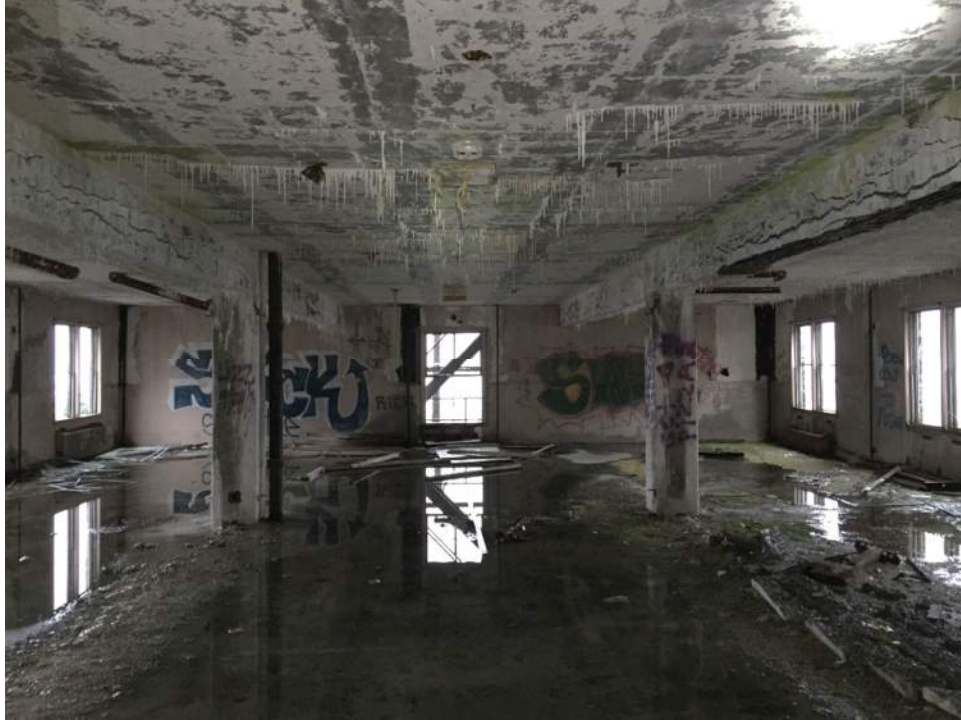
Figure A45 – 1st floor day room with beam each beam line extremely deteriorated.

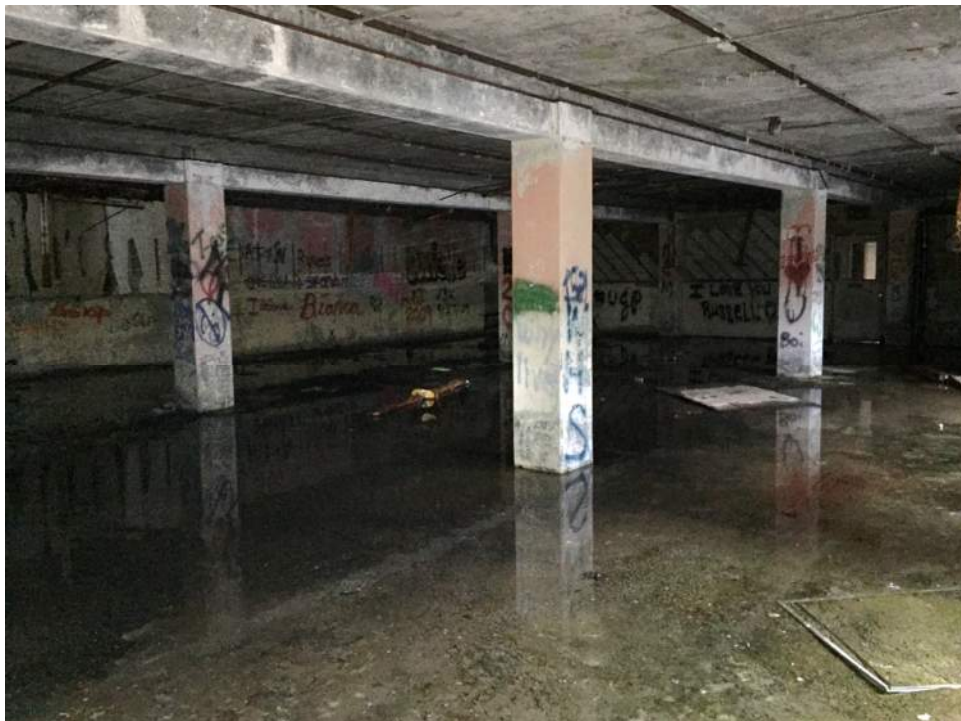
Figure A46 – Flooded 1st floor room.

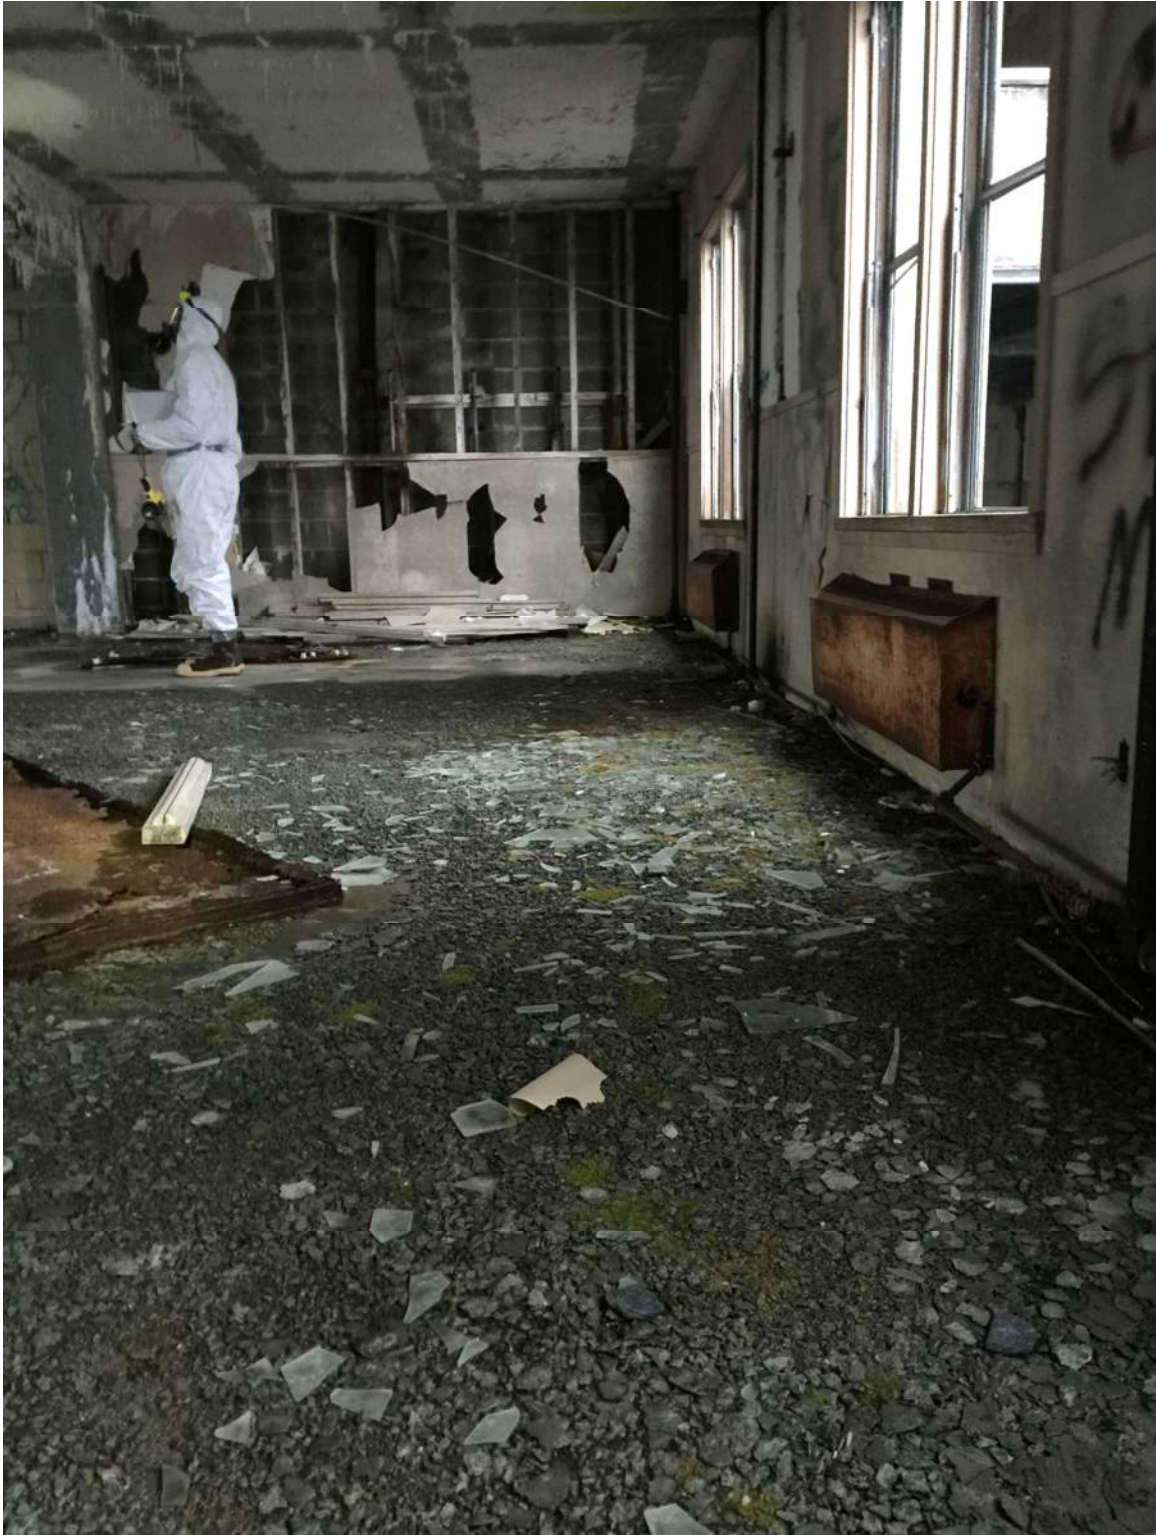
Figure A48 – Severely deteriorated 1st floor slab adjacent to north facing windows.

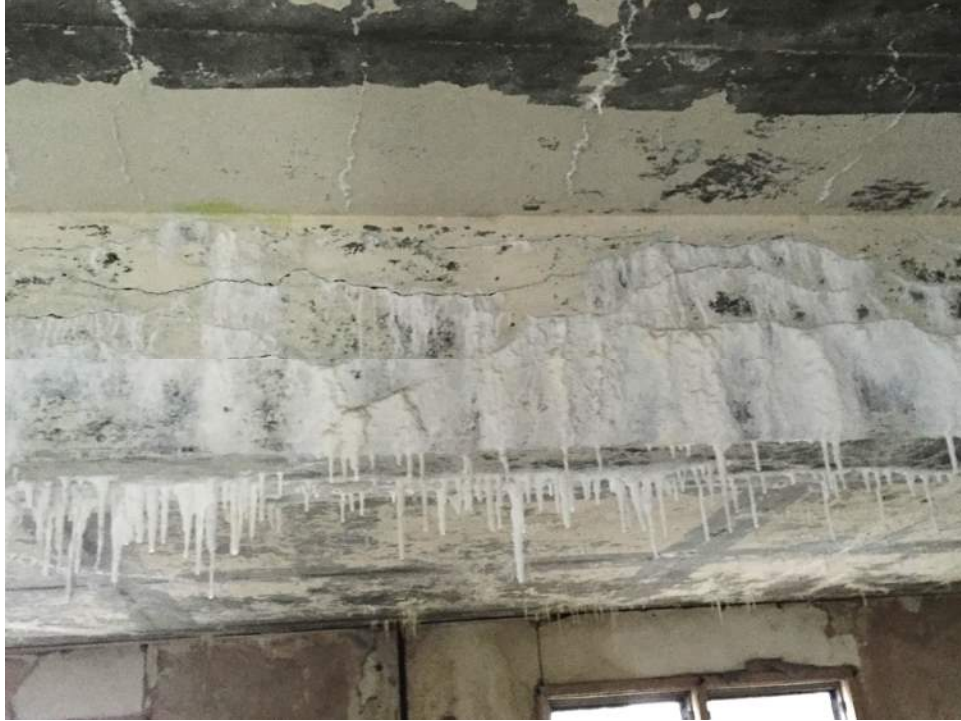
Figure A49 – Close up of stalactites and calcium carbonite forming on the side of the concrete beam, through large horizontal cracks.

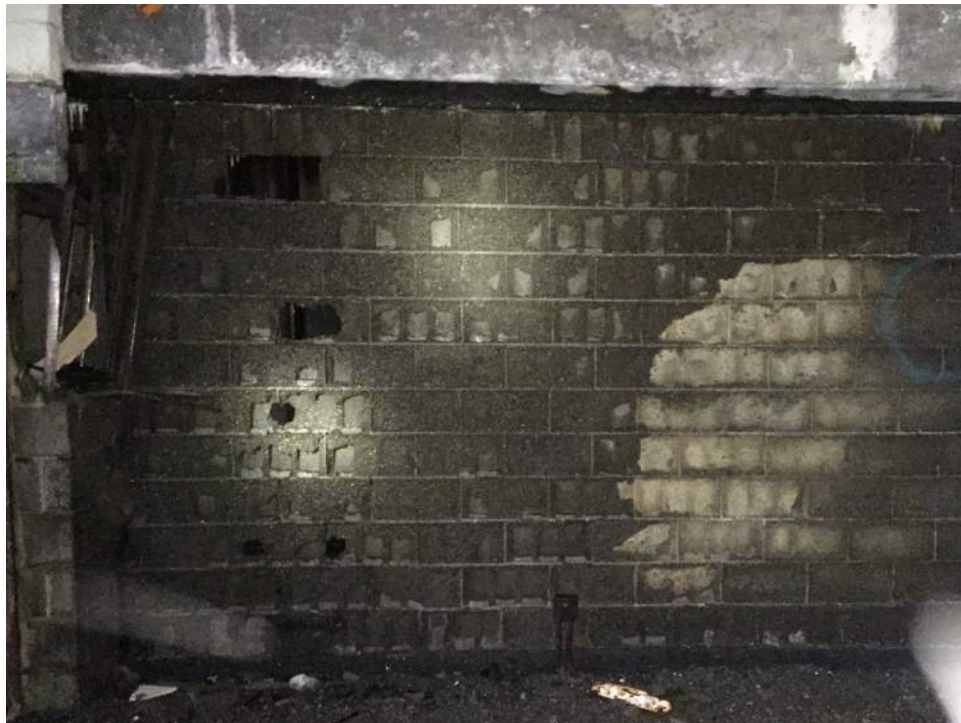
Figure A50 – Severely deteriorated CMU at 1st floor, with holes eroded complete through.

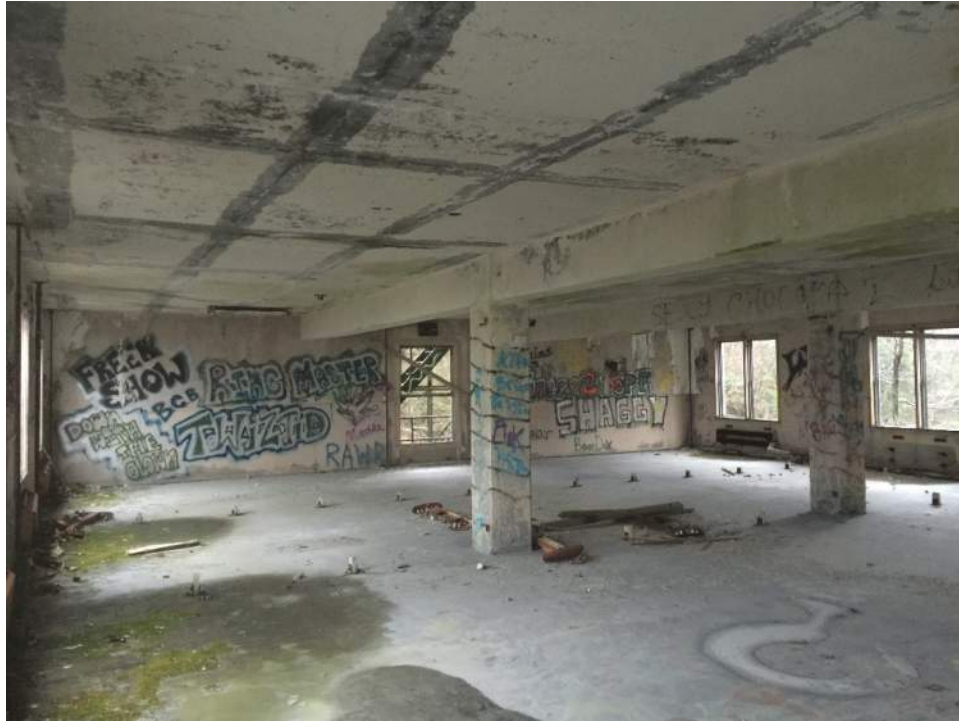
Figure A51 – Squad Room on southern end of Unit G’s 2nd floor. This portion of the building is generally in the best condition.

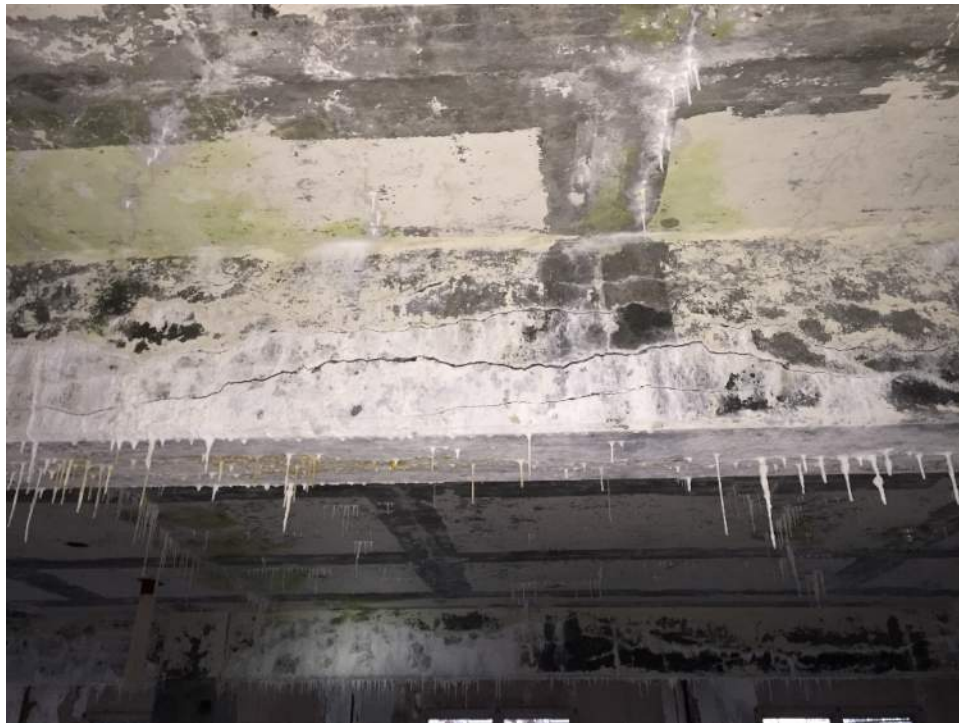
Figure A51 – 2nd floor beam with large horizontal cracks.

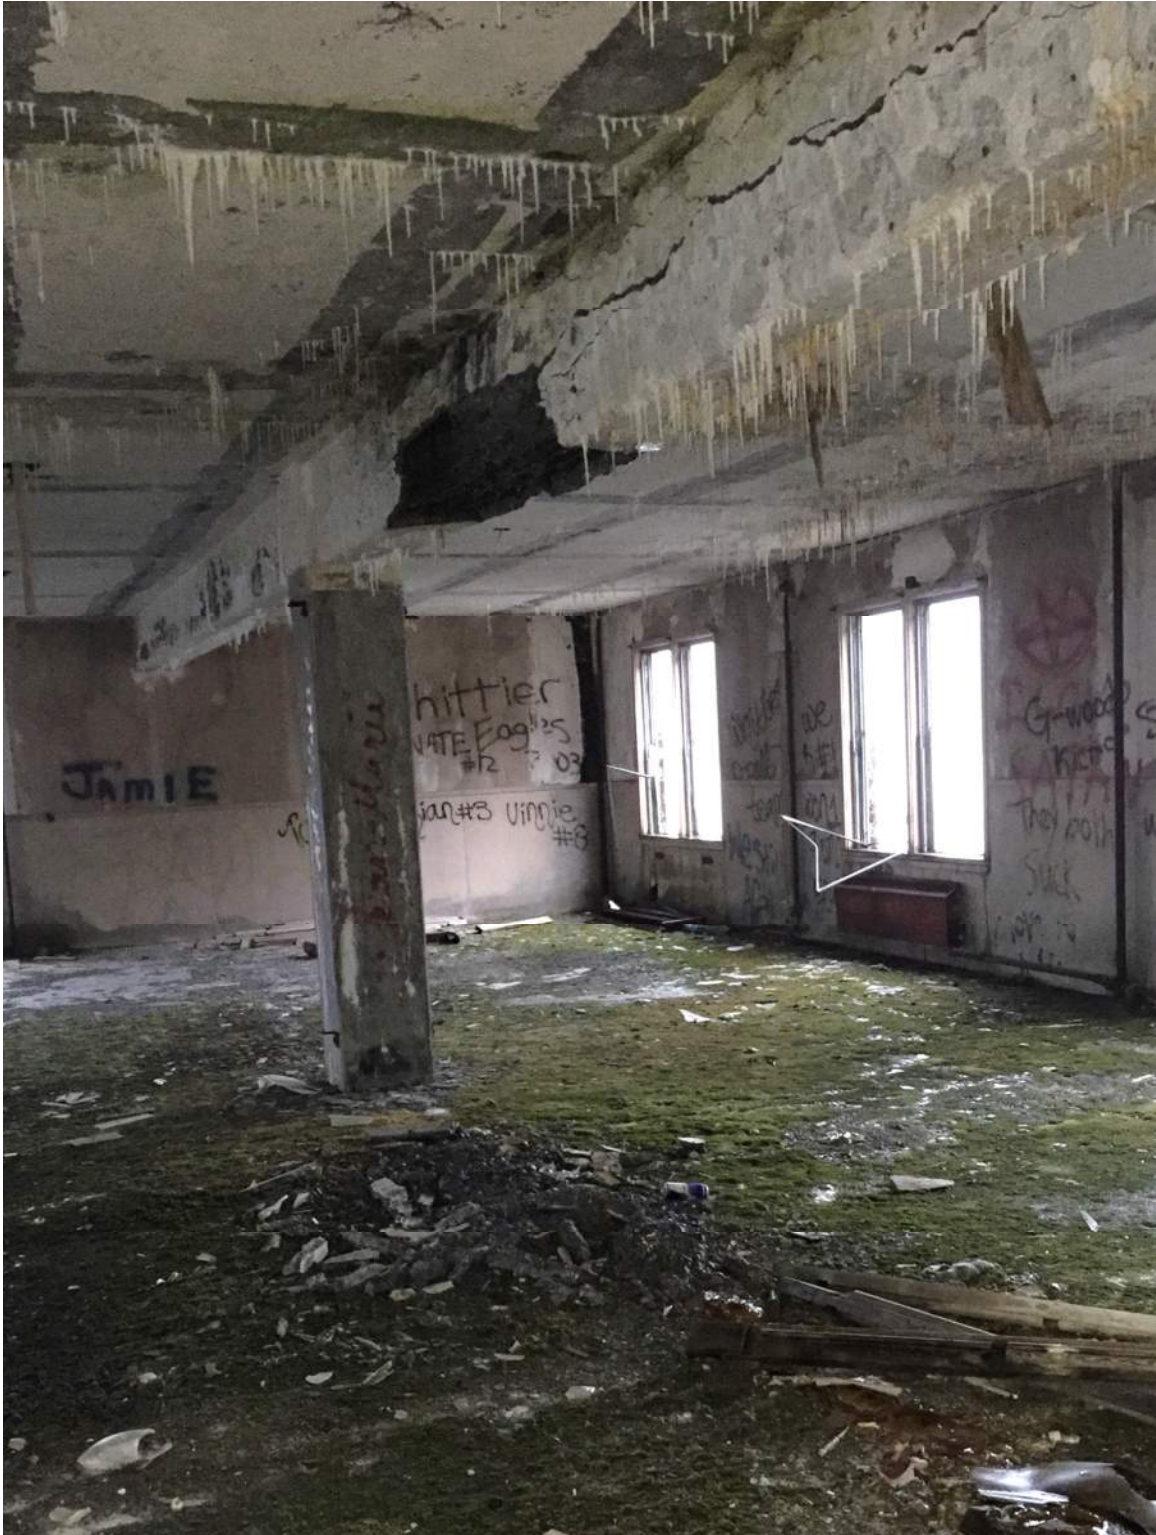
Figure A52 – Floor beam at 2nd level Squad Room, northern half of Unit G. Beam is approaching collapse.

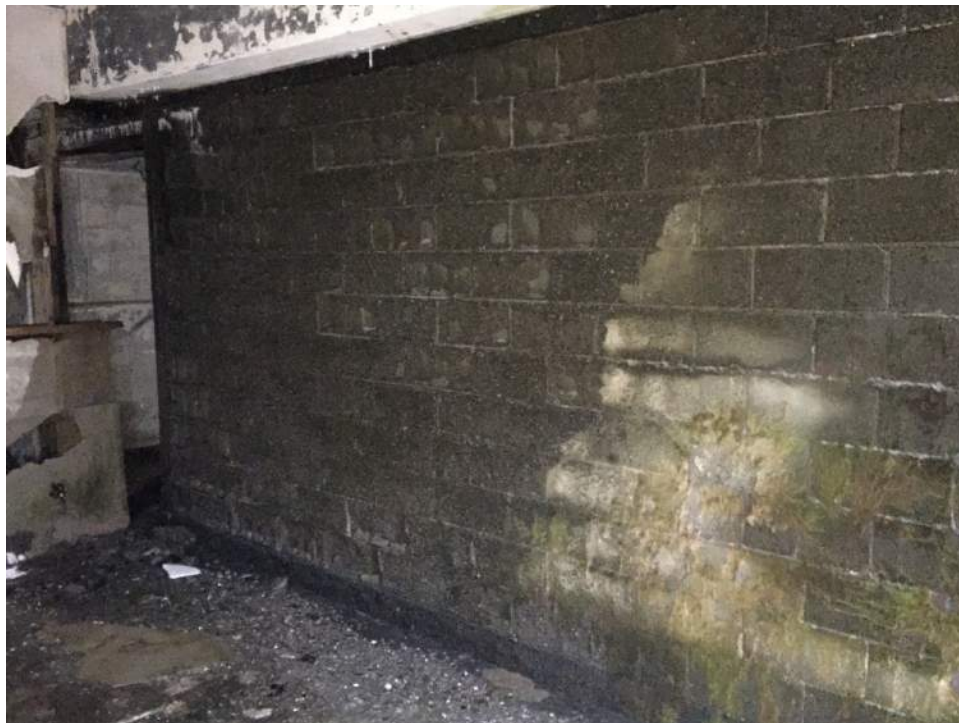
Figure A54 – Deteriorated CMU wall at the 2nd floor level.

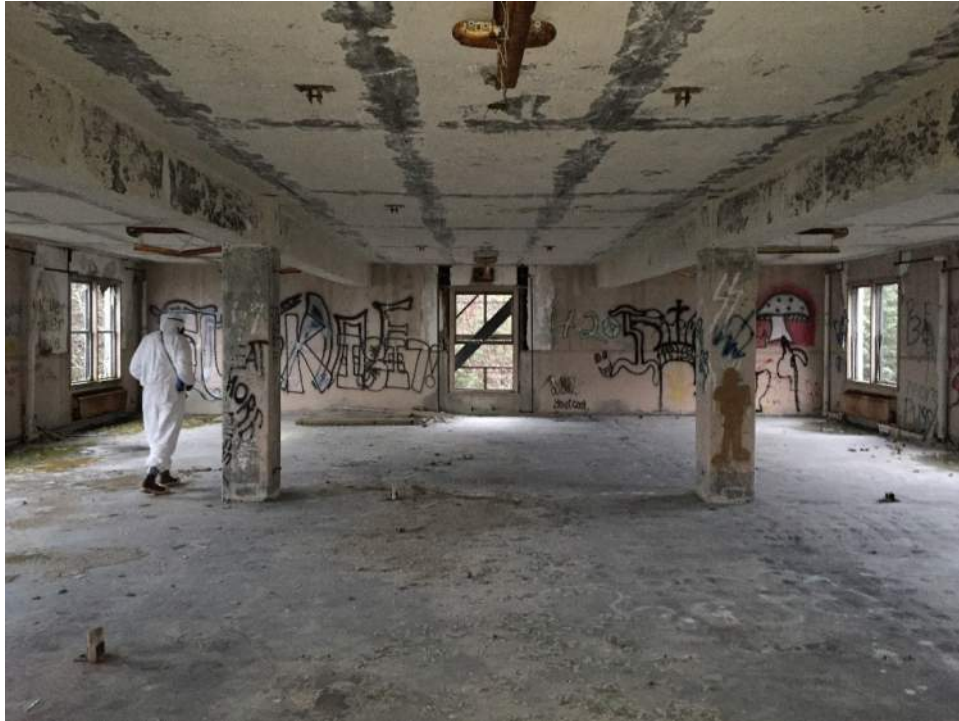
Figure A55 – Squad Room on southern end of Unit G’s 3rd floor. This portion of the building is generally in the best condition.

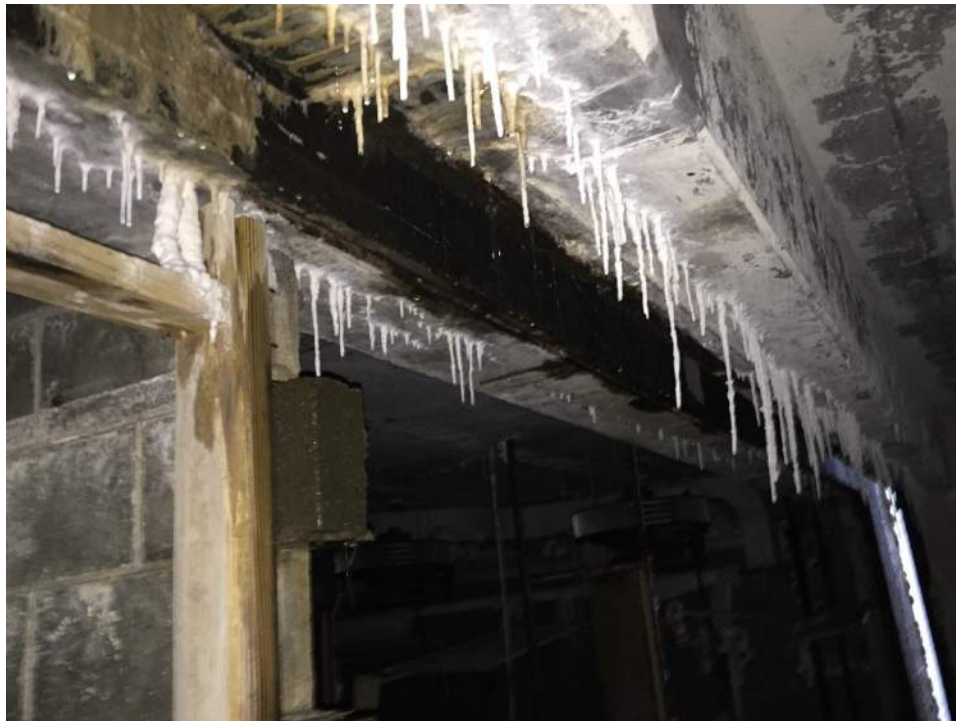
Figure A56 – Seismic joint with 3rd floor beams each side. Stalactites present on each beam and flashing is missing at joint.

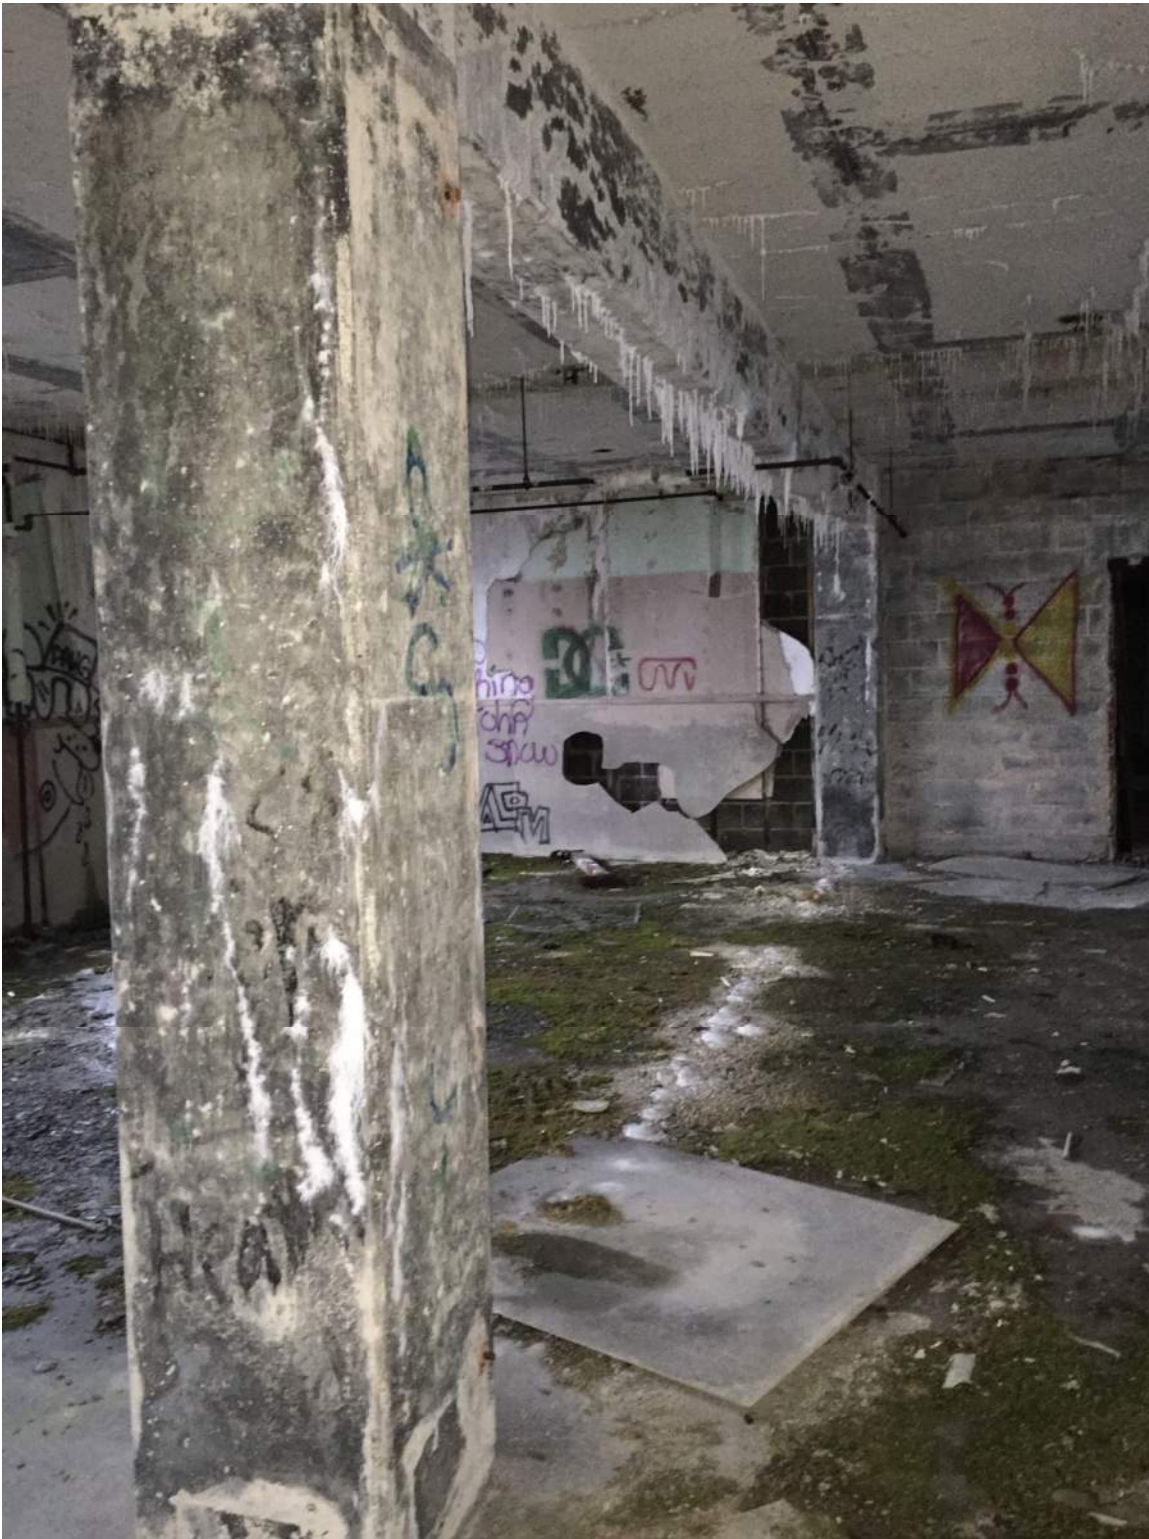
Figure A57 – 3rd floor Squad Room on northern half of unit. Stalactites and stalagmites are present along beam line.

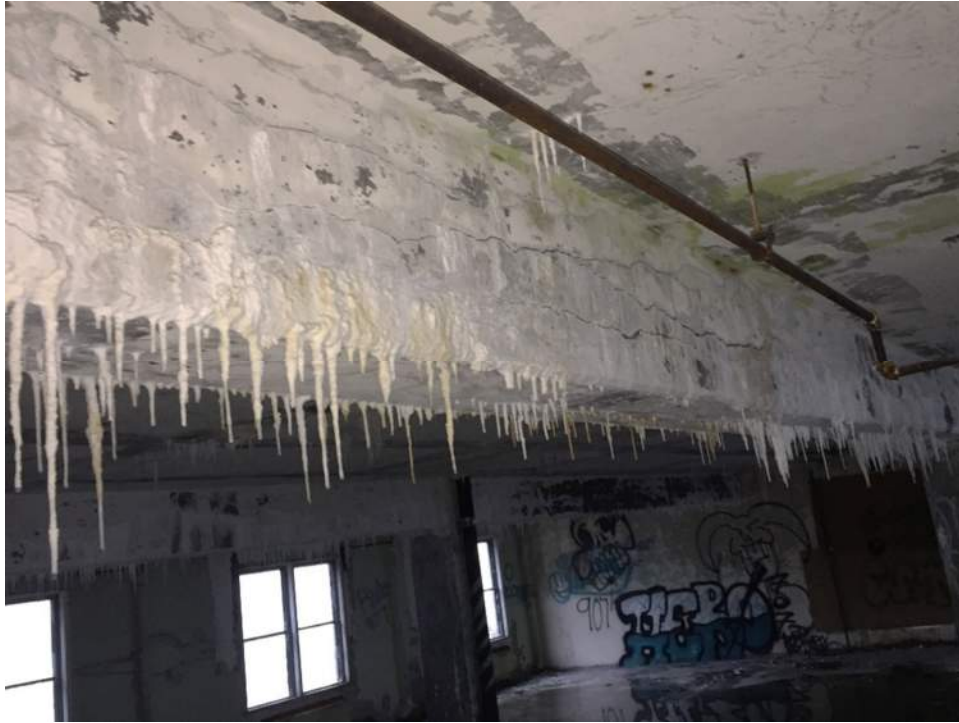
Figure A60 – 3rd floor beam with horizontal cracking along beam face.

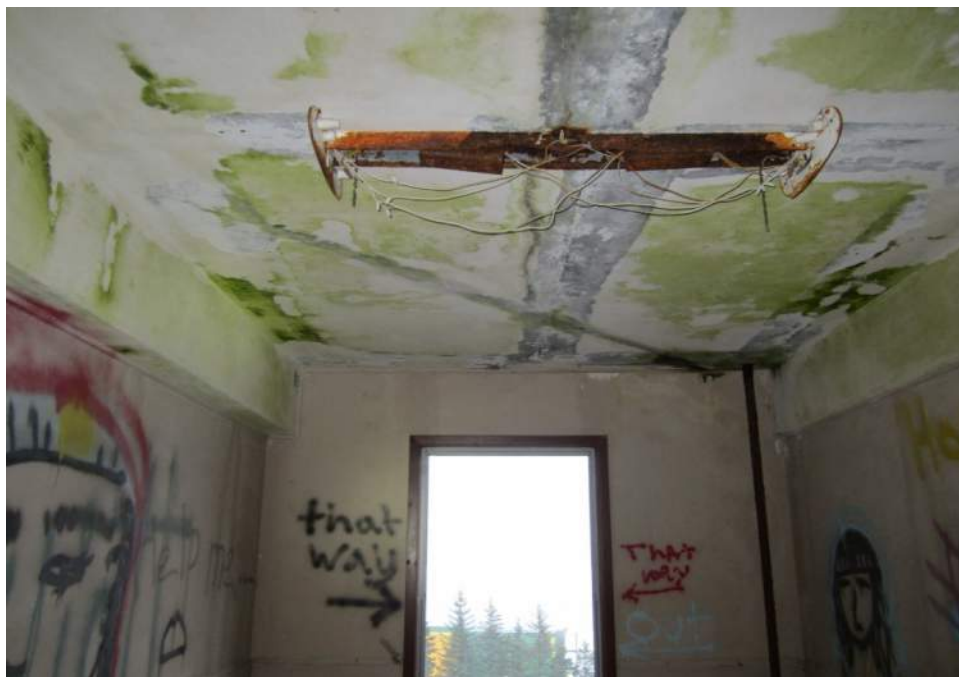
Figure A61 – 3rd floor barracks with architectural finishes still intact (although damaged).

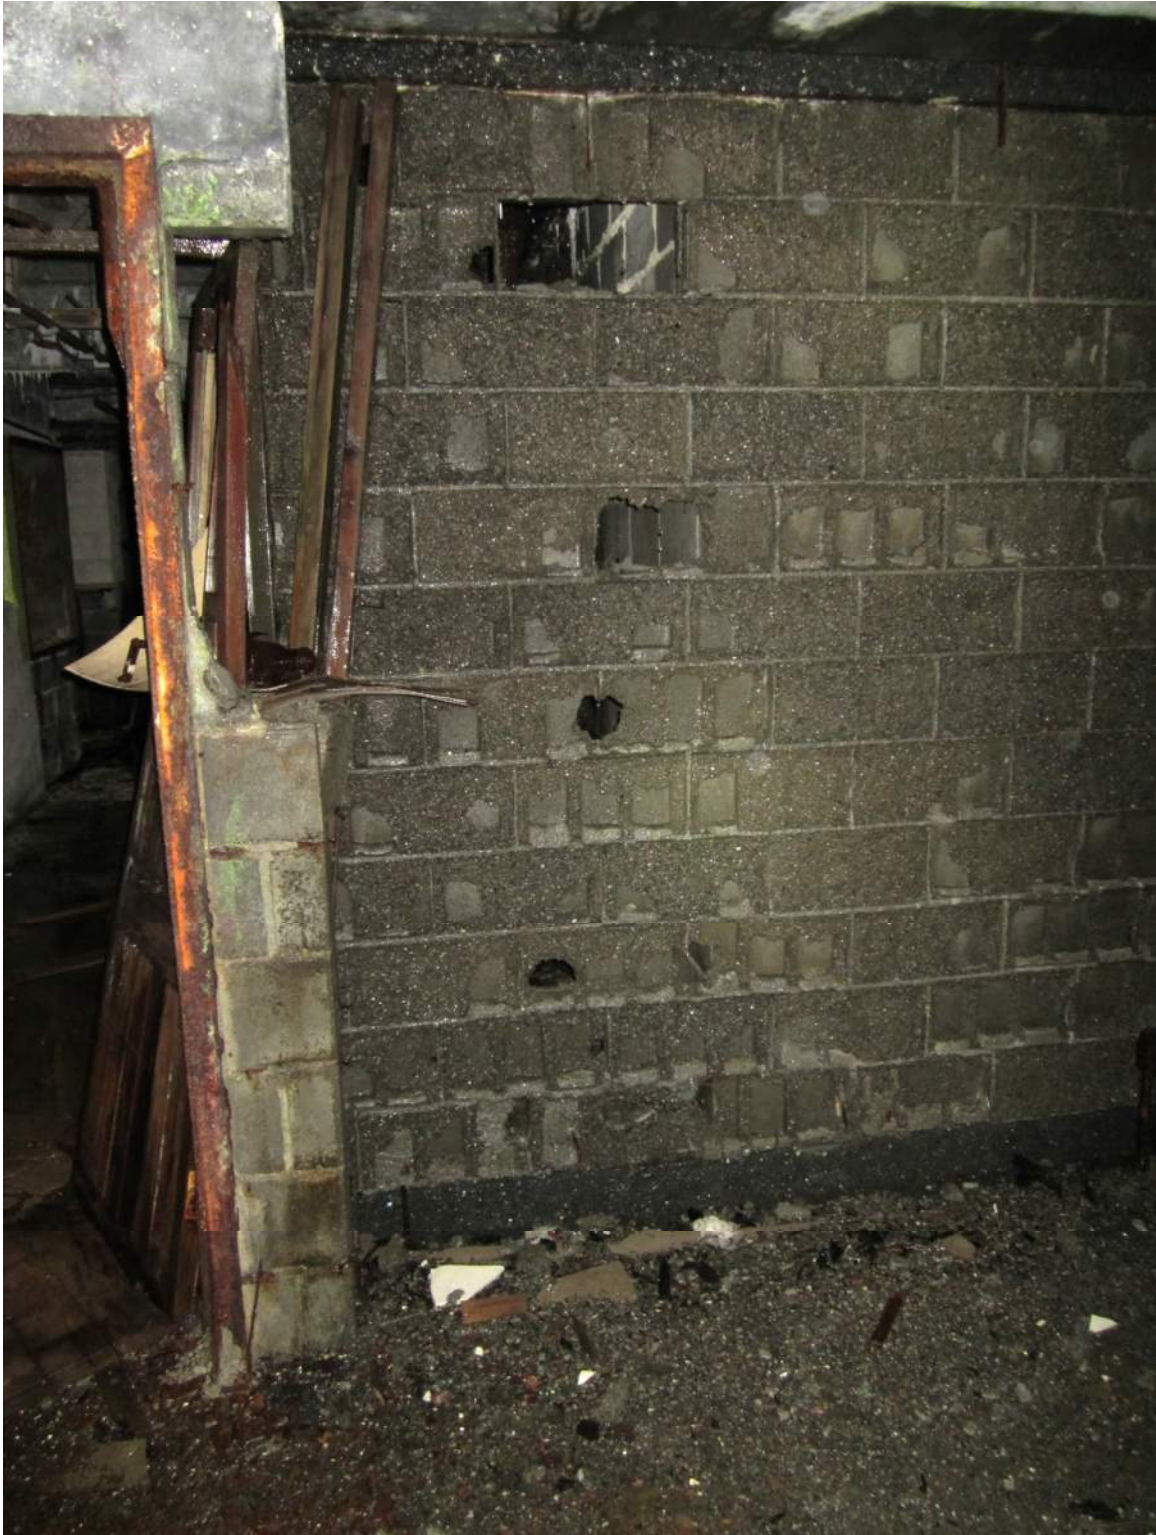
Figure A62 – Severely deteriorated CMU wall at 3rd floor level.

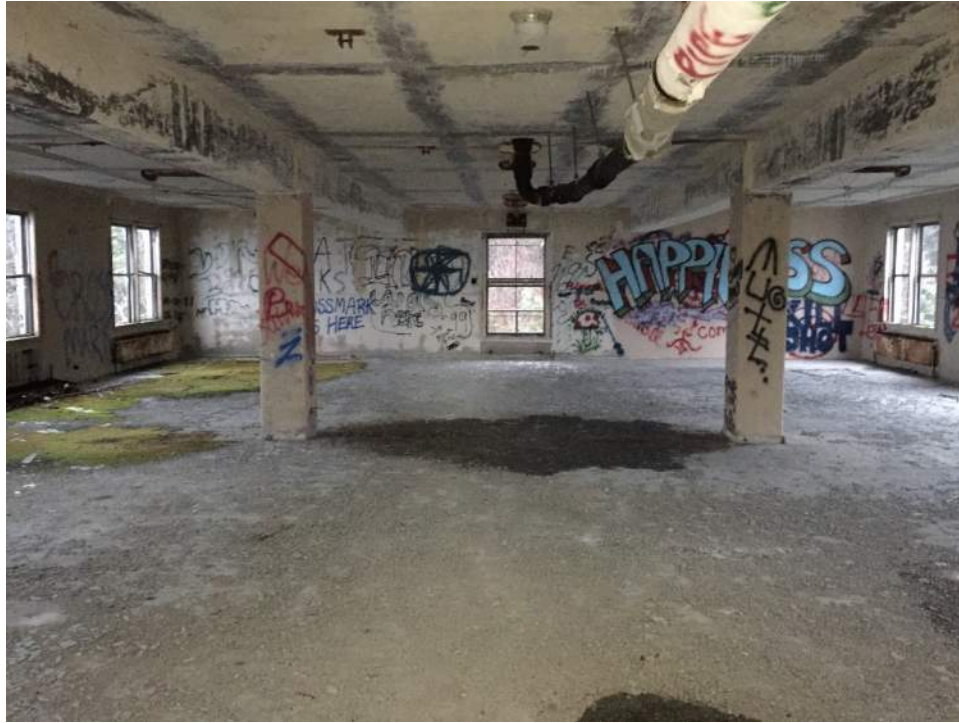
Figure A63 – Squad Room on southern end of Unit G’s 4th floor. This portion of the building is generally in the best condition.

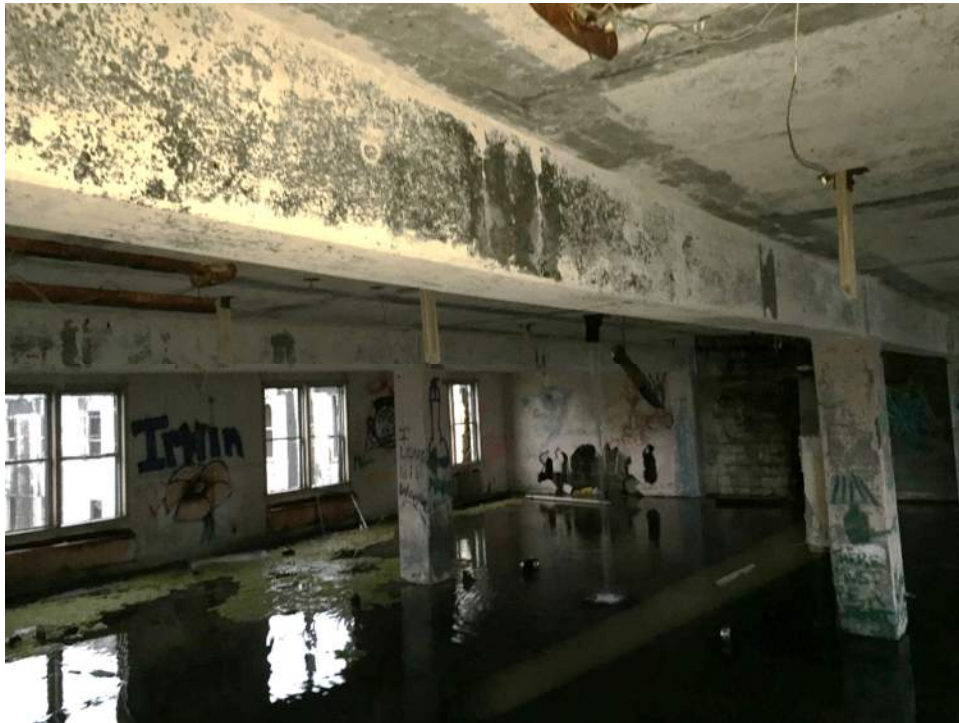
Figure A64 – Flooded squad room on norther side of the building.

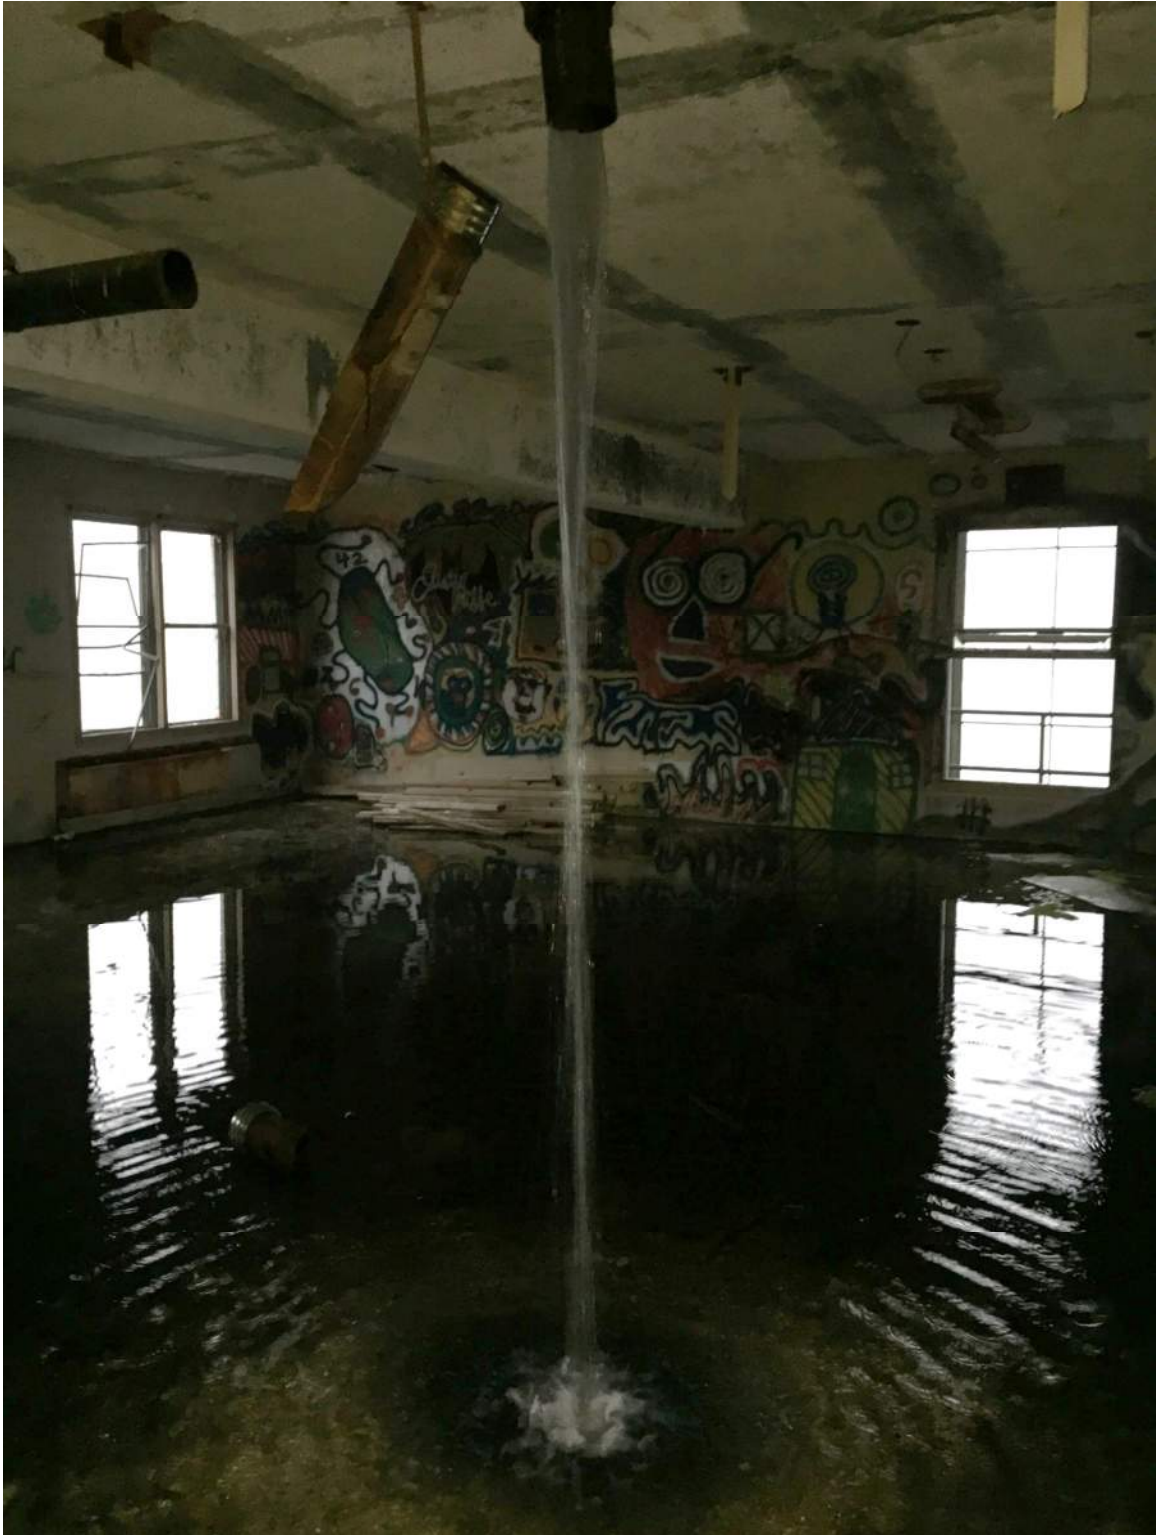
Figure A65 – Broken rain leader draining directly onto floor slab.

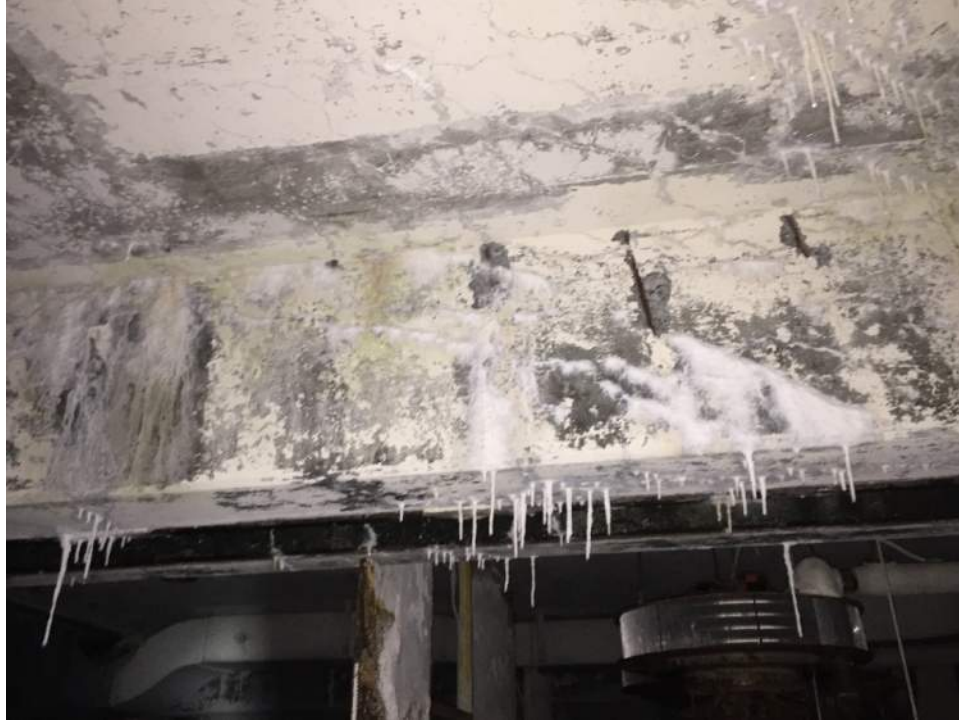
Figure A66 – Close up of deteriorating roof beam with exposed stirrups.

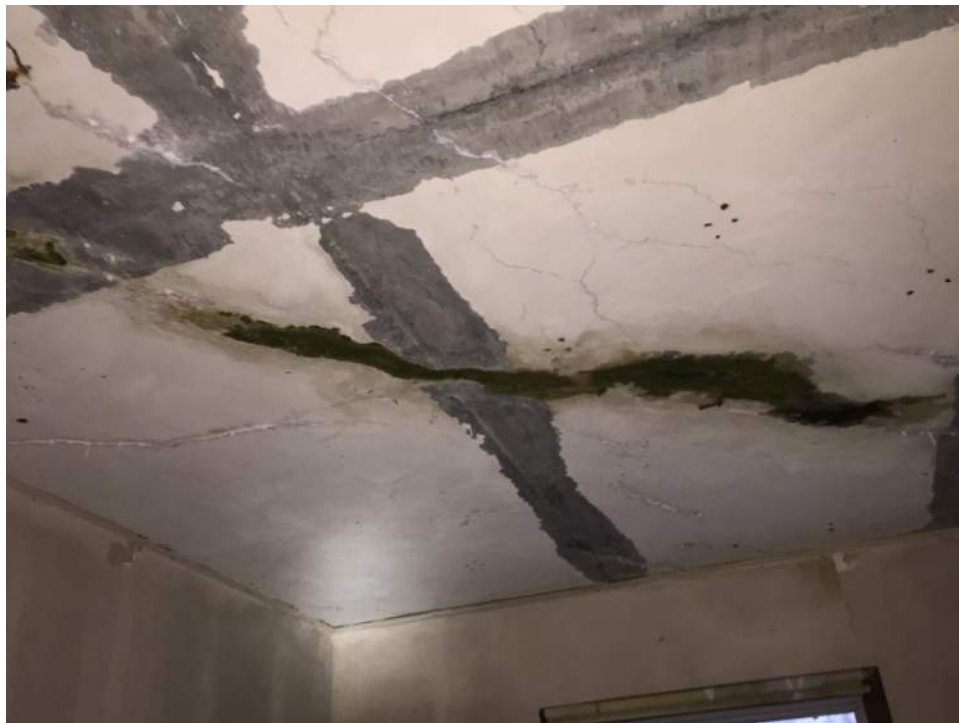
Figure A67 – Cracking in roof slab above 4th floor barracks.

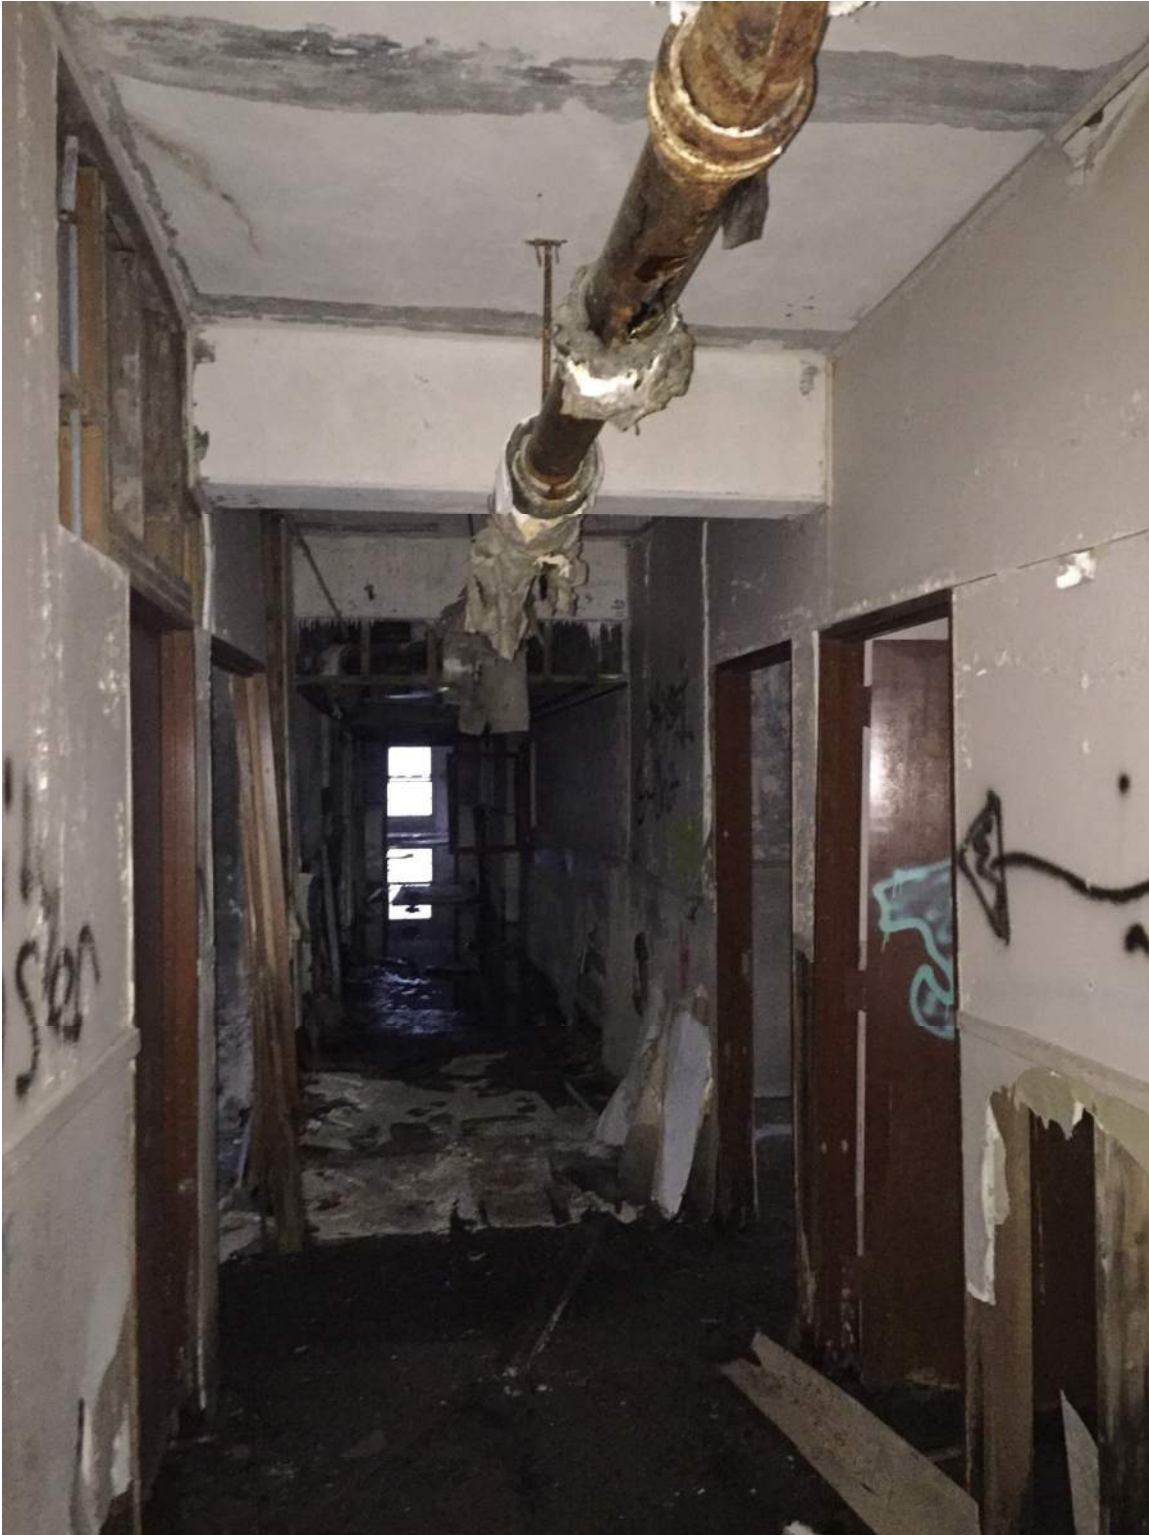
Figure A68 – 4th floor corridor showing more architectural finishes still in place.
