Alaska Department of Environmental Conservation

Structural Assessment for Remedial Design

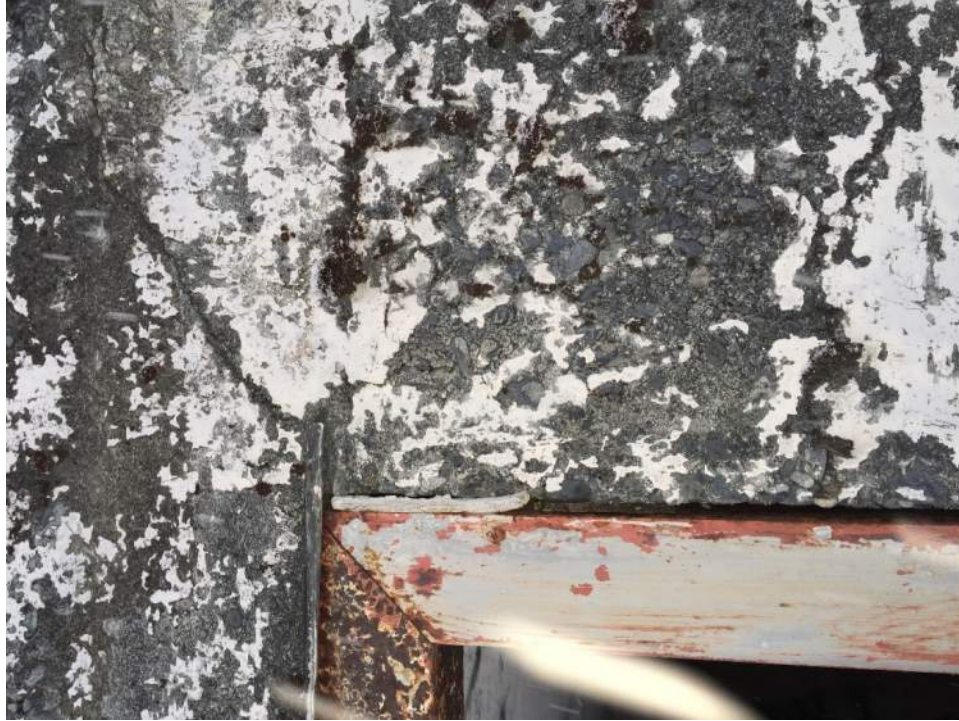
Figure A75 – Shallow surface defects of concrete penthouses, typical.

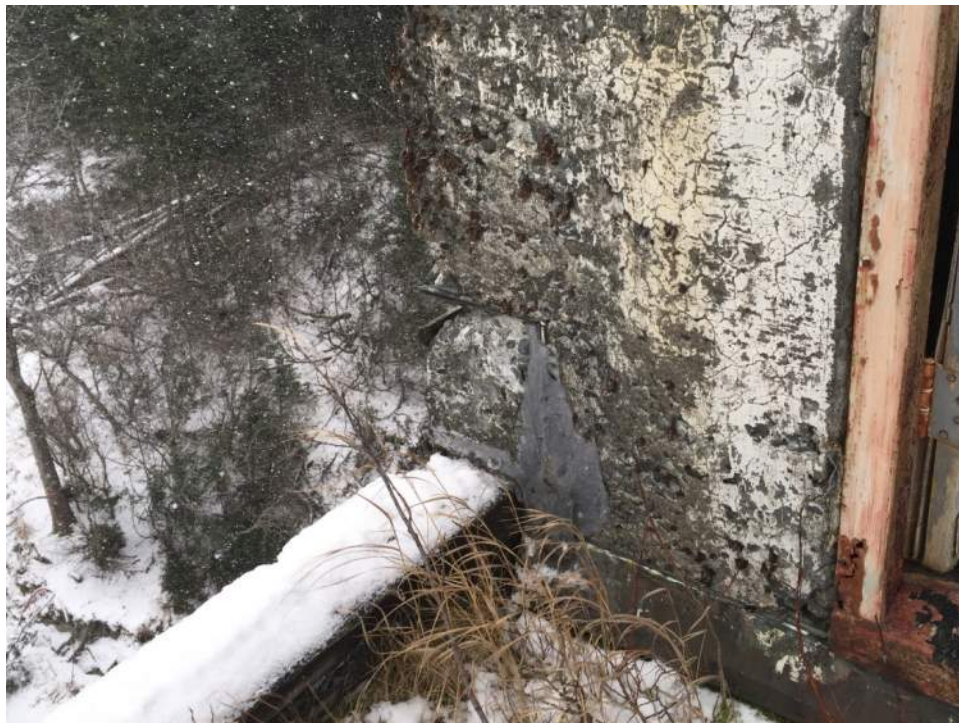
Figure A76 – Shallow surface defects of concrete penthouses, typical.

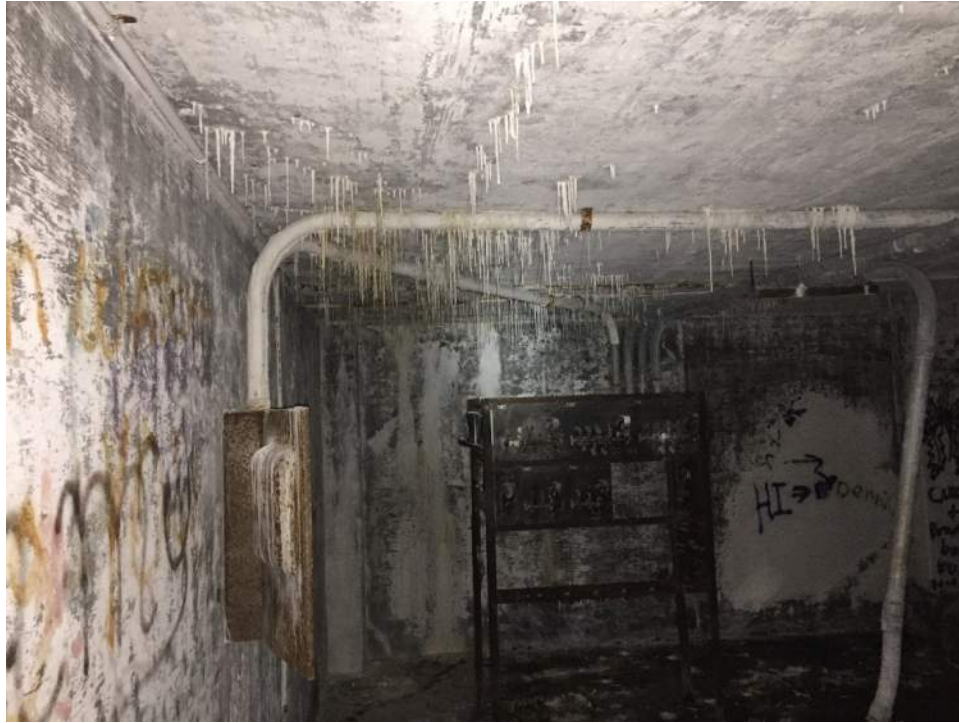
Figure A77 – Typical penthouse mechanical mezzanine. Stalactites visible from the ceiling slab.

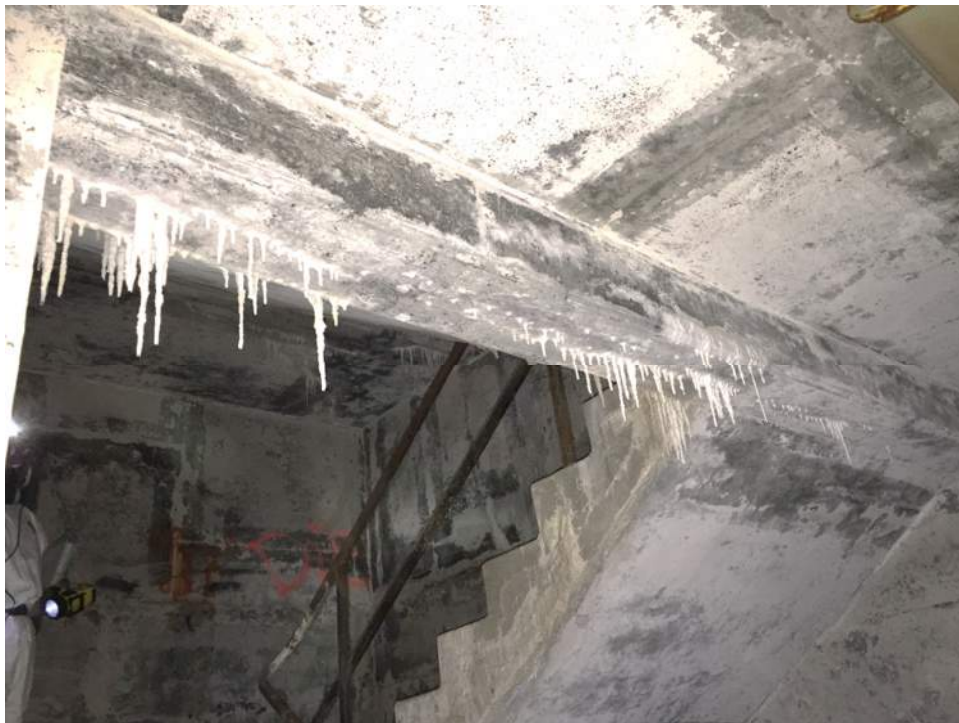
Figure A78 – Stairwells to for roof access were typically in fair condition, but not free of defects.

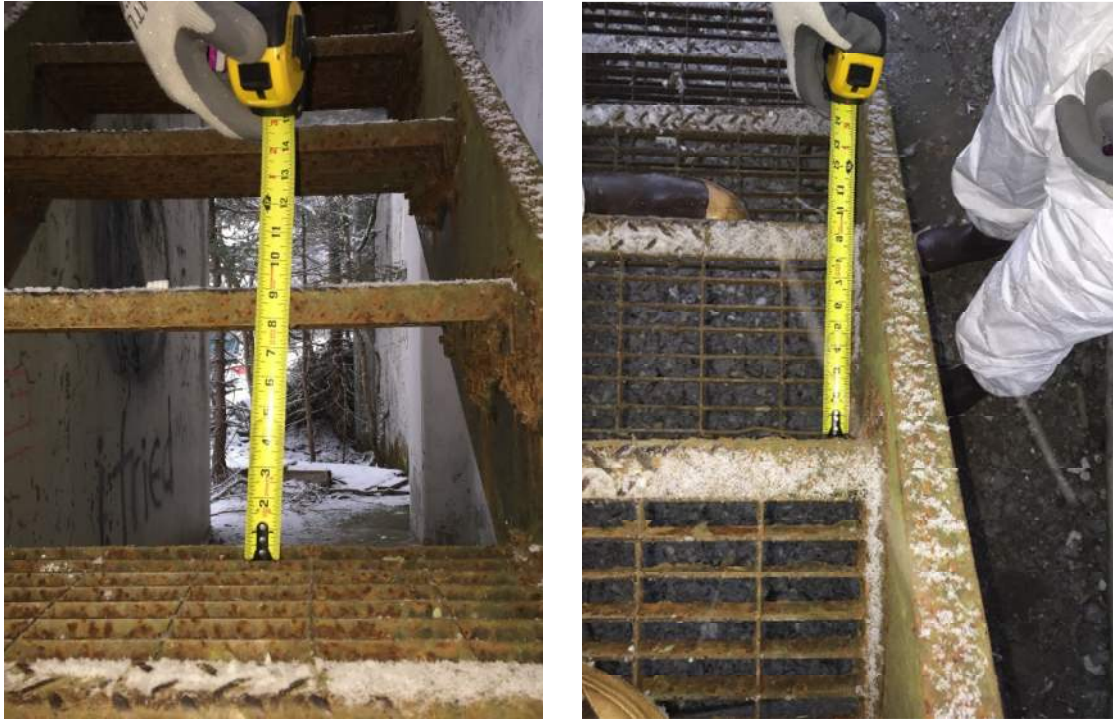
Figure A79 – Egress stair rise and run.

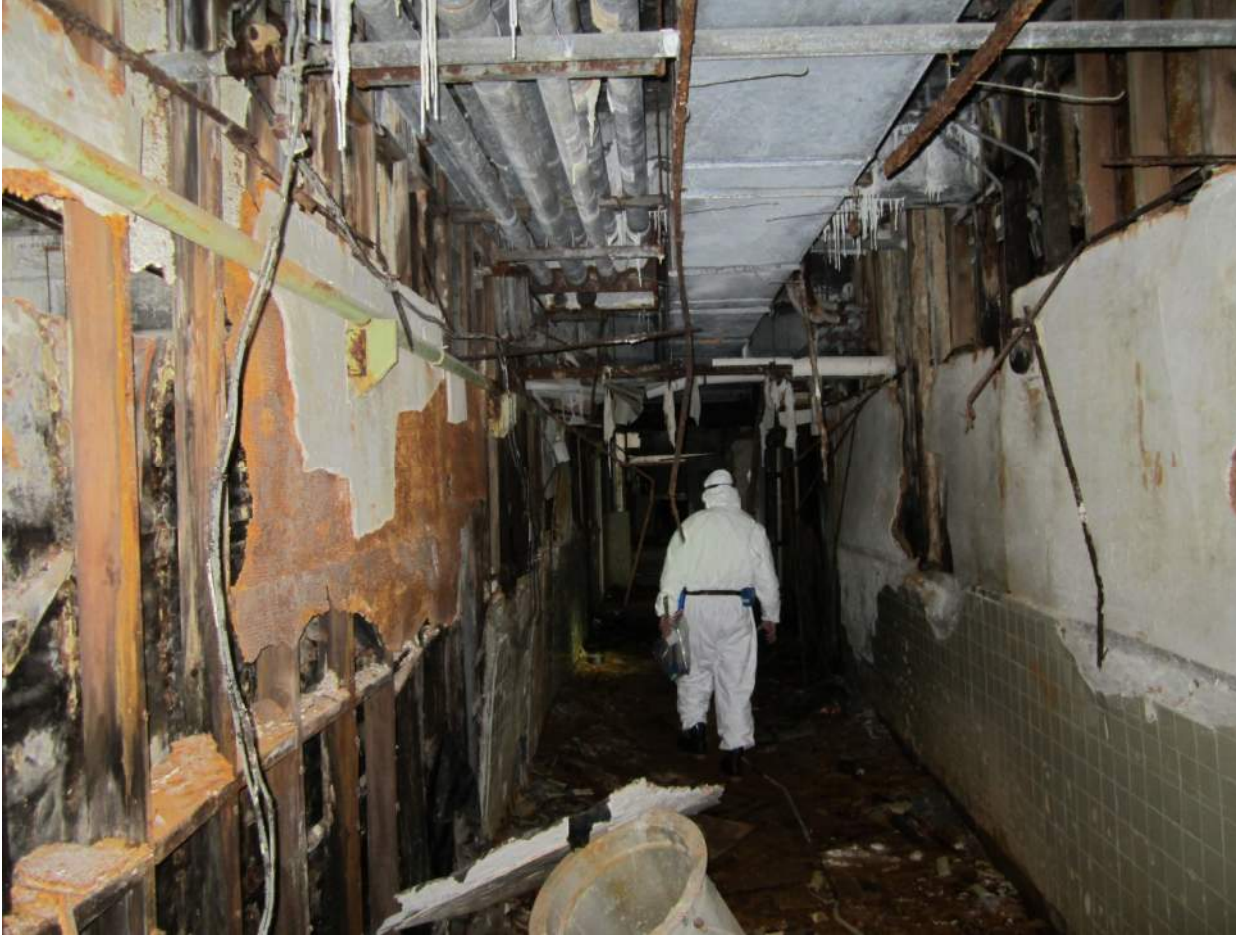
Figure A81 – Example of typical condition of nonstructural components.

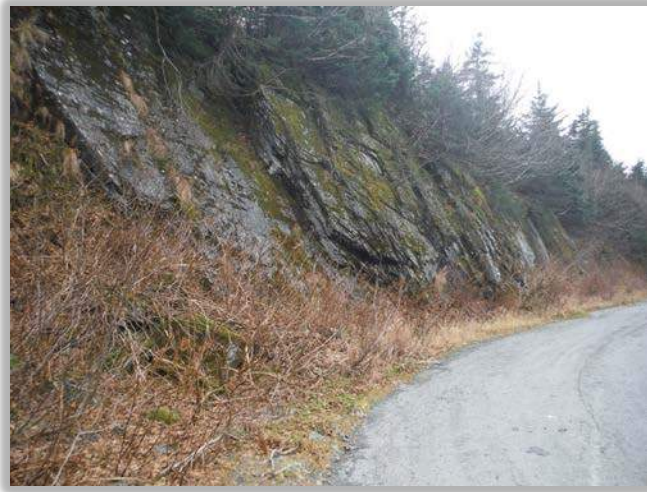
Excavated rock slope behind the northeast corner of the building. Looking southwest.

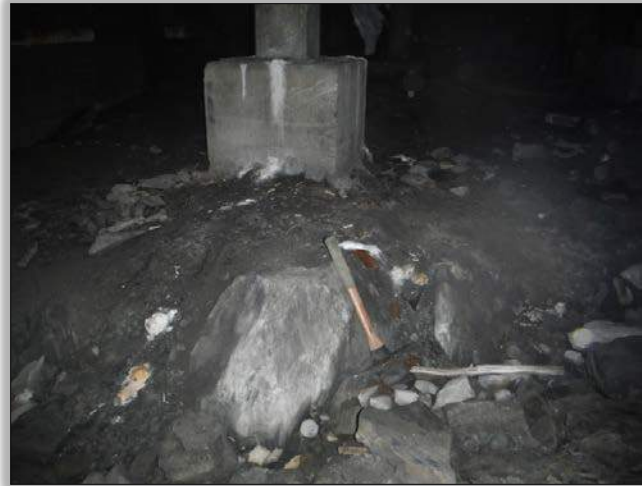
Typical footing observed in the sub-basement area of Unit A.
Note potential in-situ bedrock exposed in foreground.

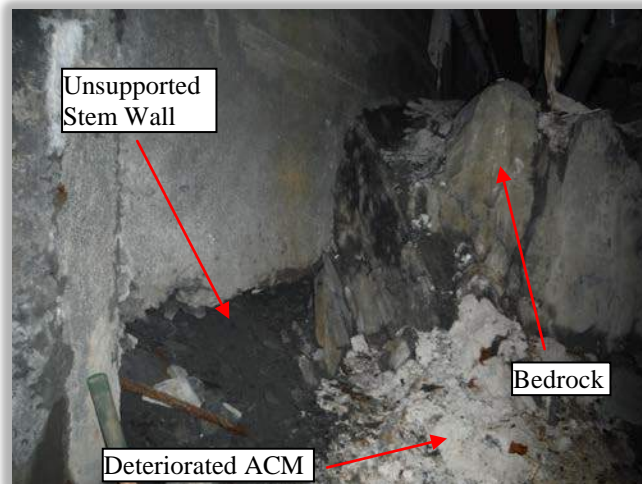
Stem wall observed in a utility tunnel near northwest corner of Unit G.

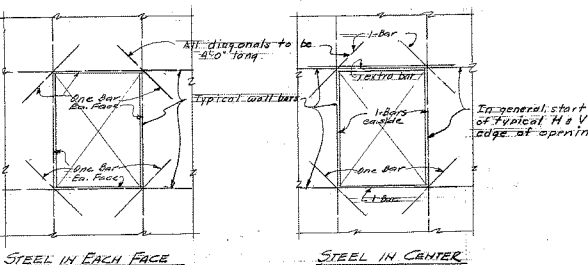
STEEL IN EACH FACE **STEEL IN CENTER**

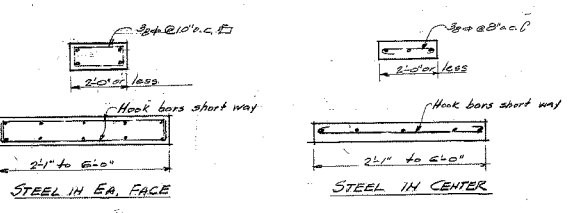
BAR IN SMALL WALL SECTIONS BETWEEN OPENINGS

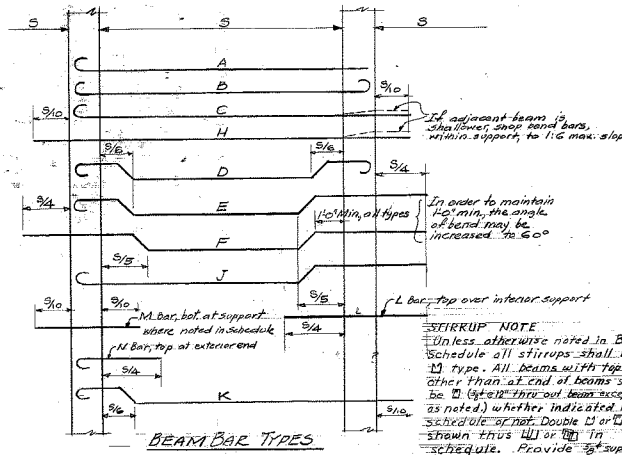
NOTES: Main beam bars to have 1 1/2" concrete cover. Main slab bars 3/4" concrete cover. In beams having bars top and bottom, top bottom bars 2'0" at supports and top bars 2'0" between supports, unless noted otherwise. Where beams and girders intersect at columns top steel in deepest member to be decked 1".

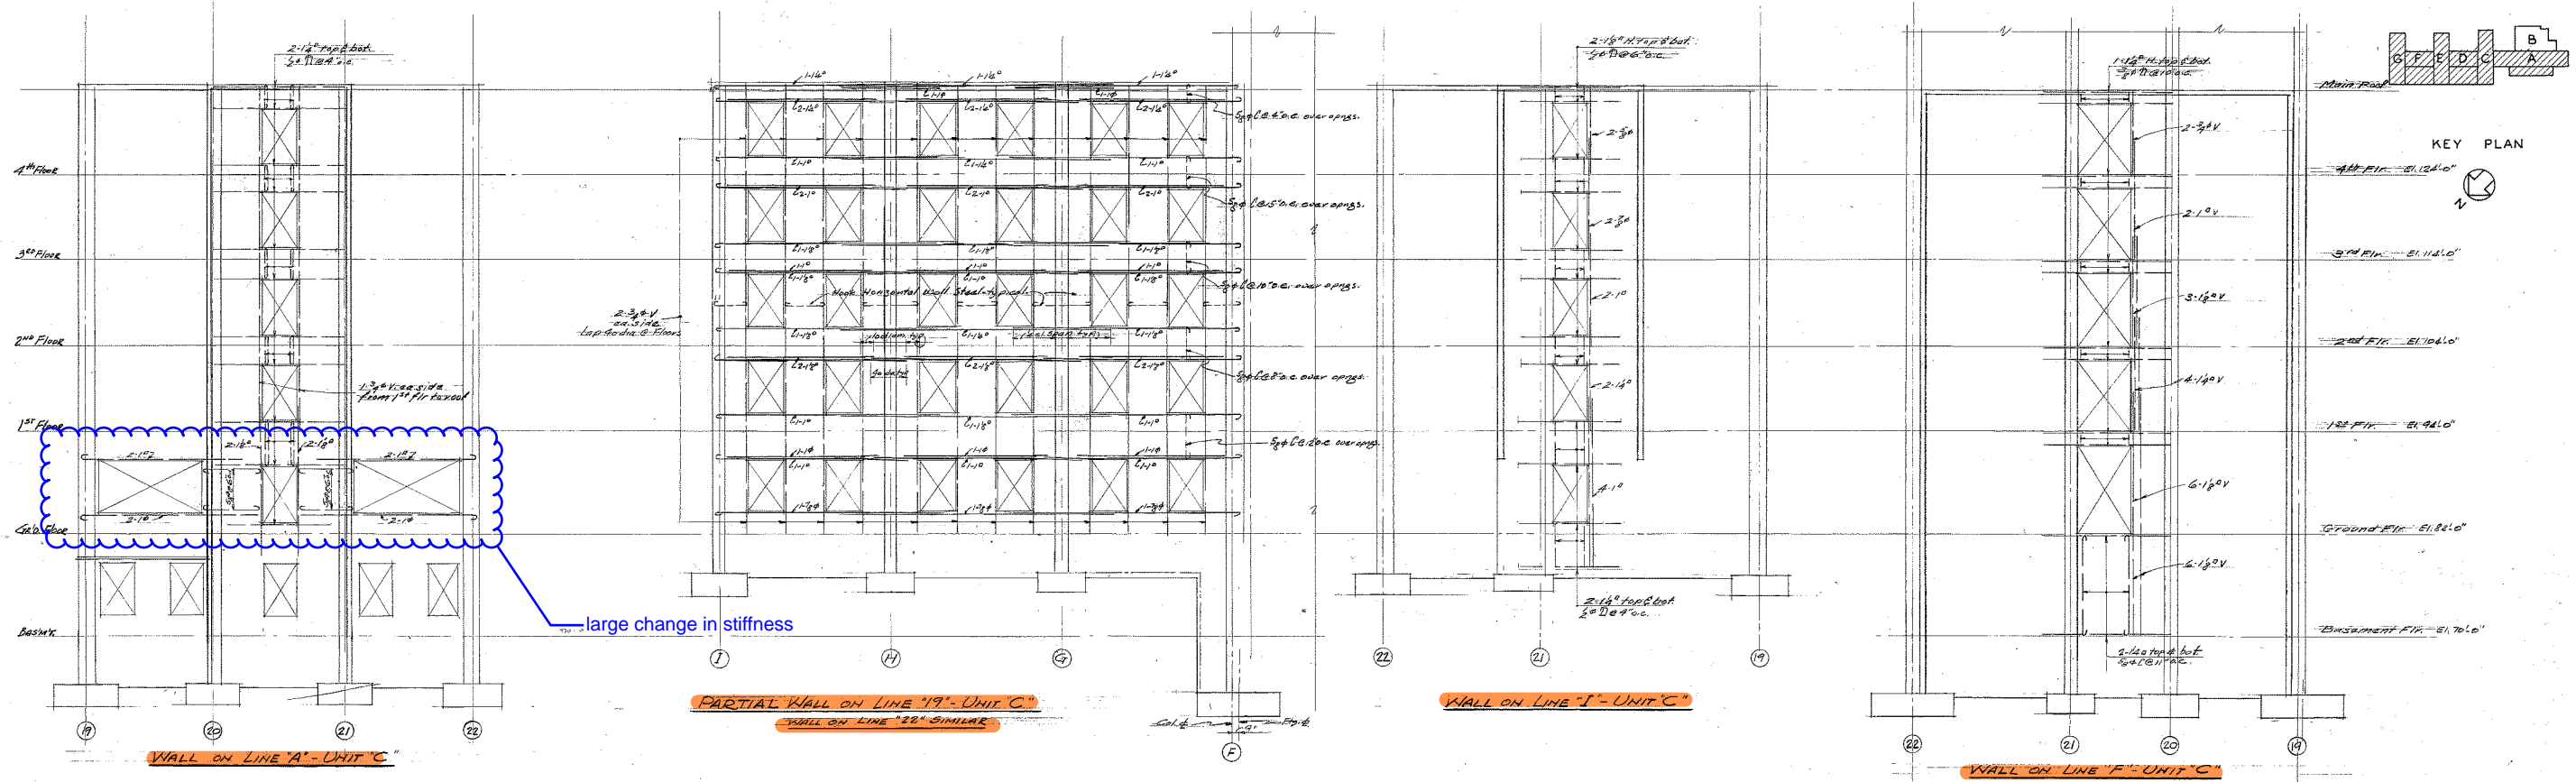
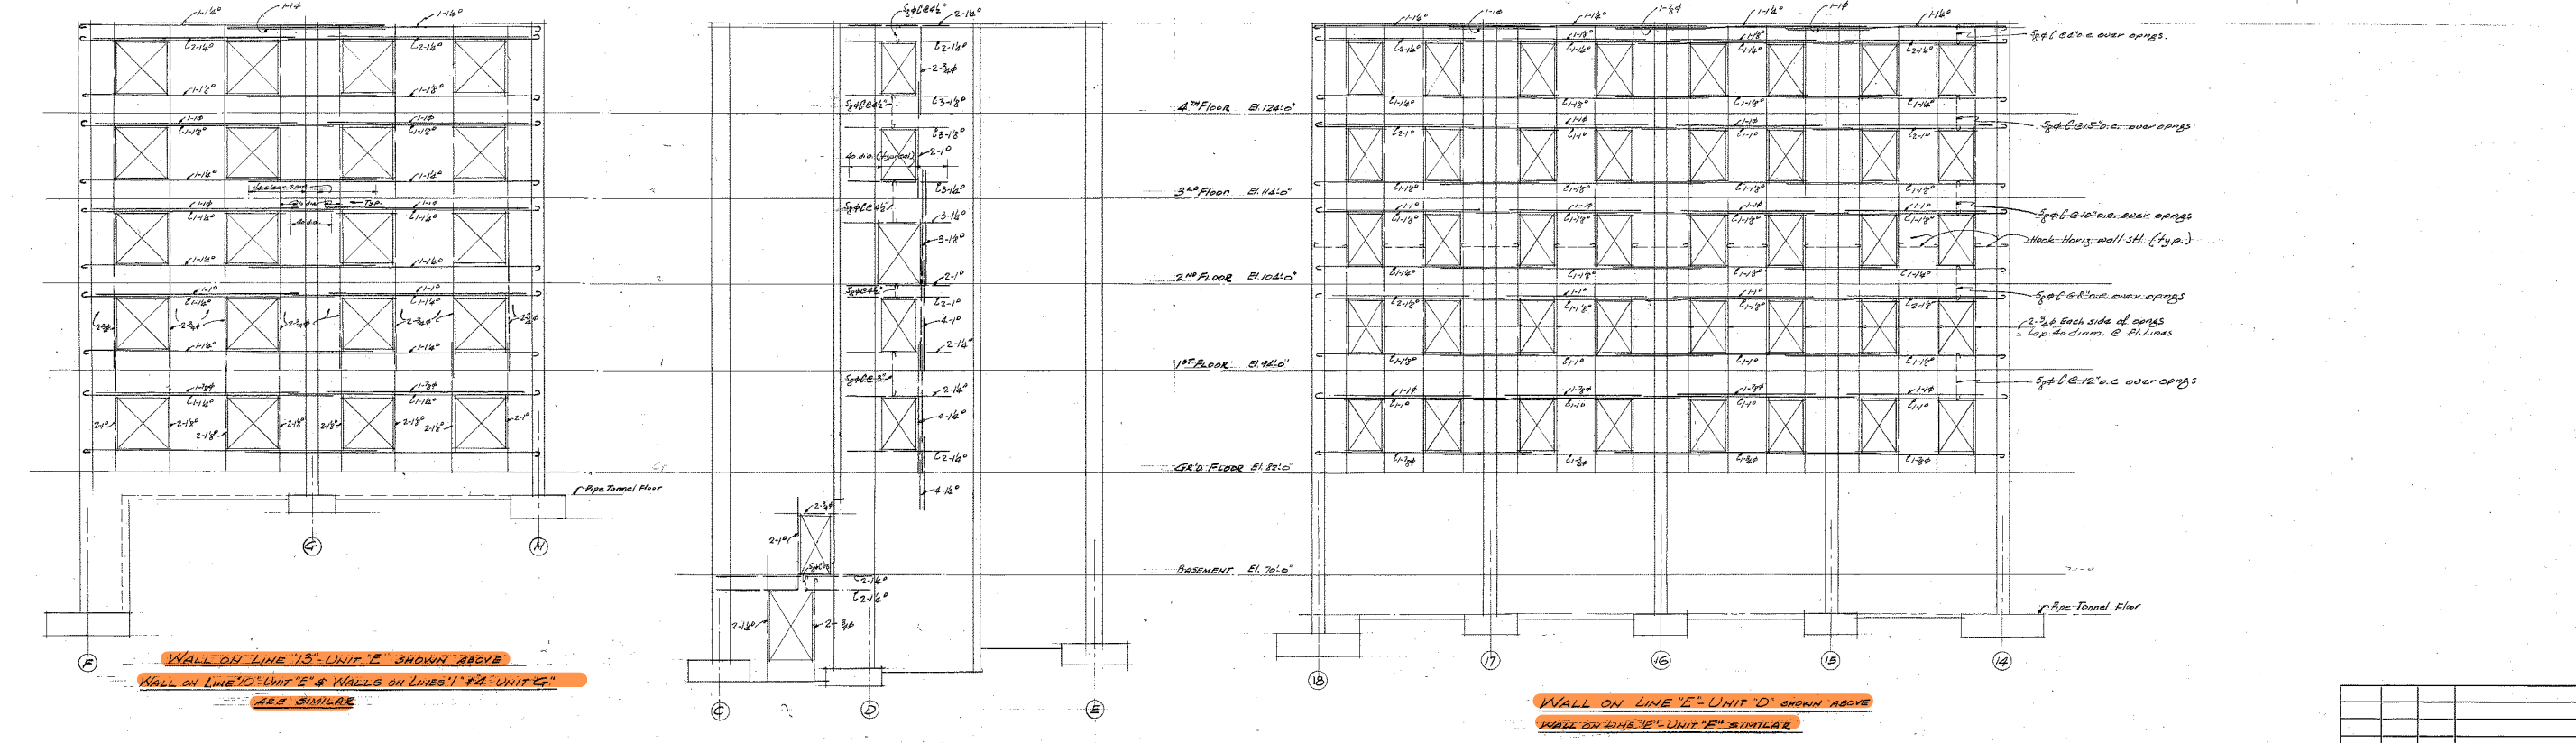
NOTE:
 All bars indicated on these elevations are in addition to typical wall reinforcement. See General Notes for typical wall reinforcement.
 All diagonal bars at openings in these elevations shall be 1-3/4" x 4-1/2" long.
 See Foundation Plans for bottom elevations of walls and footings.

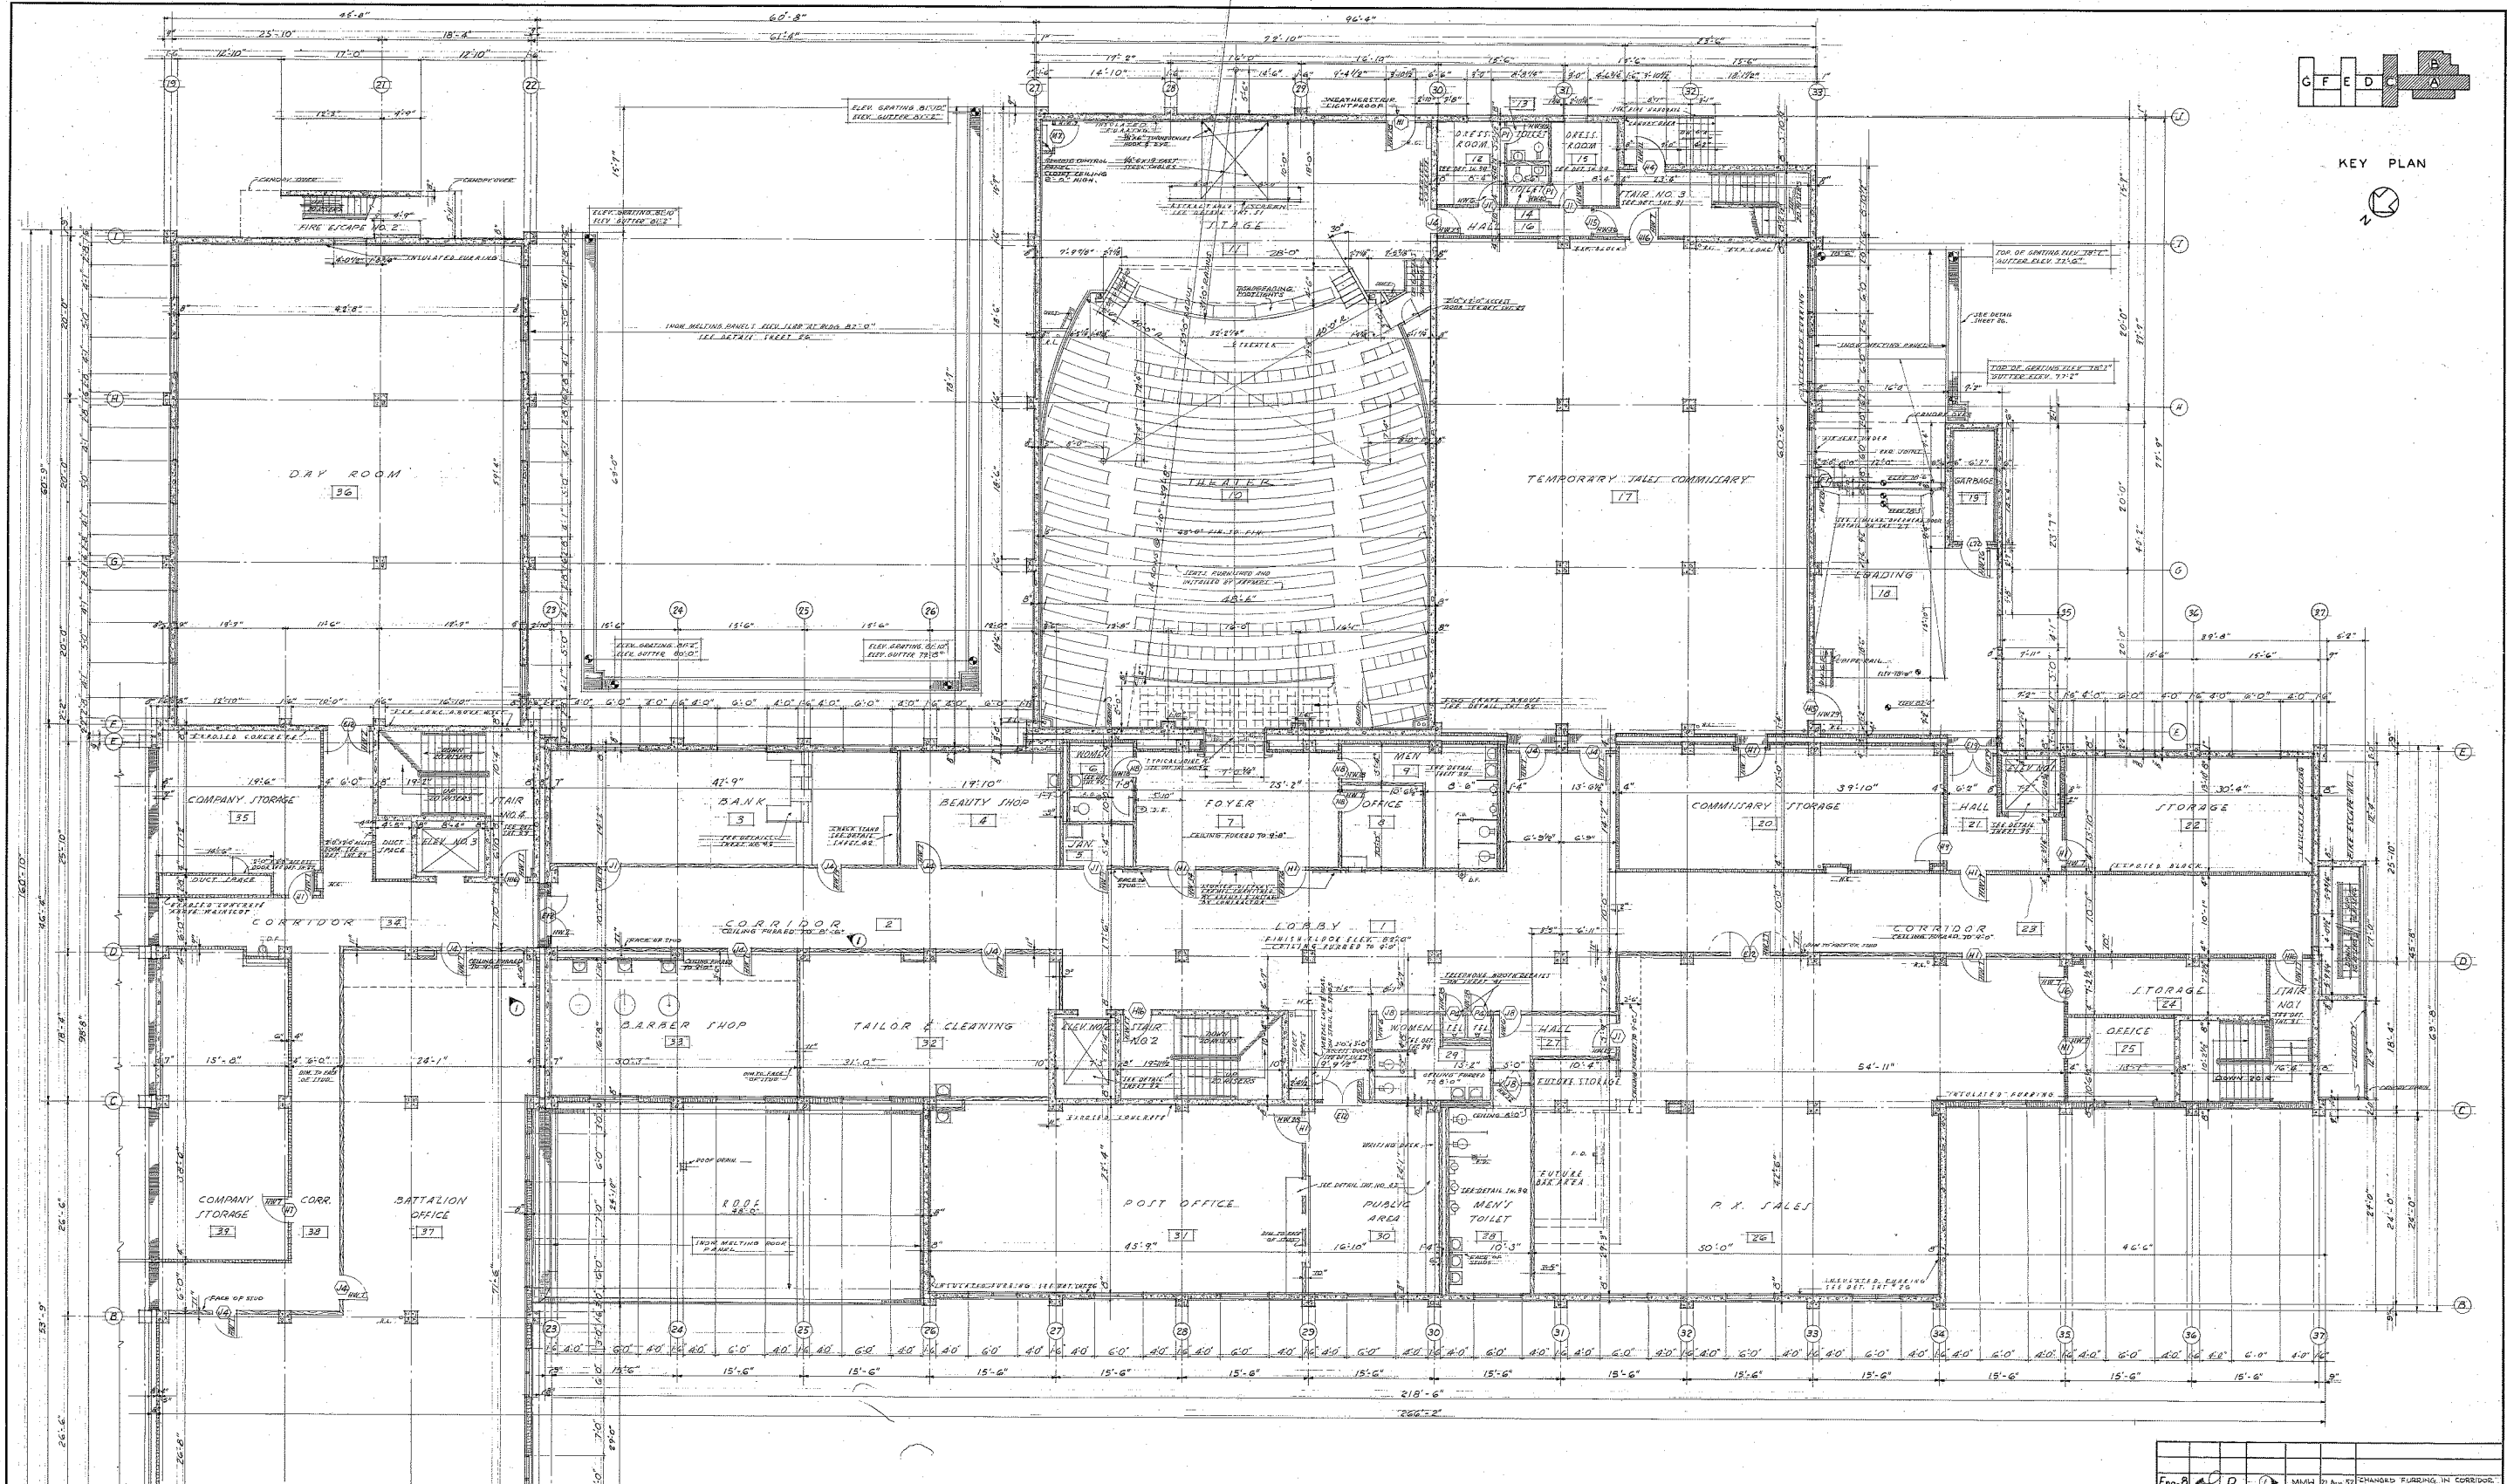
CANOPY IN CRITICAL CONDITION
FAILURE APPEARS TO BE IMMINENT

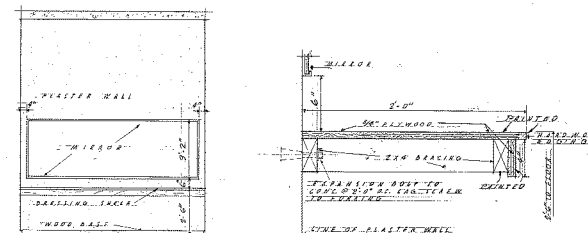
ELEVATION SECTION
DETAILS DRESSING ROOM SHELF RM. 12 & 15

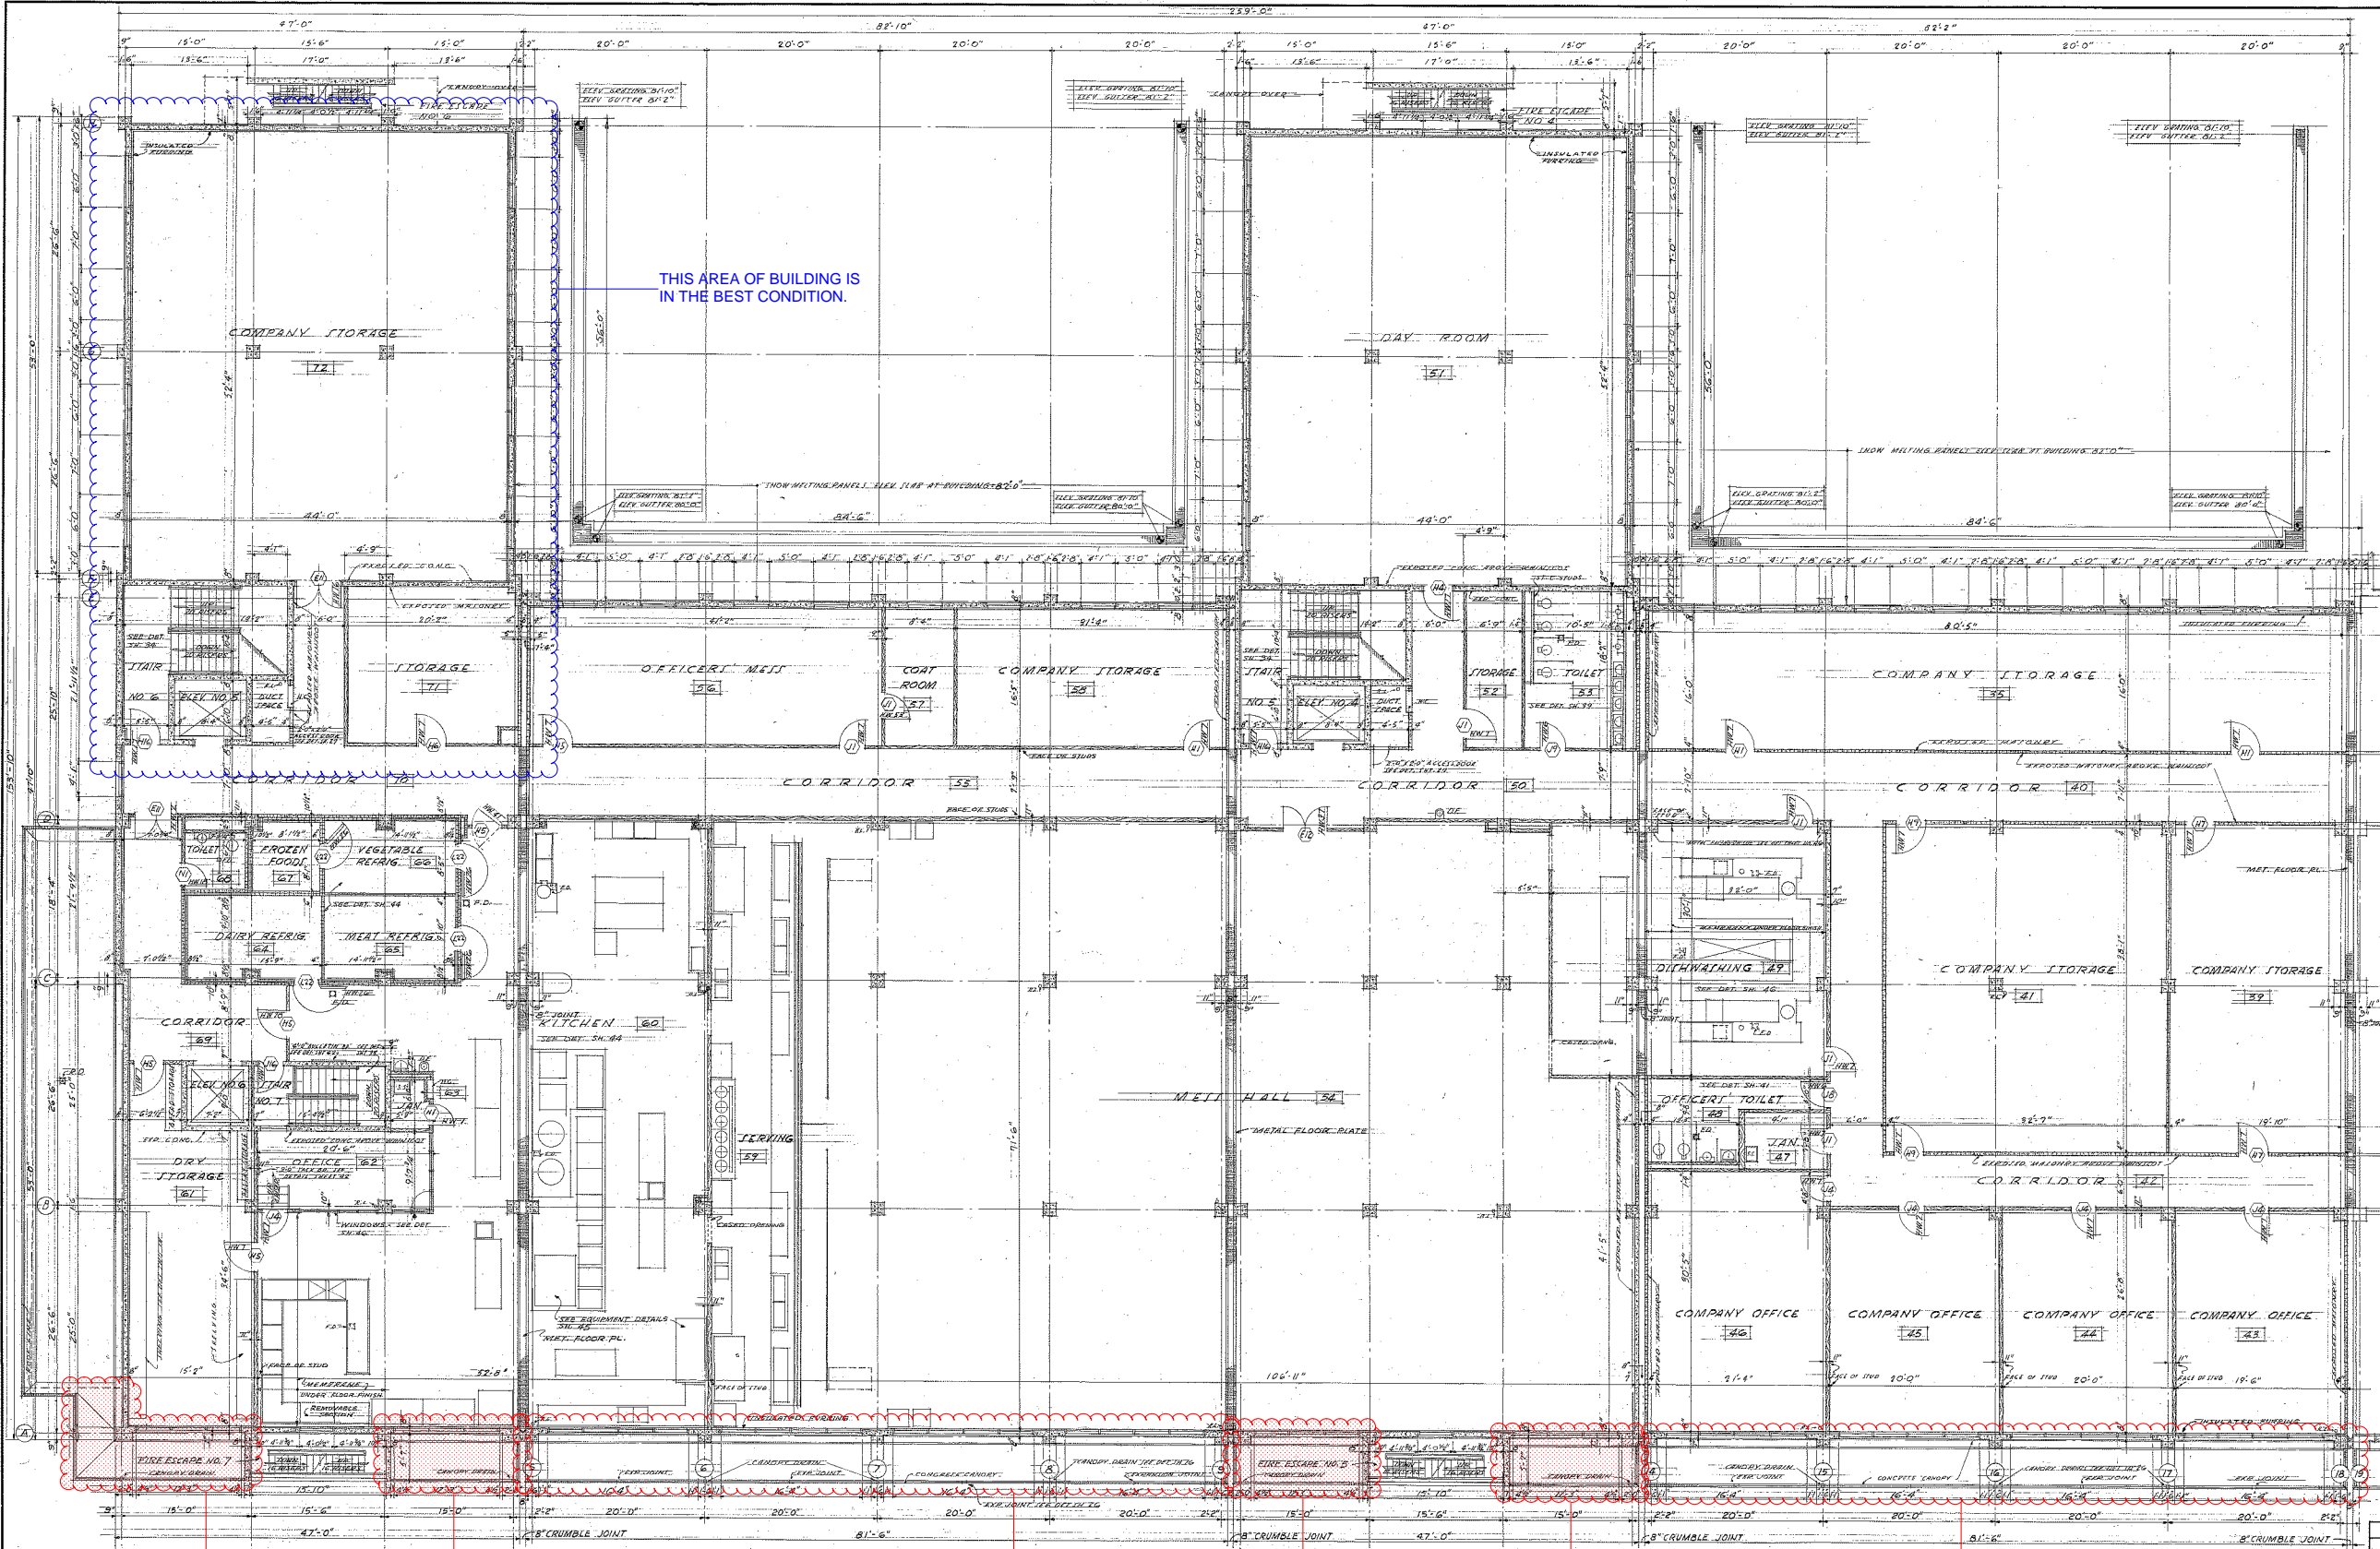
CANOPY IN POOR CONDITION CANOPY IN POOR CONDITION CANOPY HAS ALREADY COLLAPSED CANOPY IN POOR CONDITION CANOPY IN POOR CONDITION CANOPY HAS ALREADY COLLAPSED

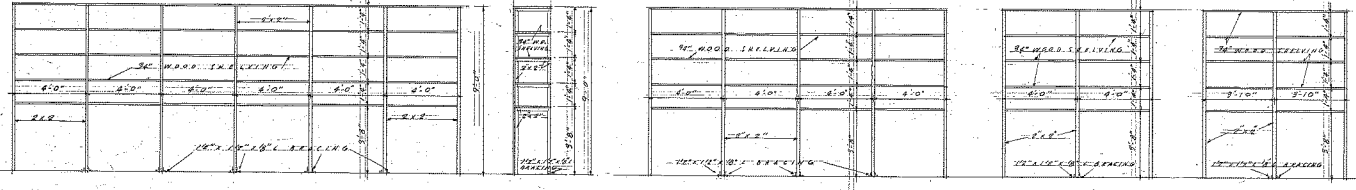
ELEVATIONS OF SHELLING IN DRY STORAGE ROOMS
