Alaska's 2011 Air Monitoring Network Plan

Chapter 2 - Anchorage

State of Alaska Department of Environmental Conservation
Division of Air Quality
Air Monitoring and Quality Assurance Section
619 E. Ship Creek Ave. Suite 249
Anchorage, AK 99501

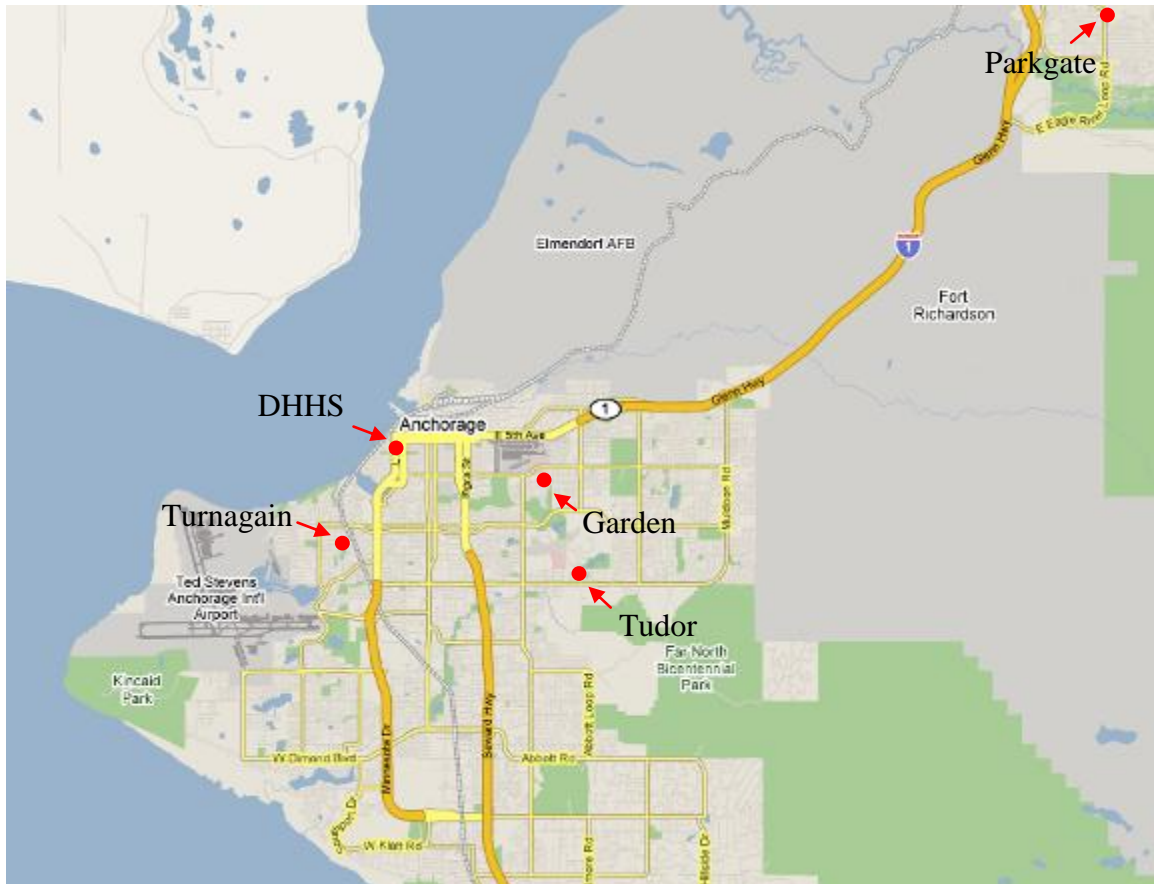
Figure 2.1:1: Map of Anchorage area. Red dots indicate monitoring sites.

and SPM monitor designations are described in Table 2-1. Figure 2.1.1 shows the entire Anchorage monitoring network. Appendix B lists siting criteria.

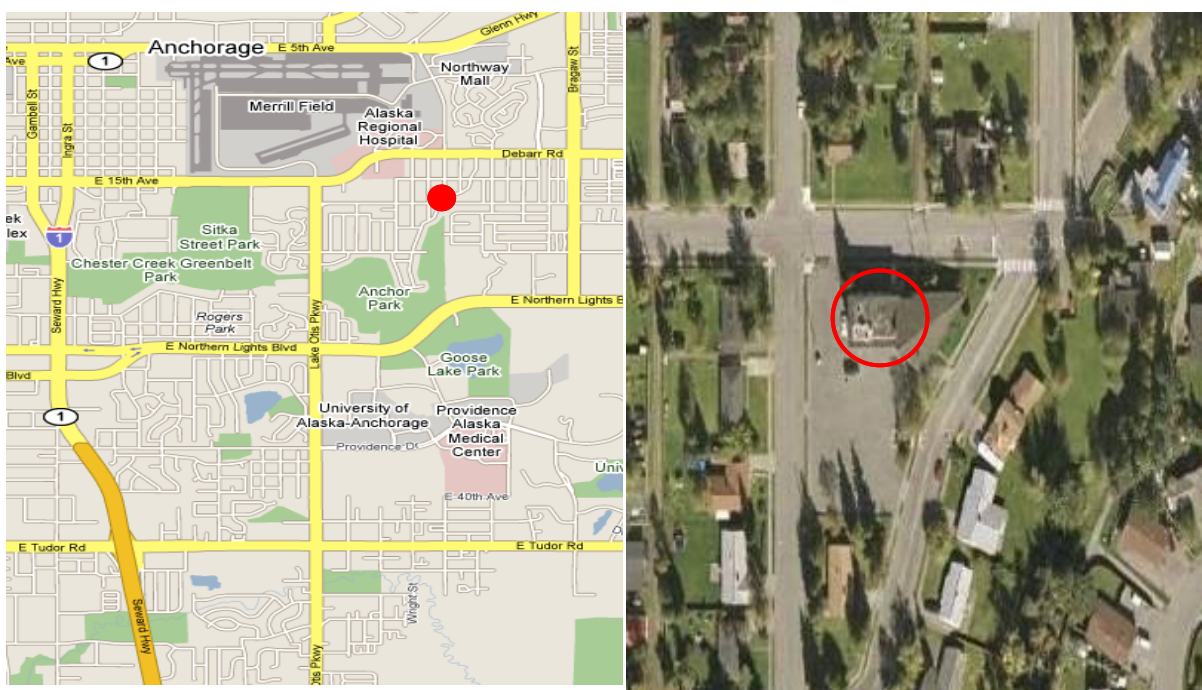
Figure 2.2:1: Street map and satellite image of the Garden monitoring site. The red circles indicate the site's location.

The Garden monitoring site is located at the Trinity Christian Reformed Church between 16th Avenue, Garden Street, and Sunrise Drive at latitude 61°12' 21.1" north (61.205861), longitude 149°49' 29.00" west (-149.824722), and 39 meters (128 feet) above sea level. Figure 2.2:1 shows a street map of the central Anchorage area and a satellite image of the area. The site is located in a suburban, residential area. Garden is a neighborhood, population-oriented CO and PM site.

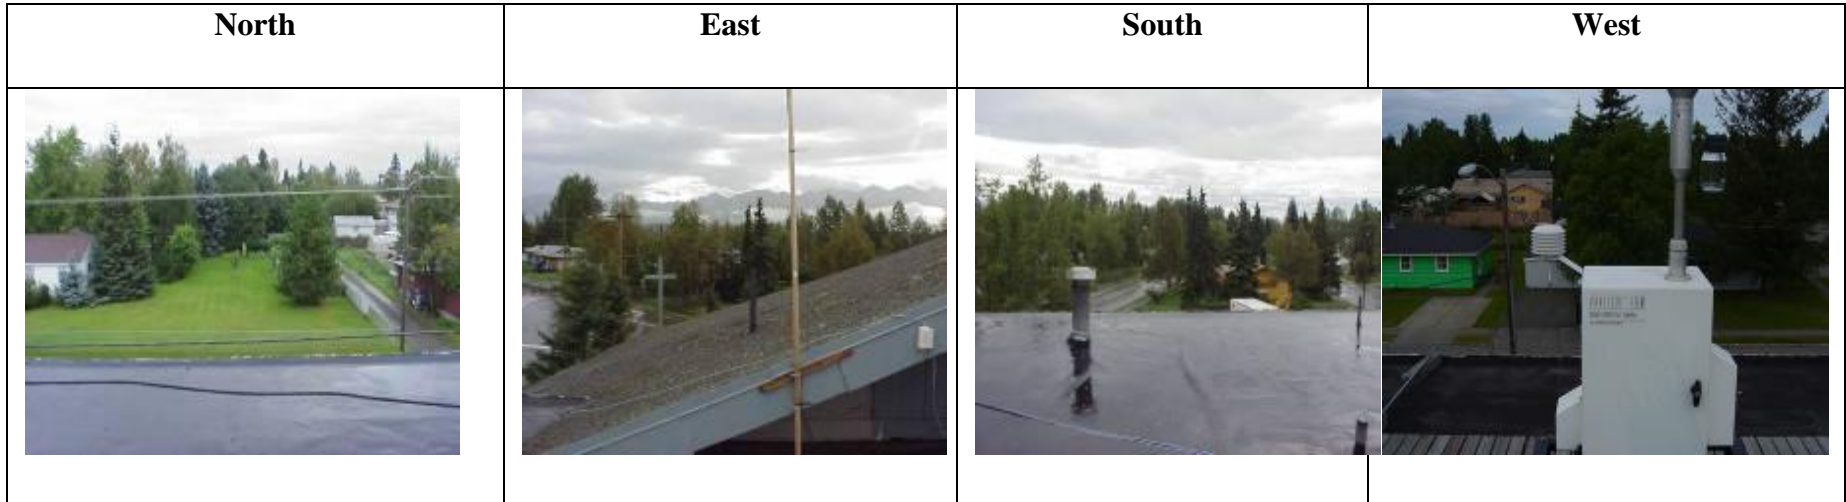
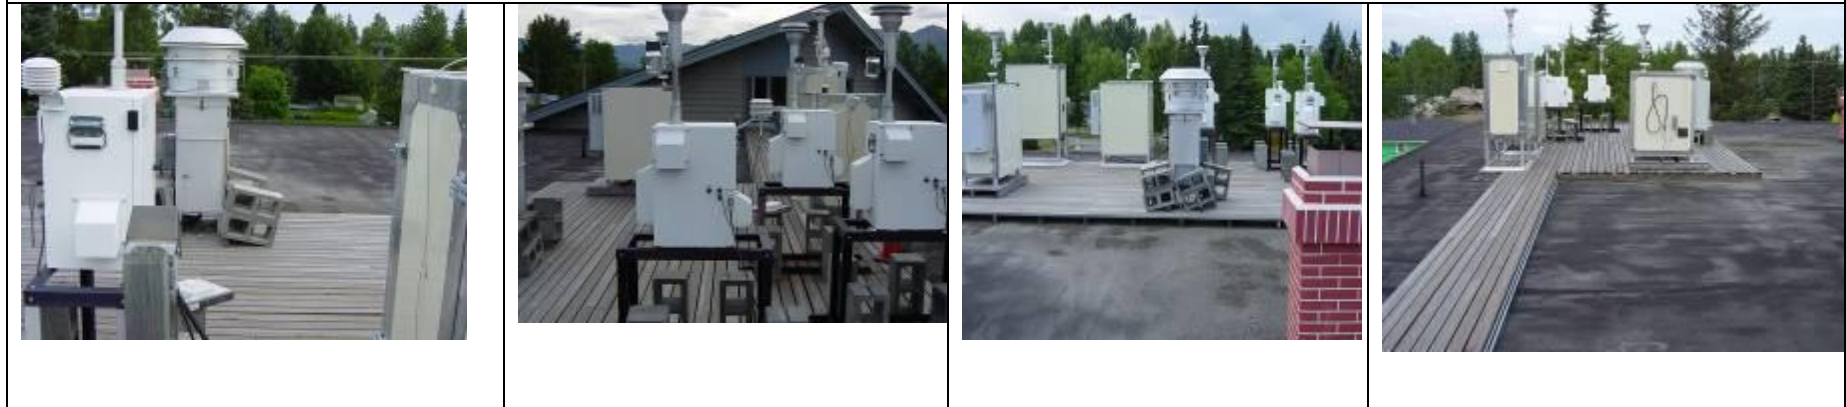
Figure 2.2:2: Pictures of the Garden Site

Views in four directions from the Garden Site

Views in four directions towards the Garden Site

The particulate matter samplers are located on the roof at the south end of the Trinity Christian Reformed Church. Access to the site is by use of a window from a split level section of the church. This split level area is several meters from the monitoring site. The roof height is six meters (19 feet), and there are no trees in the vicinity that significantly exceed the height of the samplers. The airflow to these samplers is unobstructed. The samplers are approximately 14 meters (32 feet) south of the nearest traffic lane of 16th Avenue.

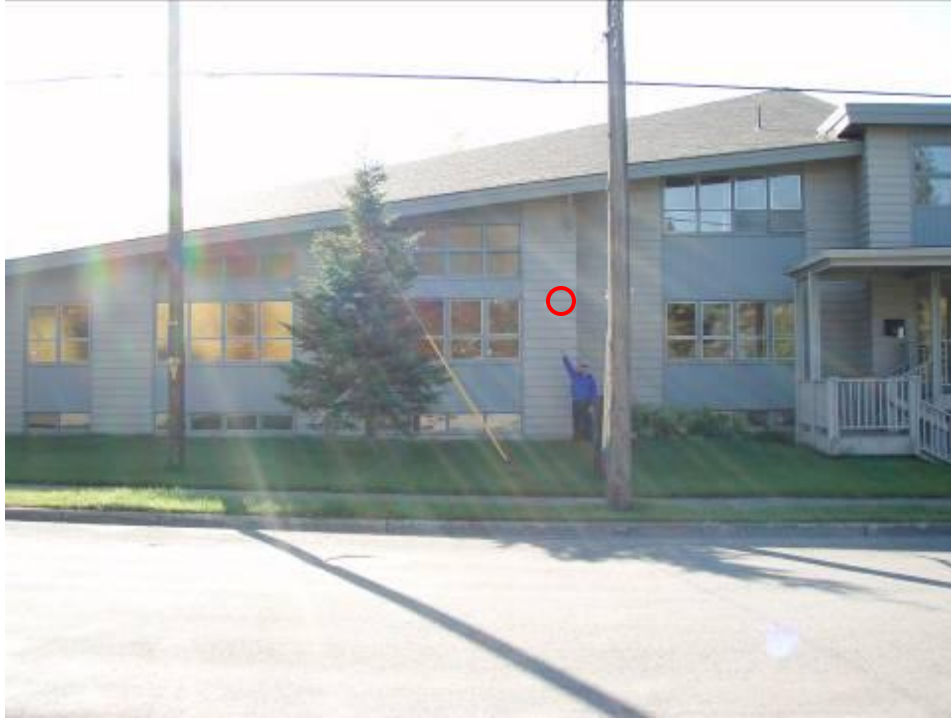
Figure 2.2:3: View of CO probe at Garden Site. The red circle indicates where the probe is located.

The CO inlet probe is fixed to the north wall of the church 3 meters (9.5 feet) above the ground approximately 10 meters (32 feet) from the nearest traffic lane of 16th Avenue. Between the inlet and 16th Avenue is one tall spruce tree. The church itself obstructs air flow from the south. The probe inlet for the ozone analyzer is located 1 meter above the roof and is unobstructed.

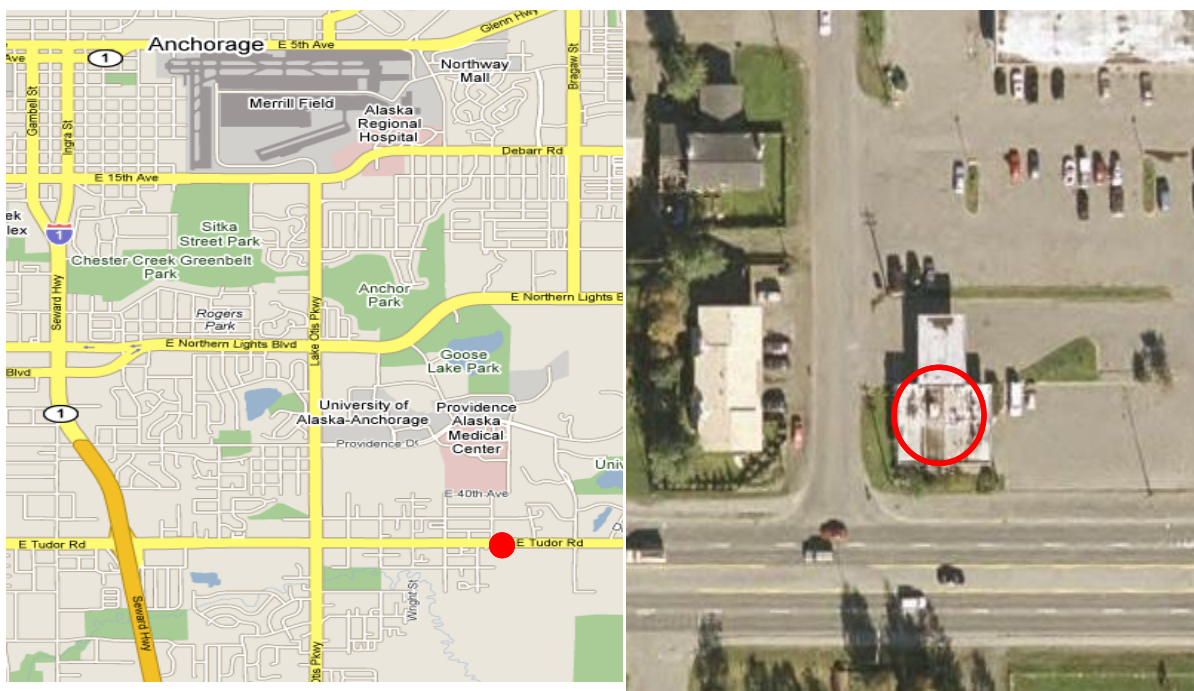
Figure 2.2:4: Street map and satellite image of the Tudor monitoring site. The red circle indicates the sites location.

The Tudor monitoring site is located at 3335 East Tudor at latitude 61°10' 51.9" north (61.181083), longitude 149°49' 2.8" west (-149.817389), and 50 meters (164 feet) above sea level. Figure 2.3:1 shows a street map of the central Anchorage area and a satellite picture of the area immediately surrounding the Tudor site. The site is located in an urban, commercial location. Tudor is a microscale, population-oriented site.

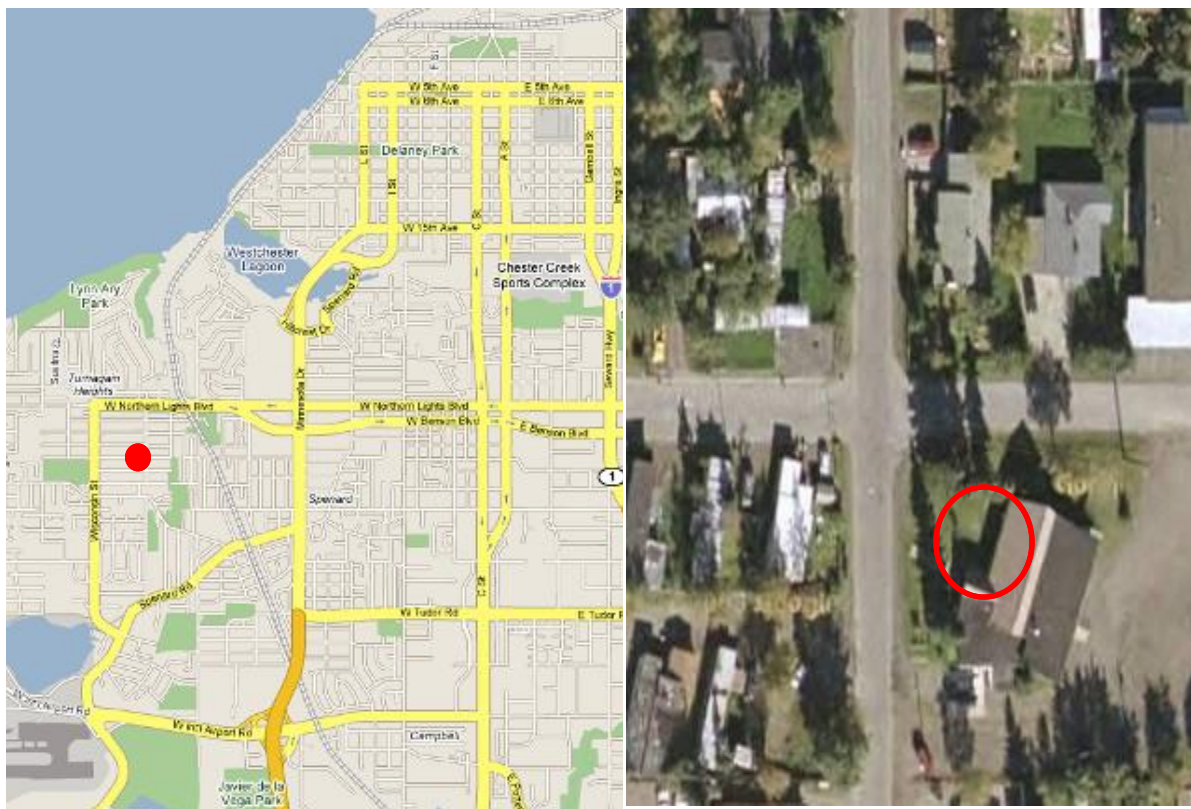
Figure 2.3:1: Street map and satellite image of the Turnagain monitoring site. The red circles indicate the sites location.

The Turnagain CO monitoring site is located at the corner of Turnagain Street and 32nd Avenue at latitude 61°11' 29.4" north (61.192222), longitude 149° 56' 6.9" west (-149.985833), and 21 meters (69 feet) above sea level. Figure 2.4:1 is street map of the western part of Anchorage and a satellite picture of the Turnagain site and surrounding area. The site is located in a suburban location. Turnagain is a neighborhood scale, population-oriented site.

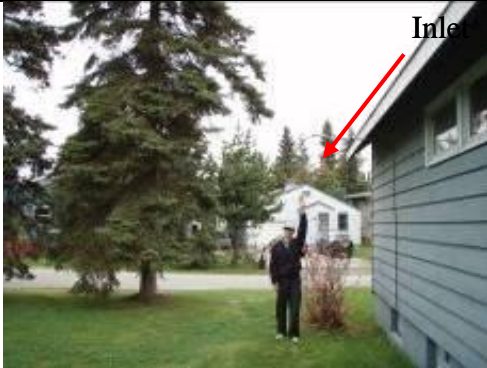
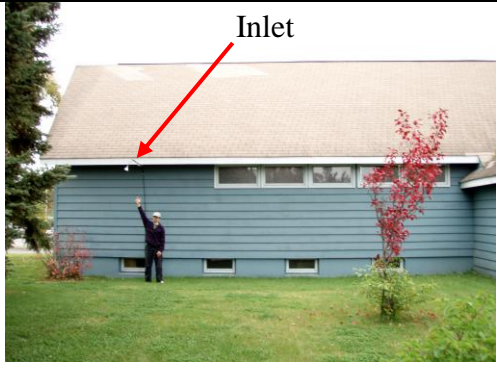
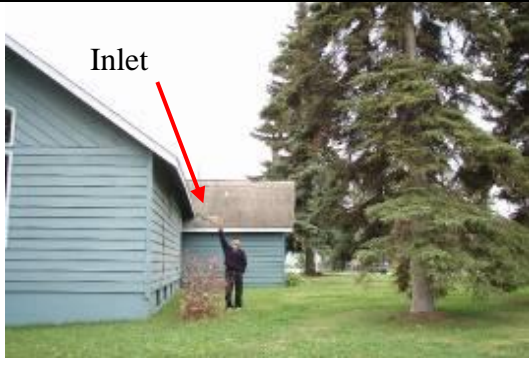
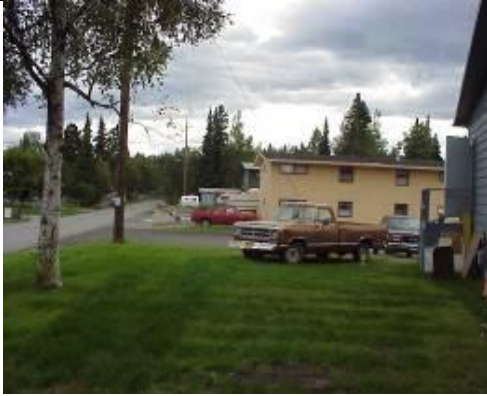
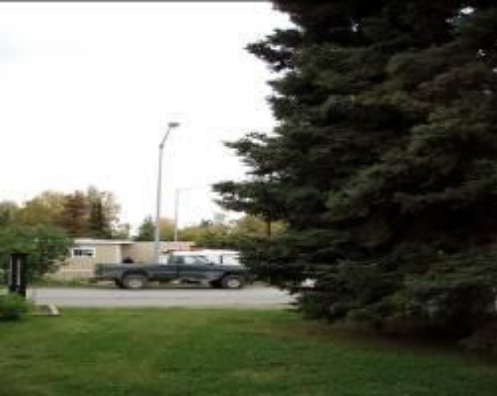
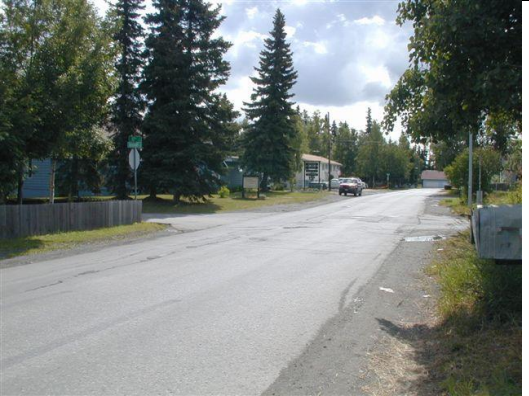
Figure 2.3:2: Pictures of the Turnagain Site

<p>Views in three directions towards the Turnagain Site</p>		
North	West	South

<p>Views in three directions from the Turnagain Site</p>

The monitor is installed in the Unitarian church. The inlet probe is approximately 3.0 meters (9.5 feet) above the ground. The inlet probe is approximately 18.5 meters (58 feet) from the nearest traffic lane of Turnagain Street. Between the inlet and Turnagain Street are several tall white spruce trees. The church itself obstructs air flow from the south and east.

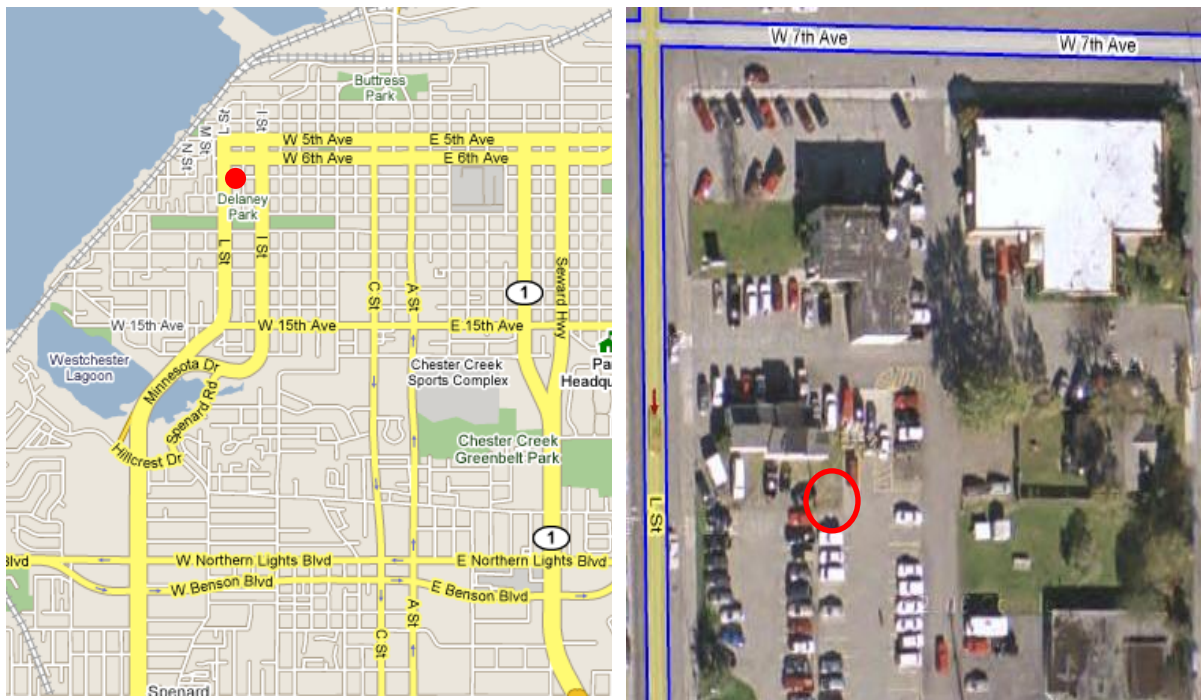
Figure 2.4:1: Street map and satellite image of the DHHS monitoring site. The red circles indicate the sites location.

The Department of Health and Human Services (DHHS) monitoring site is located in the employee parking lot for DHHS at latitude 61° 12' 54.1" north (61.215027), longitude 149° 54' 11.2" west (-149.903111), and 35 meters (115 feet) above sea level. Figure 2.5:1 shows a street map of the western part of Anchorage and a satellite picture of the DHHS site and surrounding area. The site is located downtown. The Municipality of Anchorage considers the DHHS site to be middle scale, representing a dimensional area up to 0.5 km.

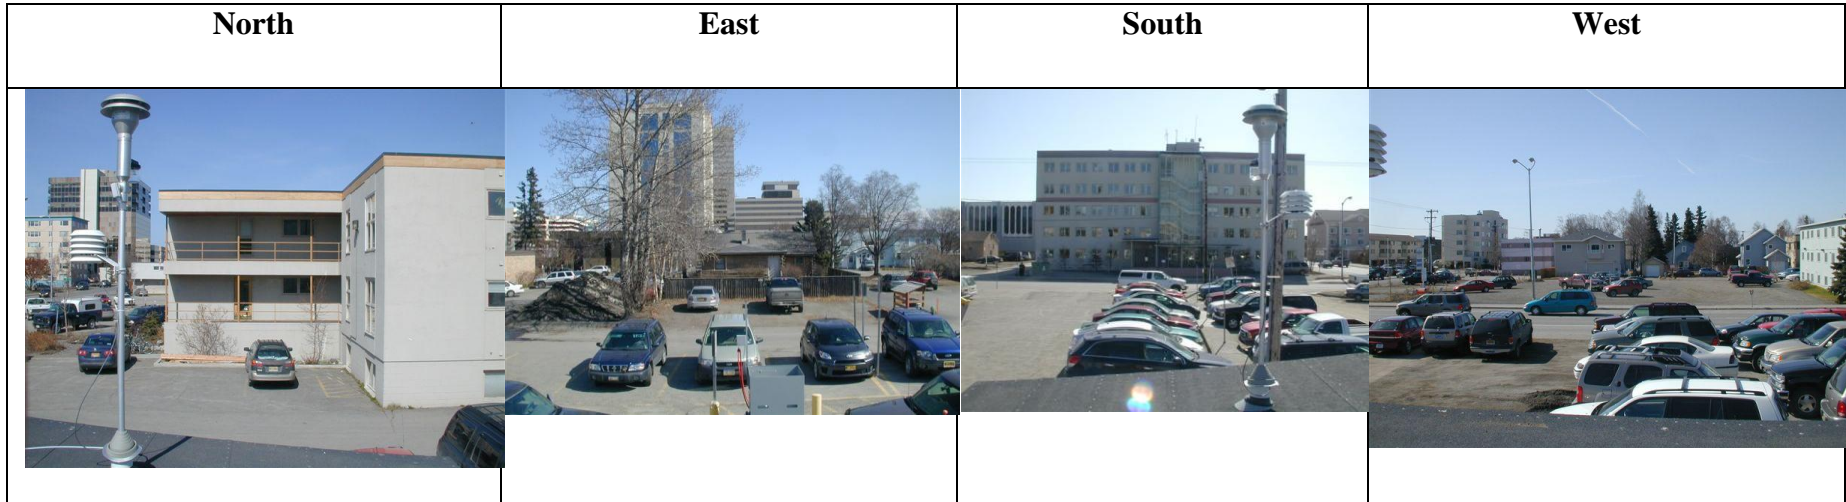
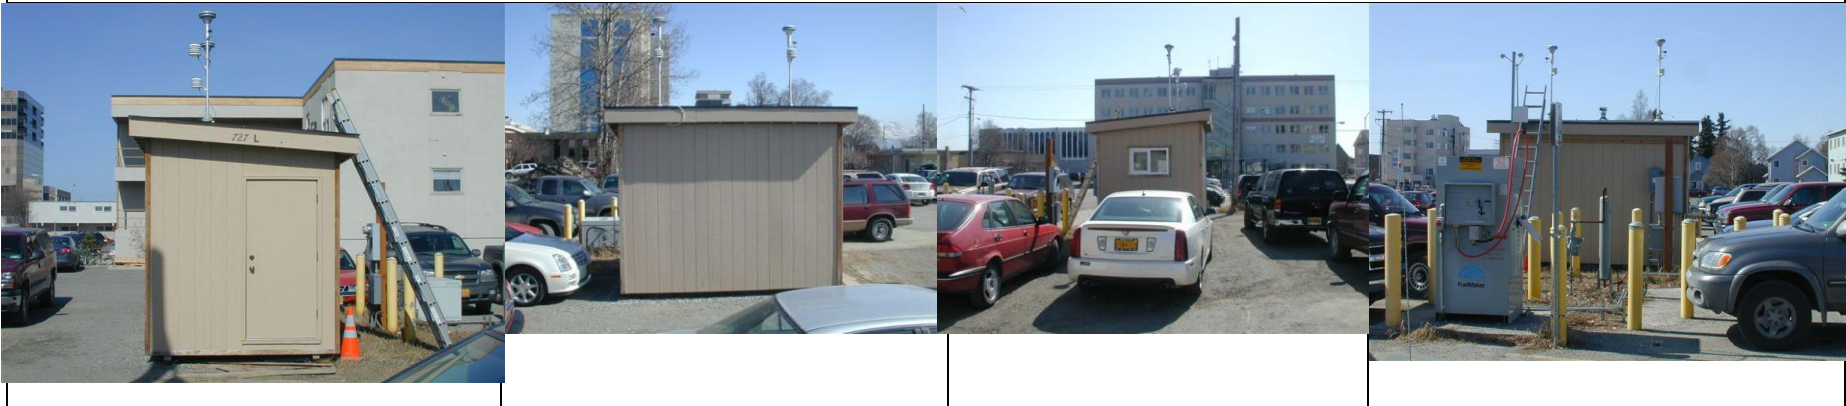
Figure 2.4:2: Pictures of the DHHS Site

Views in four directions from the DHHS Site

Views in four directions towards the DHHS Site

The monitors are installed in a small shed building located at 727 L Street. The CO inlet probe is approximately 3 meters (9.5 feet) above the ground. The inlet probe is approximately 28 meters (85 feet) from L Street, the nearest traffic lane. The probe extends off the northwest corner of the shed, and air flow to the probe is unobstructed for 270 degrees. The PM₁₀ and PM_{2.5} inlets each extend 1 meter above the shed roof with 2 meters of separation between them. This site has sufficient separation distance from surrounding buildings to meet EPA siting criteria.

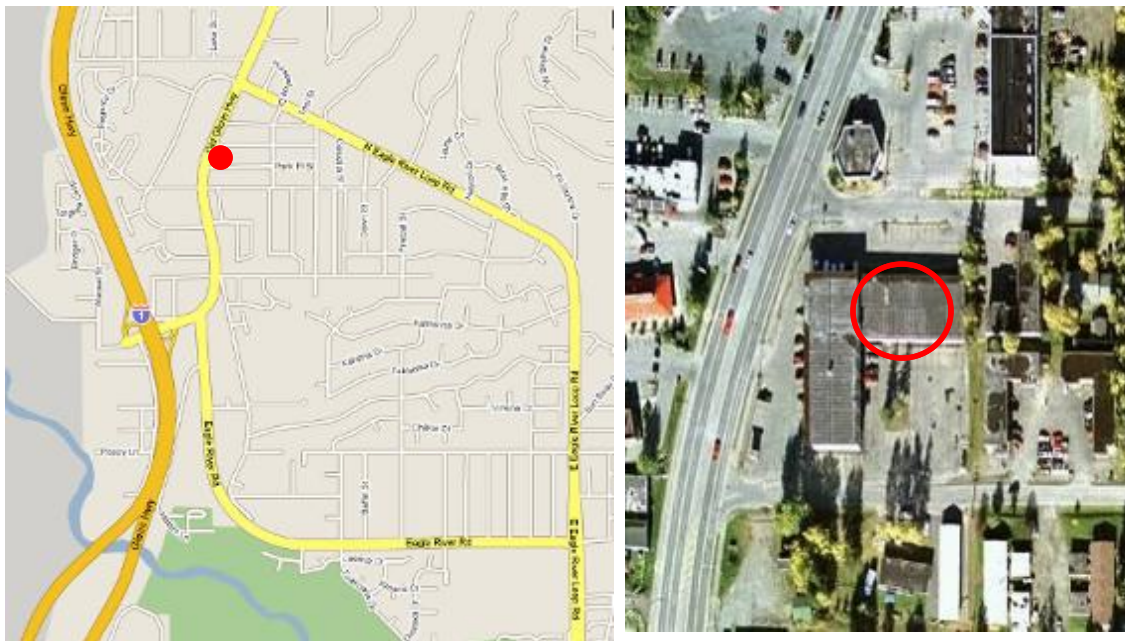
Figure 2.5:1: Street map and satellite image of the Eagle River monitoring site. The red circle indicates the sites location.

The Parkgate PM₁₀ monitoring site is located at the Parkgate Business Center building in Eagle River (a bedroom community of Anchorage that lies within the Municipality) at latitude 61° 19' 36.0" north (61.326667), longitude 149° 34' 10.8" west (-149.569667), and 100 meters (328 feet) above sea level. Figure 2.6:1 is a street map of the western Eagle River area and a satellite picture of the Parkgate site and surrounding area. The site is located in a suburban/commercial use area with monitoring site classified as neighborhood scale, population-oriented monitoring site.
